**NATIONAL REGISTER OF HISTORIC PLACES
PROPERTY PHOTOGRAPH FORM**

HISTORIC Cedars Plantation or Williams Home Place

CITY/TOWN Oak Ridge VICINITY OF COUNTY Morehouse STATE Louisiana

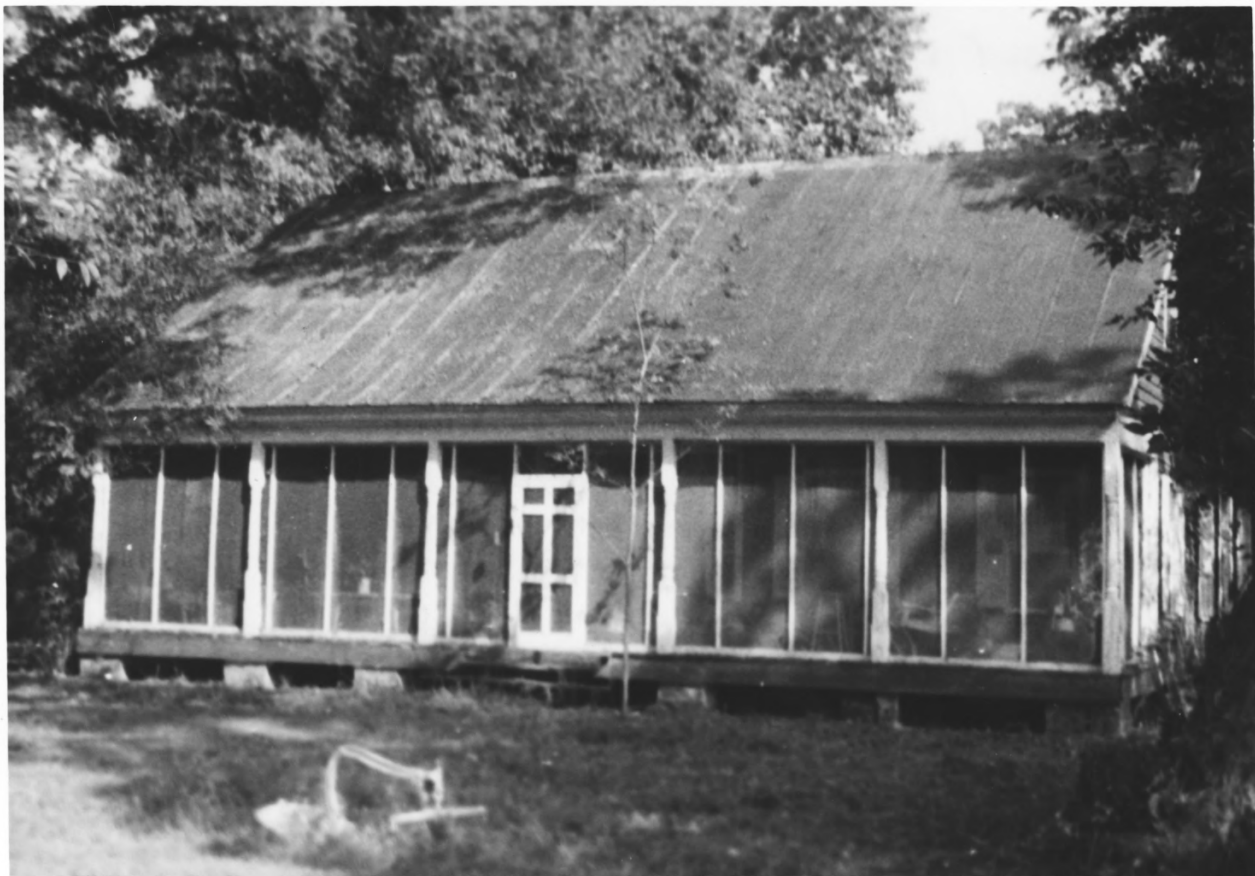
PHOTO NO. 1 of 16

Front of the house facing southeast. Original shingles are under the present tin roof. Stucco covered brick piers replace huge cypress blocks used on original foundation. Original gallery not screened. Turned milled columns replaced square cypress columns in 1870.

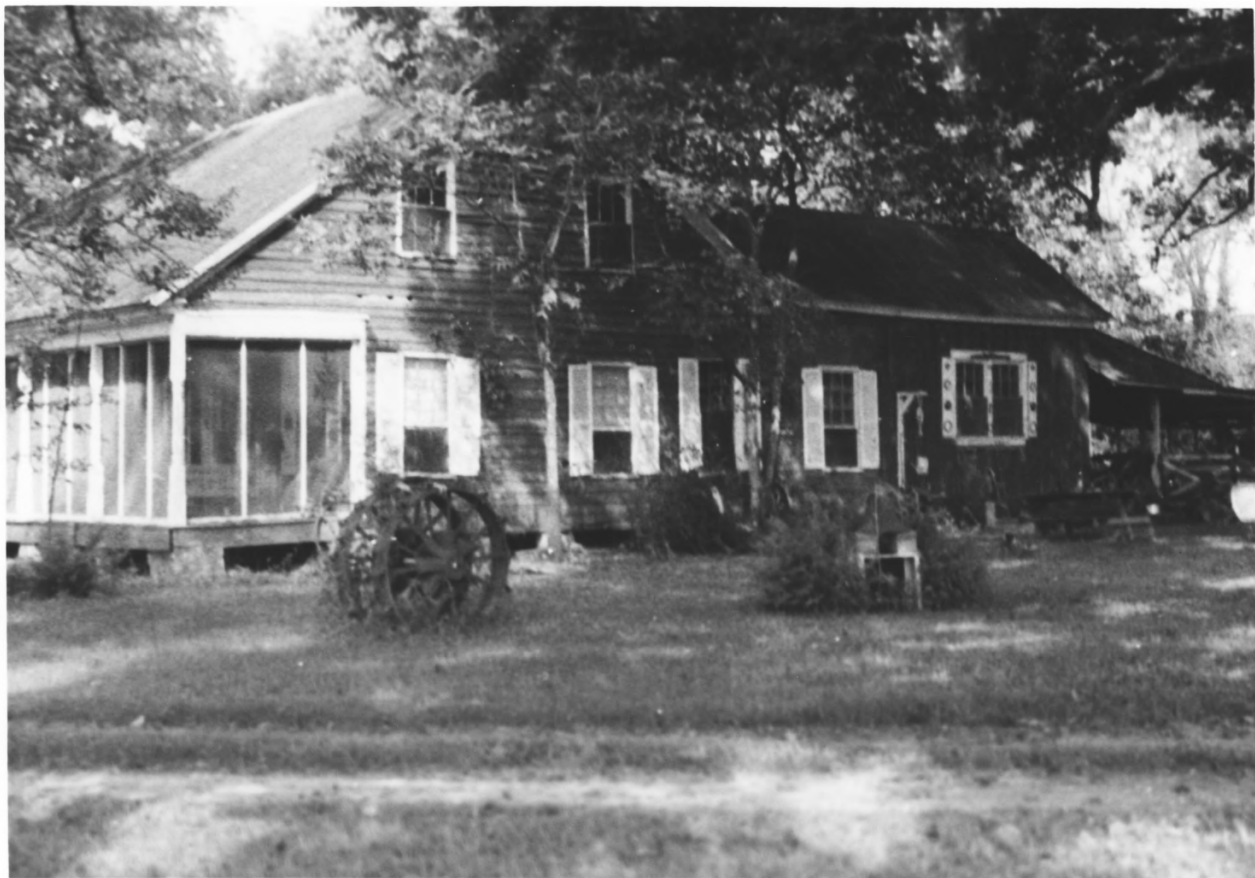
PHOTO NO. 2 *2/16*

Easterly side of house showing wing forming the L where the kitchen was added in 1870. Original part of house is that portion where the straight side of the roof line joins the roof rising to form the gable. Shutters shown are original and there are four sets on gallery windows.

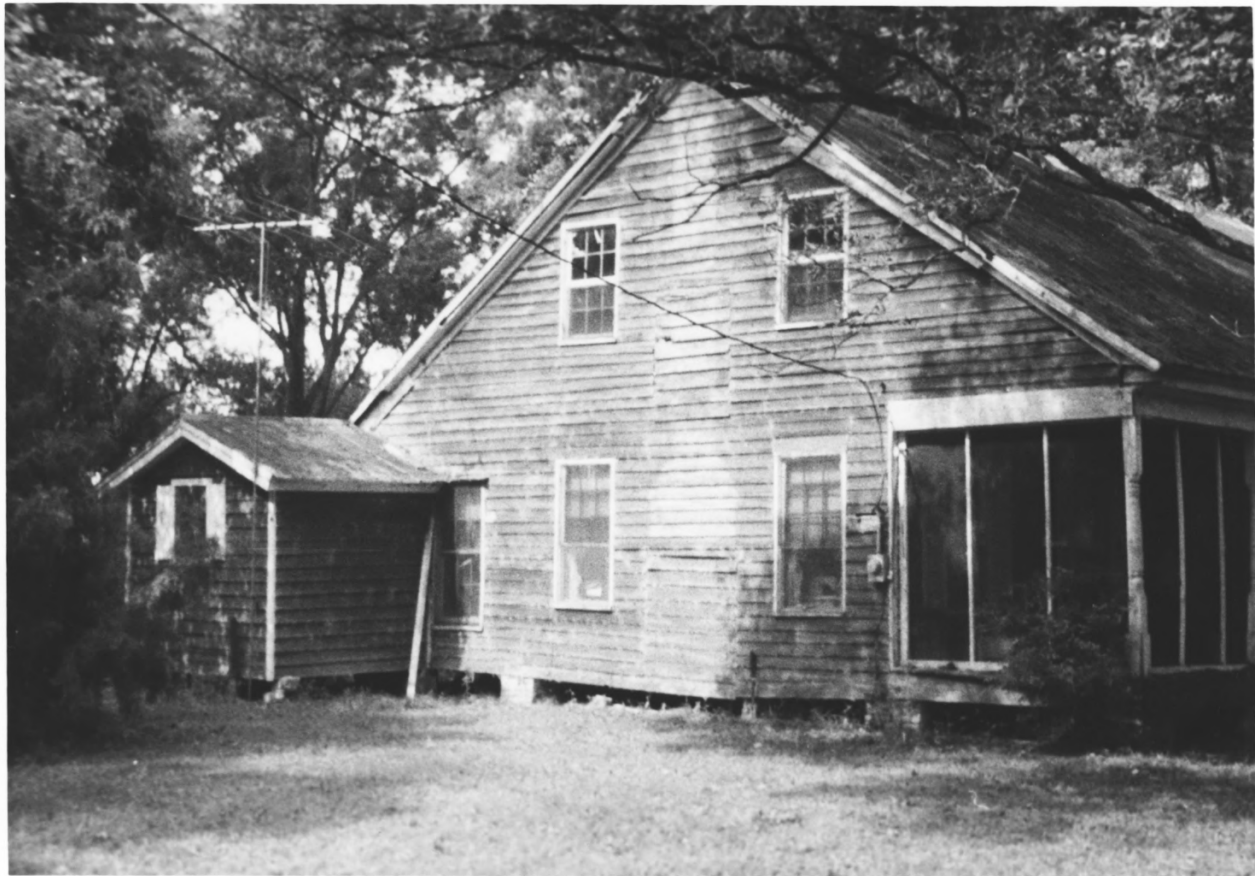
PHOTO NO. 3 of 16

Westerly direction showing roof and gallery detail. Also showing position of chimney which furnished a fireplace for upper and lower front rooms. Another chimney was identical on easterly side of house; chimneys removed because they were unsafe. Also shows detail of bathroom addition.

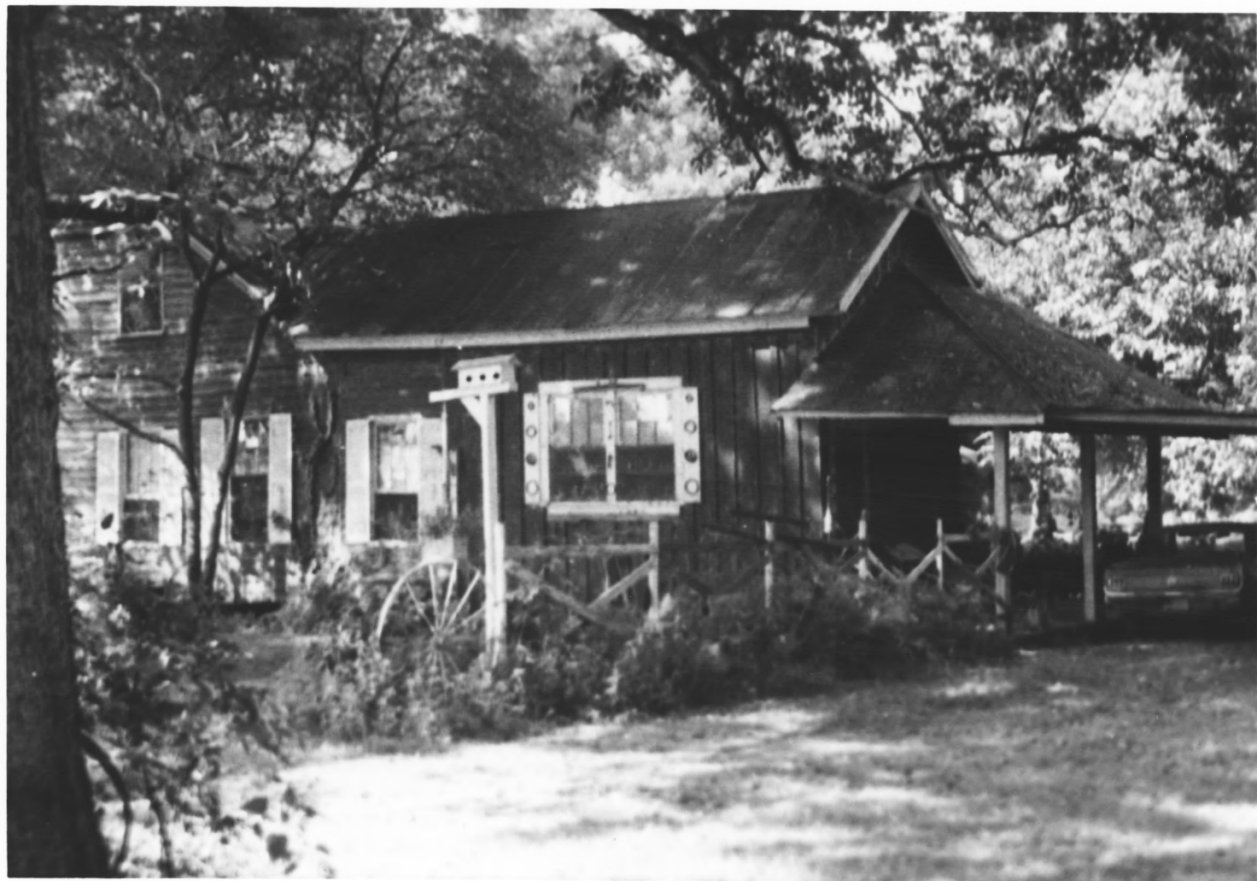
PHOTO NO. 4 of 16

Easterly direction showing kitchen wing added in 1870. Also showing roof line joined to original house. Double carport was added off gallery in 1952 for convenience. Tin roofing added over original cypress shingles.

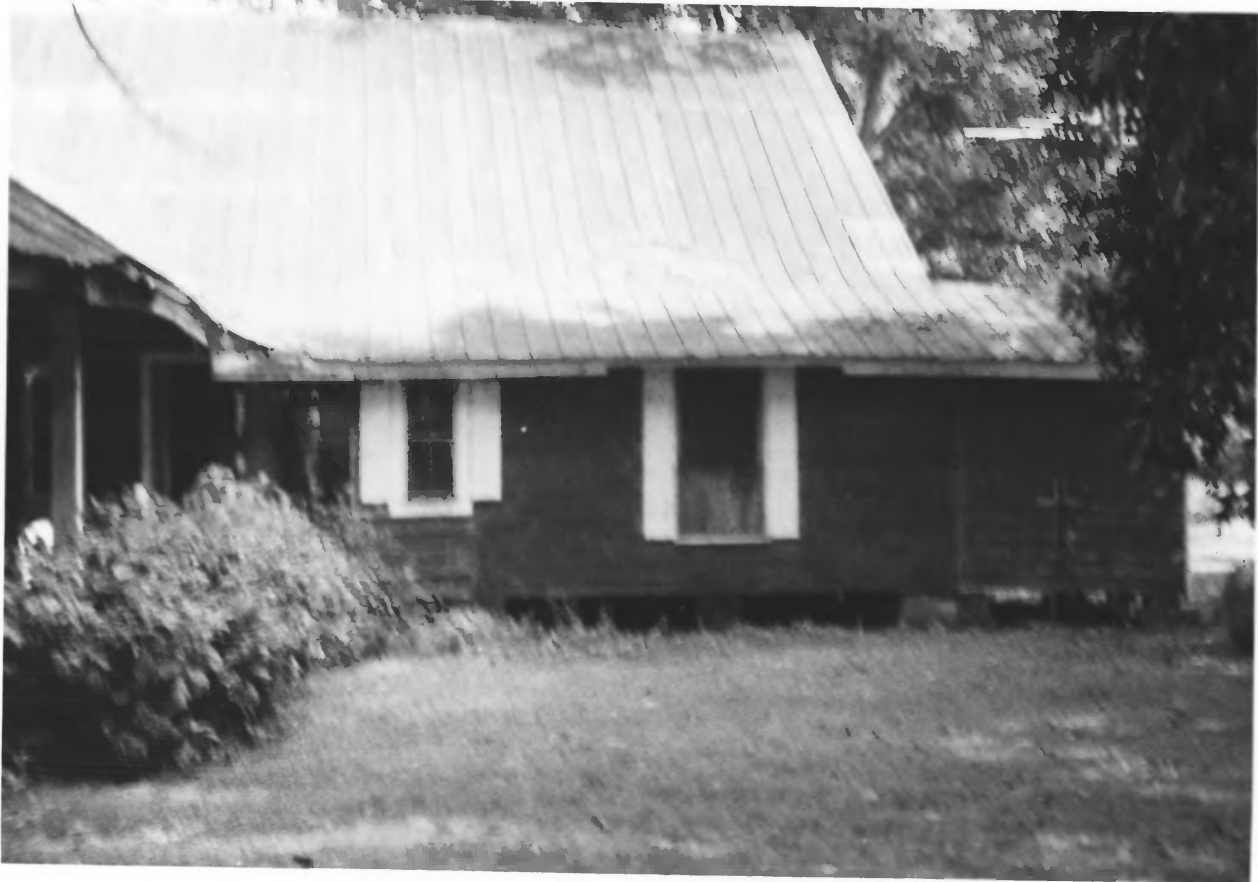
5 of 16

Northerly direction showing back of house where the wing was added in 1870 forming the kitchen and back gallery. To right is shown small bathroom added in 1920.

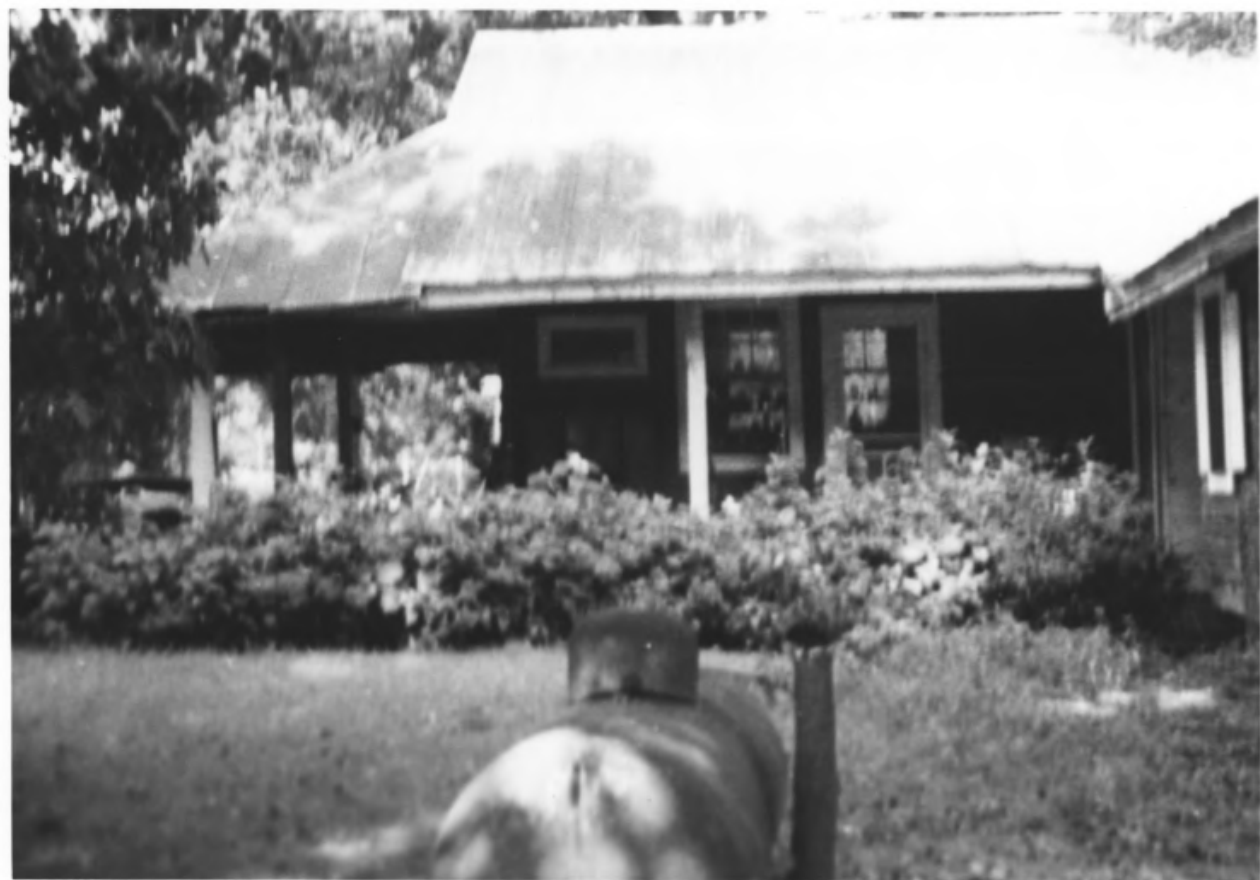
PHOTO NO. 6 w/16

Westerly direction showing kitchen and gallery wing added in 1870. Gallery was screened but present owner has removed screening and wood floors and concreted floors at ground level.

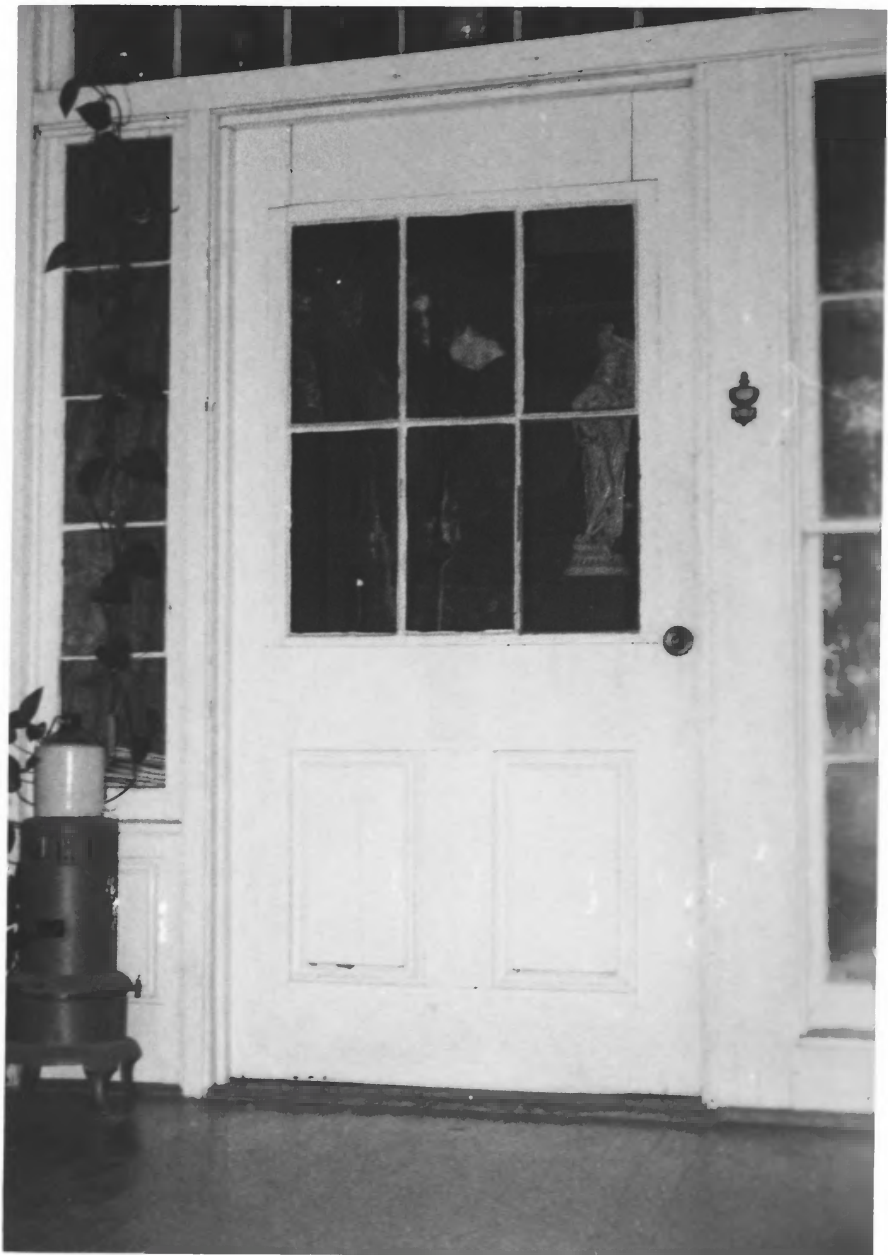
7 of 16

Showing detail of front door; door was damaged in a storm and window panes replaced solid panels. Another solid four paneled door was to right of door but was destroyed by storm and replaced with window as shown. All window panes are original bubble glass. Antique windows used in repair work.

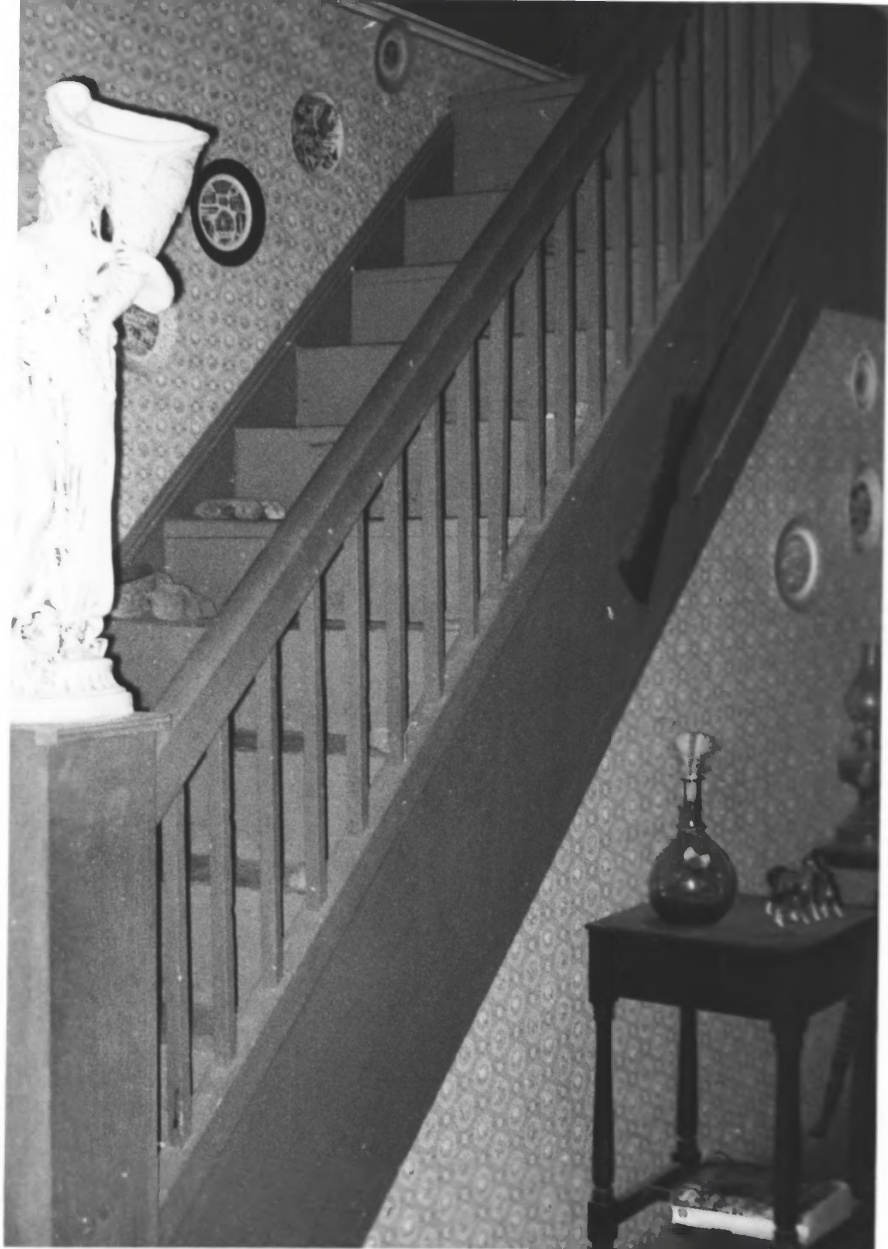
8 2/16

Showing detail of stair construction. Board under rail is hand planed from a single timber 18" wide and 10' long. Plane marks are visible. Treads and risers are heart pine. Stairs original except were turned around to rise from front hall instead of back hall as originally built.

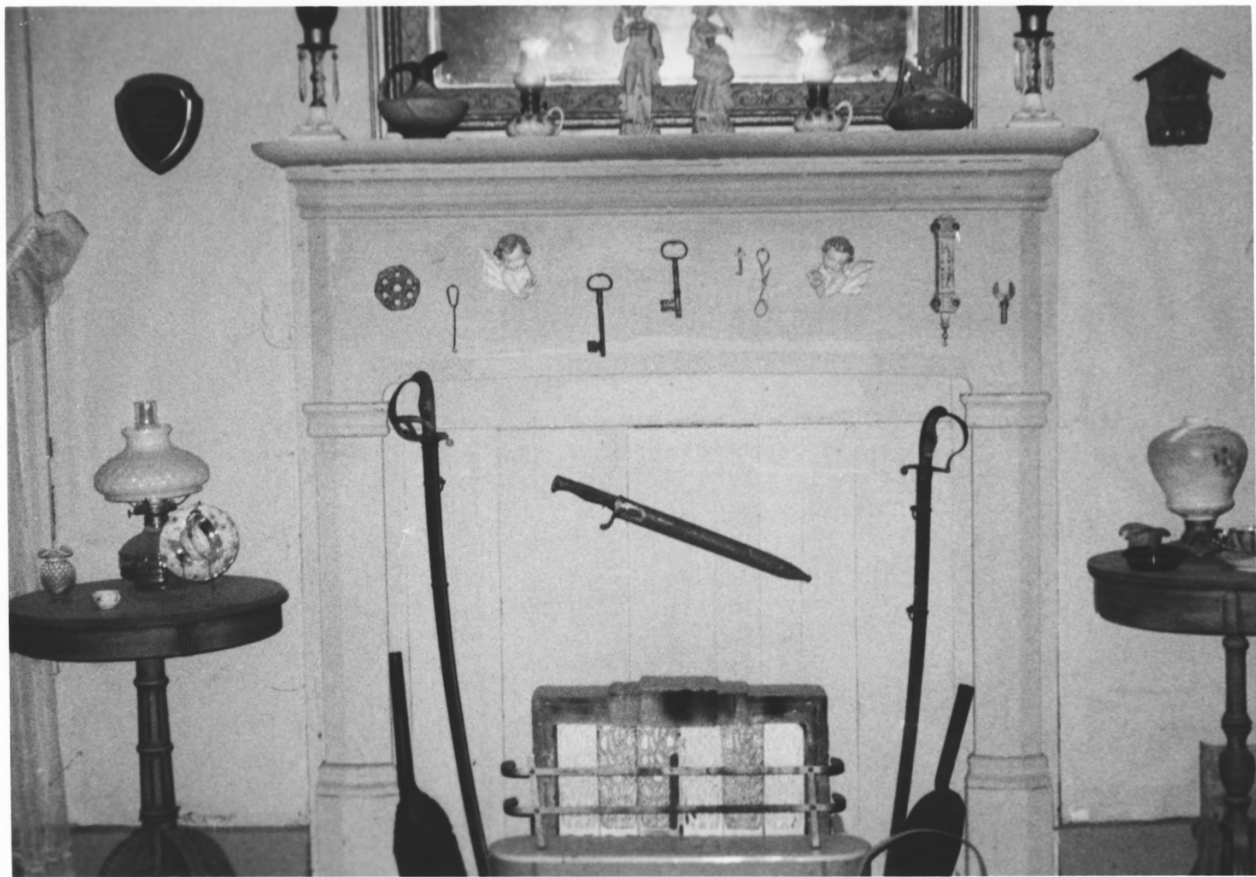
9 of 16

Detail showing original hand made mantel in parlor. Made from heart pine.
All original except boards that cover fire place opening. Another mantel
identical in front bedroom on other side of hall.

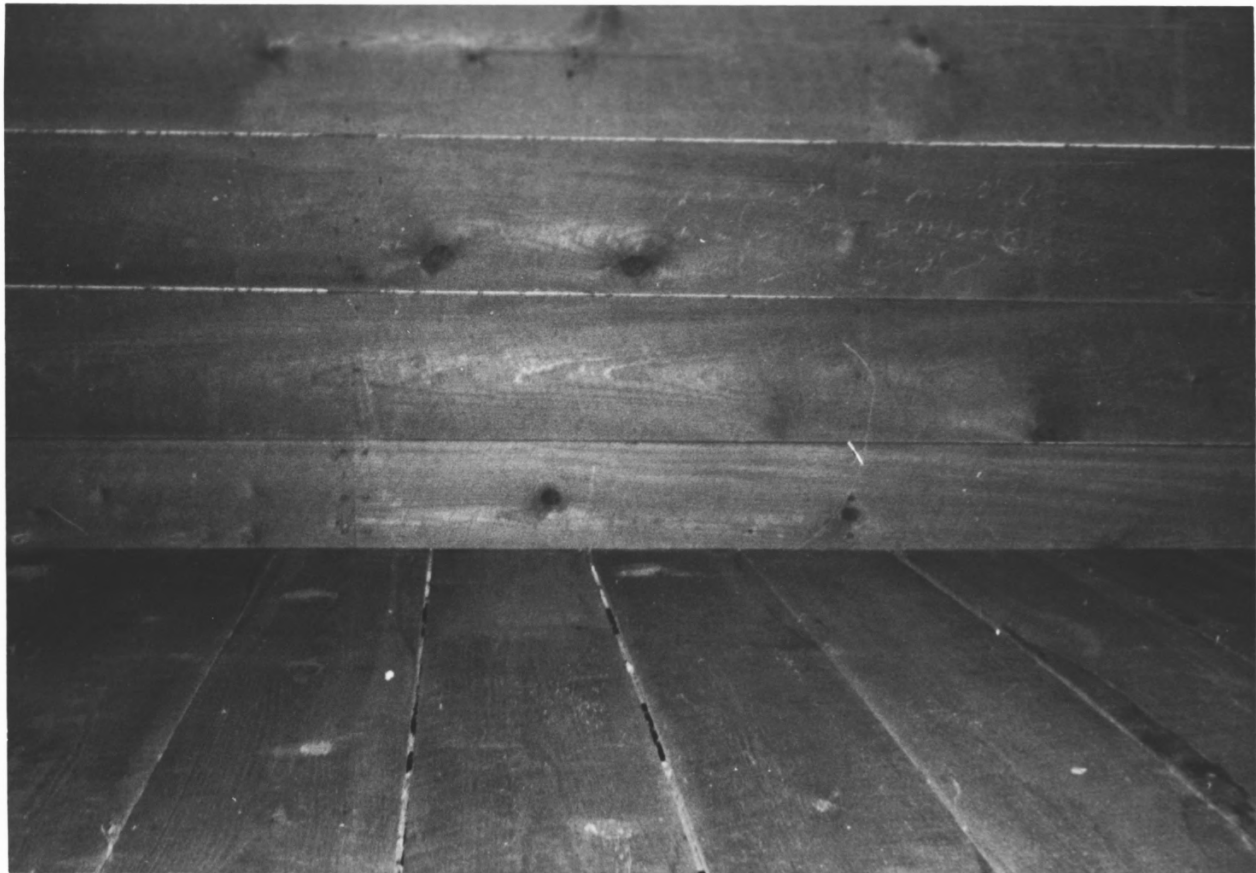
PHOTO NO. 10 w/16

Construction detail showing random width rough board used to seal the upper rooms and hall.

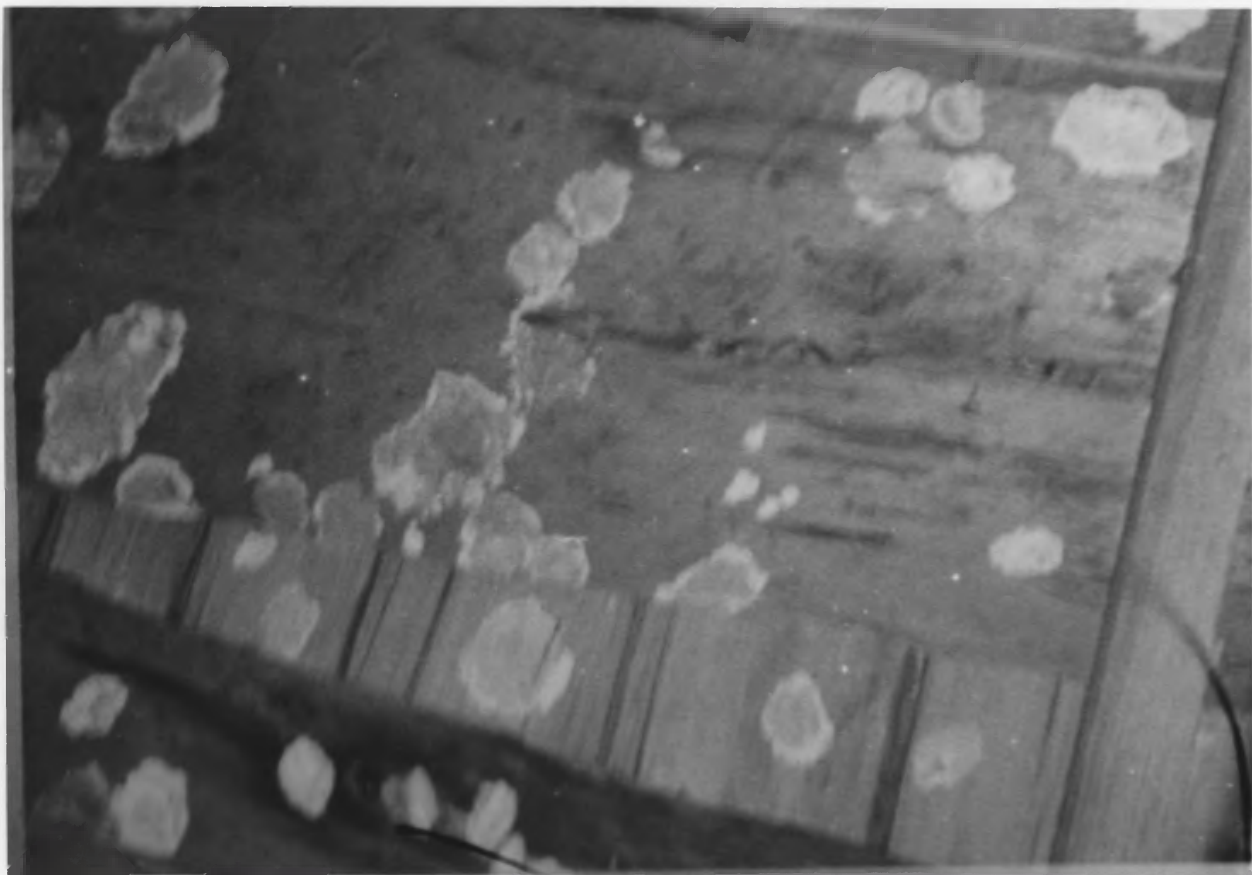
PHOTO NO. 11 of 16

Construction detail in attic showing original cypress hand split shingles and random width boards used as sheathing. Original rafter detail also shown. White spots are nests or houses of a wasp-like insects who make their nests with mud.

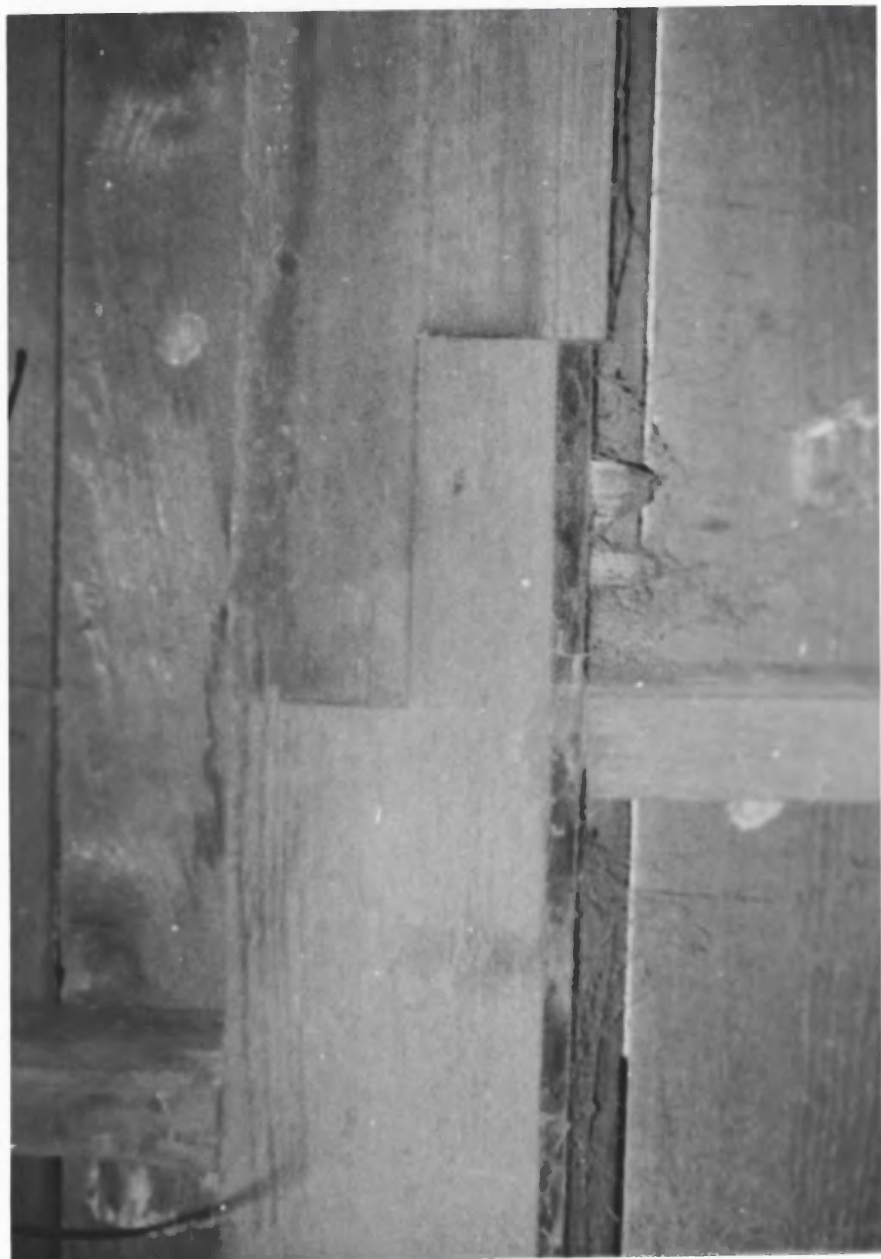
PHOTO NO. 12 of 16

Construction details showing notched and pegged timbers in the attic
of the house

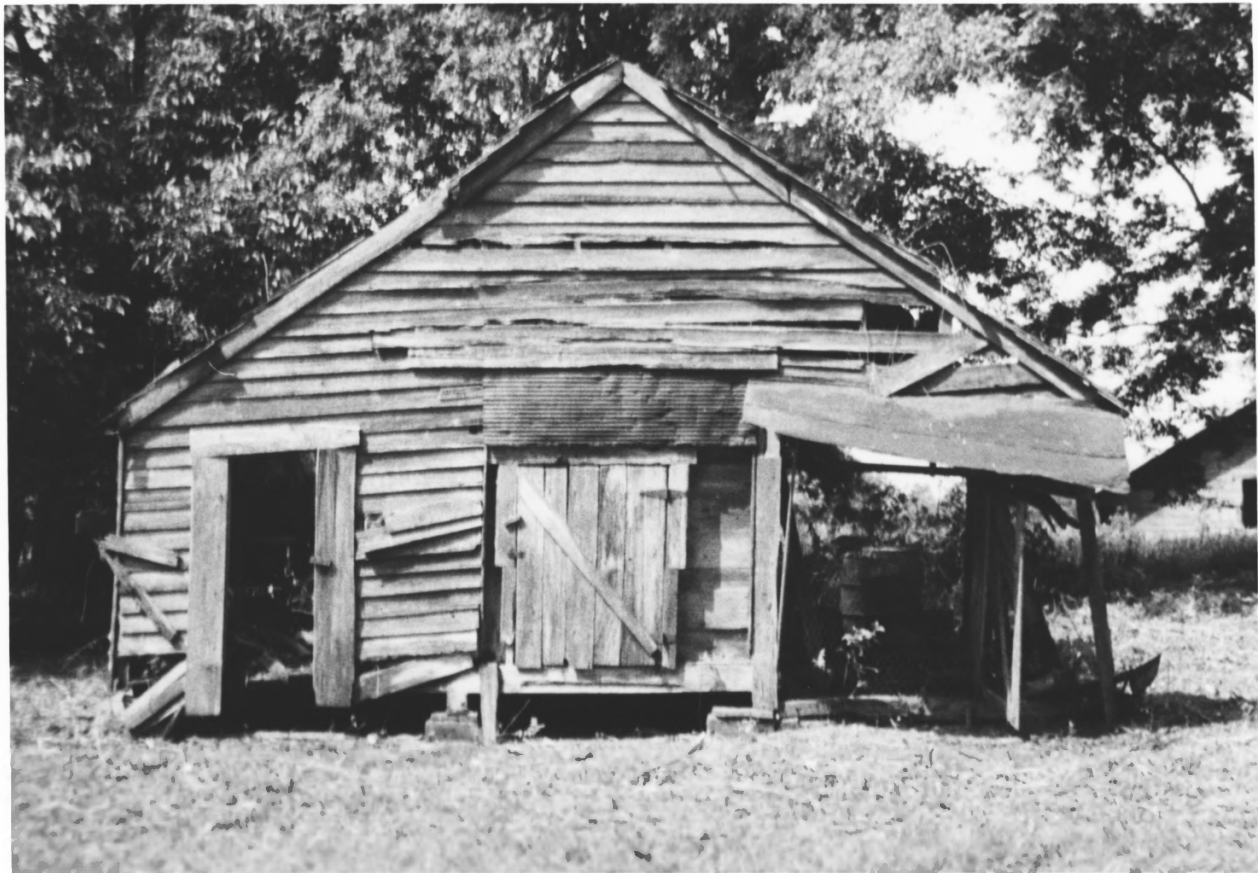
PHOTO NO. 13 of 16

Original "buggy" house. Carriage was parked to right. Center door opened to tack room for harness and farm tools. Opening to left was feed room for carriage horses, who were fed separately from work animals. Faces west side of house.

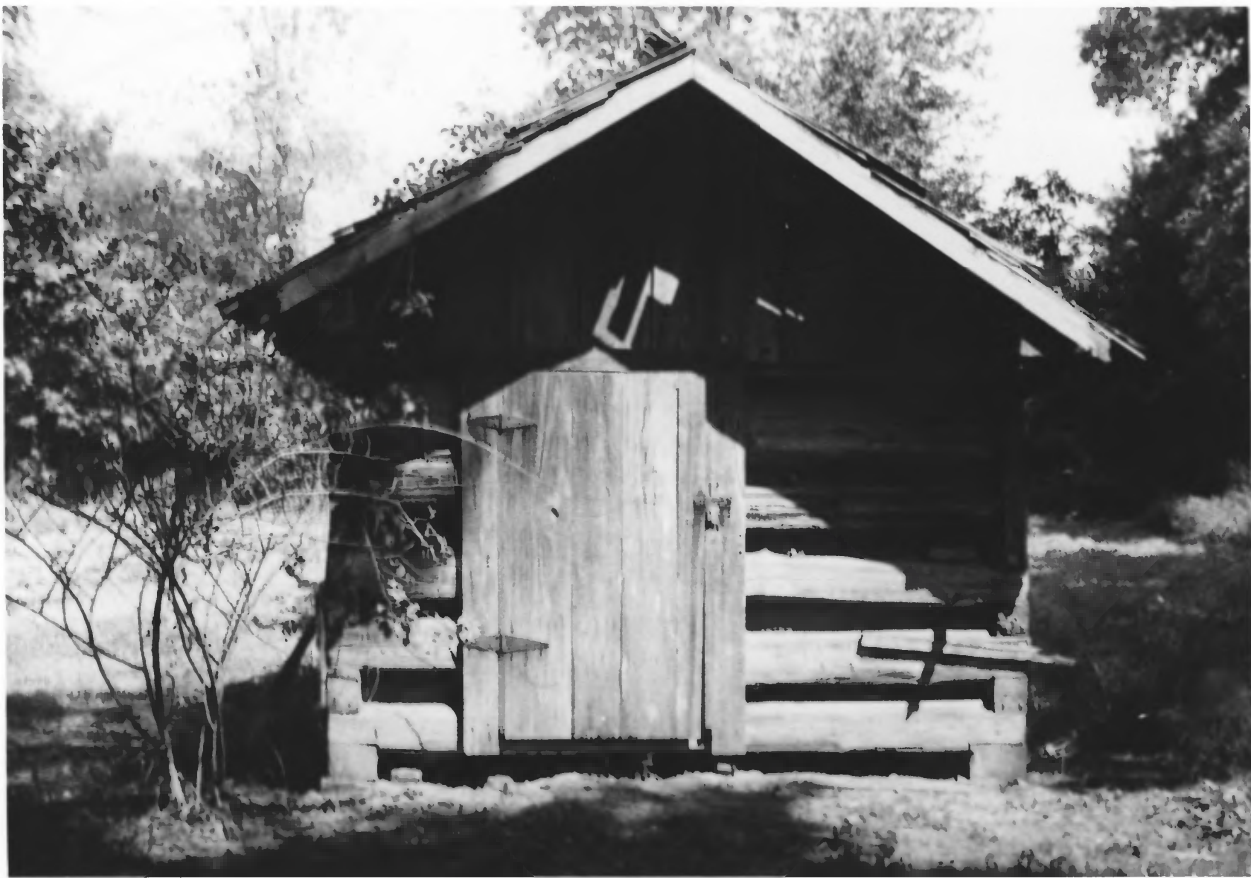
PHOTO NO. 14 of 16

Front view of log smoke house, facing back of the house. Logs are battened inside with boards.

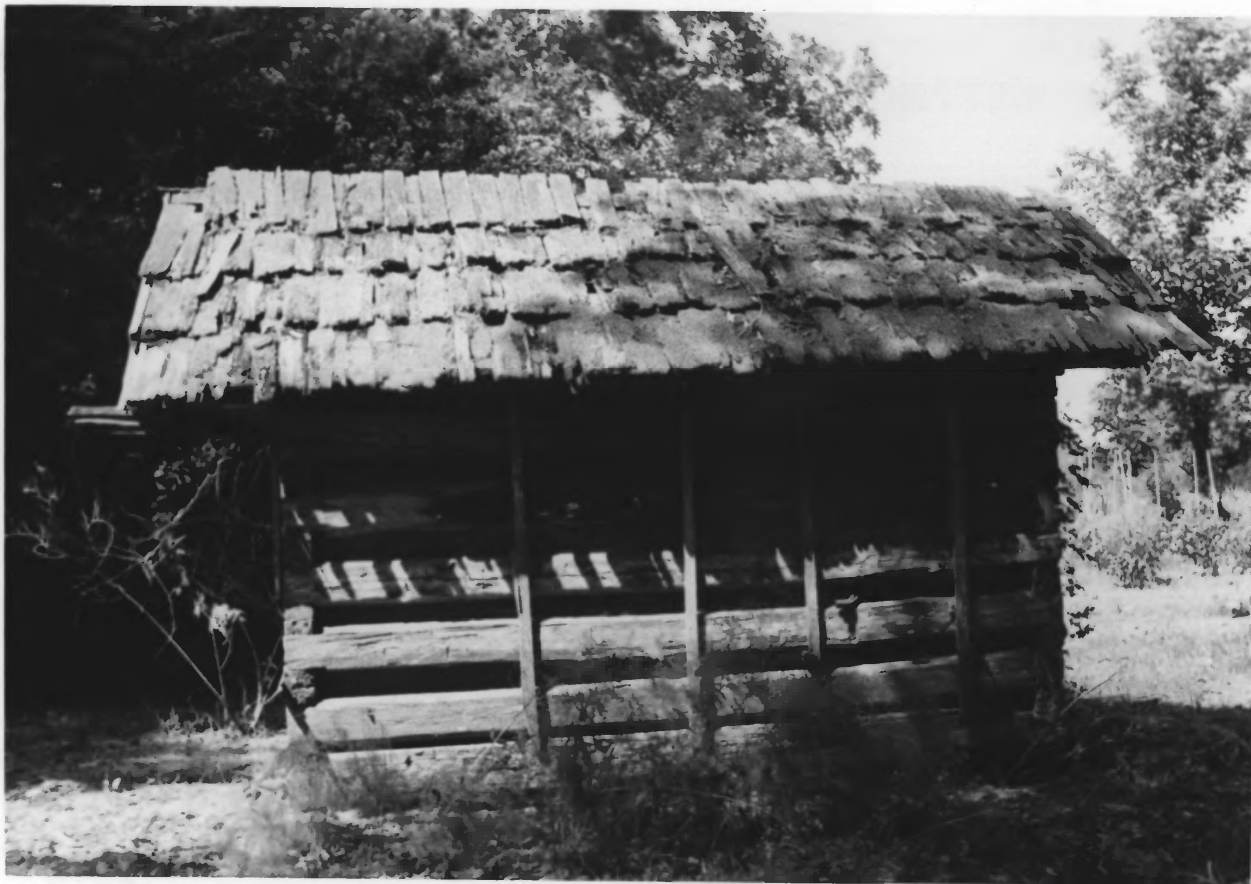
PHOTO NO. 15 of 16

Side view of log smoke house showing detail of original roof covered with hand split cypress shingles. Note moss growing on shingles. Hogs were hung from timber projecting from front of building when butchered and cleaned.

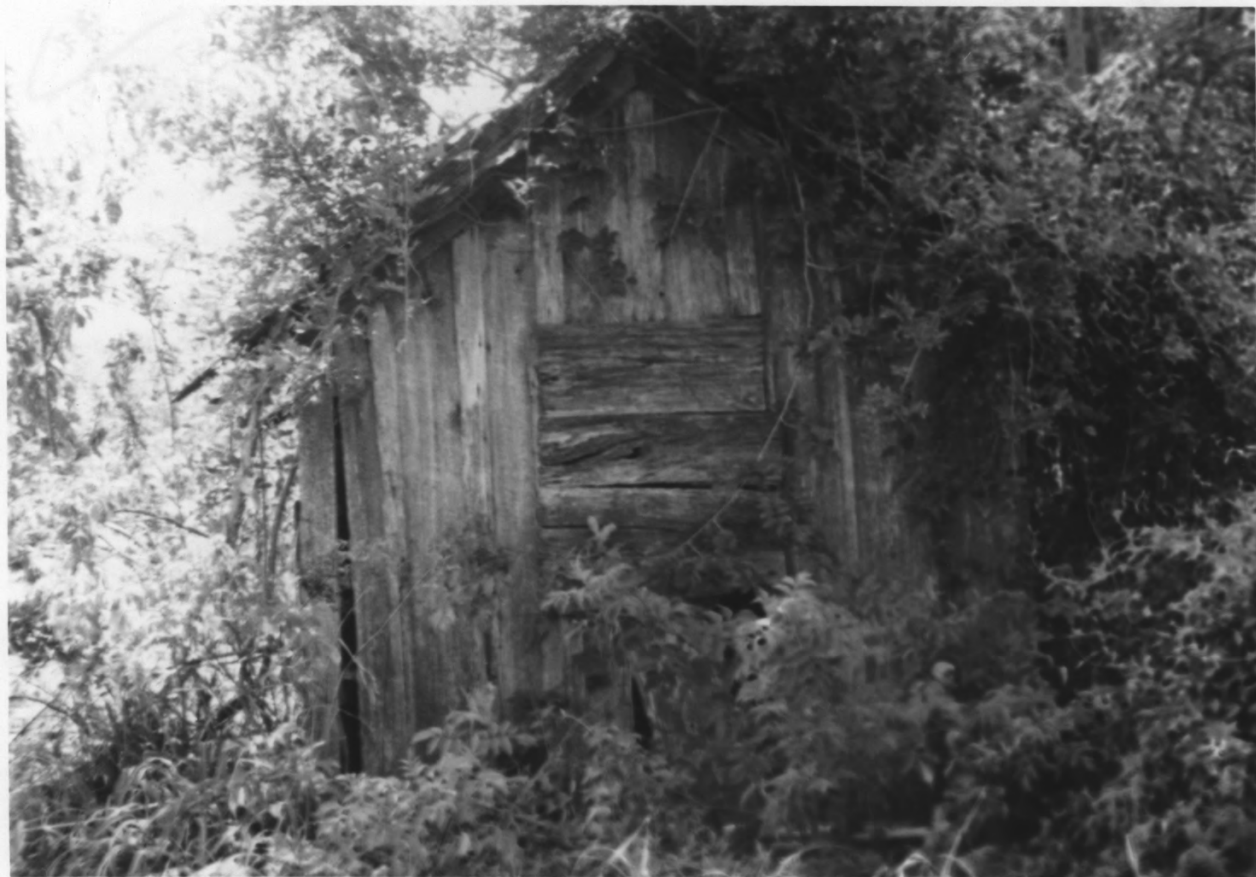
PHOTO NO. 16 *4/16*

Back view of original milk house. Building is so covered with vines another view could not be taken. Has original cypress hand split shingles. Boards have been nailed over only window. Originally had a board shutter closing.
