**NATIONAL REGISTER OF HISTORIC PLACES
REGISTRATION FORM**

historic name Poplar Rural District
other names/site number N/A

The Ethnic Historic Settlement of Shelby and Audubon Counties: 1860-1941

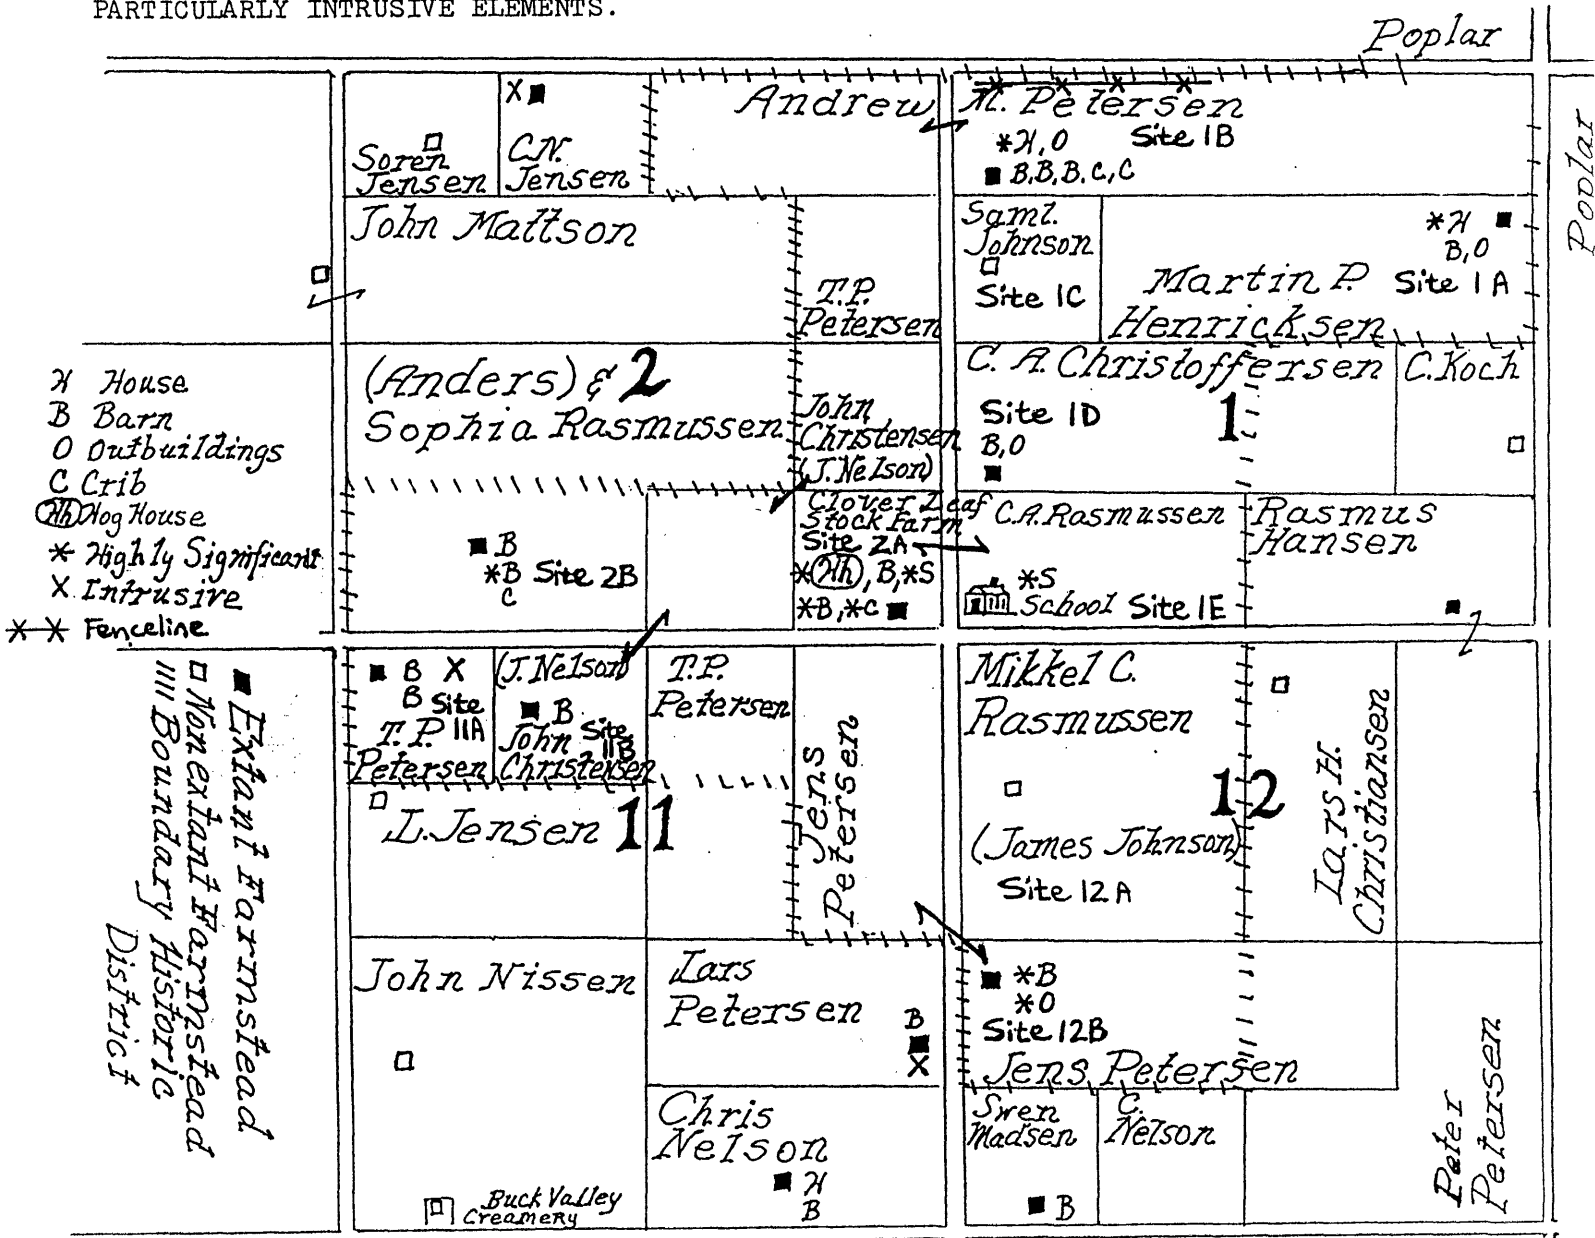
Section number Map Page 1

MAP SHOWING BOUNDARIES OF POPLAR RURAL DISTRICT AND JACKSON #1 SCHOOL DISTRICT
C. 1900 INCLUDING CONTRIBUTING BUILDINGS, HIGHLY SIGNIFICANT RESOURCES, AND
PARTICULARLY INTRUSIVE ELEMENTS.

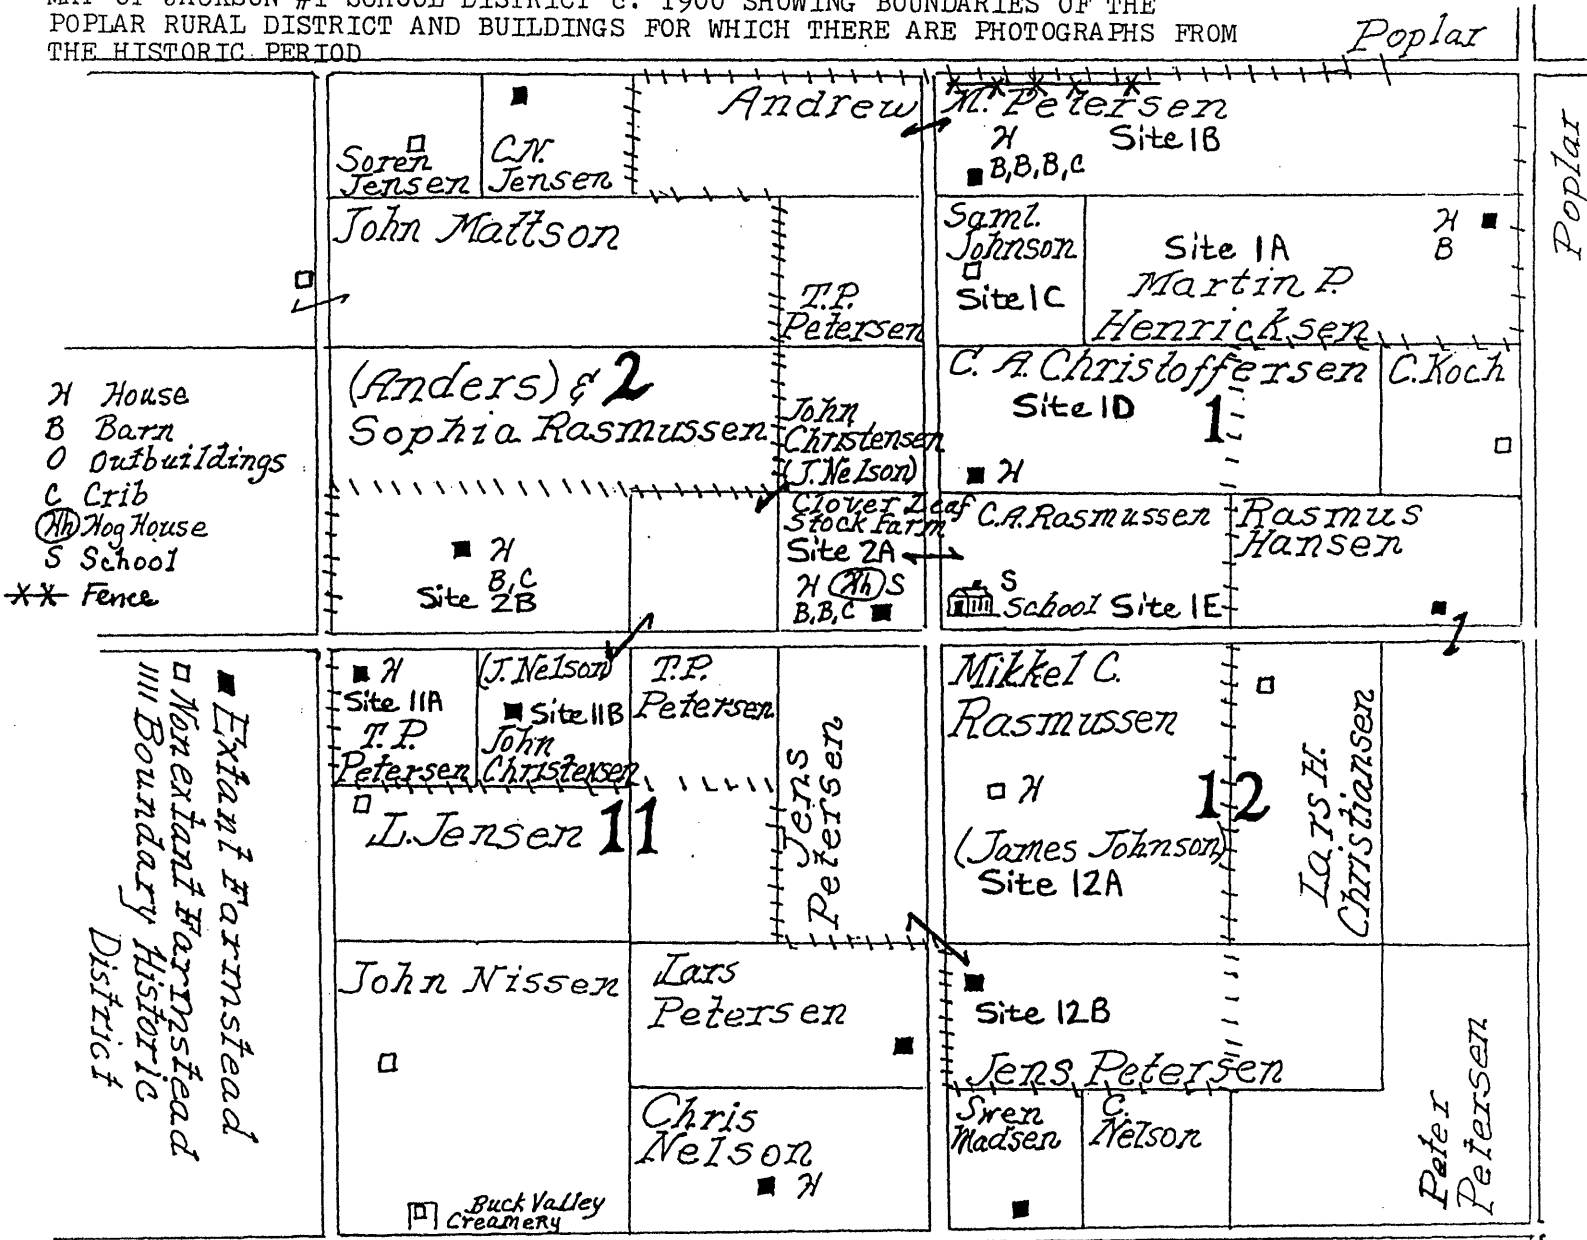
Section number Map Page 2

MAP OF JACKSON #1 SCHOOL DISTRICT c. 1900 SHOWING BOUNDARIES OF THE
POPLAR RURAL DISTRICT AND BUILDINGS FOR WHICH THERE ARE PHOTOGRAPHS FROM
THE HISTORIC PERIOD

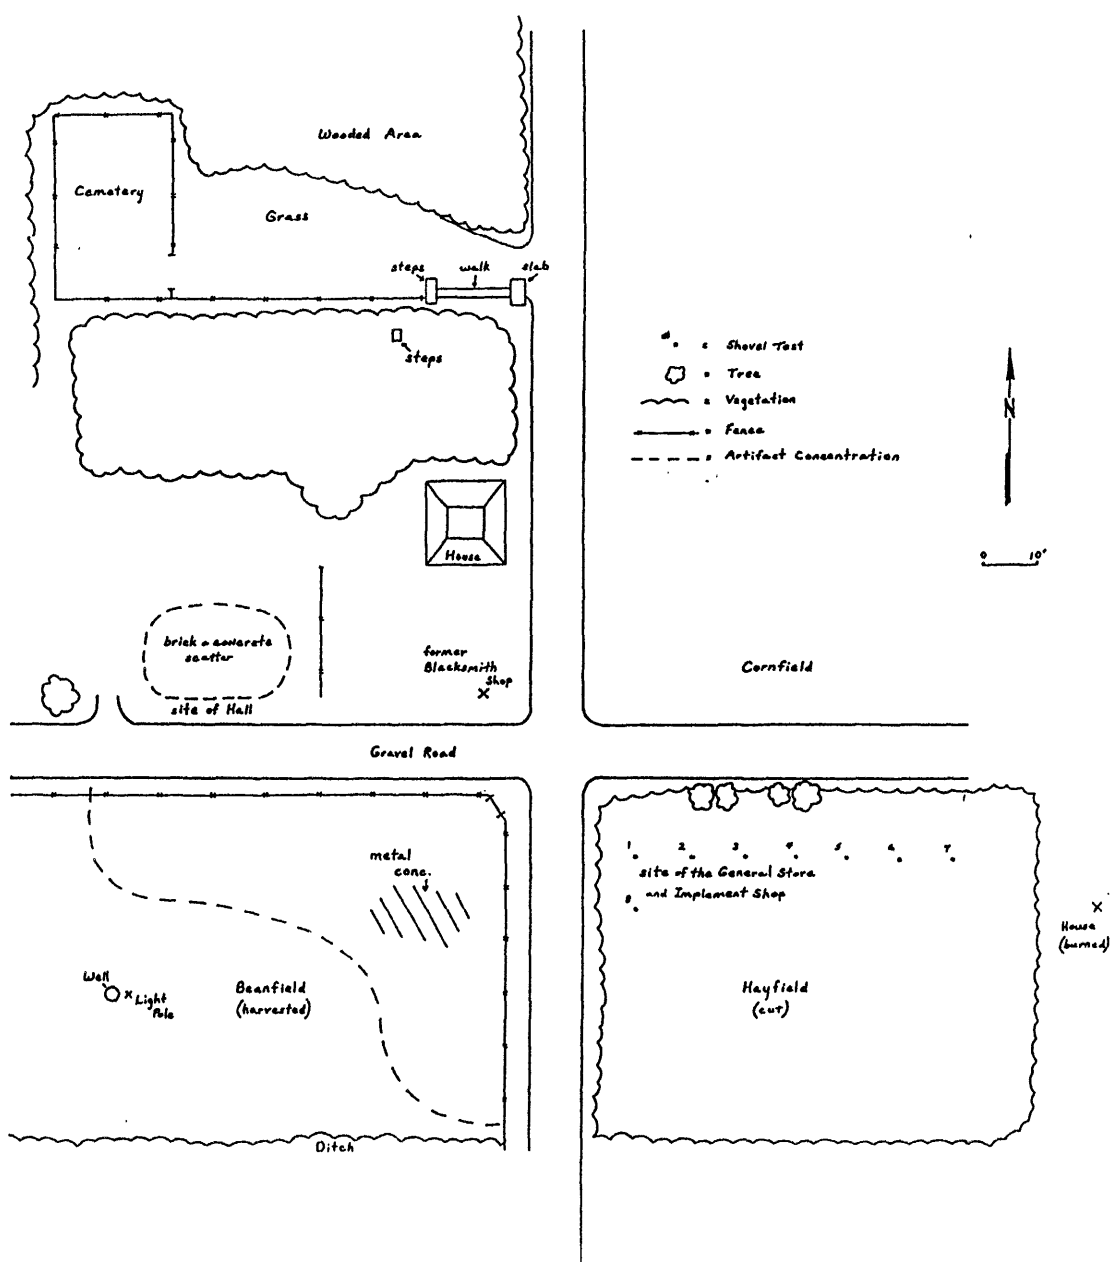
Section number Map Page 3

POPLAR TOWNSITE--ARCHAEOLOGICAL SITES 13AB7 and 13SH7, SURFACE FEATURES.

The only archaeological site recorded to date within the district boundaries is that of the Poplar townsite, which has been designated by two site numbers because it is situated in both Shelby and Audubon counties. This site includes the archaeological remains of the commercial buildings and the church of the former community as well as the remains of the church cemetery. The individual eligibility of this archaeological site could not be determined by the present investigation, therefore, it cannot be individually counted as a contributing or noncontributing resource. It is recommended that a Phase II archaeological investigation be conducted to evaluate the significance of this archaeological

It is recommended that the boundaries of the rural district include the archaeological remains of the townsite of Poplar which include the location of the former commercial buildings, the church, and the cemetery. Shovel testing and surface collection in the areas of the former lumberyard and general store and implement shop have indicated a good potential for subsurface features, particularly in the location of the original general store. Late nineteenth to early twentieth century artifacts were collected, and cultural deposits are present below the plow zone. The constraints of the present investigation precluded Phase II-level investigation of this archaeological site, but it is recommended that such an investigation be undertaken to fully evaluate the potential significance of this site and its eligibility for inclusion as a contributing property to the Poplar district. At this point, it can only be considered as part of the landscape component of this district that is a potentially contributing property in need of further archival and field investigation to determine its status. Such an investigation should include an evaluation of the archaeological potential of the boarding house site as well as a determination of other potential archaeological components of the residences once situated to the south of the general store and the residences once situated to the north of the harness shop and livery barn.
