HISTORIC PROPERTY INVENTORY FORM

Site No.: 304
Site Name: Historic J. GROVER ISRAEL HOUSE
Common _____
Field Recorder: NC/ER
Date Recorded: 10-31-85
Owner's Name: Gene Pruitt
Street: 305 S. Sixth
City/Town: Dayton
County: Columbia
Zip Code: 99328

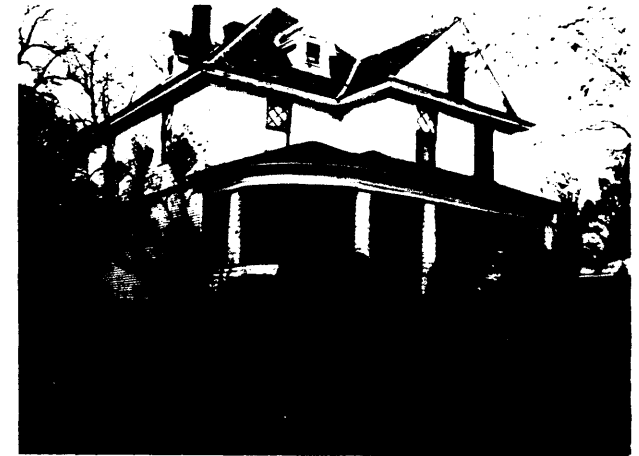
Photography Neg. No.: 3+07
(Roll No. + Frame No.)
View: Northwest facade
Date: 10-31-85

Large 2½ story shingled upper and clapboard at lower level house with flared, steeply pitched hip roof and projecting front end gable roof addition with cutaway bay. There are small gambrel roof shingled dormers, one in each side slope of the hip roof. Boxed eaves; upper two floors have double hung windows with multi-diamond pane upper and plain lower glass. Wraparound porch with dentil trim under eave and fish scale shingled porch supports and balustrade. Projecting bay with hip roof, dentil trim on eaves, at side.

Interior--intact with ornately carved Corinthian Columned fireplaces, typical Victorian interior--high ceilings, grooved door surrounds with cornerblocks, turned balustrade on stair. Original fixtures in bathroom. Pressed metal wainscoting in kitchen. In need of work, but very much intact with original interior and exterior.
