# National Register of Historic Places Registration Form

St. John Baptist Church and Rectory Kay County, Oklahoma Name of Property County and State 4. National Park Service Certification I hereby certify that this property is: \_\_ entered in the National Register determined eligible for the National Register determined not eligible for the National Register removed from the National Register other (explain:) Date of Action 5. Classification Ownership of Property (Check as many boxes as apply.) Private: Public - Local Public - State Public - Federal **Category of Property** (Check only one box.) Building(s) X

# **Narrative Description**

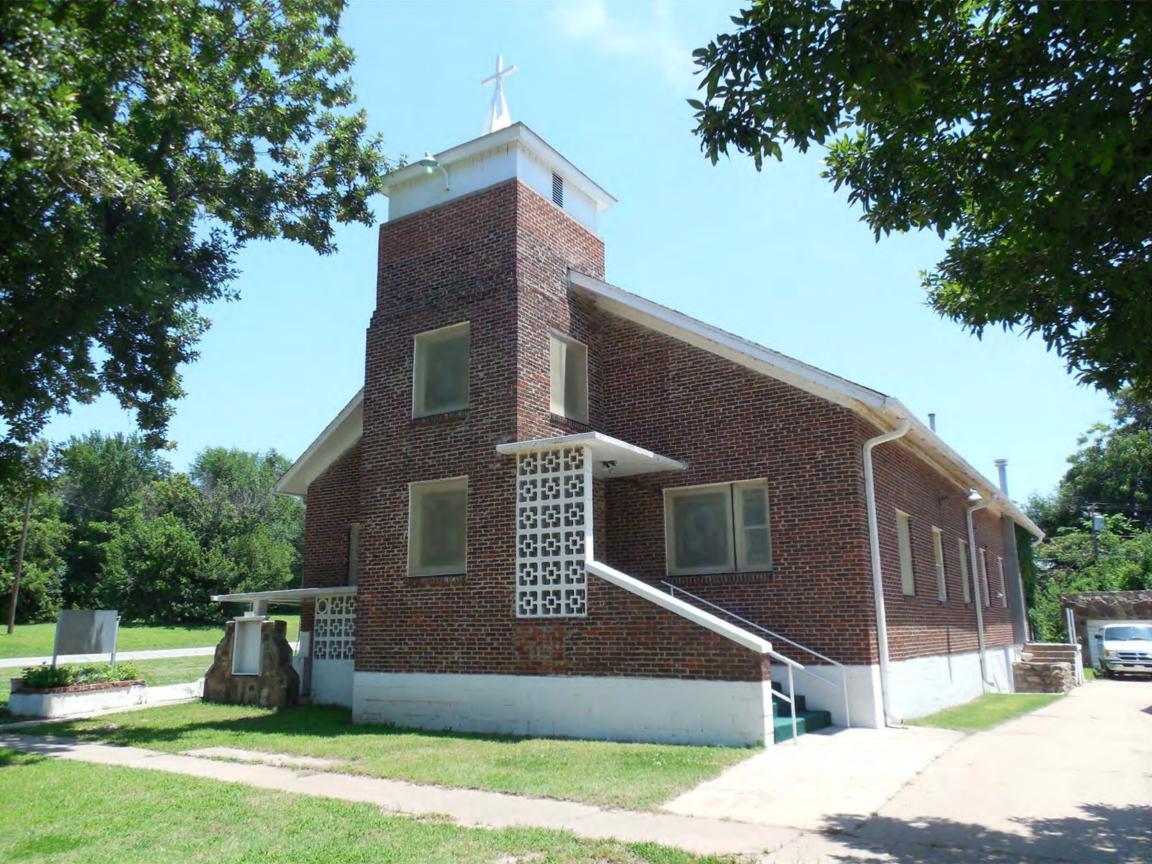
Photograph Number	Subject	Direction
0001	Church: west and south elevations	Northeast
0002	Church: north and west elevations	South-Southeast
0003	Church: east and north elevations,	Southwest
0004	Rectory: west and north elevations	Southeast
0005	Rectory: south elevation	North
0006	Garage: north elevation	South

The west elevation is the primary elevation and the most decorative. Centered on that elevation is a rectangular bell tower. It is set partially into the west exterior wall and extends outward from it. On the south side of the bell tower, exterior steps with a concrete-capped brick banister lead up to a double door entrance into the building's main floor. A flat concrete roof shelters the doorway. A vertical panel of decorative concrete blocks supports the roof. On the north side a flat concrete roof resting on a concrete post, smaller panel of decorative concrete blocks, and a concrete retaining wall shelter the stairwell to the basement. A low concrete wall also edges the walkway to the street. Near the building is a sign board set into a native stone base. The bell tower rises above the peak of the roof on the west elevation. A rectangular stained glass window with a wood frame and brick sill is set in the north, west, and south sides of the bell tower at the height of the entrance into the main floor. A similar stained glass window is set on either side of the bell tower in the main wall of the building. These two windows are paired with a narrower one-over-one hung window toward the outside. A similar row of single stained glass windows is set a level above the first on the bell tower. Just above those windows, the bell tower narrows slightly but continues above the peak of the roof. A cap of vertical wood siding tops the brick portion. It has rectangular louvered vents on the south and north sides and a small lamp hung from the west side. Atop the bell tower is a small eight-sided steeple with a cross at its apex.

door opening onto a flight of steps up to the west. Along the south side of the building are five regularly spaced stained glass windows in wood frames with brick sills. The first, third, and fifth are fixed. The second and fourth are hung one over one. All have translucent covers. The southwest corner of this elevation includes the main stairway leading up to the entrance into the south side of the bell tower.
