Property Name: Coggon Commercial Historic District

# National Register of Historic Places Registration Form

historic name Coggon Commercial Historic District

Name of Multiple Property Listing Iowa's Main Street Commercial Architecture

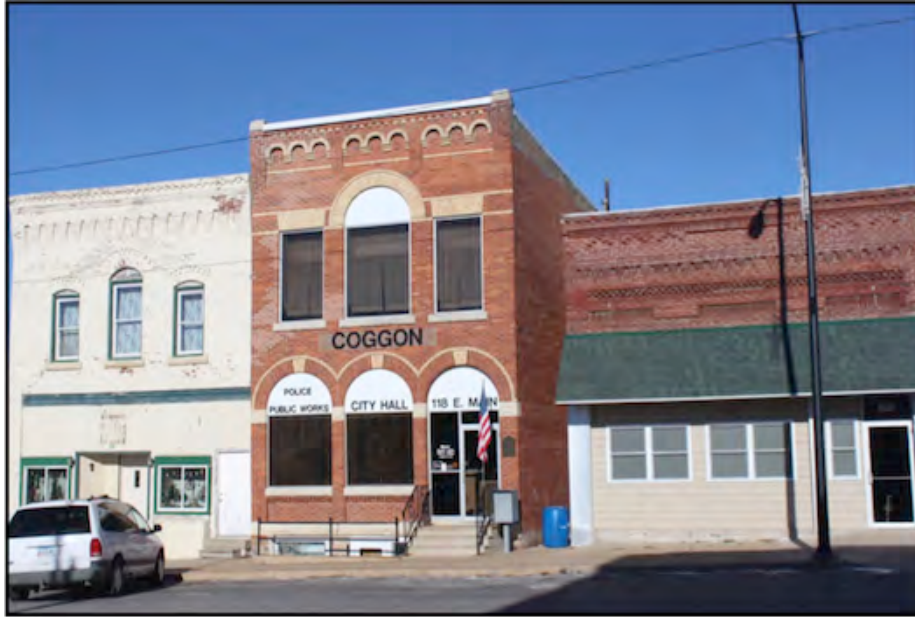
Figure 15. Coggon Bank, 118 East Main Street.

This two-story brick commercial building was designed in the Italianate style of the Late Victorian era and constructed in 1890. The south-oriented building sits on a stone foundation and was constructed using stretcher-bonded red brick. The first and second stories contain three bays, each with a replaced fixed window. The first story's two windows and door openings are topped with fan-arched polychromatic brickwork with decorative cream-color bricks creating the illusion of a keystone. The second story contains three window openings with the center window designed with a round arch in the cream-color brick and the two side windows topped with flat, cream-color brick lintels. The four original rounded arch transoms have been infilled with painted wood panels replaced around 1982 along with the fixed windows that exist today.<sup>2</sup> Historic photographs (see Figures 10 and 12) show glass fan lights on the transoms and sash windows on the second level. Rusticated stone sills sit underneath all windows. The building's cornice contains decorative polychromatic arched, corbelled brickwork that echoes the arches found on the façade (Figure 16). Stairs on the west side of the facade lead down to a basement level entrance that shows exposed limestone and granite structural elements. A replaced metal door with a sidelight and a fixed window are visible from the sidewalk. The building's first story is raised and a four-step concrete stair reaches the entrance door at the right side arch of the façade. A pair of wrought iron balustrades flank the front steps. The entrance has a replaced metal framed glass door with a transom window and sidelight. Inside the building, the original bank vault is still present.

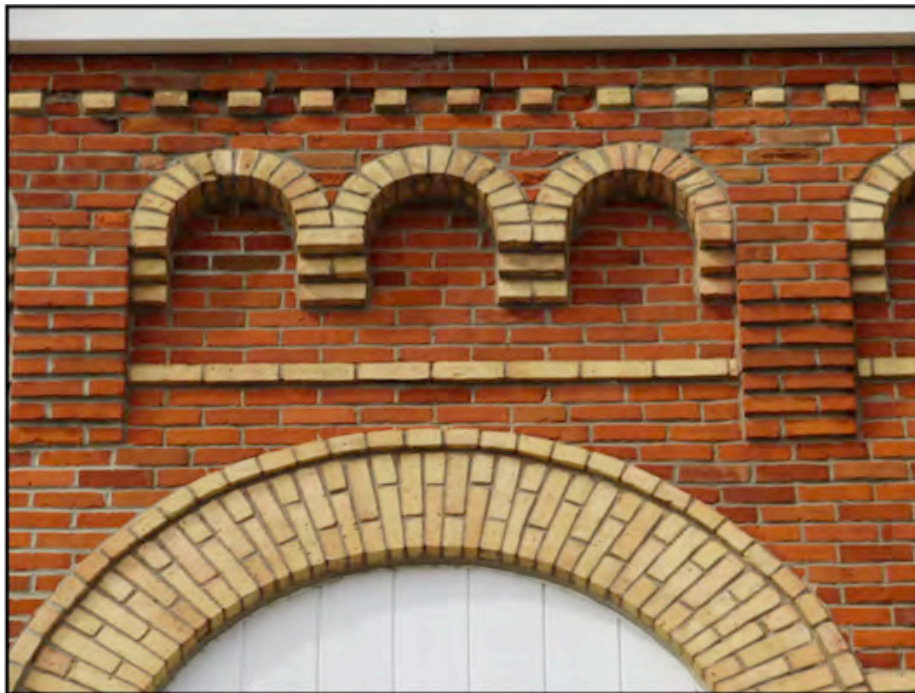
Figure 16. Detail of brickwork, 118 East Main Street.

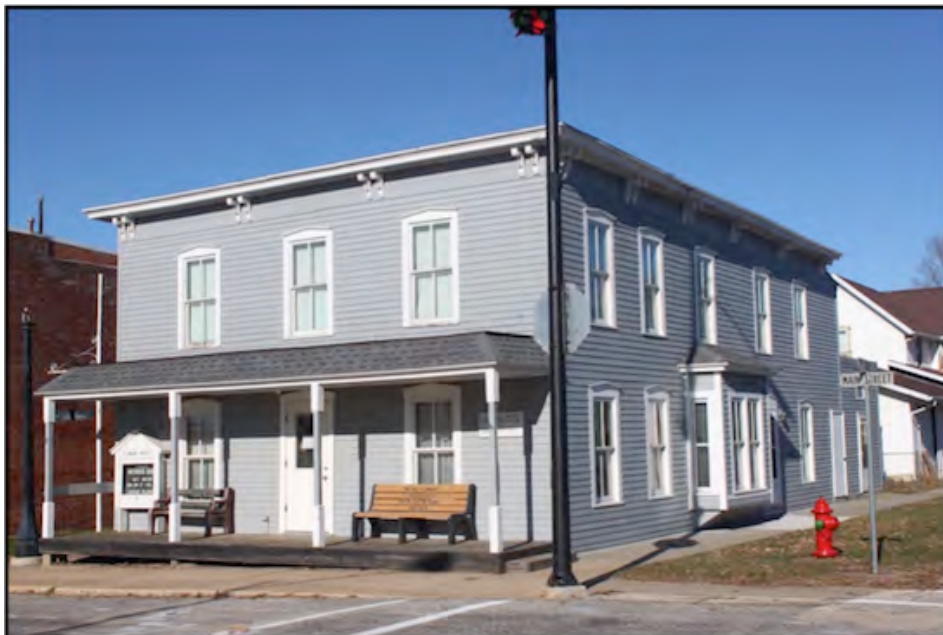
Figure 21. Clemons House, 126 East Main Street.

The Clemons House was constructed as a hotel in 1887 in the Italianate style. The wood frame building sits south-oriented at the northwest corner of East Main Street and 2nd Street North. The two-story building has three bays in width (north and south elevations), five bays in length (east and west elevations), and an addition on the north elevation. The building is clad in horizontal wooden siding. Other than the primary entrance, each bay contains a sash window. The windows are two-over-two light sash windows that have been replaced using the original design and are topped with triangular wooden lintels that appear to be original to the building. The facade is divided by a full length raised wooden porch supported by wooden posts and clad in asphalt shingles. Paired white-painted brackets sit below the asphalt clad hipped roof. The original porch had thicker columns, decorative wood brackets and a wood siding awning. The primary entrance is centered on the facade under the porch. The paneled door contains a fixed window on the top half. On the east elevation, a bay window projects from the center of the first story. The bay window contains four narrow sash windows. Two metal doors sit on the northern side of the east elevation. Above the northernmost door is a small fixed window. The north elevation contains a single story addition with a shed roof. A concrete block

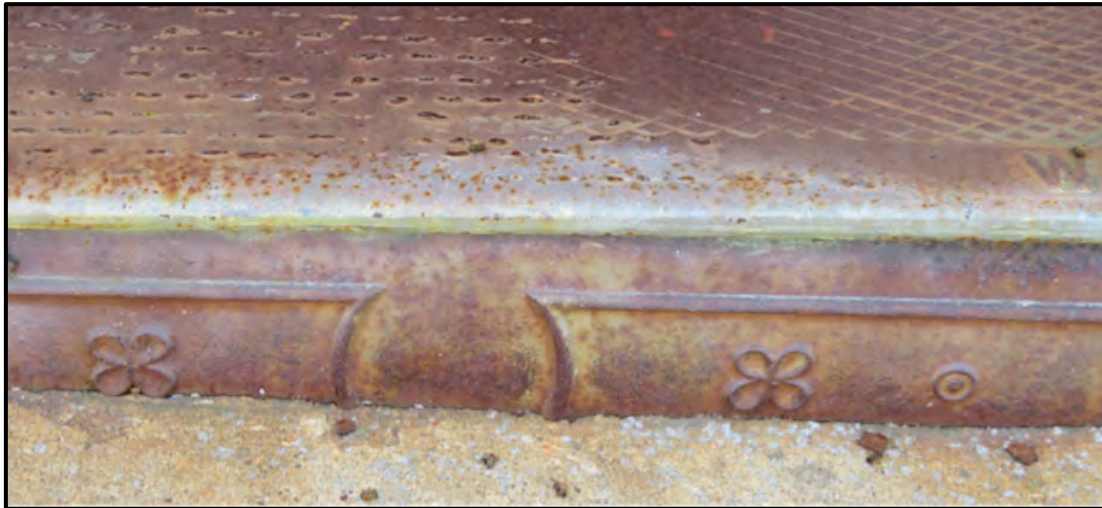
Figure 28. Metal step detail, 123 East Main Street.

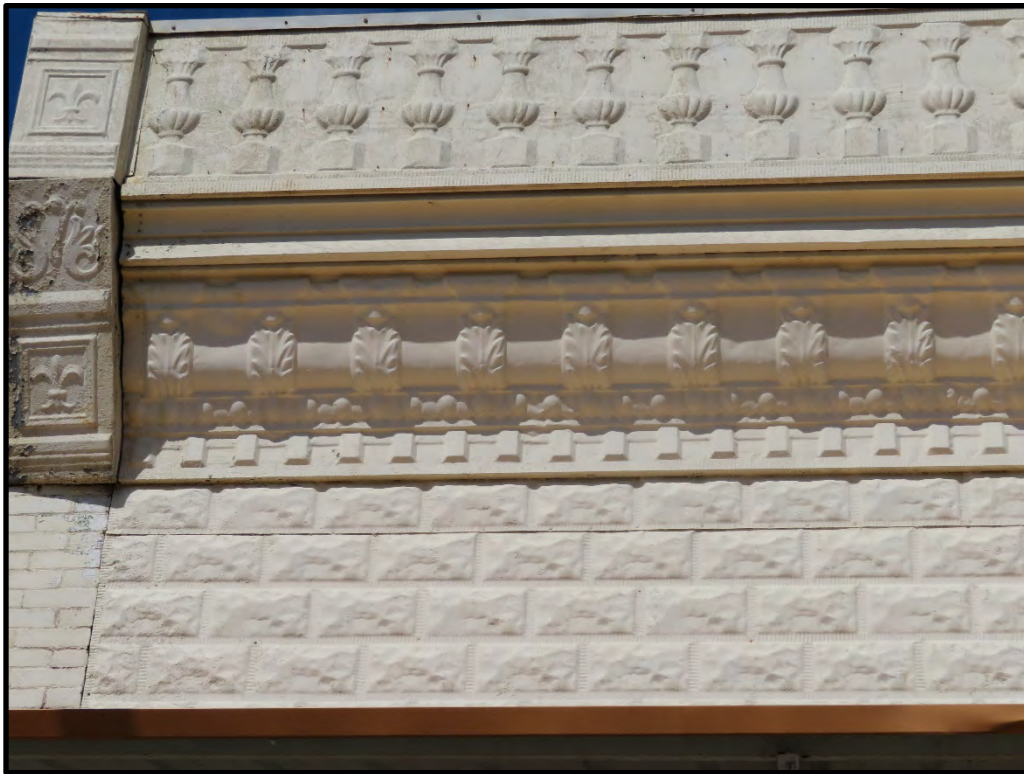
Figure 34. Detail of decorative pressed metal, 202 East Main Street.

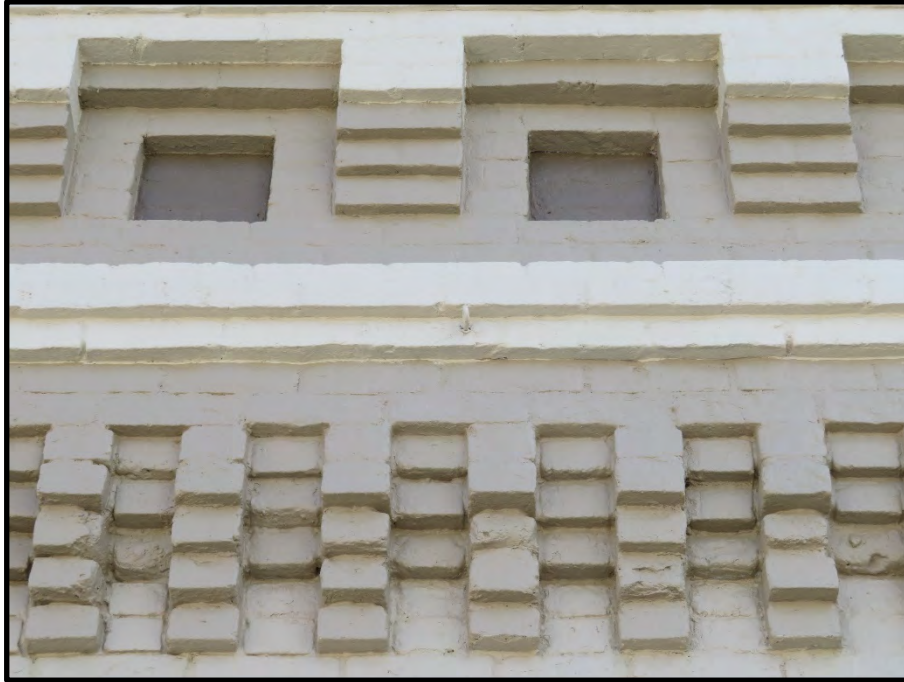
Figure 46. Detail of decorative brickwork, 201-203 East Main Street.

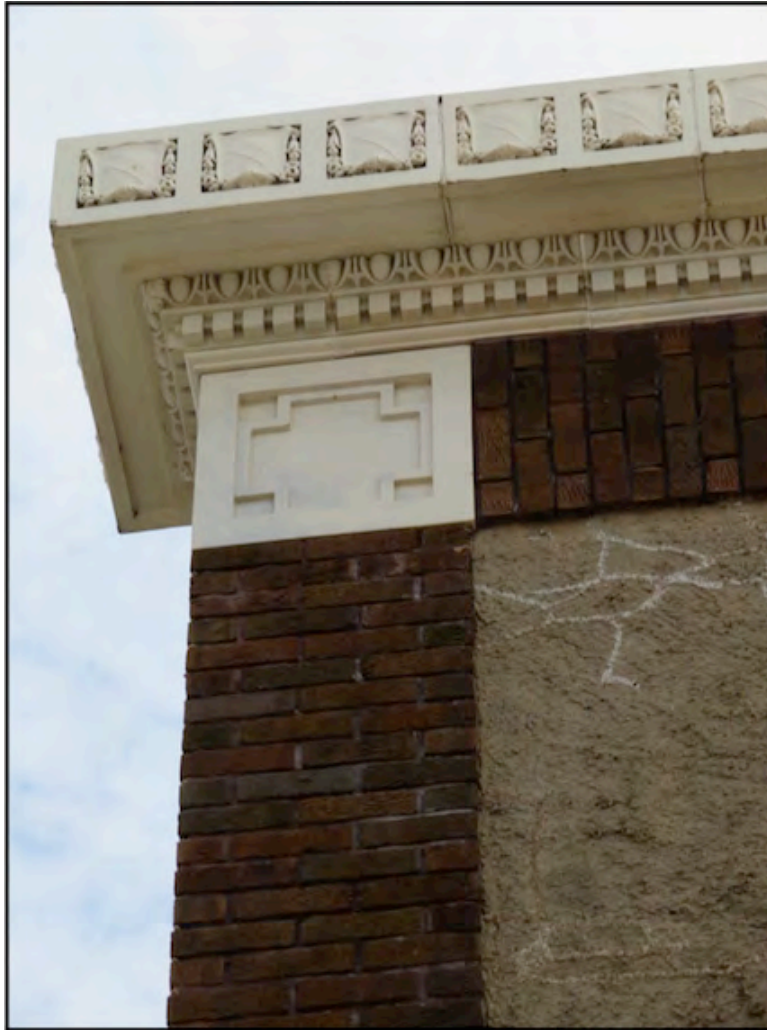
Figure 50. Upper corner detail, Coggon Opera House, 209 East Main Street.
