MINDEN
FLOUR
MILLING
COMPANY
INCORPORATED
MARCH 5
1906

MINDEN FLOUR MILLING CO. - #1

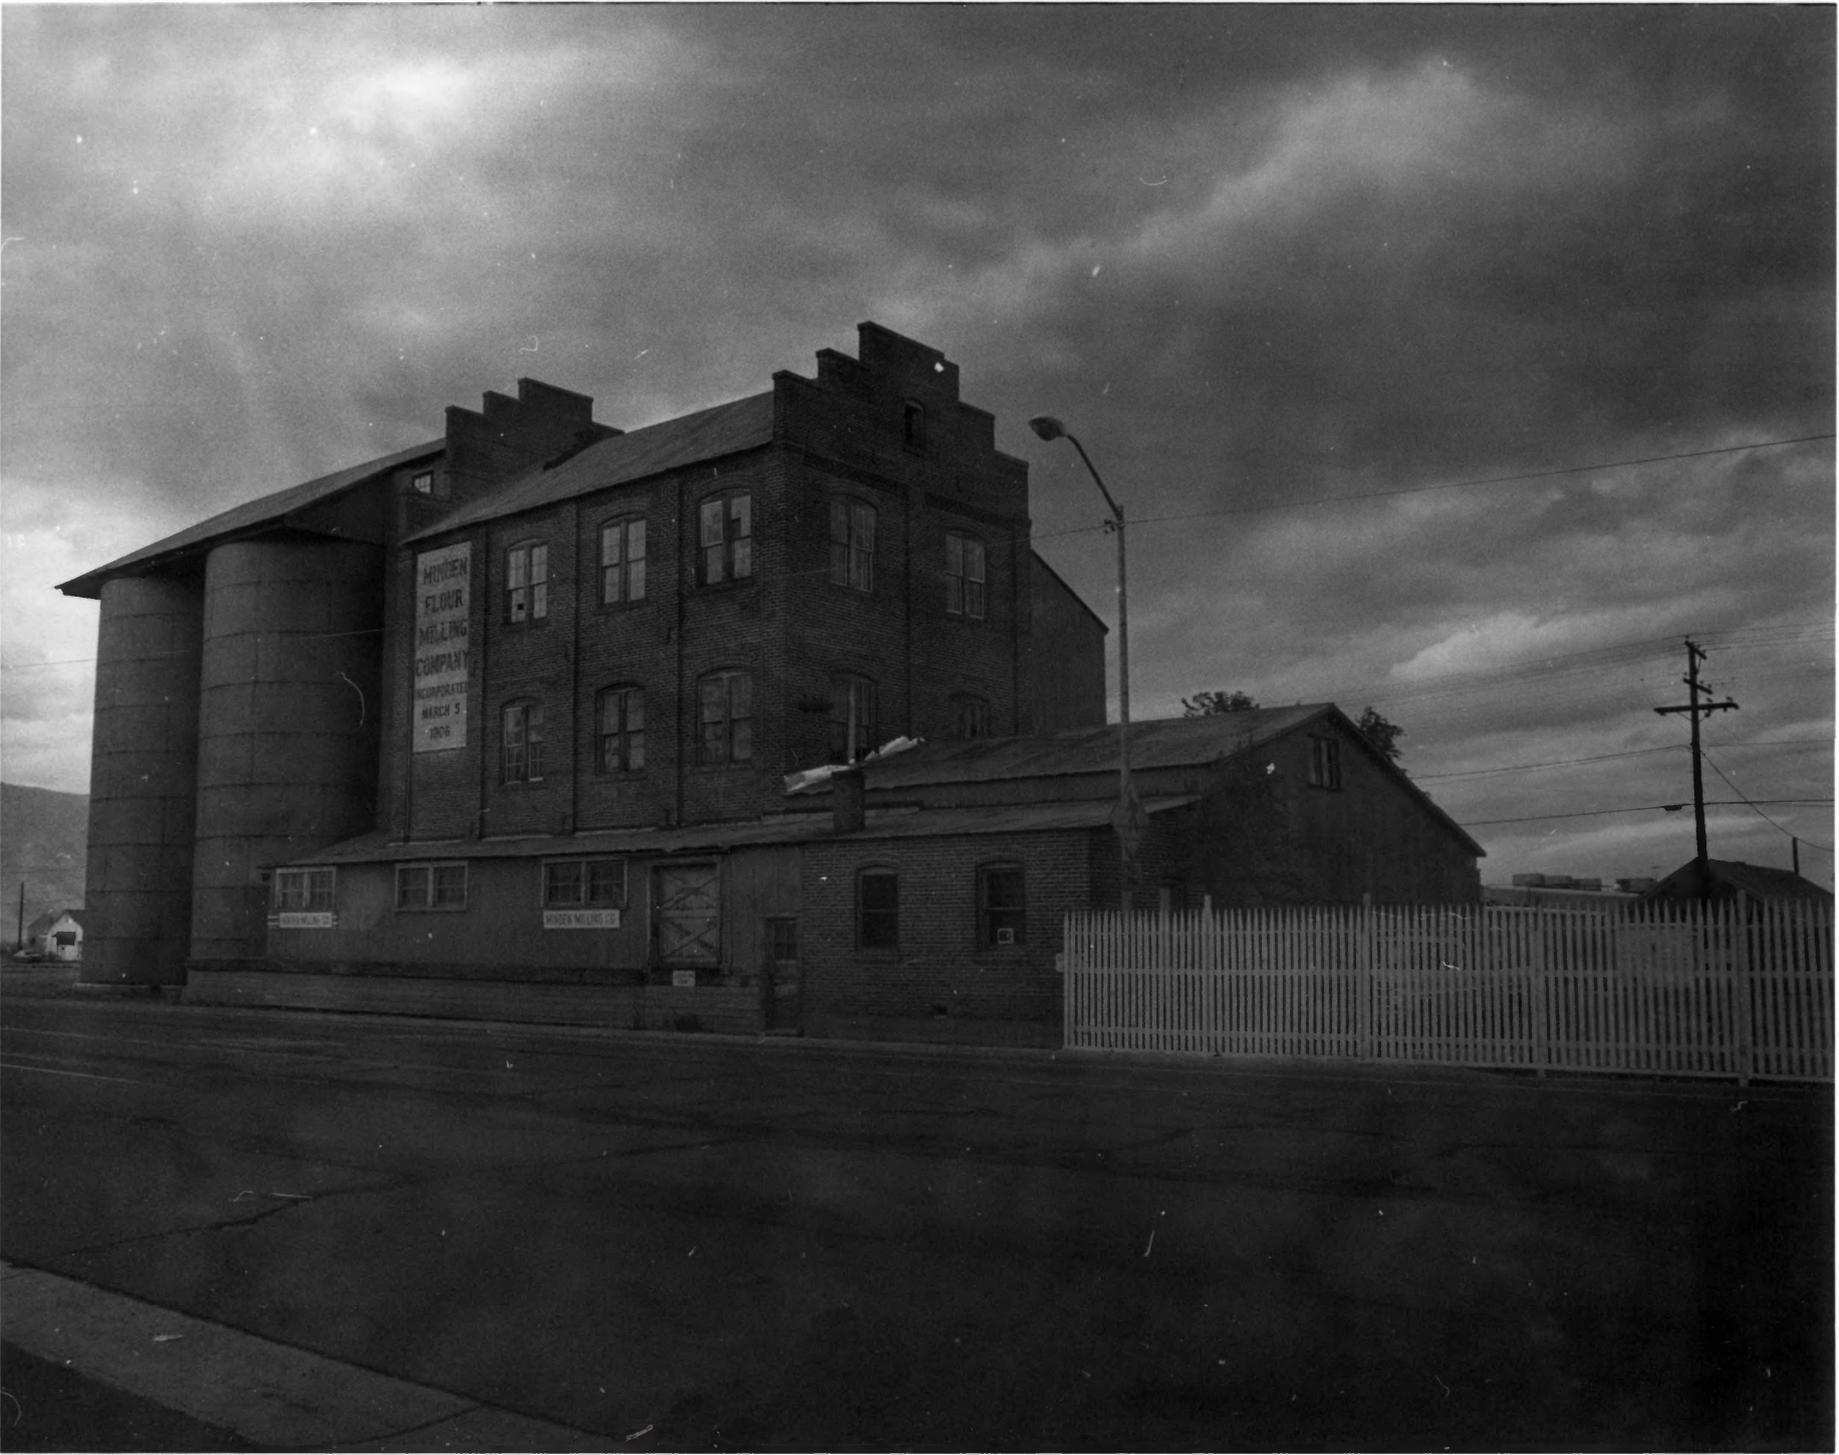
South-side view of mill located adjacent to
U.S. Highway 395 (foreground) in Minden, Nv.

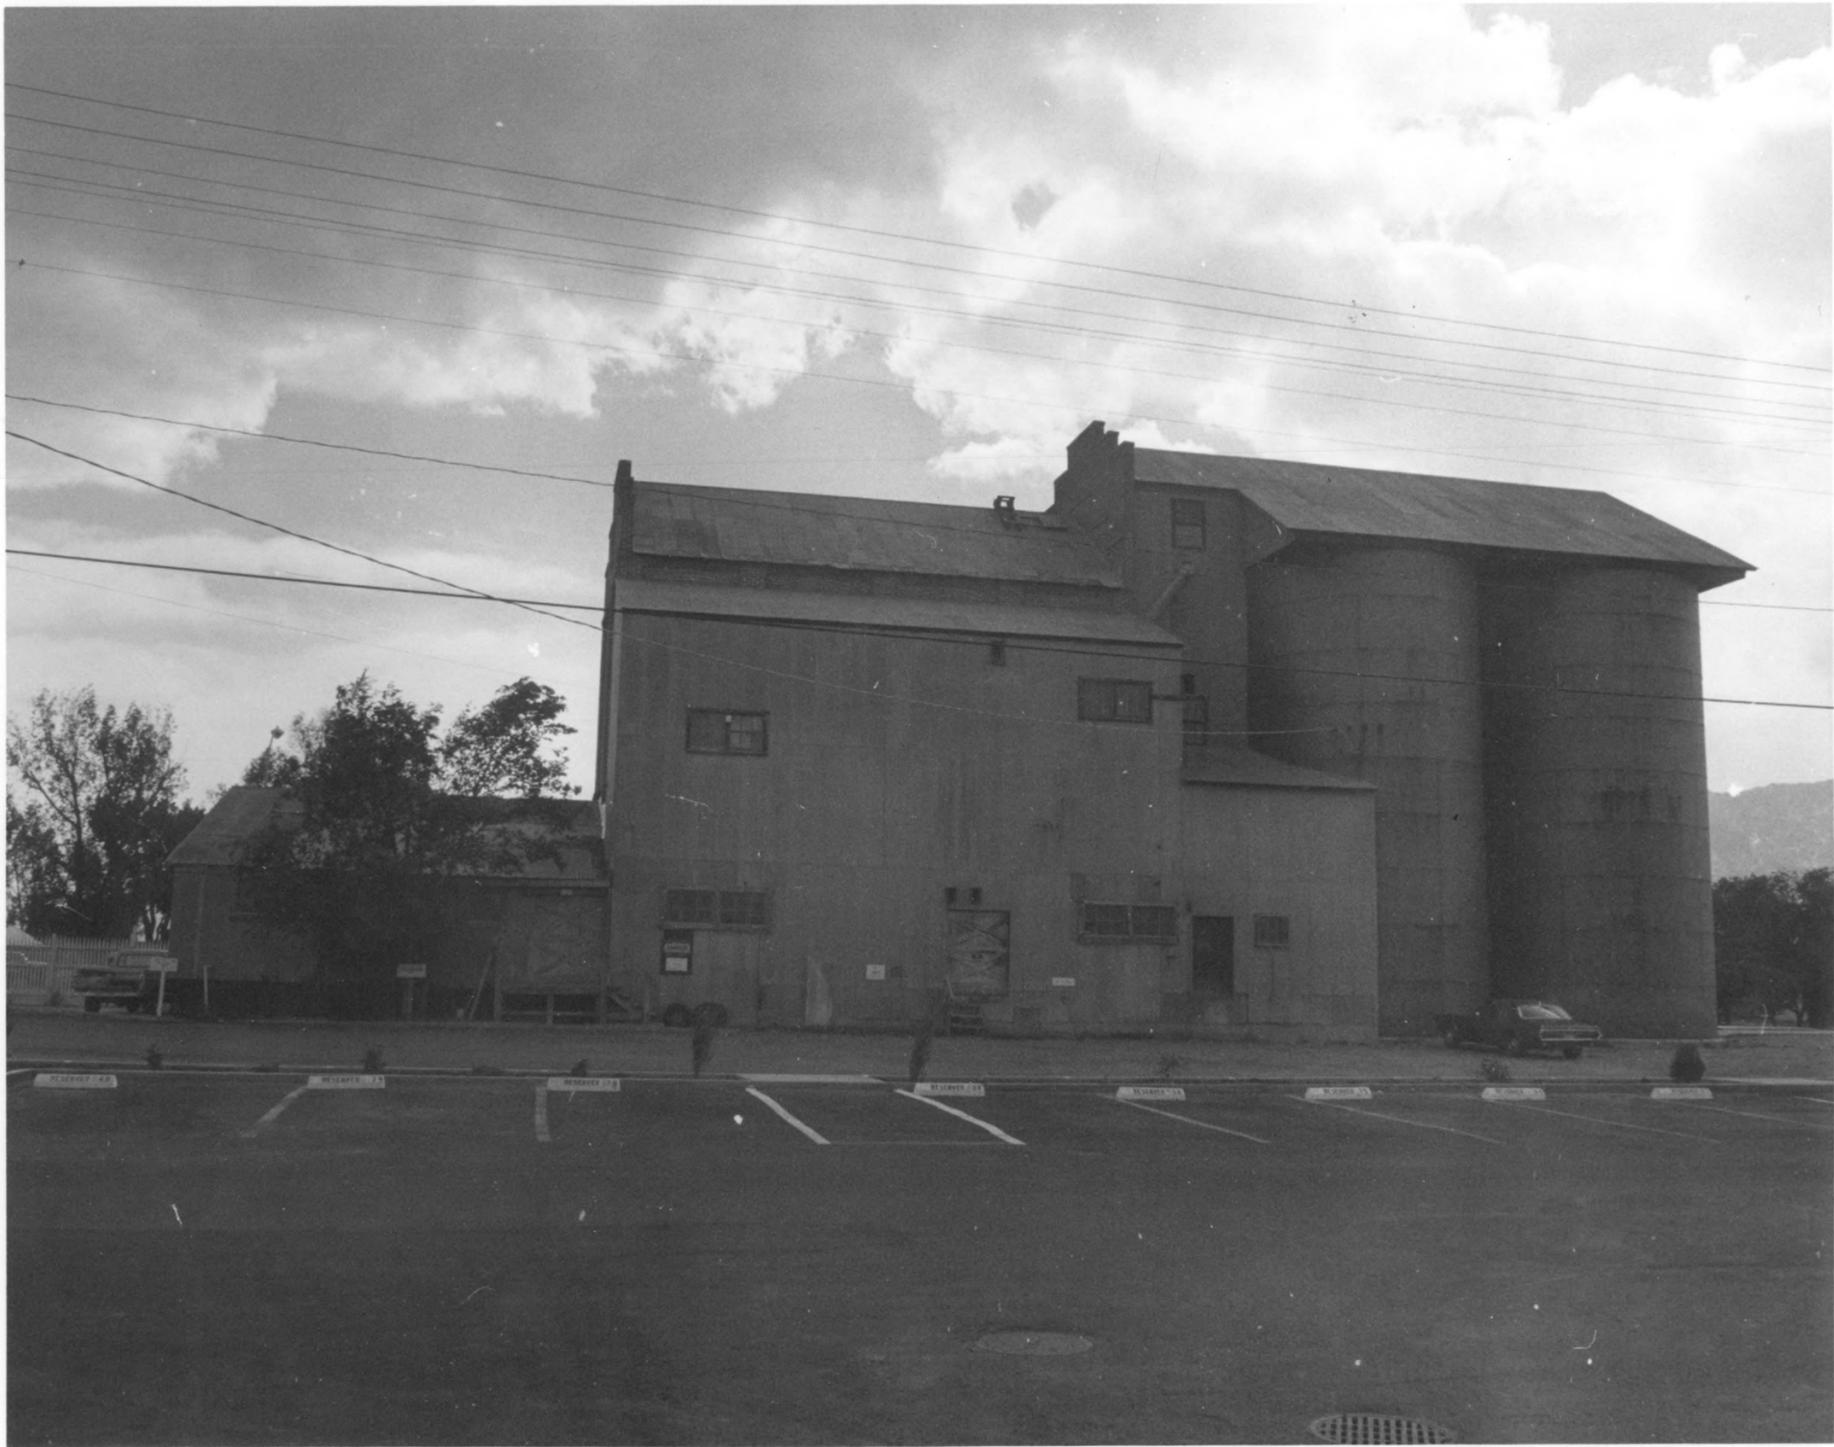
MINDEN FLOUR MILLING CO. - #2

North-side view of mill showing corrugated sheet metal sheds attached to the main brick structure, and the four 45'high by 23'diameter steel grain-storage silos. The V&T Railroad served the mill from this side.

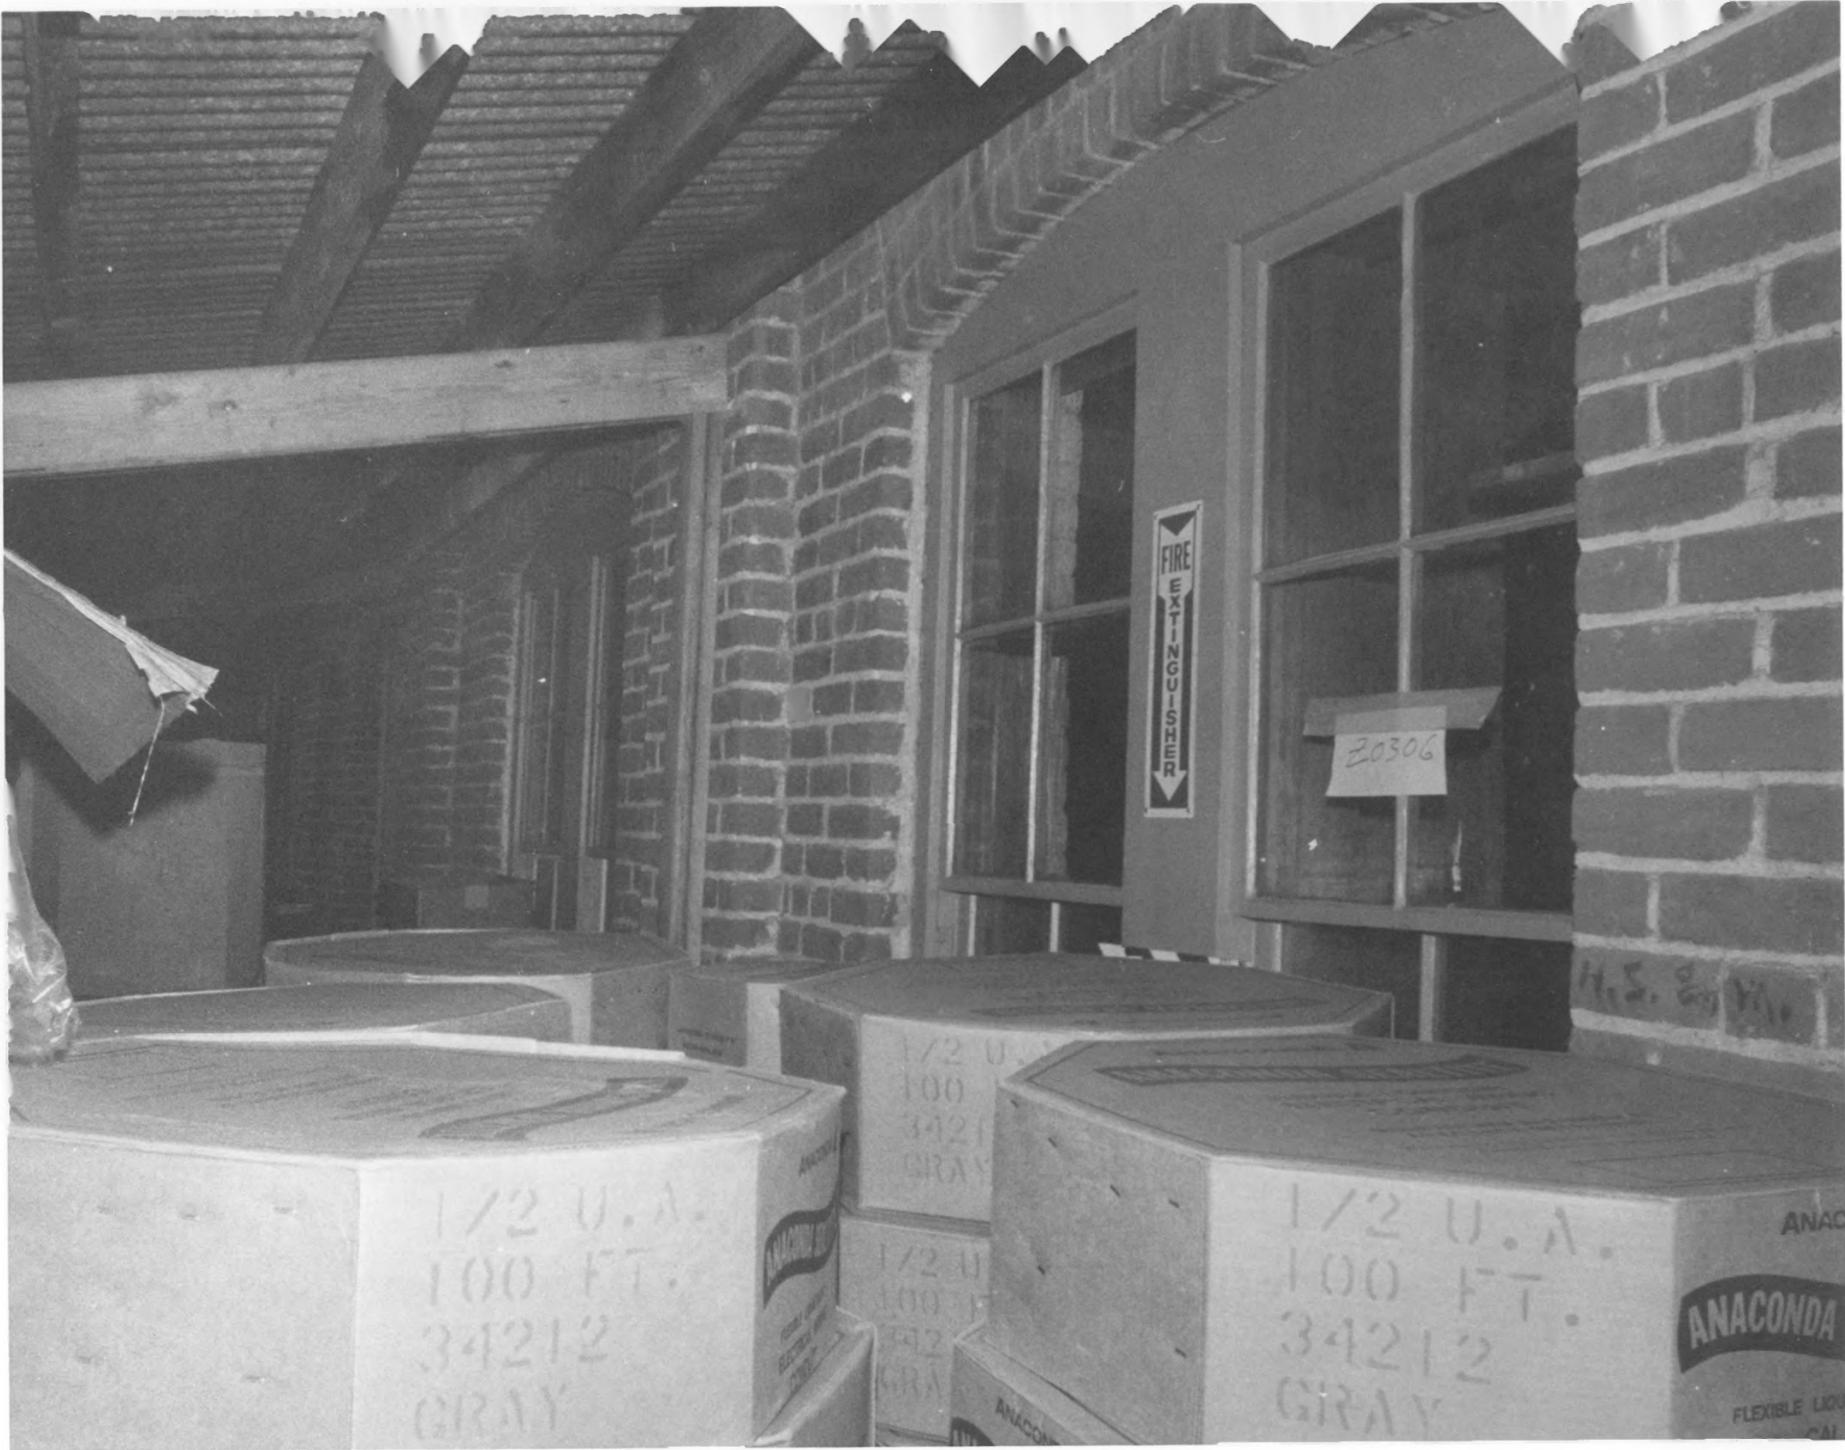
MINDEN FLOUR MILLING CO. - #3

South-side (U.S.Hwy 395) one-story dock area (now enclosed) with corrugated sheet metal roof. South-side brick wall contains large windows looking into first-floor main room of brick structure. (Boxes are temporarily stored for Bently Nevada Corp).

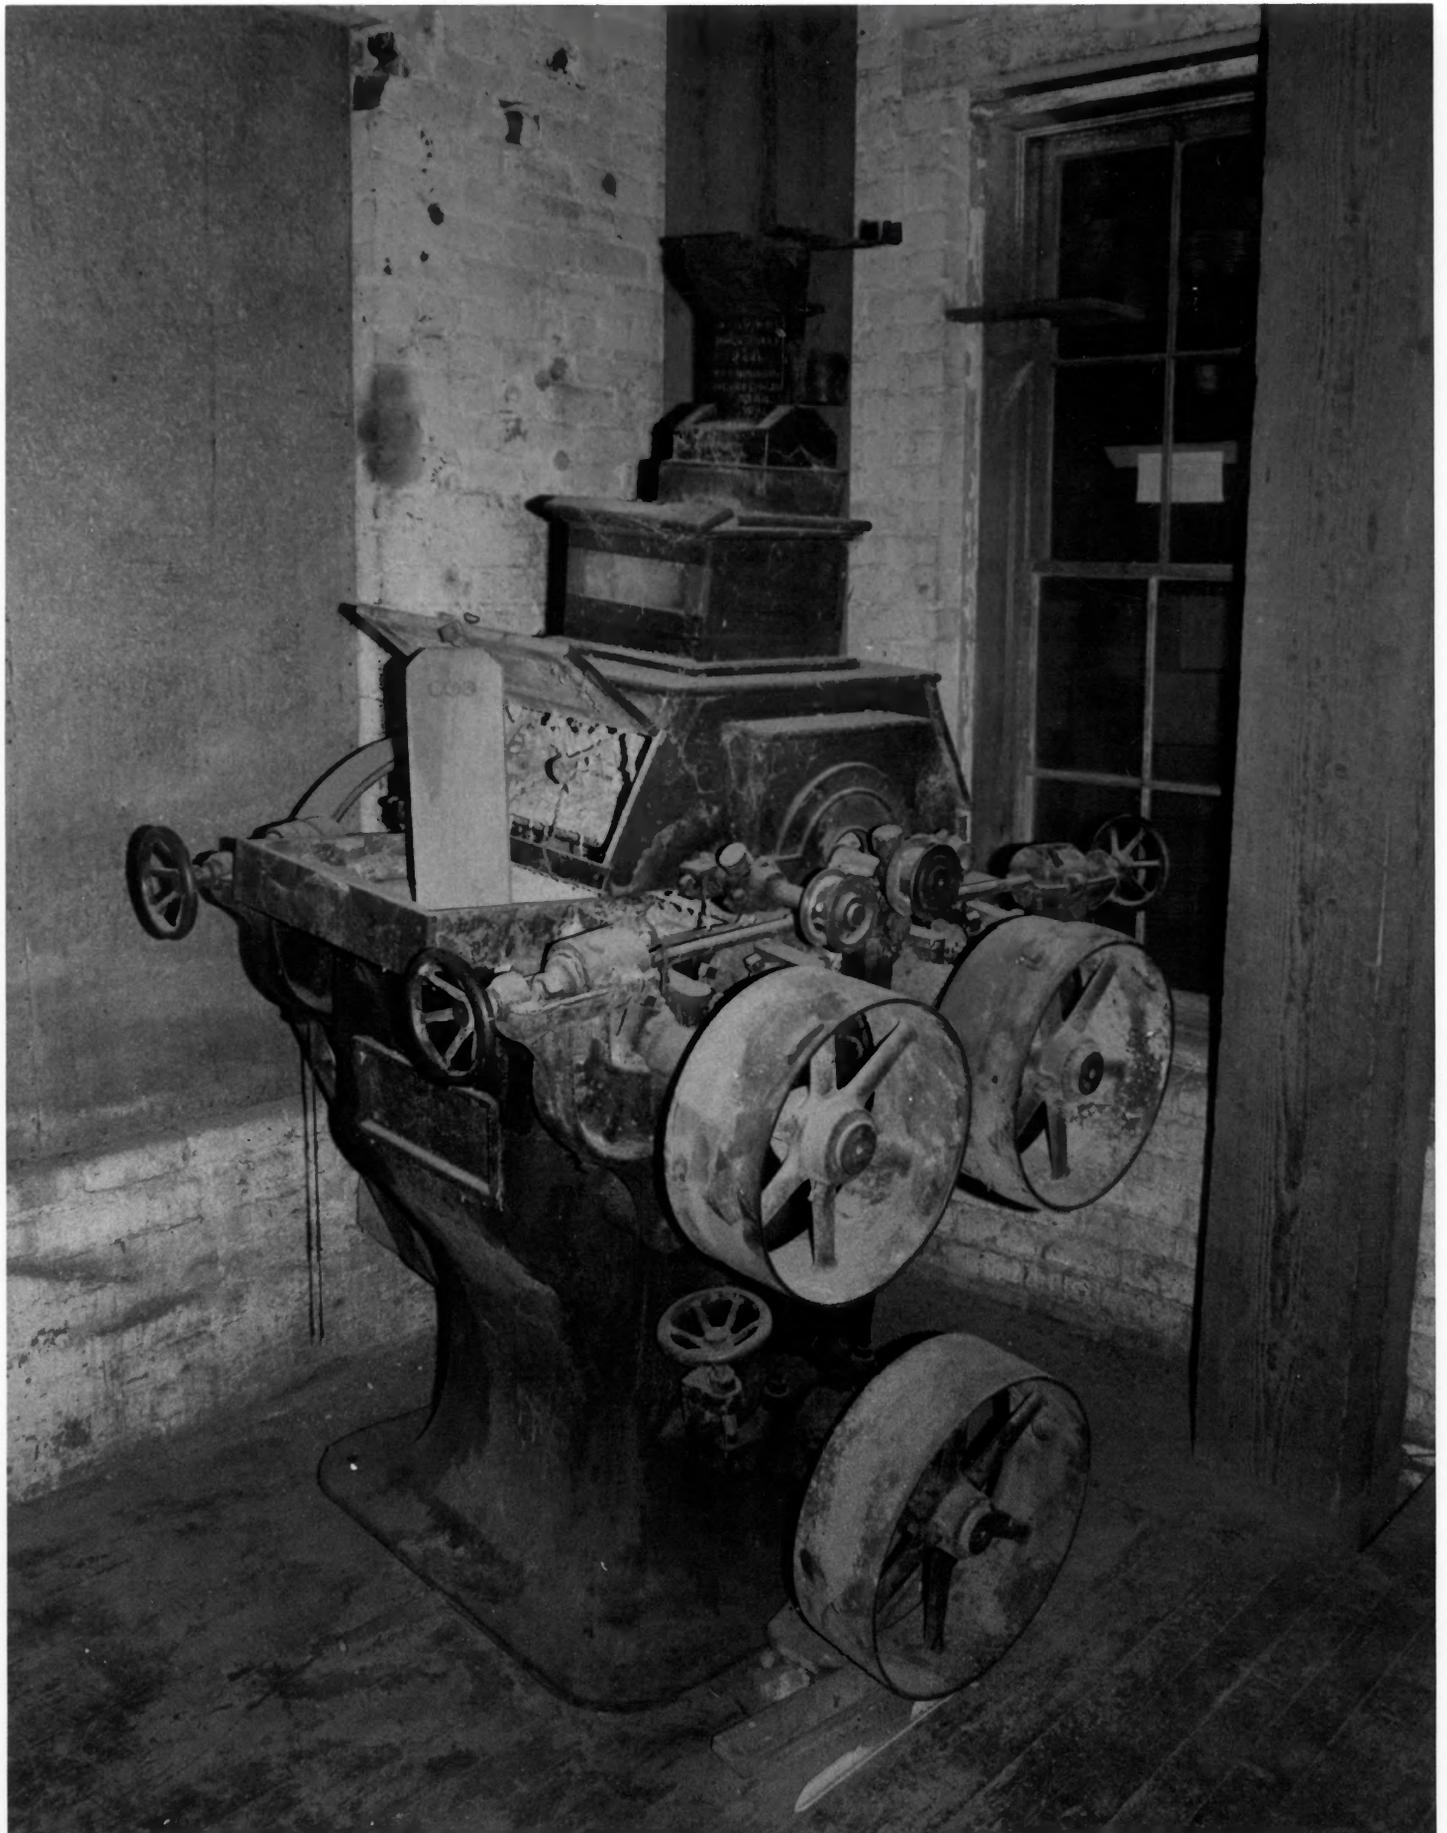
MINDEN FLOUR MILLING CO. - #4

Late 1800's Allis-Chalmers belt-driven
milling machine located on first floor.

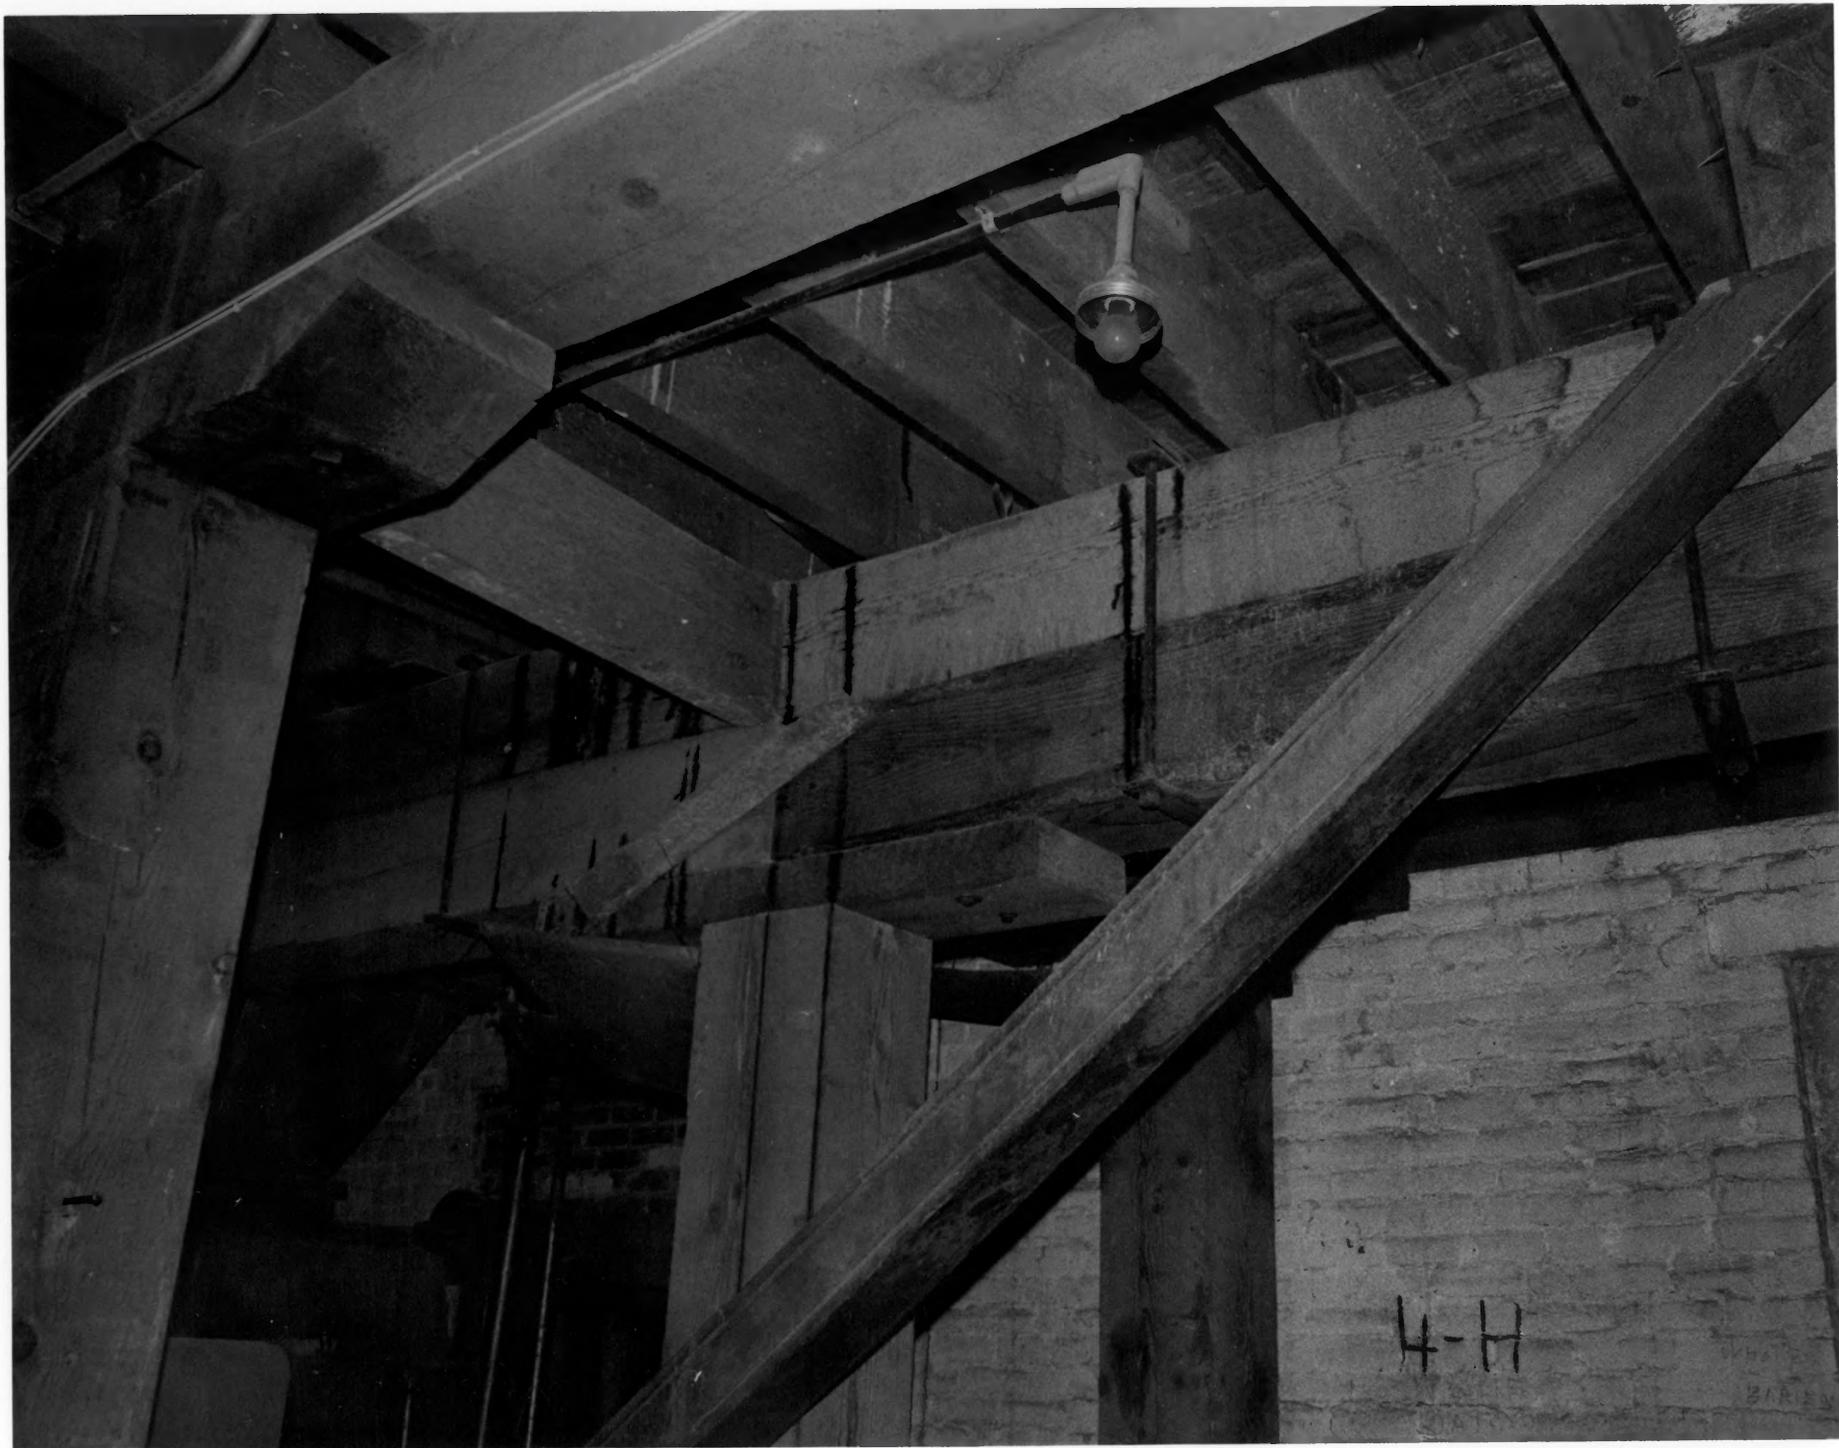
MINDEN FLOUR MILLING CO. - #5

View toward ceiling of first floor showing extra support posts and beams installed to support molasses tanks on second floor when mill was converted to a feed mill in 1942. Shown is east brick wall of main structure and one of many pine grain chutes (running diagonally top right to bottom middle).

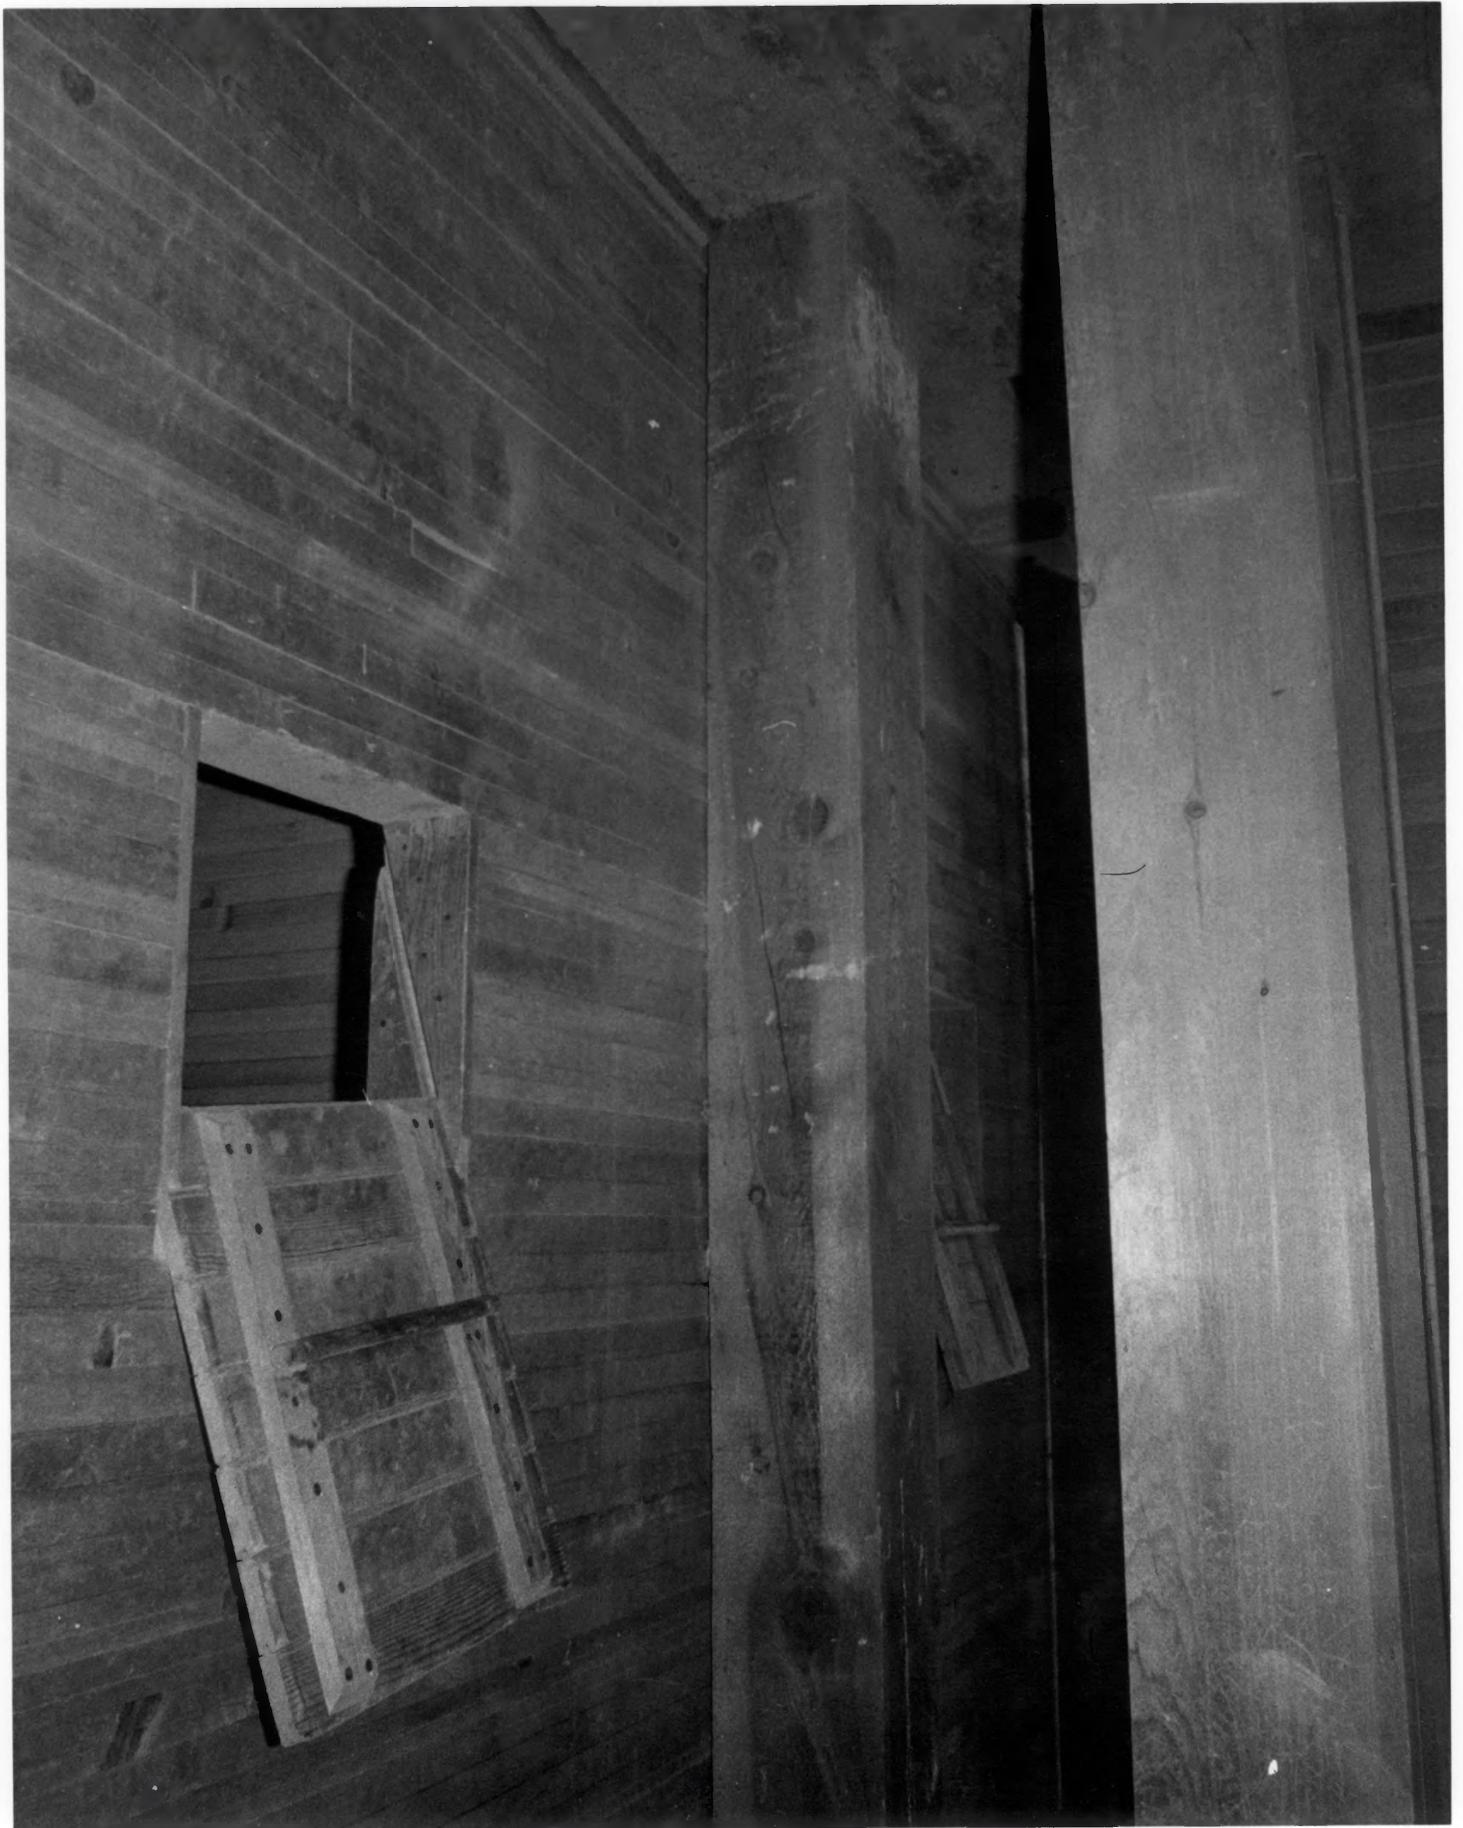
MINDEN FLOUR MILLING CO. - #7

Second-floor view of pine grain bin (one of four against west brick wall) which extends up through third floor. Note use of full-measure 2" by 6" pine stacked flat to form bin walls and the smooth wood surface inside the bin created by constant flow of grain.

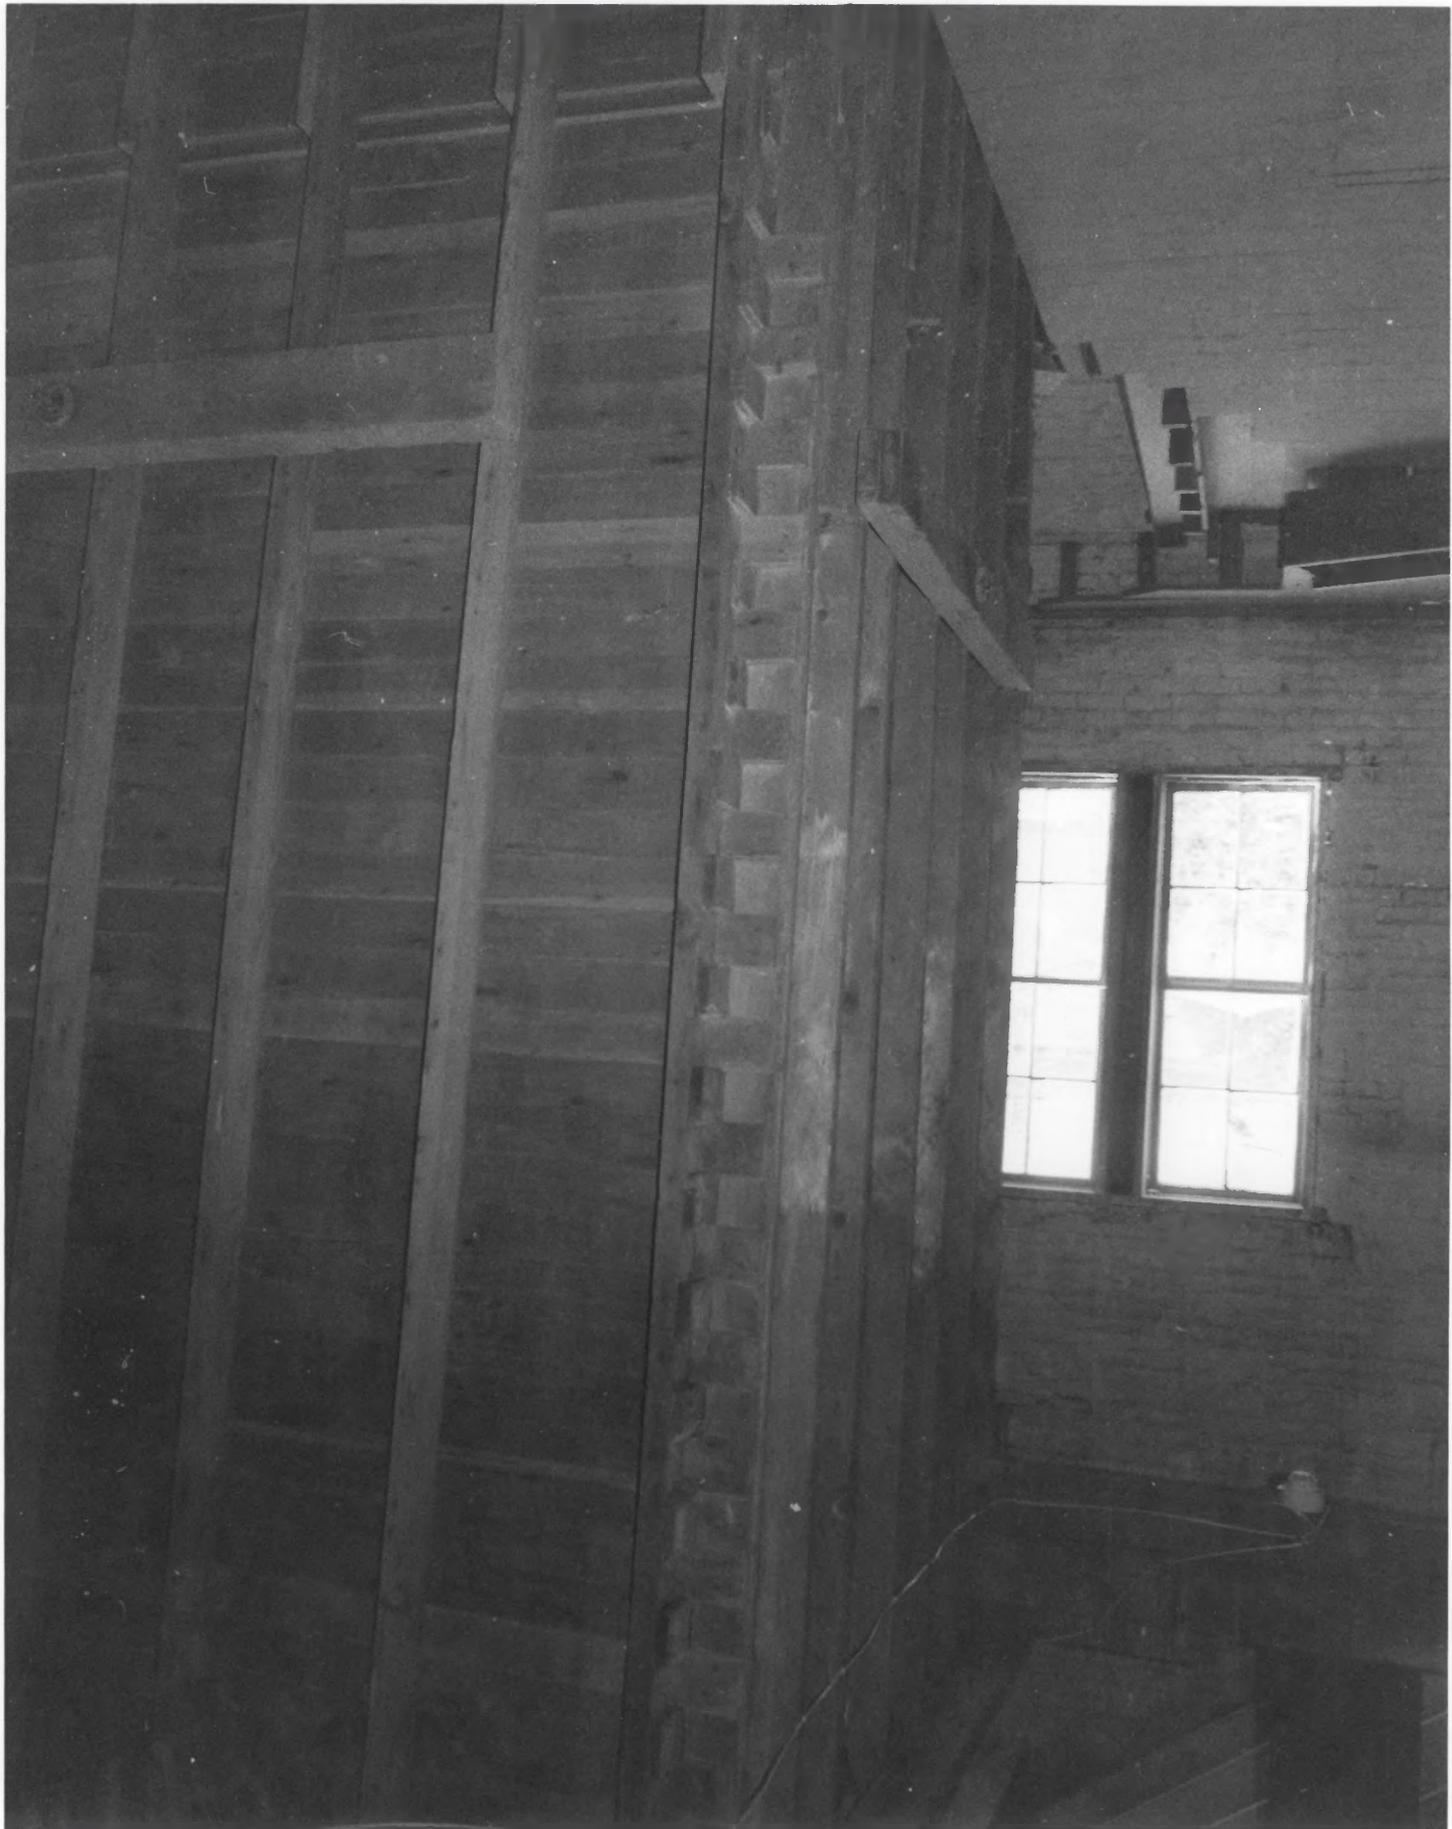
MINDEN FLOUR MILLING CO. - #8

Third-floor pine bin in middle of floor with intricate carpentry. Floor in background partially removed in 1942 to accomodate metal molasses tanks installed on second floor. Windows facing east.

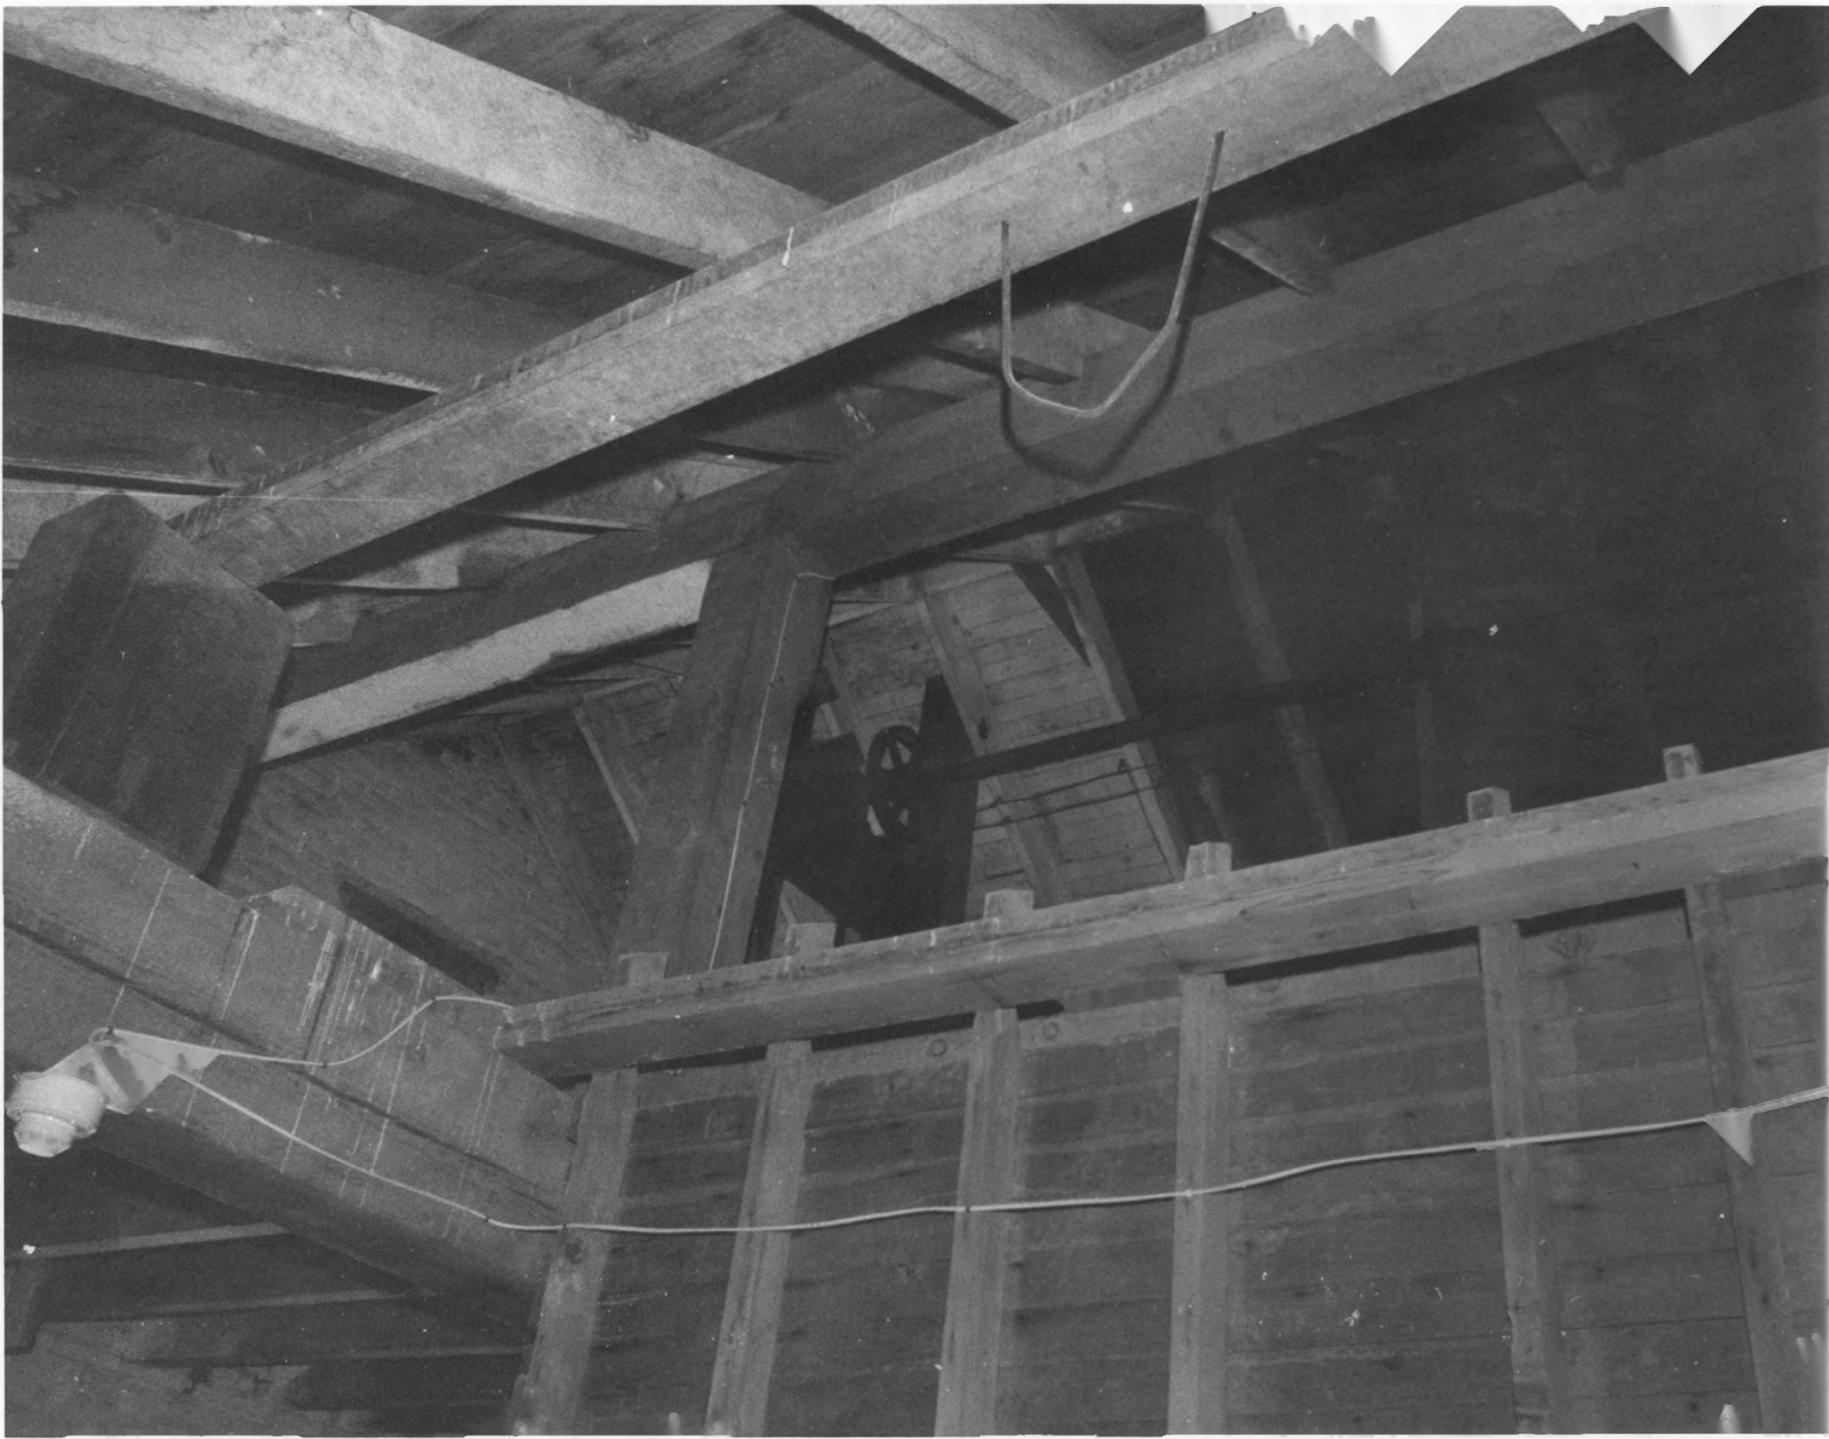
MINDEN FLOUR MILLING CO. - #9

View looking up to roof and loft area from third floor showing massive beams, machinery, and top of one of a number of storage bins within the mill. White object (lower left) is a smoke alarm installed in recent years.
