MINDEN
FLOUR
MILLING
COMPANY
INCORPORATED
MARCH 5
1906

MINDEN FLOUR MILLING CO. - #1

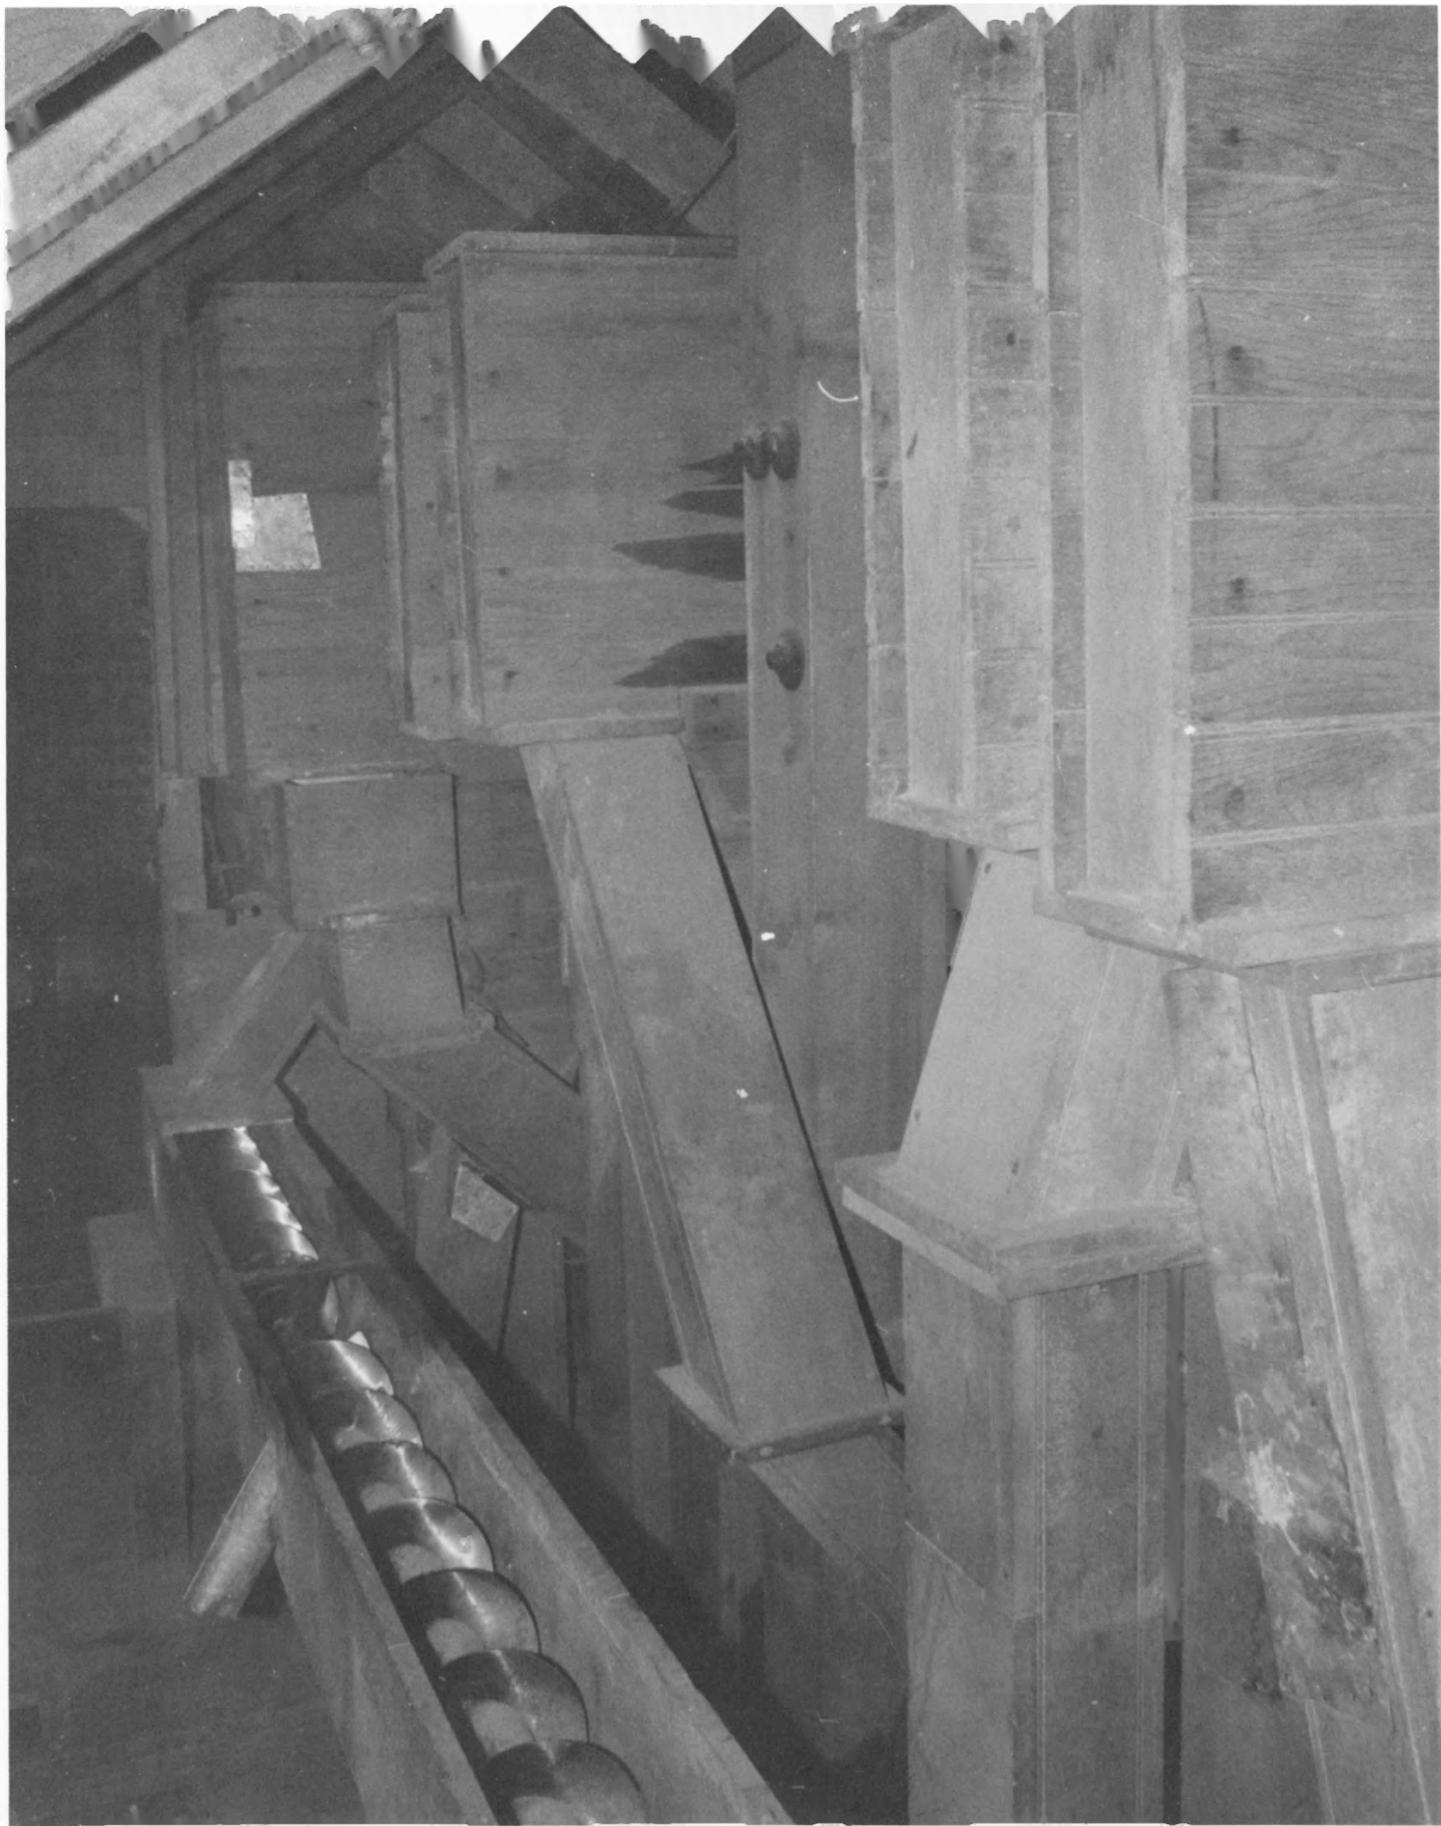
MINDEN FLOUR MILLING CO. - #10

Screw conveyor and chutes in loft area over third floor (looking in direction of silos to the west).

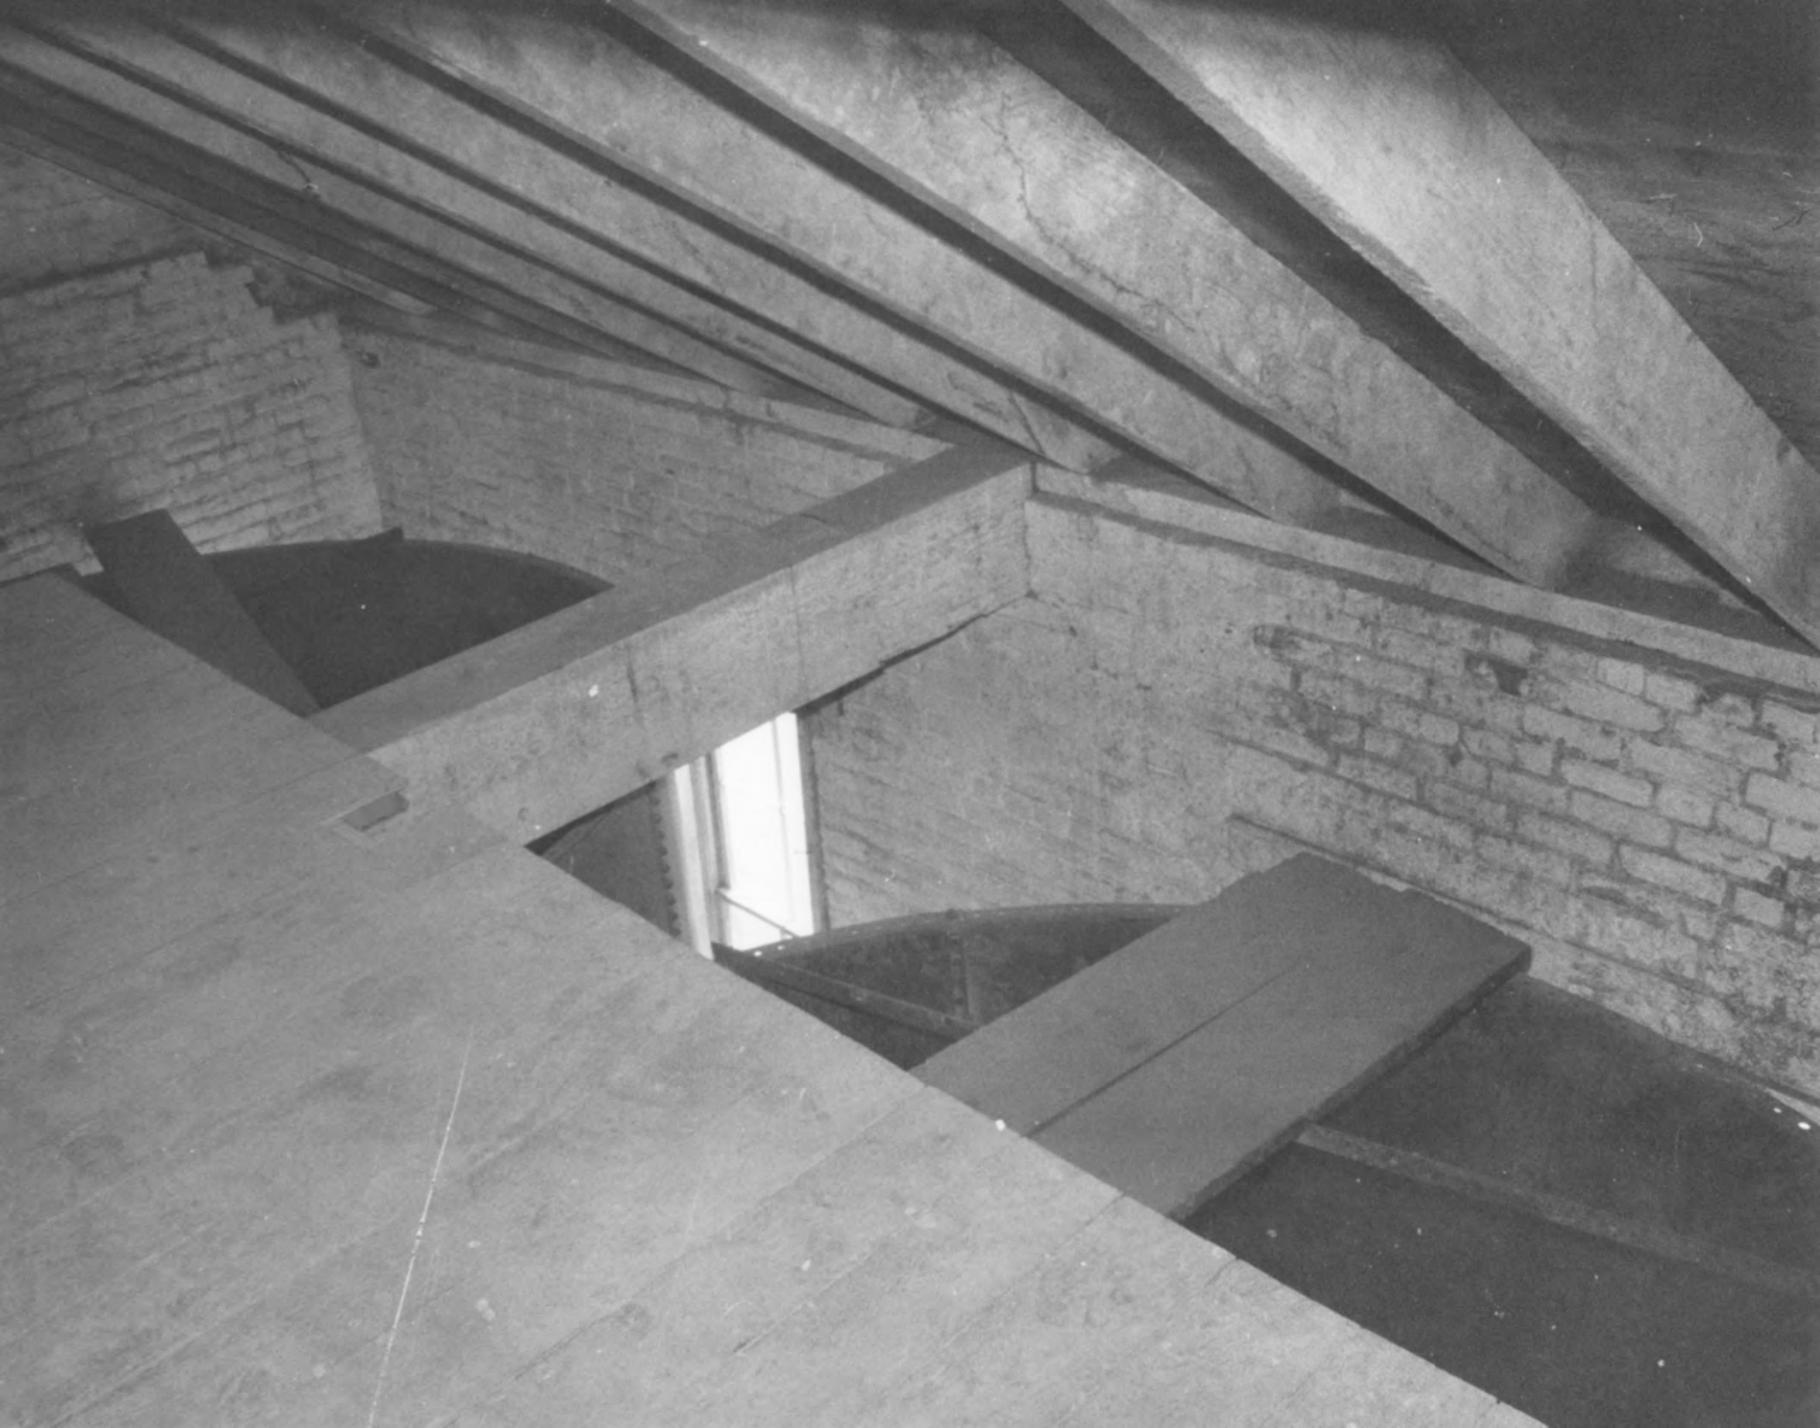
MINDEN FLOUR MILLING CO. - #11

View from loft area toward southeast corner of brick building looking down into molasses tanks.

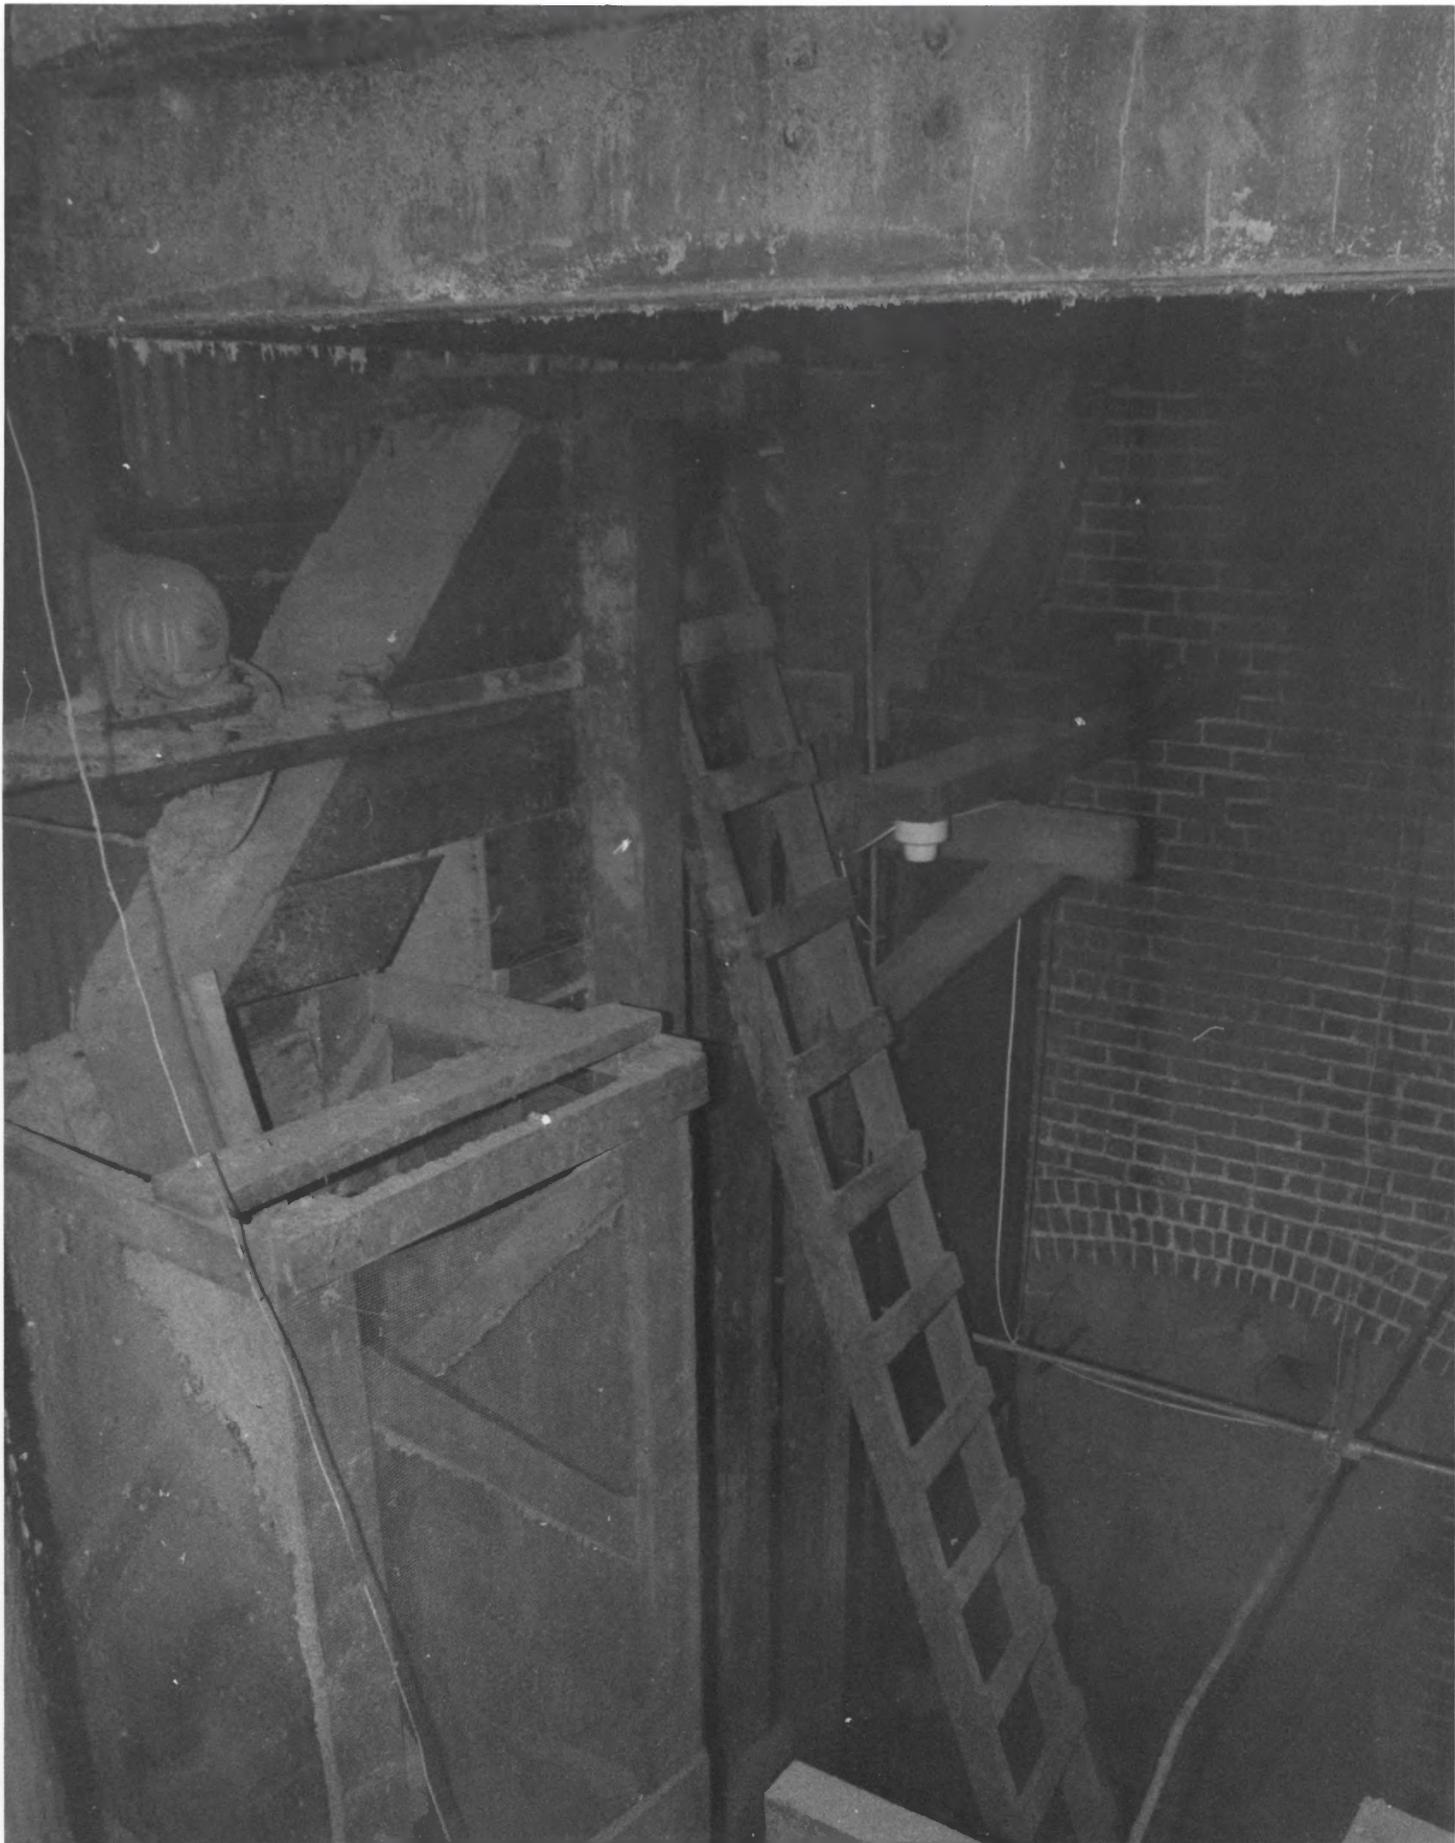
MINDEN FLOUR MILLING CO. - #12

View from approximately second-floor level looking into 3-story partition between silos and main brick building. A screened materials bin is at left.

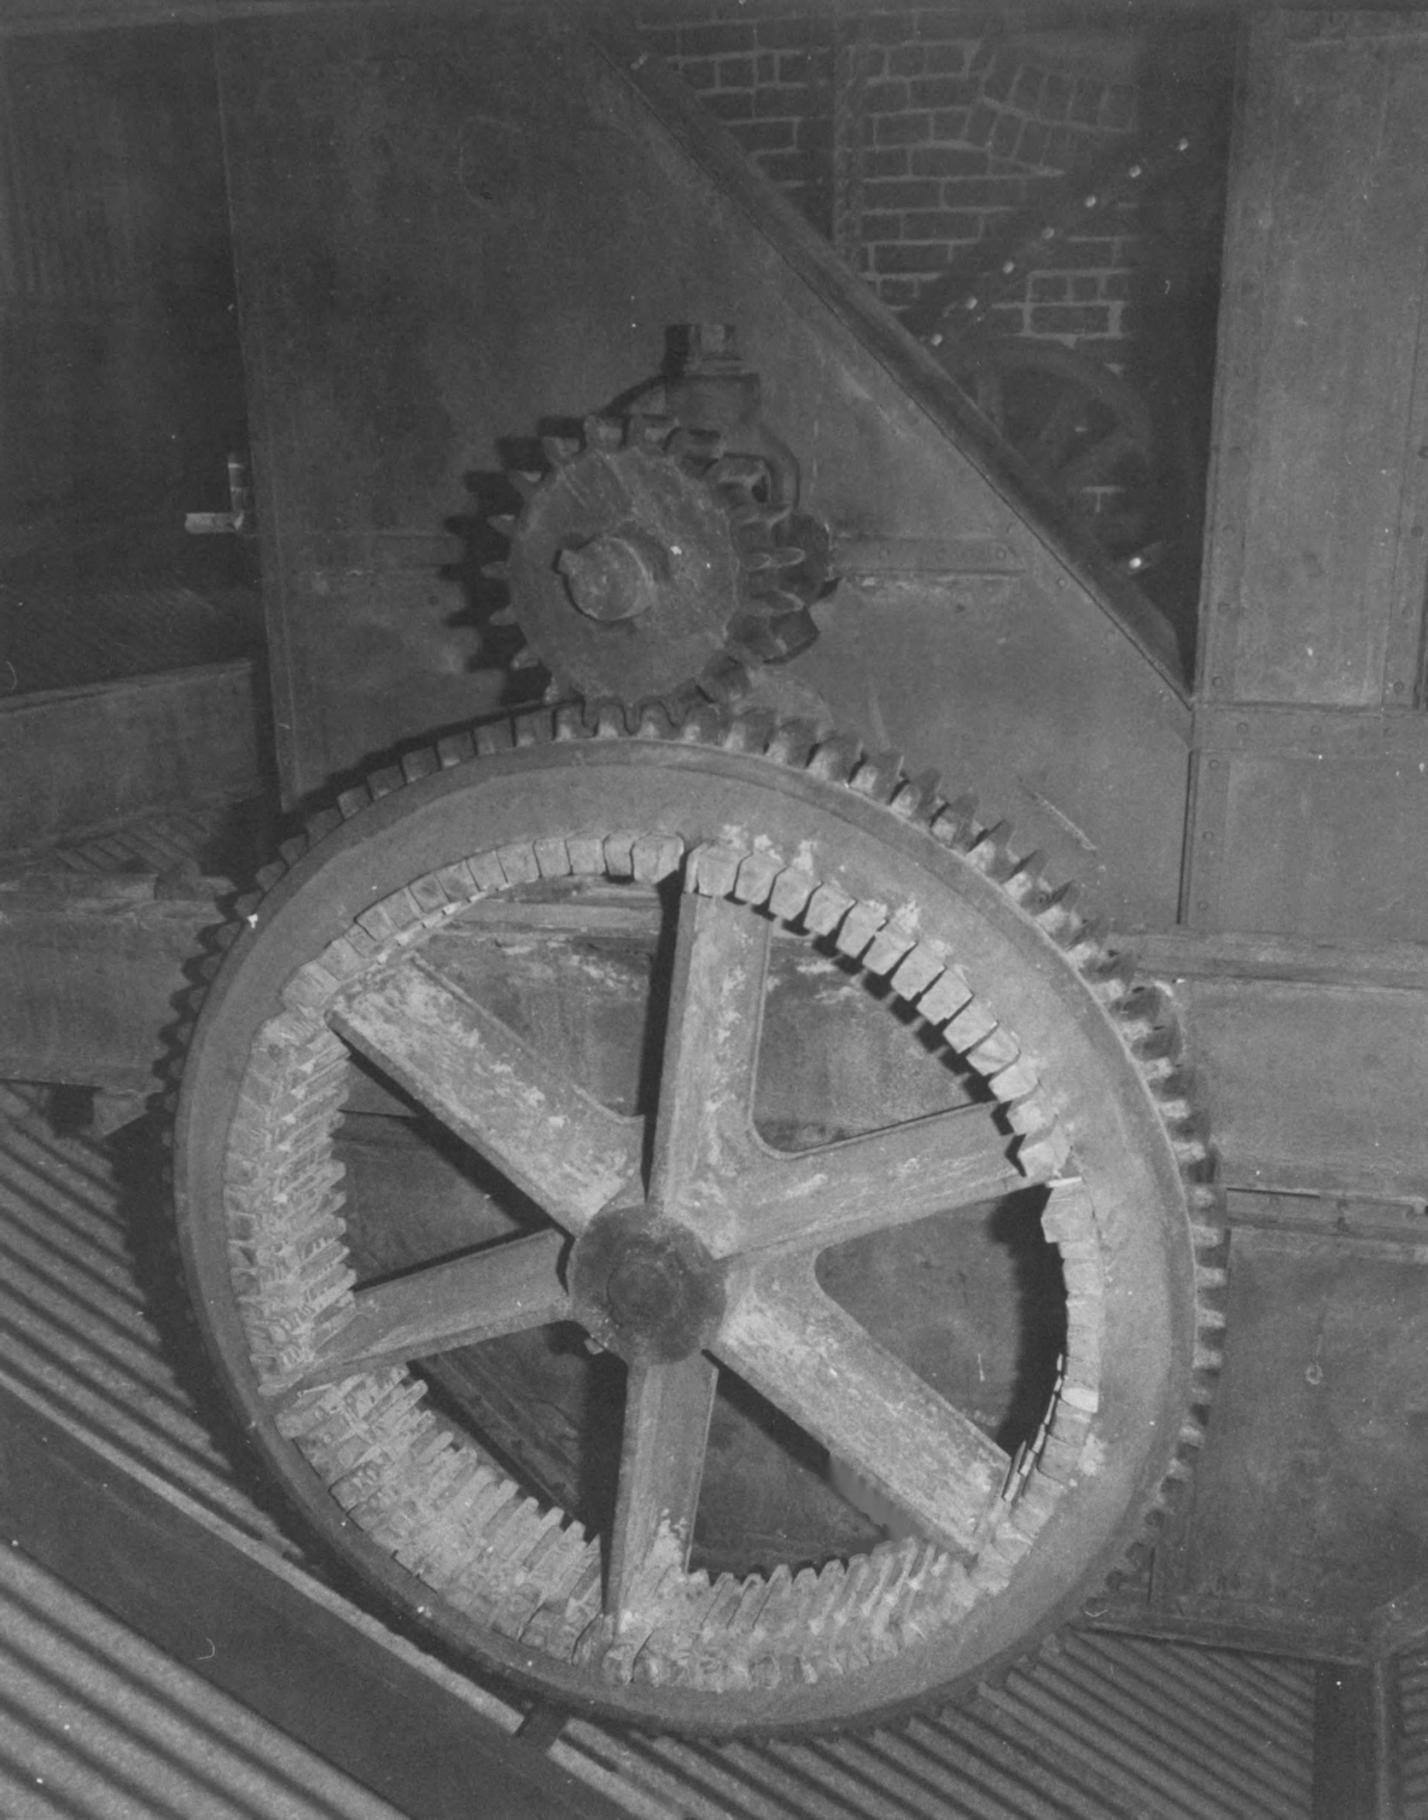
MINDEN FLOUR MILLING CO. - #13

Huge bull-wheel with wooden teeth and wedges located in corrugated sheet metal roof over silos. West brick wall and one of many rope-driven wheels are in background.

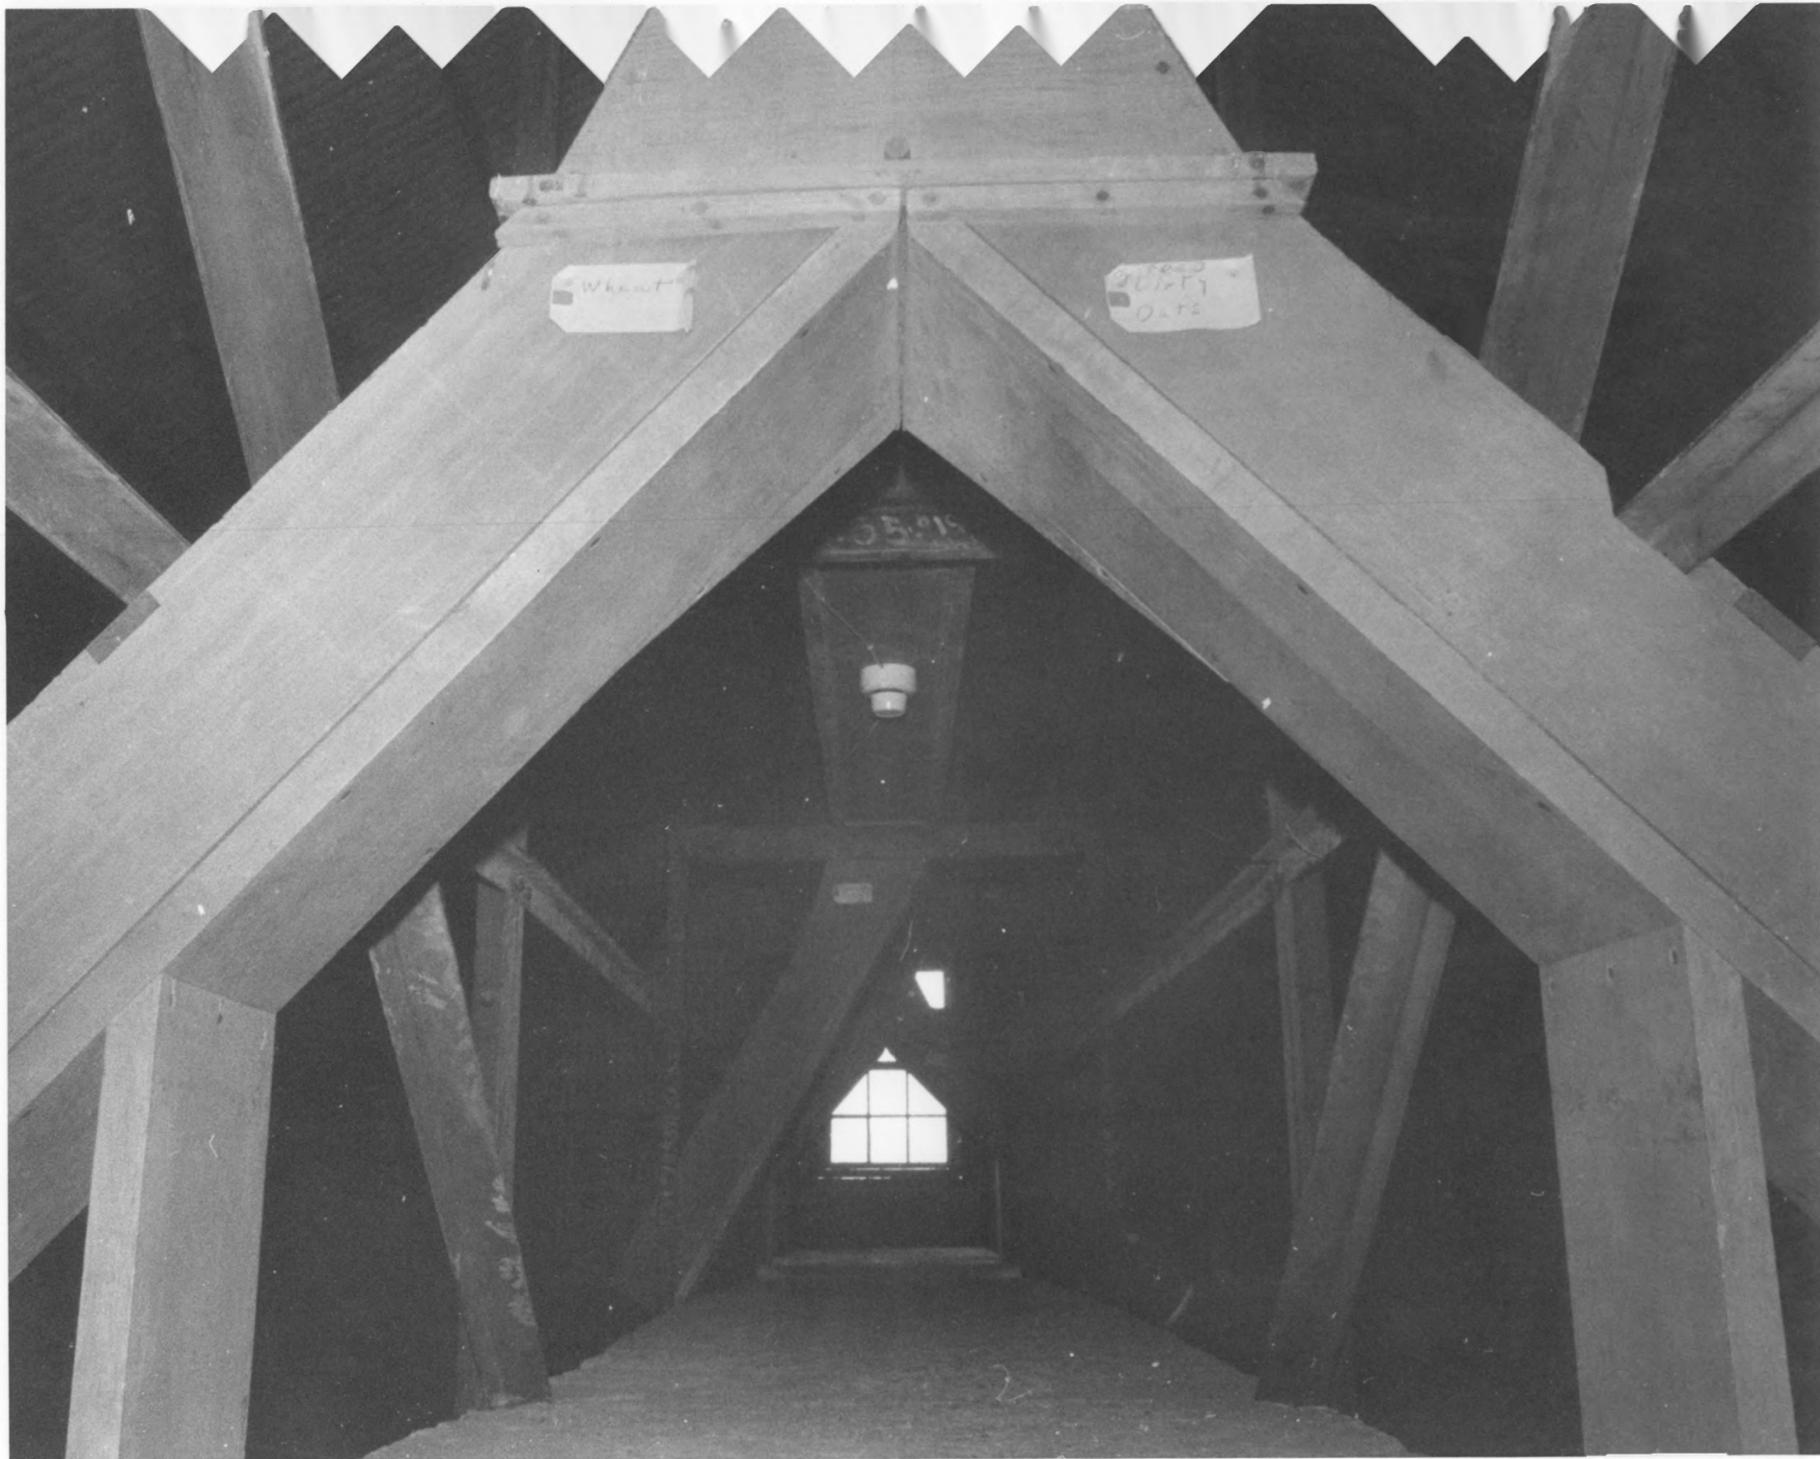
MINDEN FLOUR MILLING CO. - #14

View looking west down catwalk over silos.
Note chutes which took grain from overhead
screw conveyor to silos below.

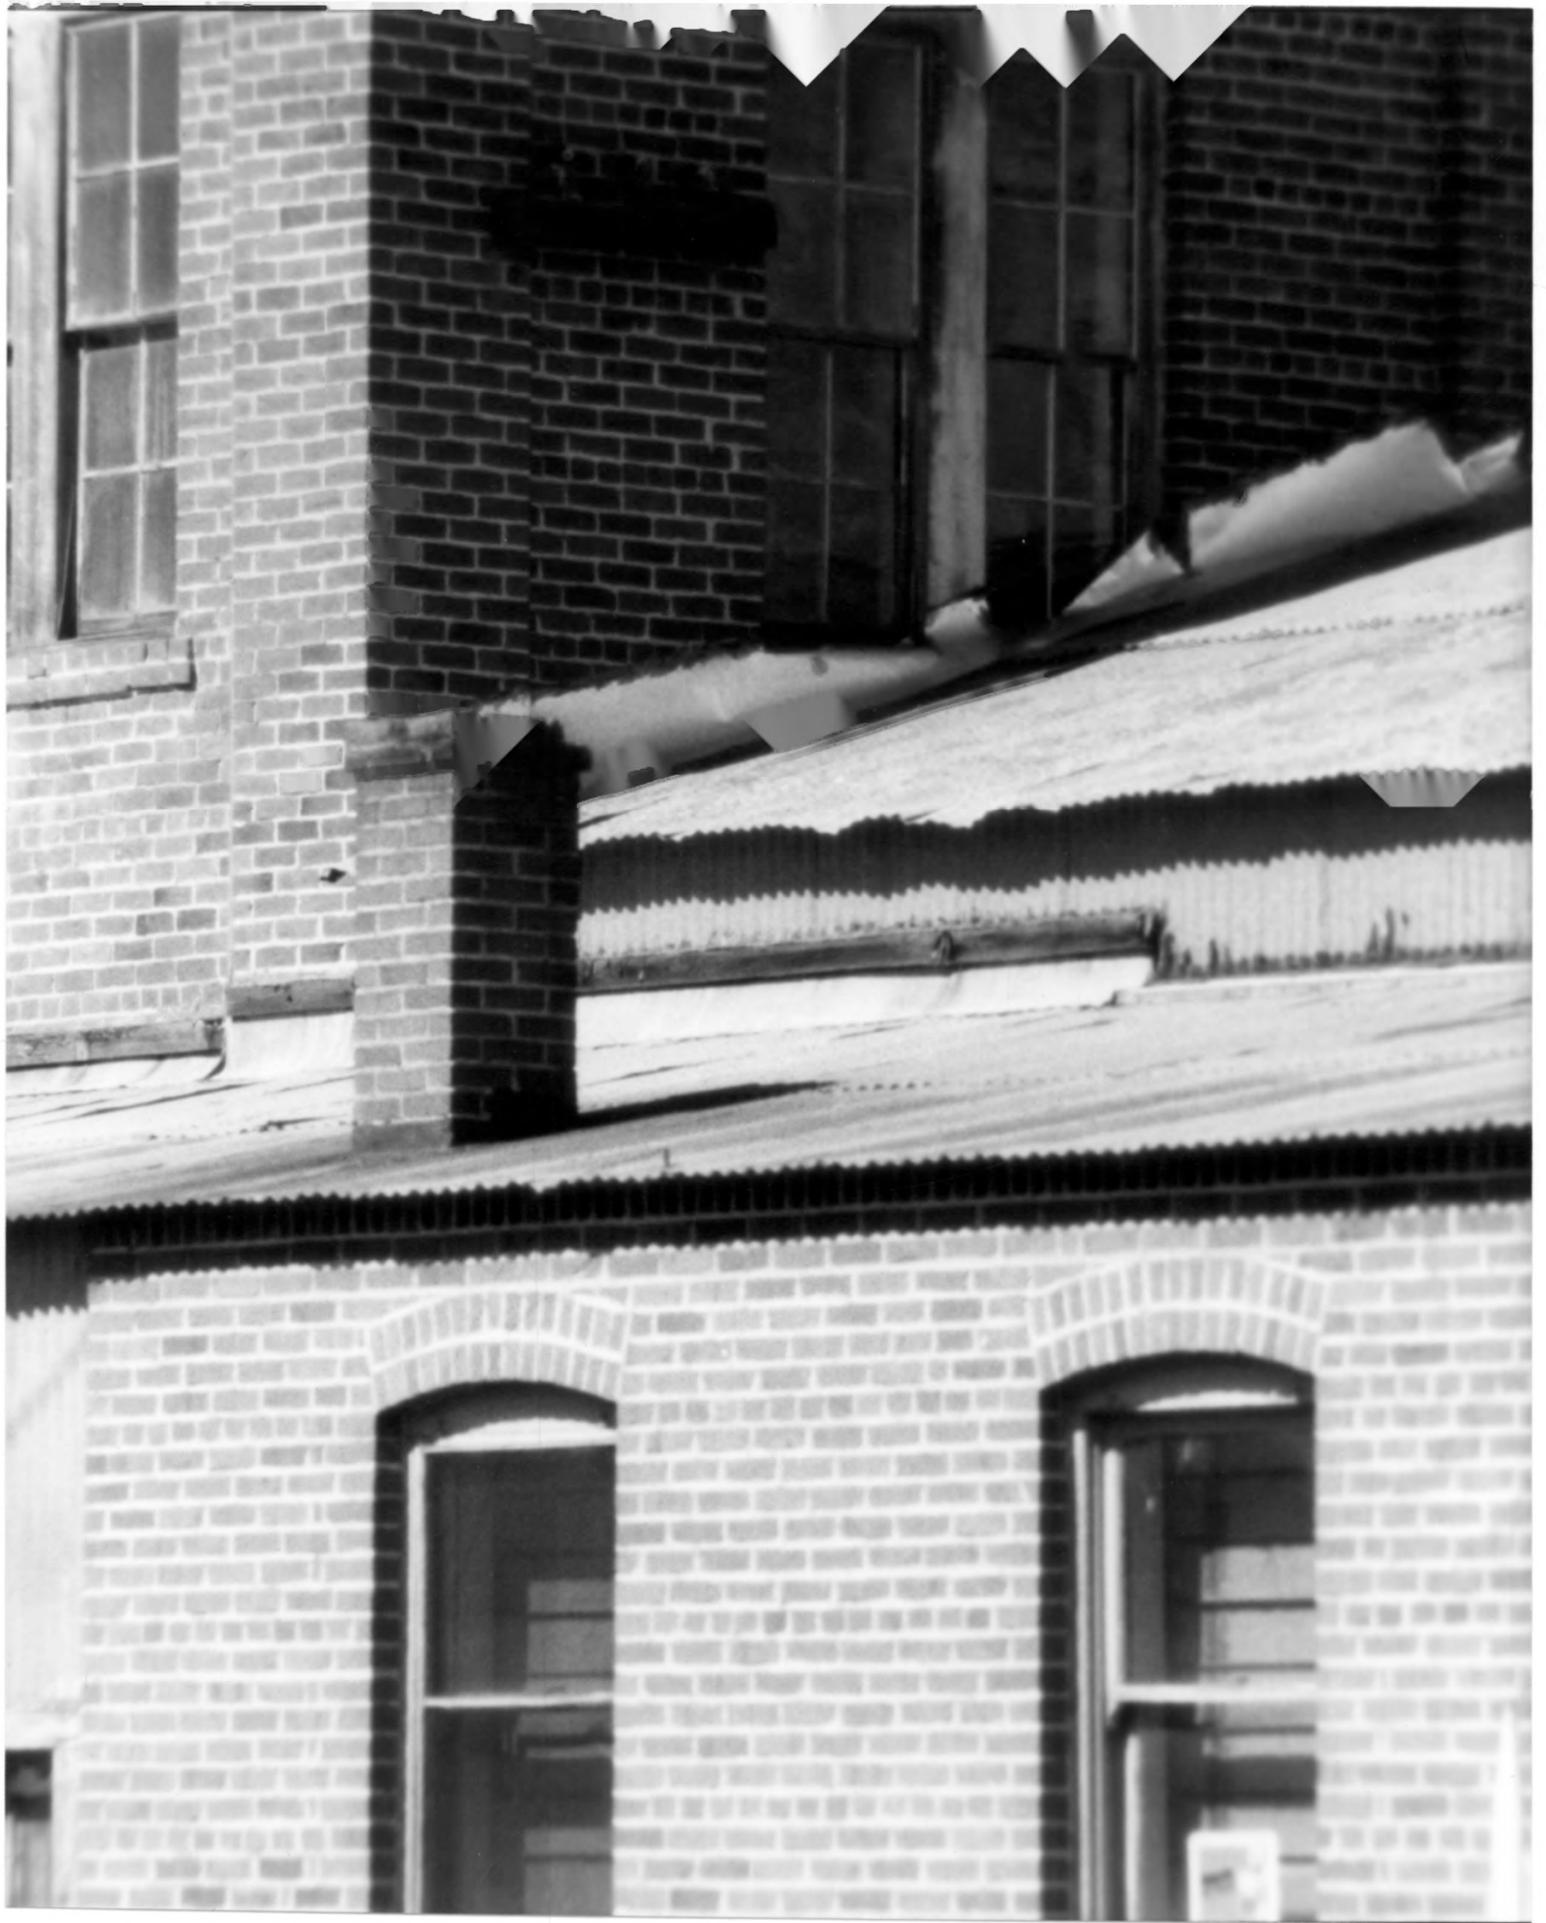
MINOEN MILL, MINOEN, NV.

DETAIL VIEW OF UPPER LEVEL WINDOW, ROOF ON
SOUTH EAST CORNER OF STRUCTURE WHERE
LOADING DOCK/STEEP JOIN 3 1/2 STOREY PORTION
