# National Register of Historic Places Inventory—Nomination Form

See instructions in How to Complete National Register Forms Type all entries—complete applicable sections MAR Name Bank of Kingston historic Madison Bank and Trust and/or common Location street & number 101 Public Square N/A not for publication N/A vicinity of congressional district city, town Kingston Arkansas code state 05 county Madison code 087 Classification Status Category **Ownership Present Use** public district \_X\_ occupied agriculture museum X private X building(s) X\_ commercial unoccupied park both private residence structure work in progress educational site **Public Acquisition** Accessible entertainment religious yes: restricted object in process scientific government X yes: unrestricted being considered industrial transportation X Not Applicable no military other: Owner of Property name Steve Smith, President, Jim McDougal, Chairman of the Board, Bank of Kingston street & number 101 Public Square N/A vicinity of city, town Kingston state Arkansas **Location of Legal Description** Circuit Clerk's Office courthouse, registry of deeds, etc. Madison County Courthouse street & number city, town Huntsvill

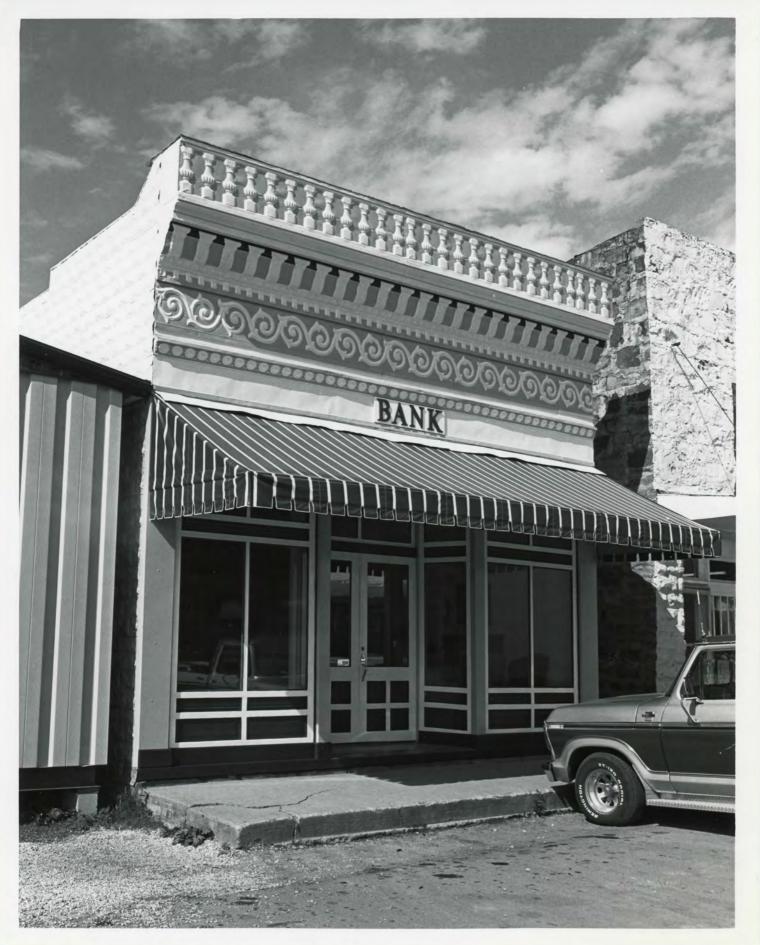
Front (south) elevation from the southwest. Photograph 2 of 7.

The symmetrical principal (south) facade of the Bank of Kingston is an unaltered wood paneled storefront which is composed of a centrally located, recessed entrance and two flanking display windows. Two vertical lights set on wood paneled bases and surmounted by transoms form the storefront windows. Splayed side-walls, containing like detailed vertical lights on wood panels, provide a smooth transition into the entry area. This main entrance is comprised of double doors, each featuring one rectangular light over four-panel base, with transom. A cloth awning, supported on a metal frame and extending across the full width of the principal elevation, shades the storefront. The building's prominent pressed tin entablature and parapet attractively complete the principal facade. An unornamented architrave, bearing the sign "Bank", caps the storefront and a band of ovolo moulding separates the architrave from the entablature's distinctive frieze. Fluid scroll designs embellish the frieze. Above the frieze, a slightly projecting cornice is articulated with pressed metal translations of dentils and modillions. The parapet that caps the entablature features a decorative raised pattern that creates the appearance of a balustrade. Documents found in the bank's original safe indicate that the exterior and interior pressed metal was purchased from Mesker & Brothers of St. Louis, Missouri and shipped to Arkansas by rail.

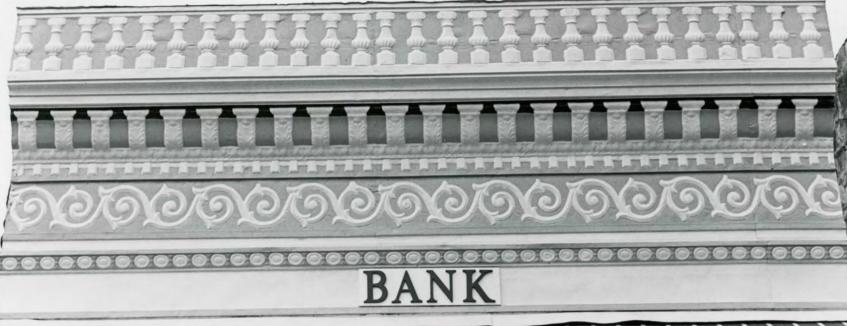
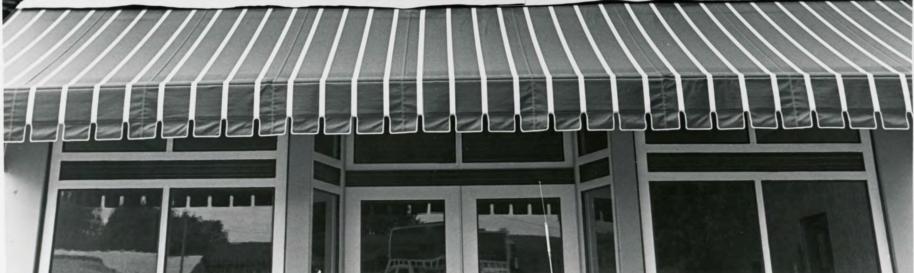
Bob Dunn, Photographer.
Photograph taken 30 April 1981.
Negative filed at Ark. Hist. Pres. Program
Front (south) elevation, cornice detail from the south.
Photograph 3 of 7.

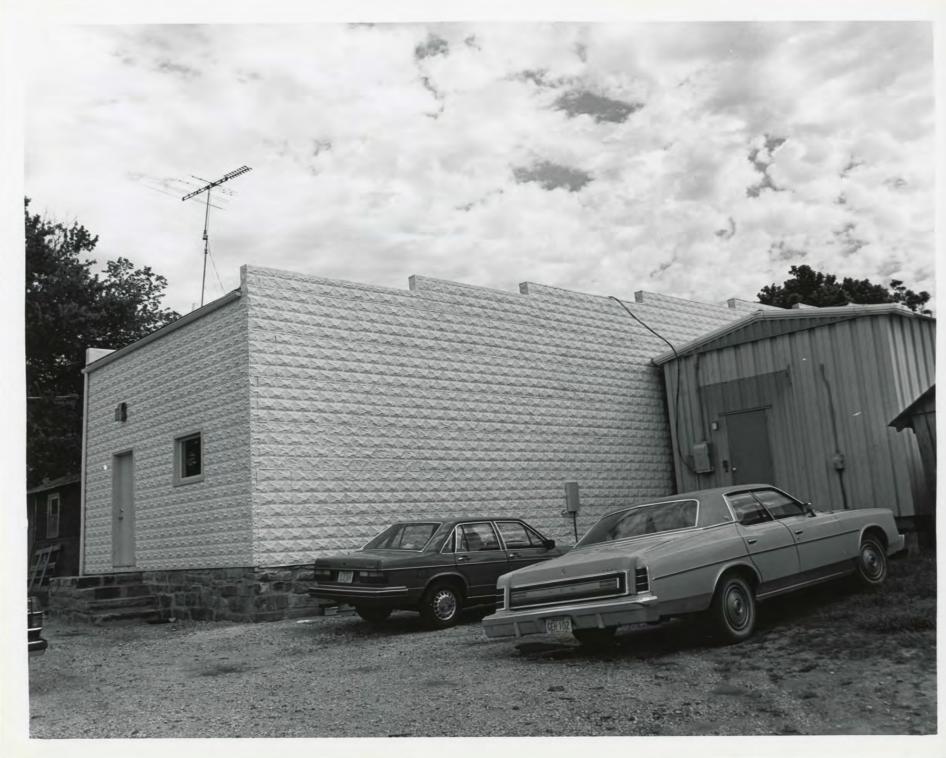
View from the northwest. Photograph 4 of 7.

The bank's east and west elevations are distinguished by pressed metal veneer fabricated in imitation of masonry. Otherwise these side elevations are uninterrupted and undistinguished. In 1981 the bank was extended to the rear (north). However, sympathetic use of pressed tin siding renders this one-story addition relatively undistinguishable from the predominant original section of the building. Further, the addition is virtually invisible from the public square and thus does not intrude upon the integrity of the bank's fine principal facade. The entire building has recently been painted in period colors of beige with marcon, black, and white trim.

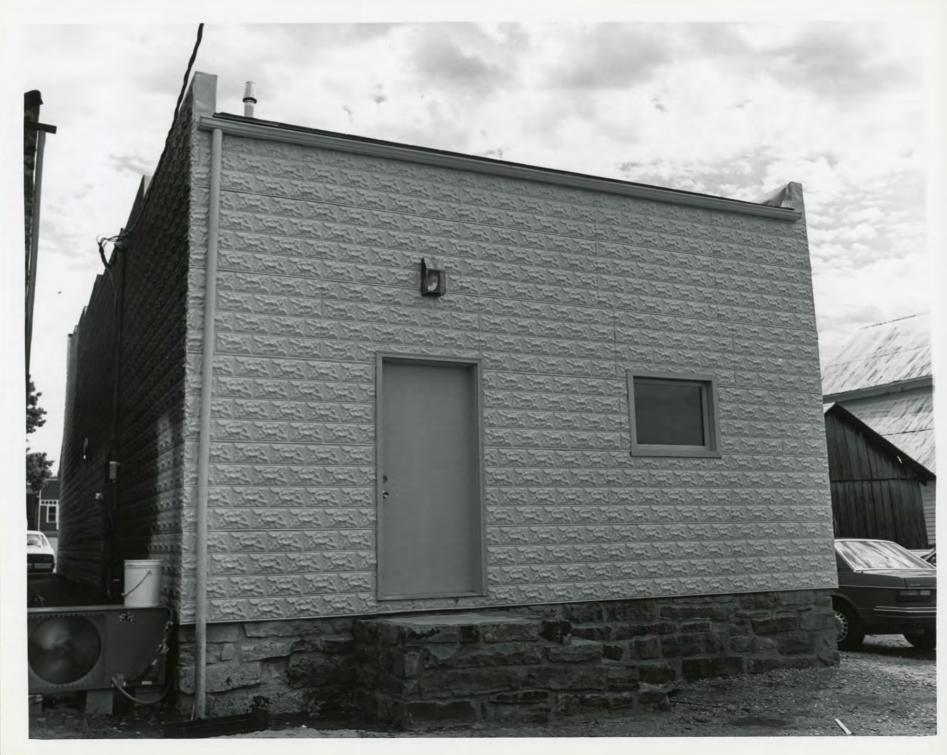
Bank of Kingston, 101 Public Square, Kingston, Arkansas. Madison County. Bob Dunn, Photographer. Photograph taken 30 April 1981. Negative filed at Ark. Hist. Pres. Program Rear (north) elevation from the northeast. Photograph 5 of 7

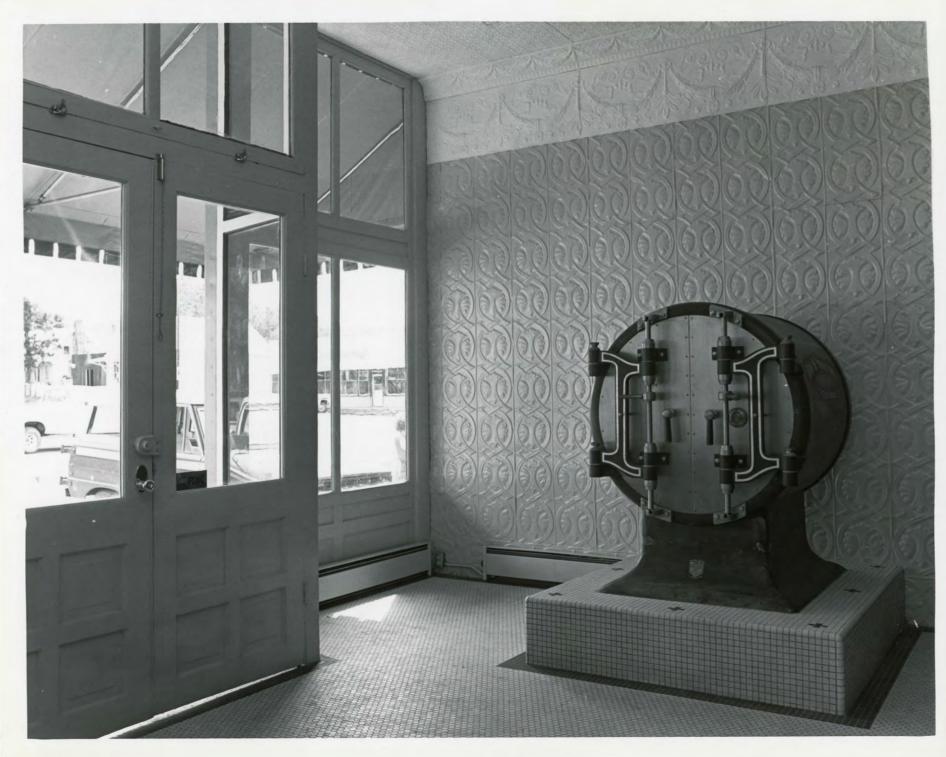
Interior. Banking room from the northeast. Photograph 6 of 7.

The interior of the Bank of Kingston, the subject of recent restoration, retains the same integrity of original fabric that so distinguishes the building's exterior. In plan, the banking room and its lobby occupy the front half of the structure, offices are located behind it, and a conference room occupies the rear addition. The teller's

cage is quite classical in design featuring Ionic colonnettes and dentiled cornices that frame the teller's windows, egg and dart moulding, paneling, beading, and applied garlands. As on the exterior, pressed metal contributes significantly to the quality of the interior design. The pressed tin walls, cornice mouldings and ceiling panels are replete with ornate designs. The interior of the rear addition continues the esthetic established in the original banking room by utilizing new pressed tin components obtained from the same firm that provided the original fabric. The banking room floor is covered with white tiles and the "1911" construction date is inlaid in a darker color tile. Two original safes have been restored and one, a barrel safe manufactured in 1916, occupies the banking room lobby. The building is heated by a replica of an 1895 wood heater.

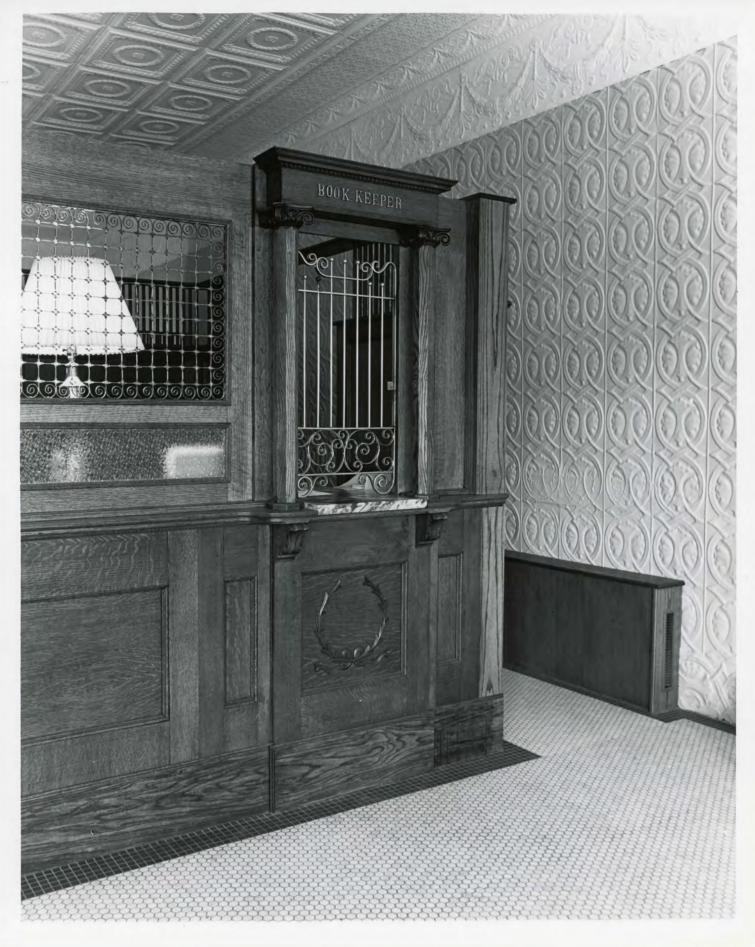
Interior. Banking room. Detail of teller's cage. Photograph 7 of 7.
