1. Silcox Hut
2. Vicinity of Government Camp, OR
3. Photographer: Upward Trails
4. Date: 1983
5. Negative Location: Files of ICE, Ltd., 5520 N. Atlantic, Portland, OR 97217
6. From south, Silcox Hut in its alpine environment, summit of Mt. Hood in background.
7. Photo #1

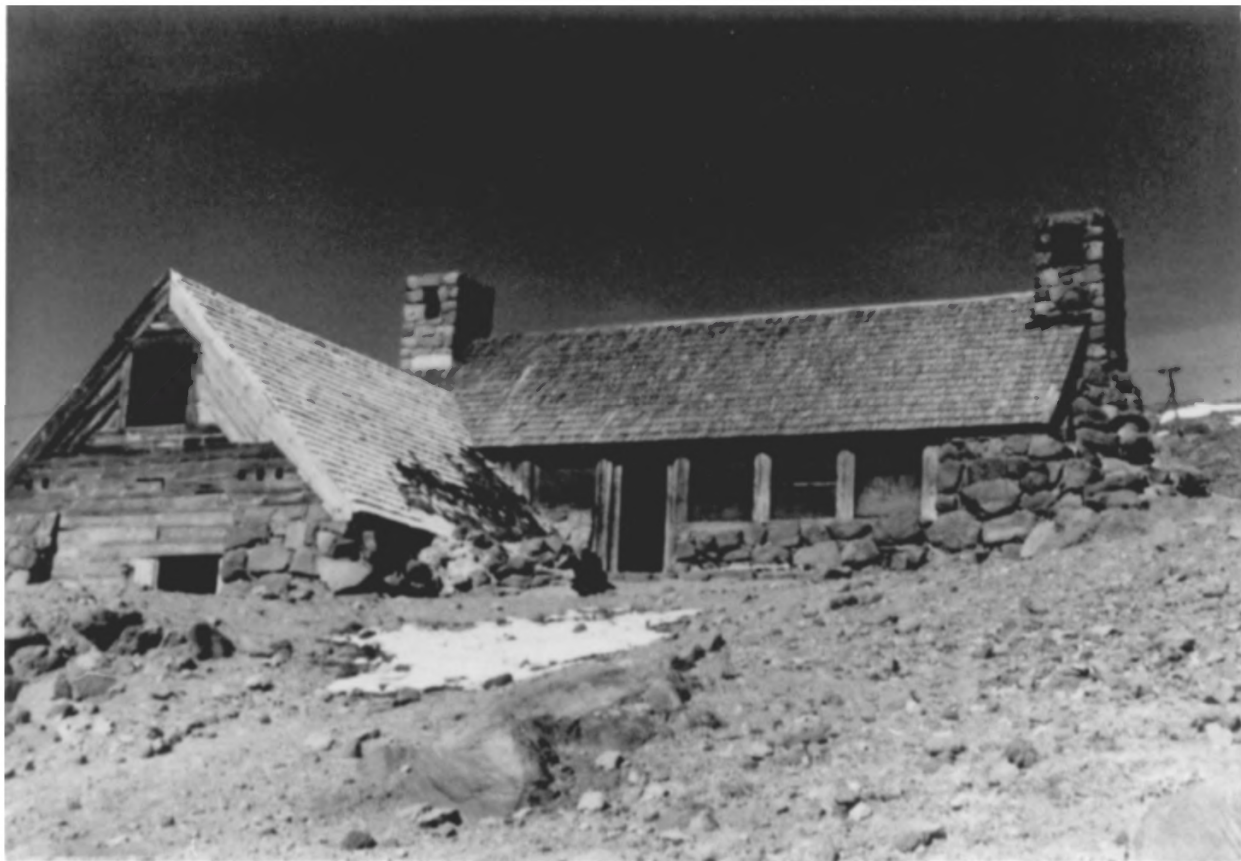
1. Silcox Hut
2. Vicinity of Government Camp, OR
3. Photographer: Upward Trails
4. Date: 1983
5. Negative Location: Files of ICE, Ltd., 5520 N.
Atlantic, Portland, OR
97217
6. Looking northwesterly at the main facade
(south) of Silcox Hut.
7. Photo #2

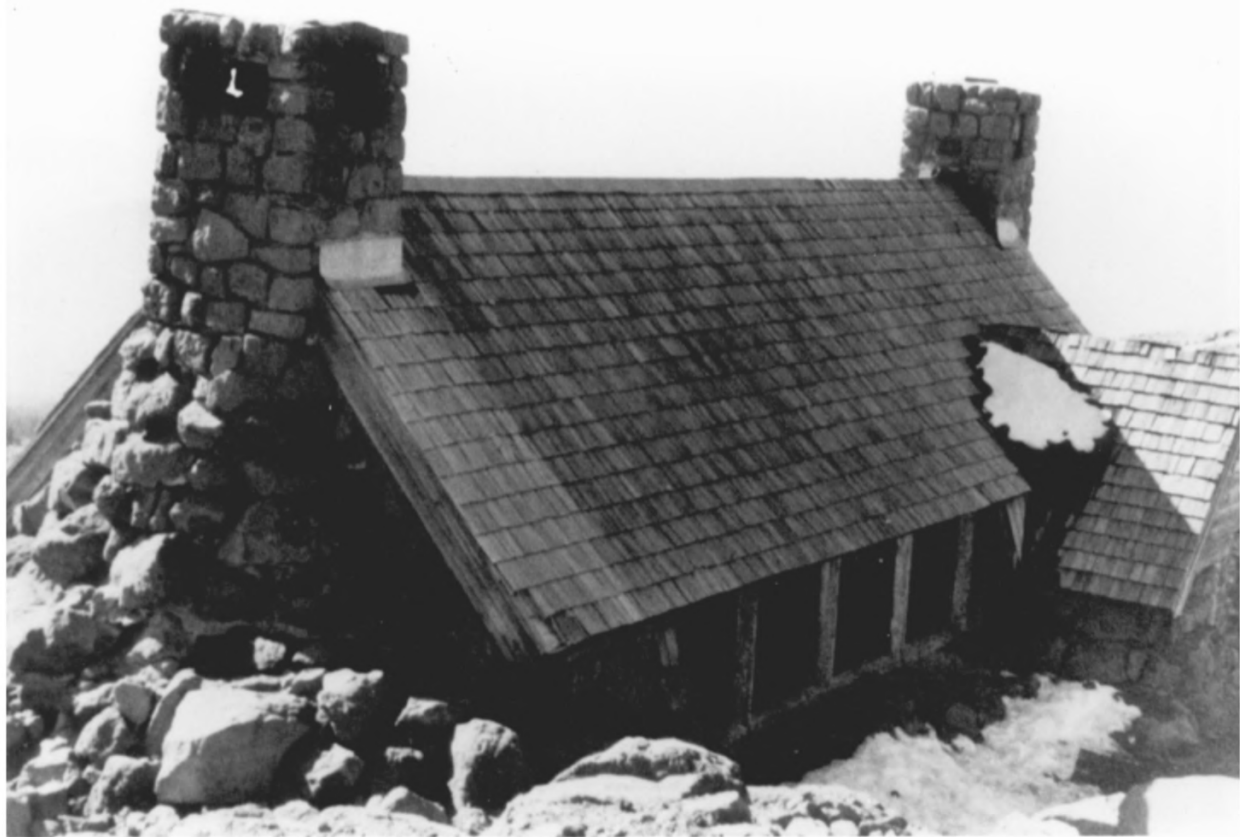
1. Silcox Hut
2. Vicinity of Government Camp, OR
3. Photographer: Upward Trails
4. Date: 1983
5. Negative Location: Files of ICE, Ltd., 5520 N. Atlantic, Portland, OR 97217
6. Looking southwesterly at north (rear) elevation of Silcox Hut. Photo also details exterior chimney on east gable end.
7. Photo #3

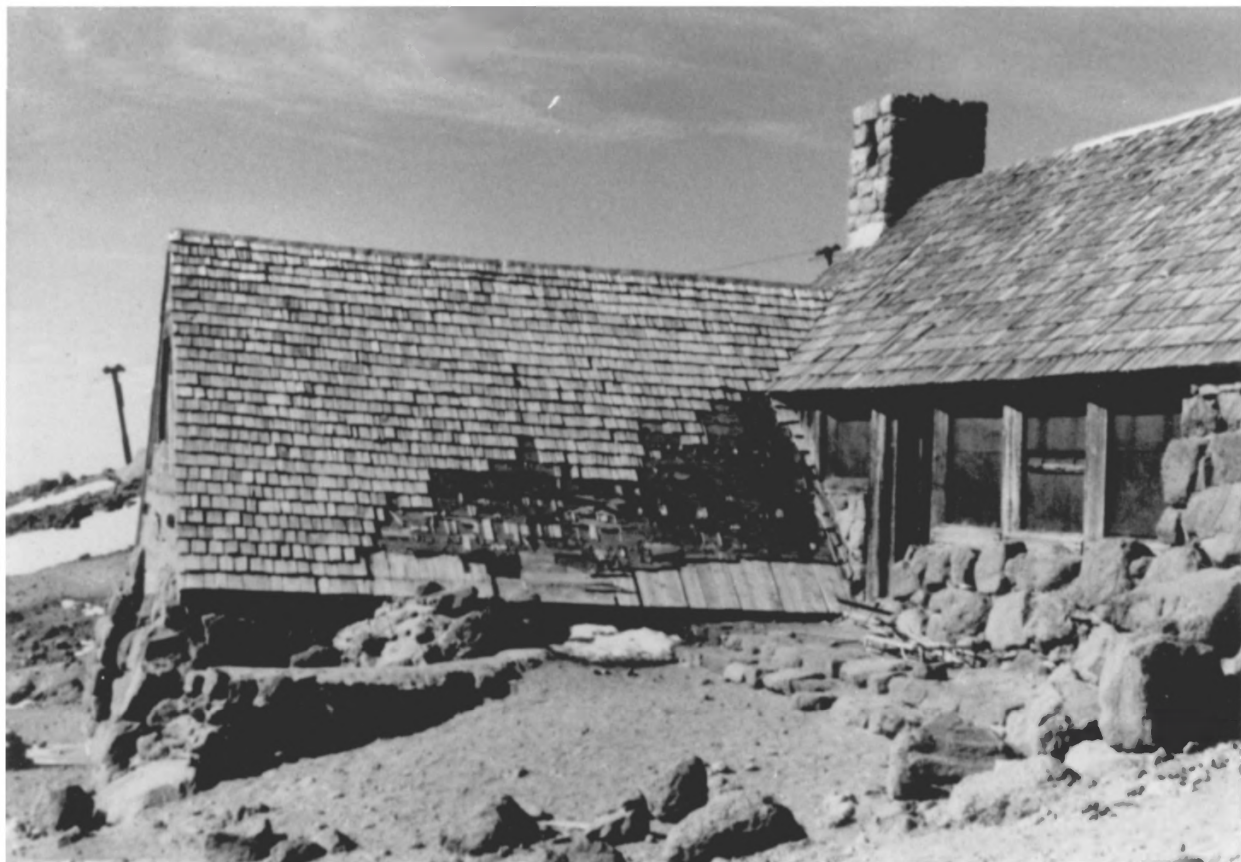
1. Silcox Hut
2. Vicinity of Government Camp, OR
3. Photographer: Upward Trails
4. Date: 1983
5. Negative Location: Files of ICE, Ltd., 5520 N. Atlantic, Portland, OR 97217
6. Looking westerly, photo shows south-projecting wing, unpaved terracing. Missing wood shingle roof materials result from severe weather conditions and vandalism.
7. Photo #4

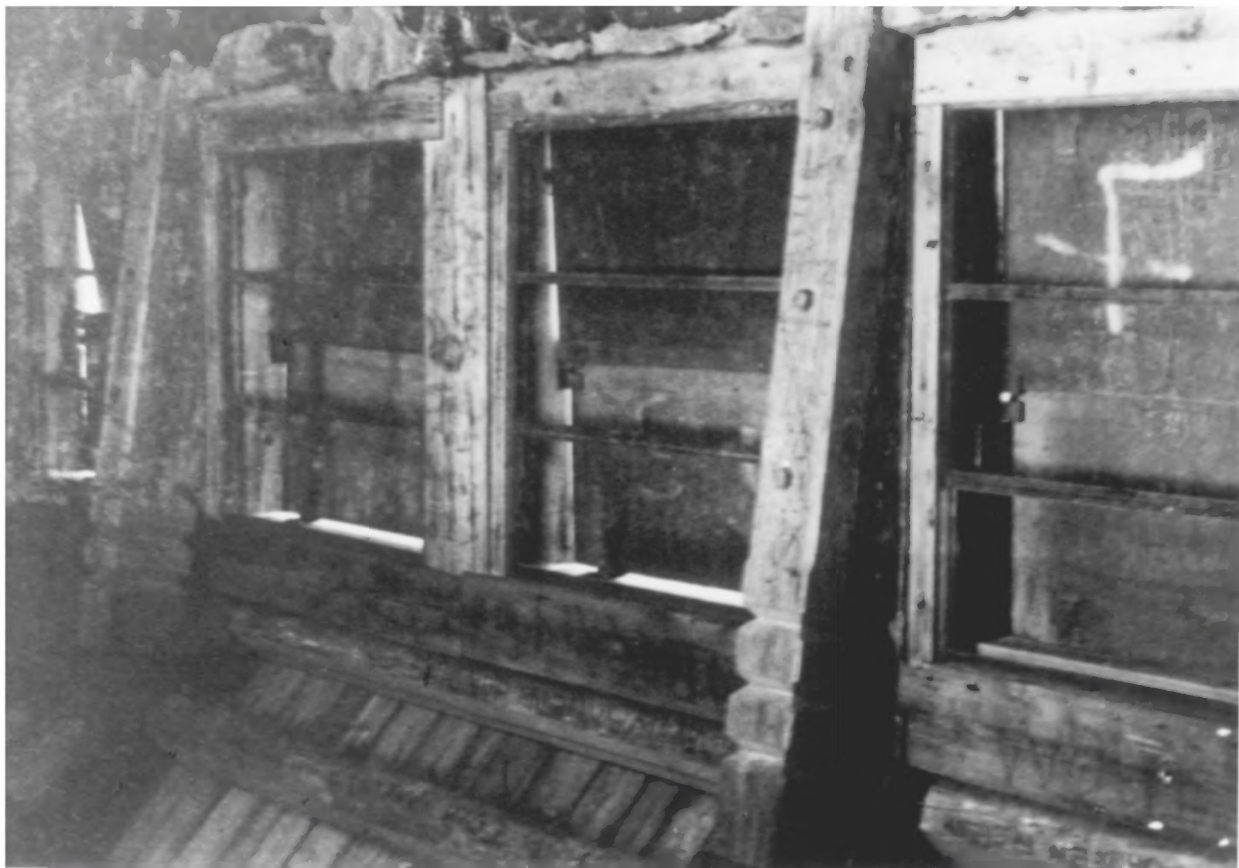
1. Silcox Hut
2. Vicinity of Government Camp, OR
3. Photographer: Upward Trails
4. Date: 1983
5. Negative Location: Files of ICE, Ltd., 5520 N.
Atlantic, Portland, OR
97217
6. Steel sash define windows of an awning type.
7. Photo #5

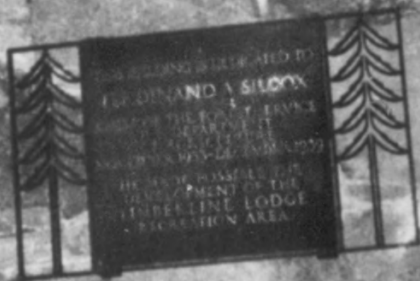
1. Silcox Hut
2. Vicinity of Government Camp, OR
3. Photographer: Upward Trails
4. Date: 1983
5. Negative Location: Files of ICE, Ltd., 5520 N. Atlantic, Portland, OR 97217
6. Bronze plaque commemorating Ferdinand A. Silcox, Chief of the Forest Service, 1933-1939, whose efforts made possible the development of the Timberline Lodge Recreation Area. Plaque is mounted above fireplace on east wall.
7. Photo #6

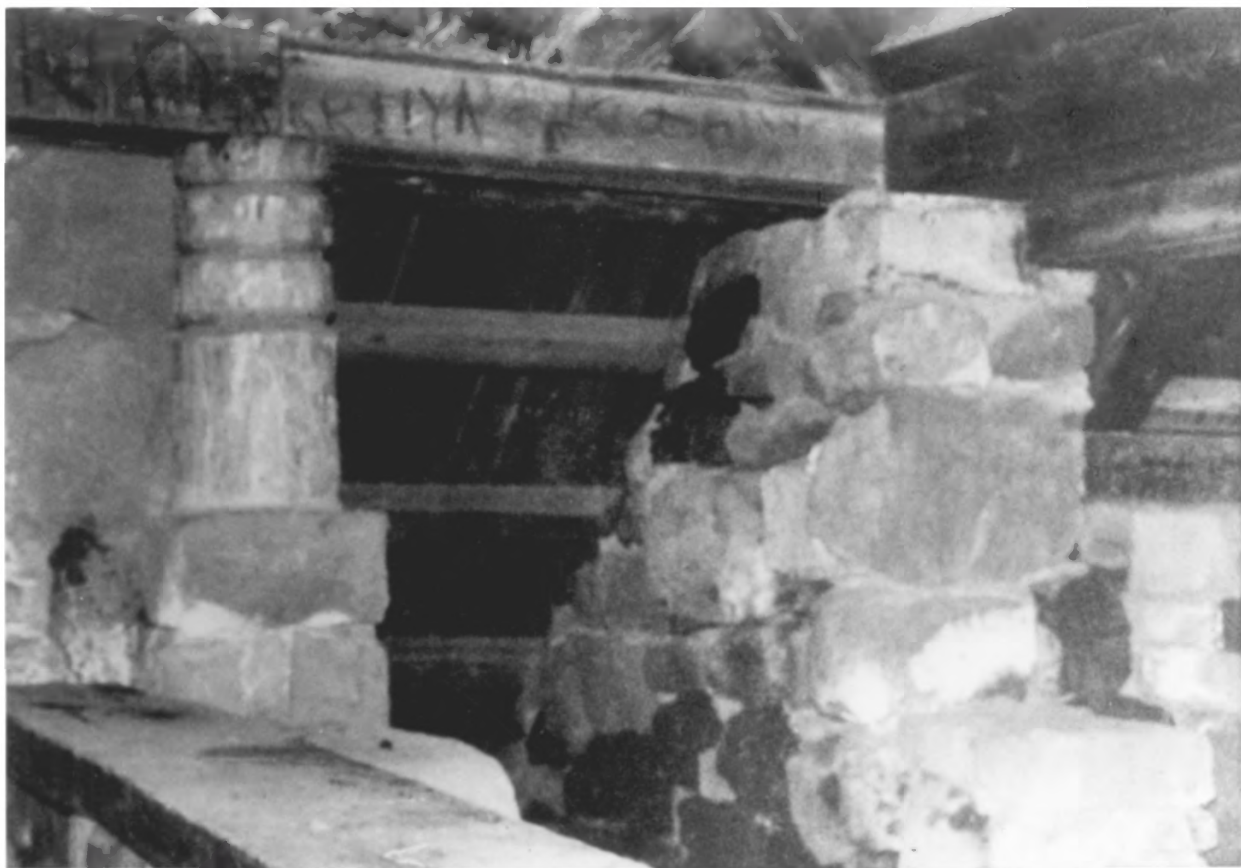
1. Silcox Hut
2. Vicinity of Government Camp, OR
3. Photographer: Upward Trails
4. Date: 1983
5. Negative Location: Files of ICE, Ltd., 5520 N.
Atlantic, Portland, OR
97217
6. Interior detail, routed ring post made from
large log.
7. Photo #7

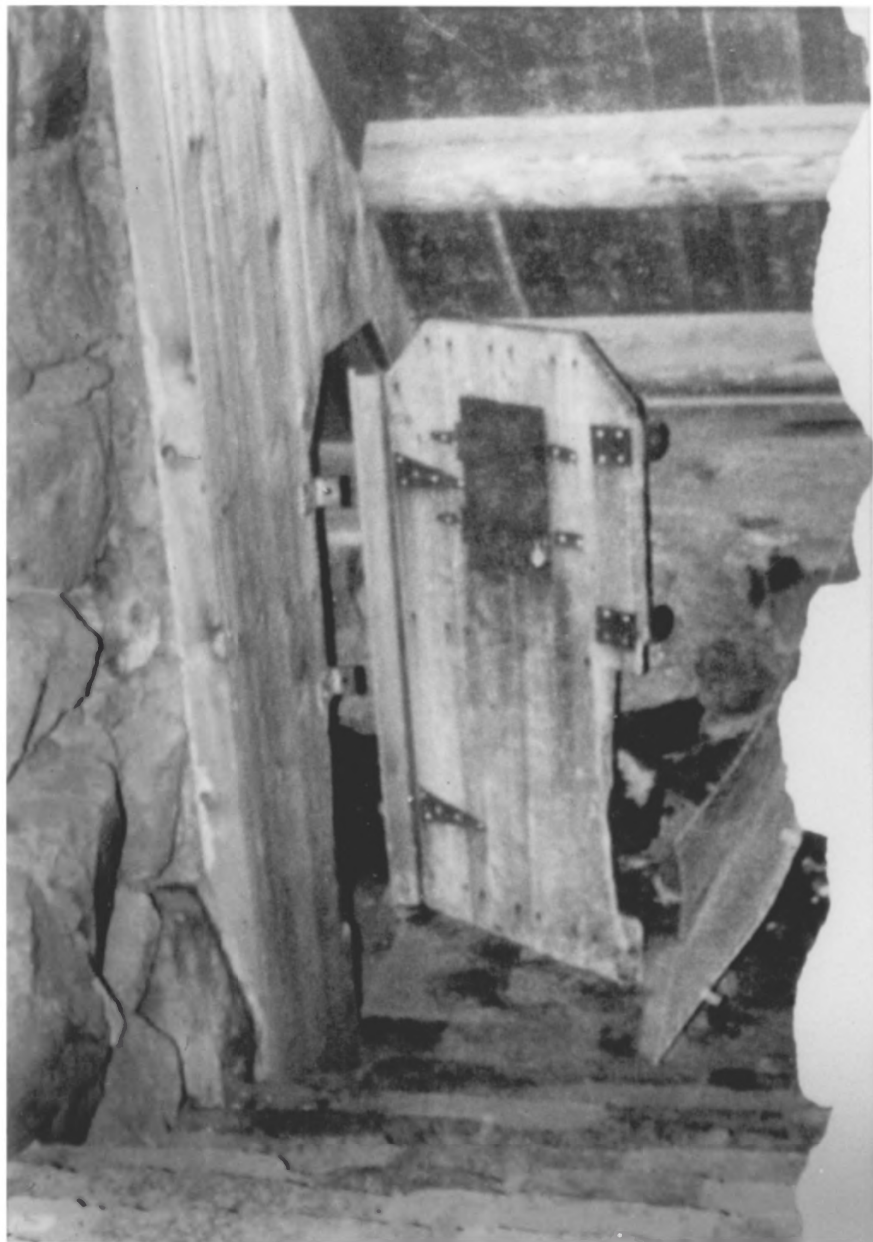
1. Silcox Hut
2. Vicinity of Government Camp, OR
3. Photographer: Upward Trails
4. Date: 1983
5. Negative Location: Files of ICE, Ltd., 5520 N.
Atlantic, Portland, OR
97217
6. Interior detail, hand hewn timber door hung
with decorative wrought-iron strap hinges.
7. Photo #8

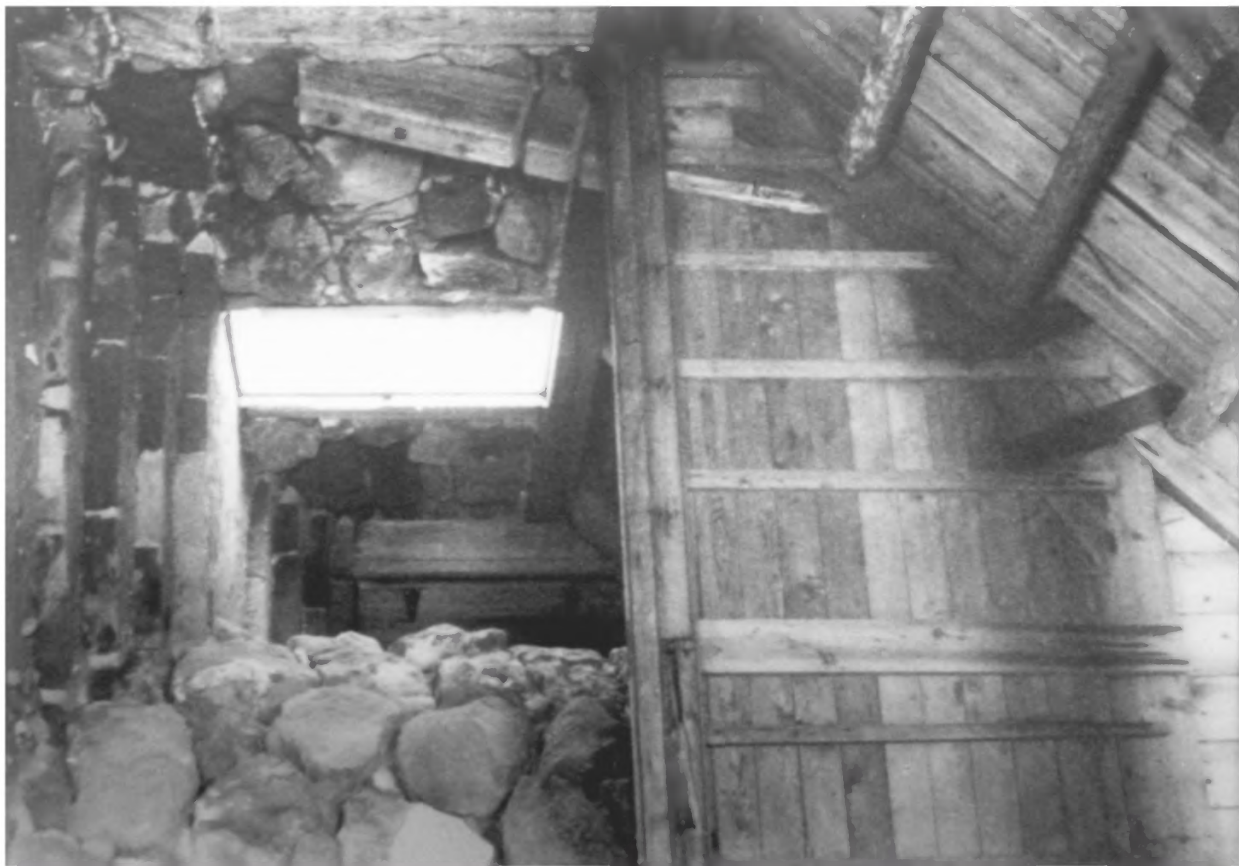
1. Silcox Hut
2. Vicinity of Government Camp, OR
3. Photographer: Upward Trails
4. Date: 1983
5. Negative Location: Files of ICE, Ltd., 5520 N.
Atlantic, Portland, OR
97217
6. Interior detail, stone stairs leading from
bull-wheel room up to dining room.
7. Photo #9

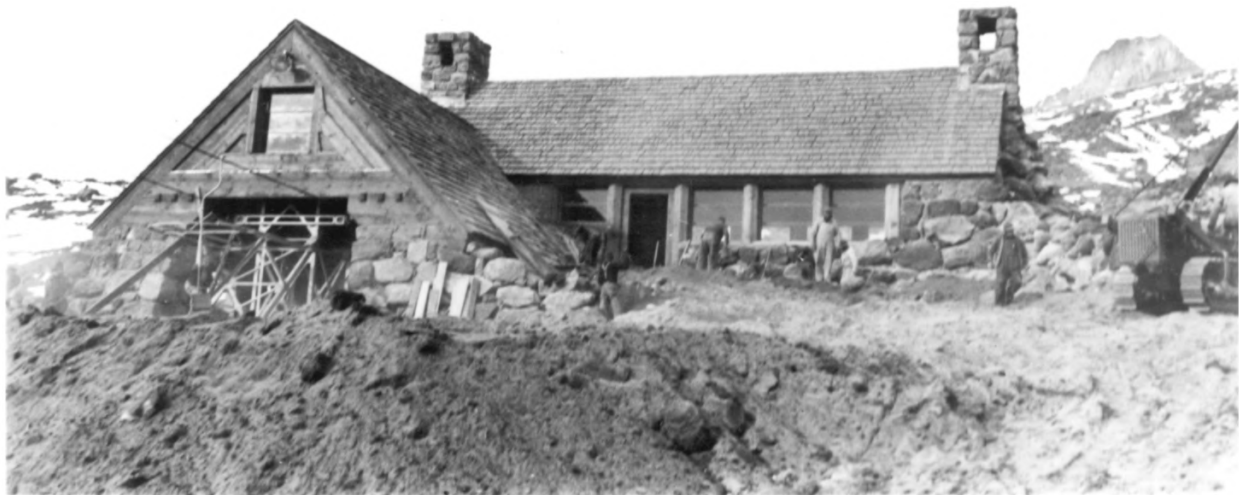
1. Silcox Hut
2. Vicinity of Government Camp, OR
3. Photographer: USDA Forest Service
4. Date: 1939
5. Negative Location: Negative #70746--Oregon
Historical Society
Collections, Portland, OR
6. From south, Silcox Hut under construction, 1939
7. Photo #10

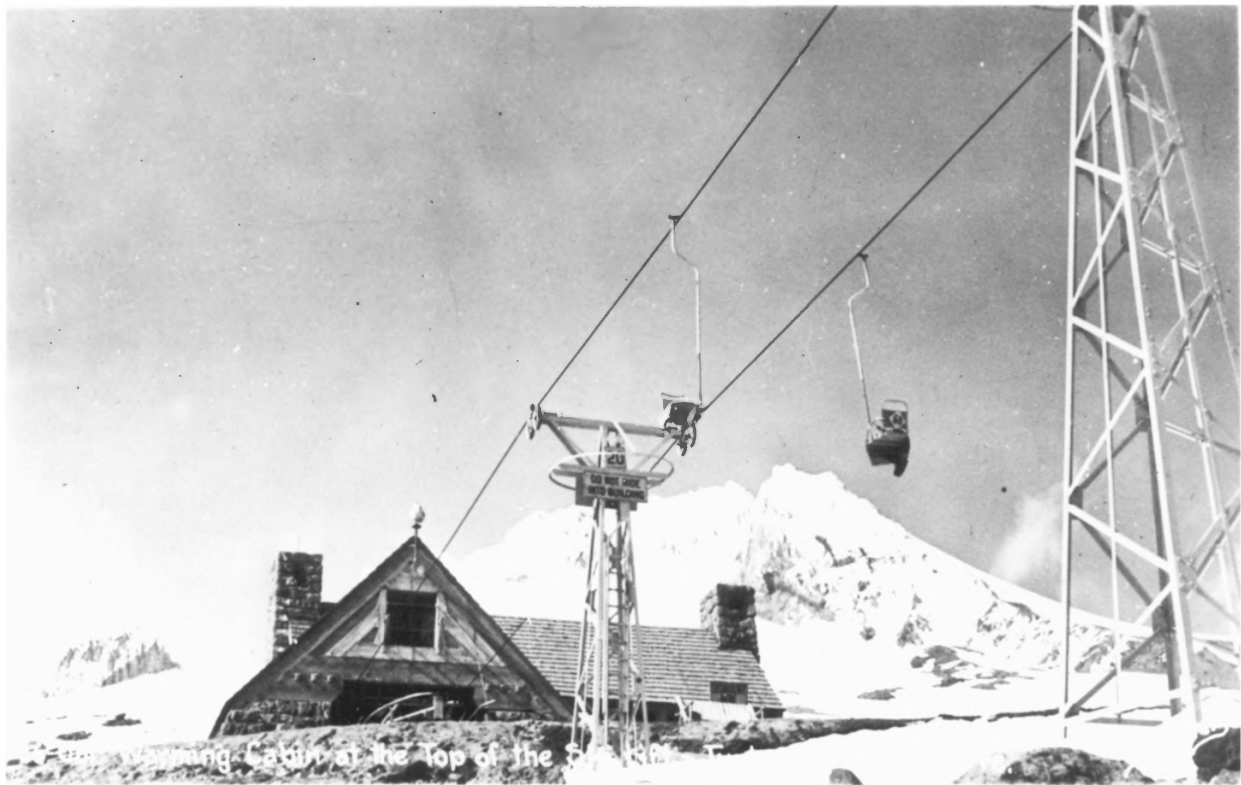
Warming Cabin at the Top of the Ski Lift

1. Silcox Hut
2. Vicinity of Government Camp, OR
3. Photographer: USDA Forest Service
4. Date: 1939
5. Negative Location: Negative #70745--Oregon
Historical Society
Collections, Portland, OR
6. Looking northeasterly, Silcox Warming Cabin at
the top of the Magic Mile Ski Lift, summit of
Mt. Hood in background.
7. Photo #11

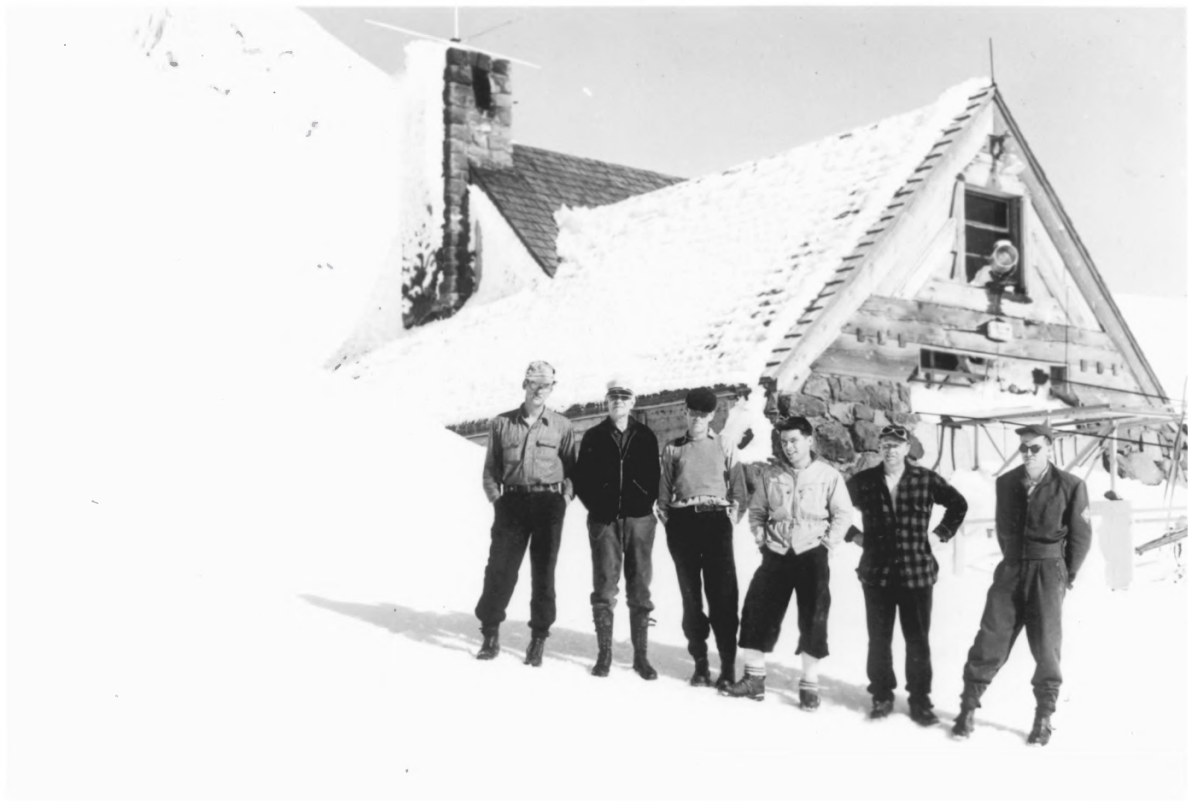
1. Silcox Hut
2. Vicinity of Government Camp, OR
3. Photographer: USDA Forest Service
4. Date: 1939
5. Negative Location: Negative #70744--Oregon
Historical Society
Collections, Portland, OR
6. Looking easterly, Silcox Hut in use winter of 1939.
7. Photo #12
