LOCATION The Museum Club
3404 E. Route 66, Flagstaff, AZ 86004
DATE circa 1931
PHOTOGRAPHER Unknown
NEGATIVE AT NAU Special Collections Library
DIRECTION Facing northwest
PHOTO NUMBER Historic #1 & #2

The Museum Club is an expressive example of a large massed Midland Tradition log house with a Tidewater front porch (now enclosed). Constructed extensively from local natural materials, it incorporates unusual natural features including the inverted forked trunk of a ponderosa pine as an entry way.

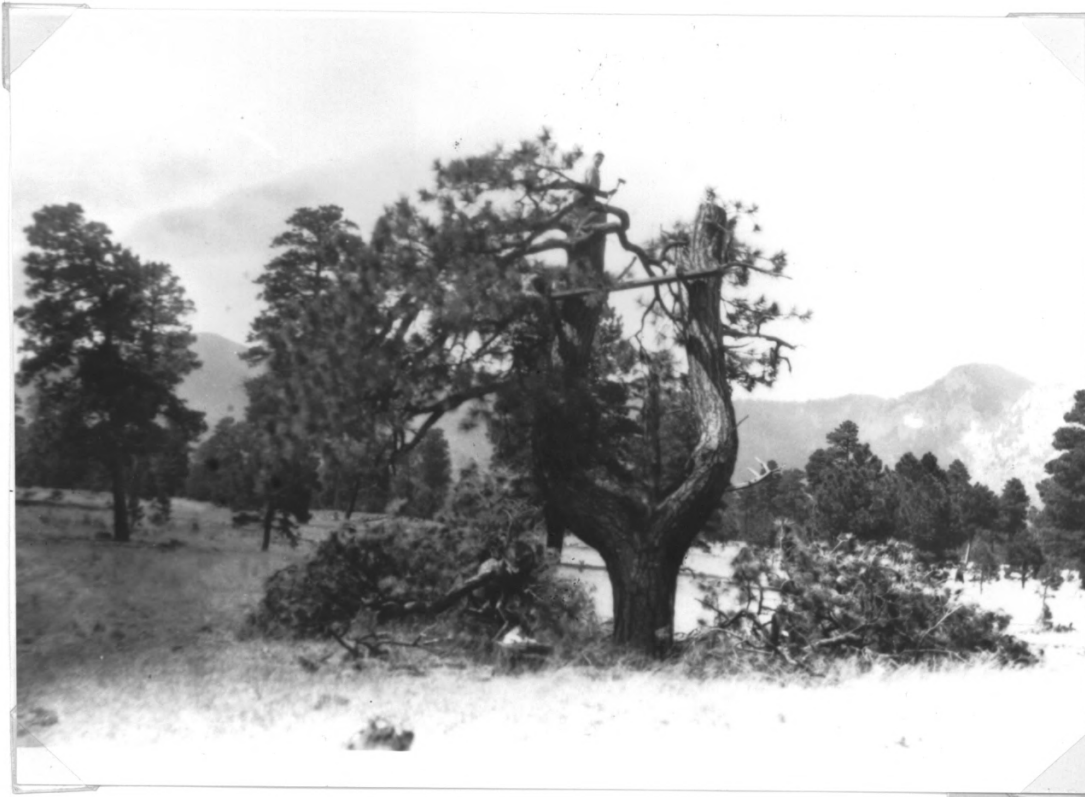
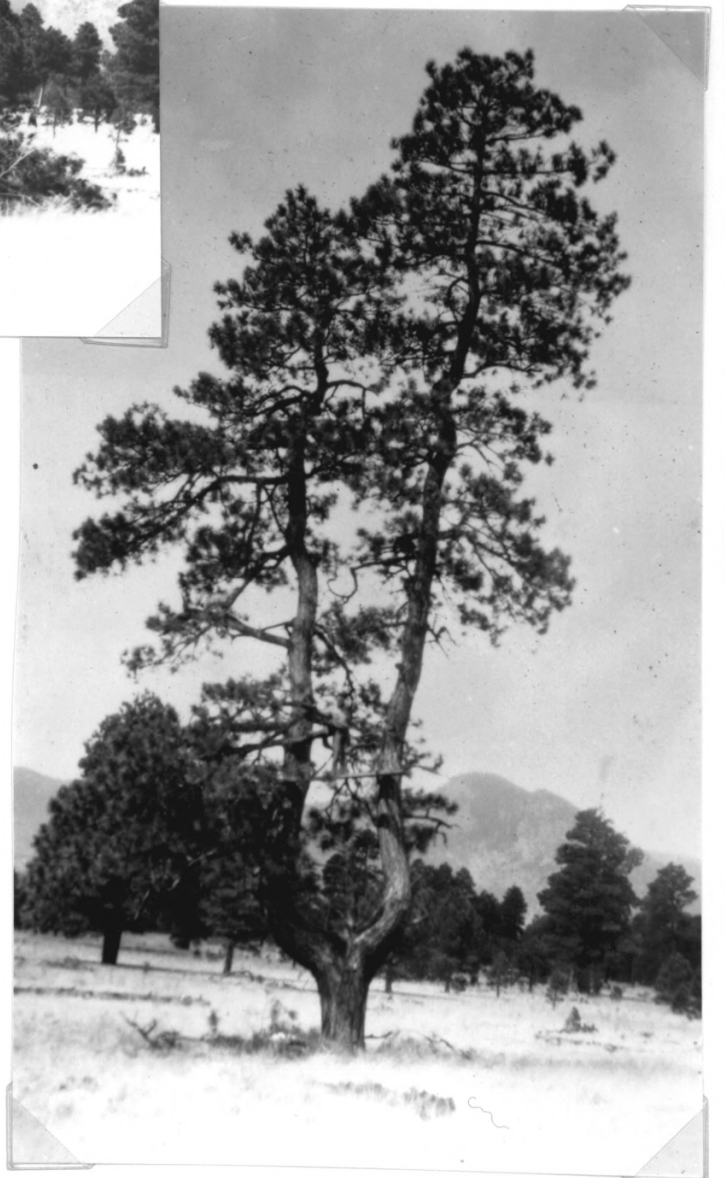
An unidentified lumberjack prunes the forked trunk of a native ponderosa pine which was used as the distinctive entry way for the Dean Eldredge Museum, known today as The Museum Club.

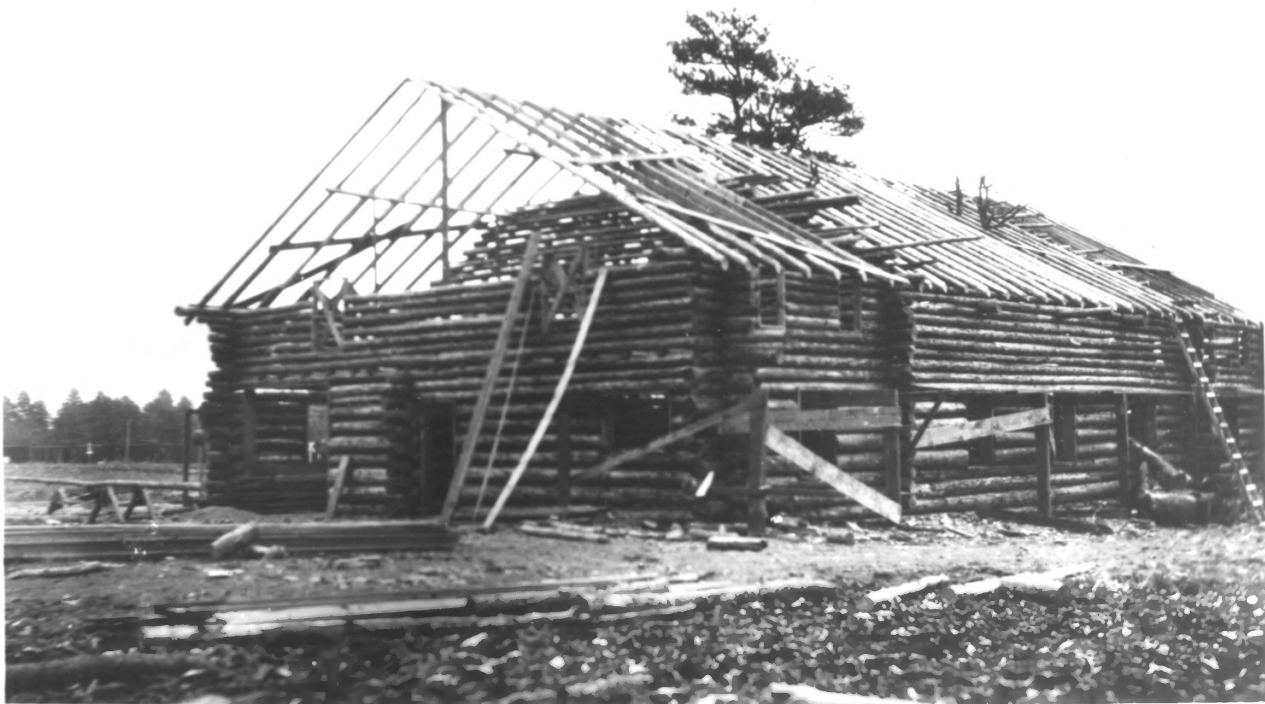
Ponderosa pine logs were used to construct the exterior walls,
built around five upright ponderosa pine trees, limbs and all (note
branches sticking through the rafters).

LOCATION The Museum Club
3404 E. Route 66, Flagstaff, AZ 86004
DATE circa 1931
PHOTOGRAPHER Unknown
NEGATIVE AT NAU Special Collections Library
DIRECTION Facing northwest
PHOTO NUMBER Historic #3

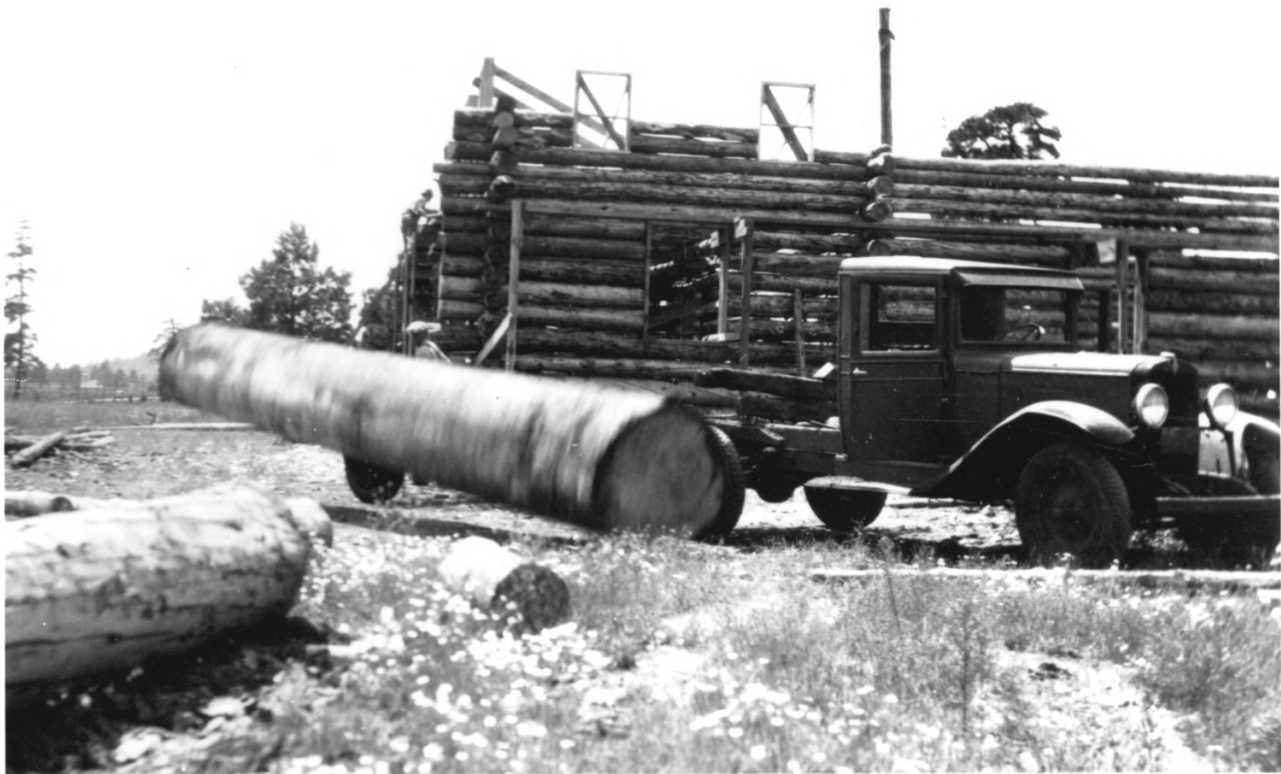
Ponderosa pine logs were used to construct the exterior walls and a full-width one-story Tidewater porch. Situated in the largest stand of ponderosa pine found in the United States, this material was readily available and lent itself to the naturalistic setting desired by the builder, Dean Eldredge.

LOCATION The Museum Club
3404 E. Route 66, Flagstaff, AZ 86004
DATE circa 1931
PHOTOGRAPHER Unknown
NEGATIVE AT NAU Special Collections Library
DIRECTION Facing west
PHOTO NUMBER Historic #4

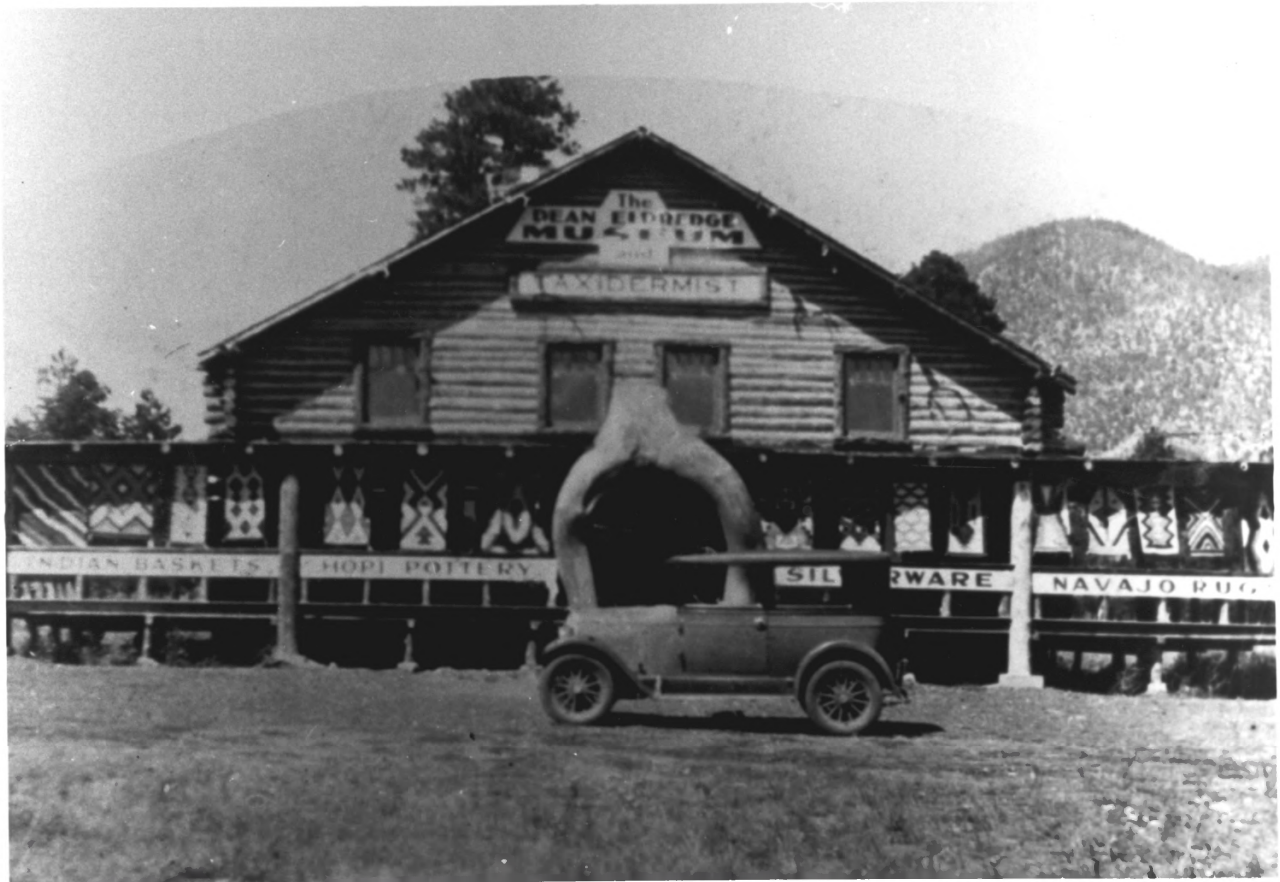
LOCATION The Museum Club
3404 E. Route 66, Flagstaff, AZ 86004
DATE circa 1989
PHOTOGRAPHER Unknown
NEGATIVE AT The Museum Club
DIRECTION Facing northwest
PHOTO NUMBER Historic #8

The Museum Club prior to stabilization and re-siding circa 1989.

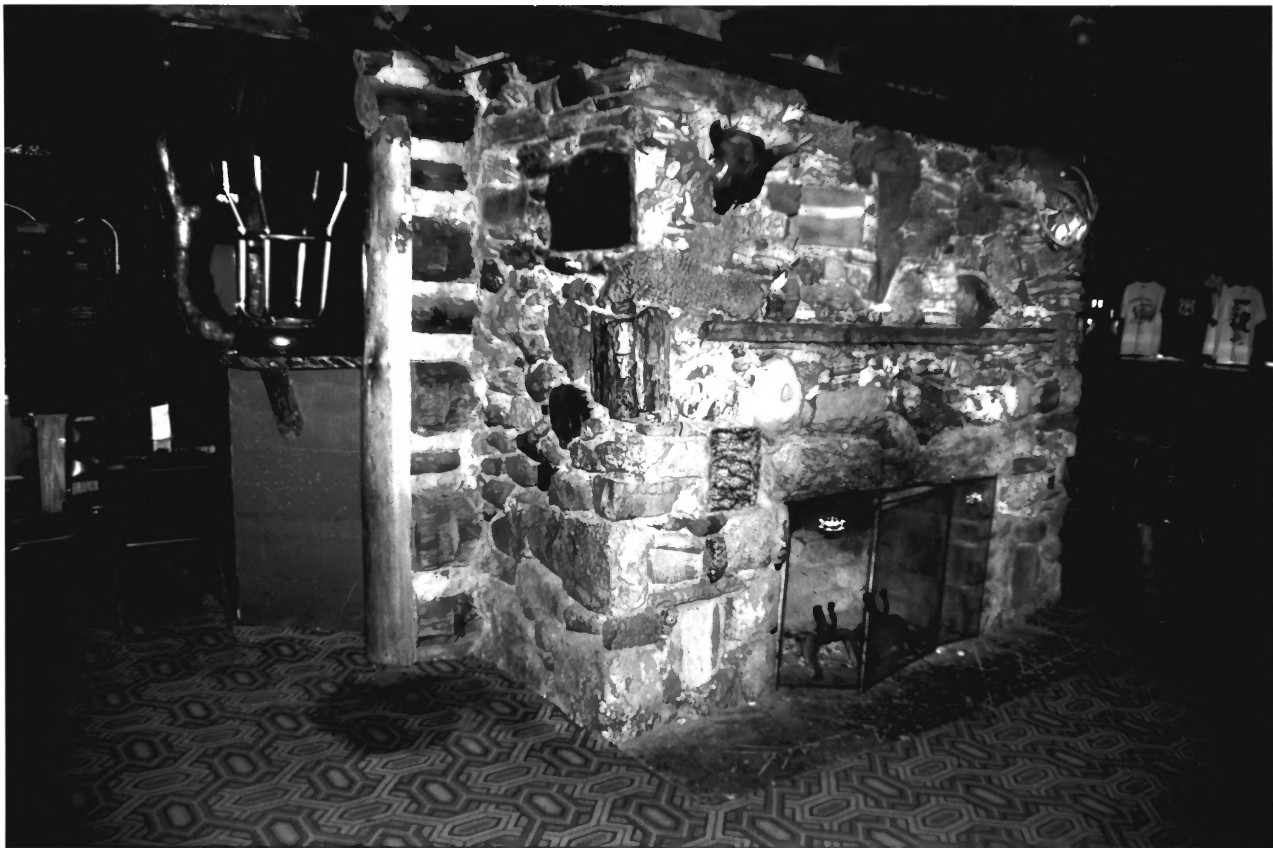
The fireplace features a plethora of mineral specimens and artifacts found in Northern Arizona including; colorful pieces of petrified wood, geodes, two Indian metates, rough malpais rock, cylindrical red volcanic "bombs and smooth river rocks with colored strata.

LOCATION The Museum Club
3404 E. Route 66, Flagstaff, AZ 86004
DATE July 3, 1993
PHOTOGRAPHER Steve Chambers
NEGATIVE AT The Museum Club
DIRECTION Interior; eastward
PHOTO NUMBER 1

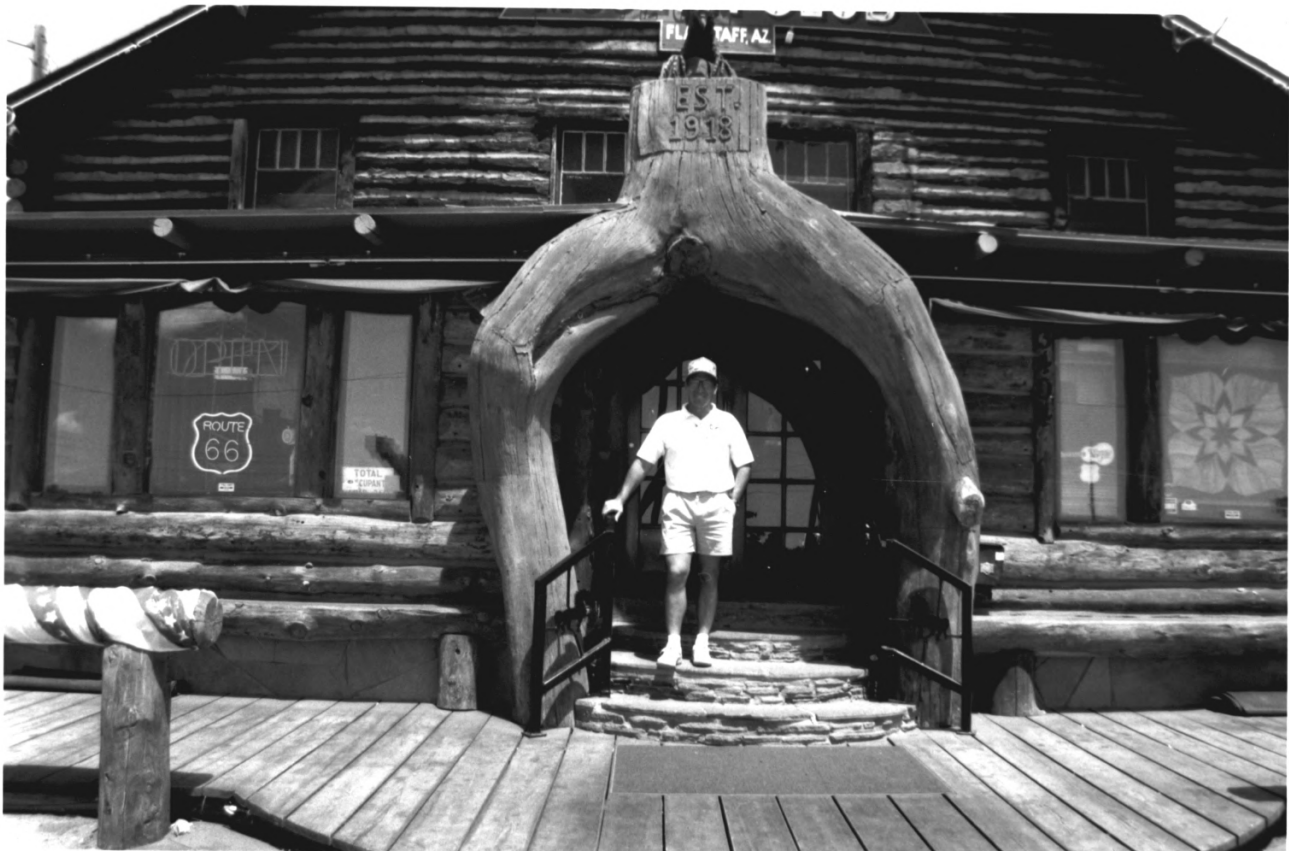
LOCATION The Museum Club
3404 E. Route 66, Flagstaff, AZ 86004
DATE July 3, 1993
PHOTOGRAPHER Steve Chambers
NEGATIVE AT The Museum Club
DIRECTION Facing northeast
PHOTO NUMBER 4

The Museum Club was once promoted as Arizona's largest log cabin. Today it remains a highlight along Arizona's Route 66.

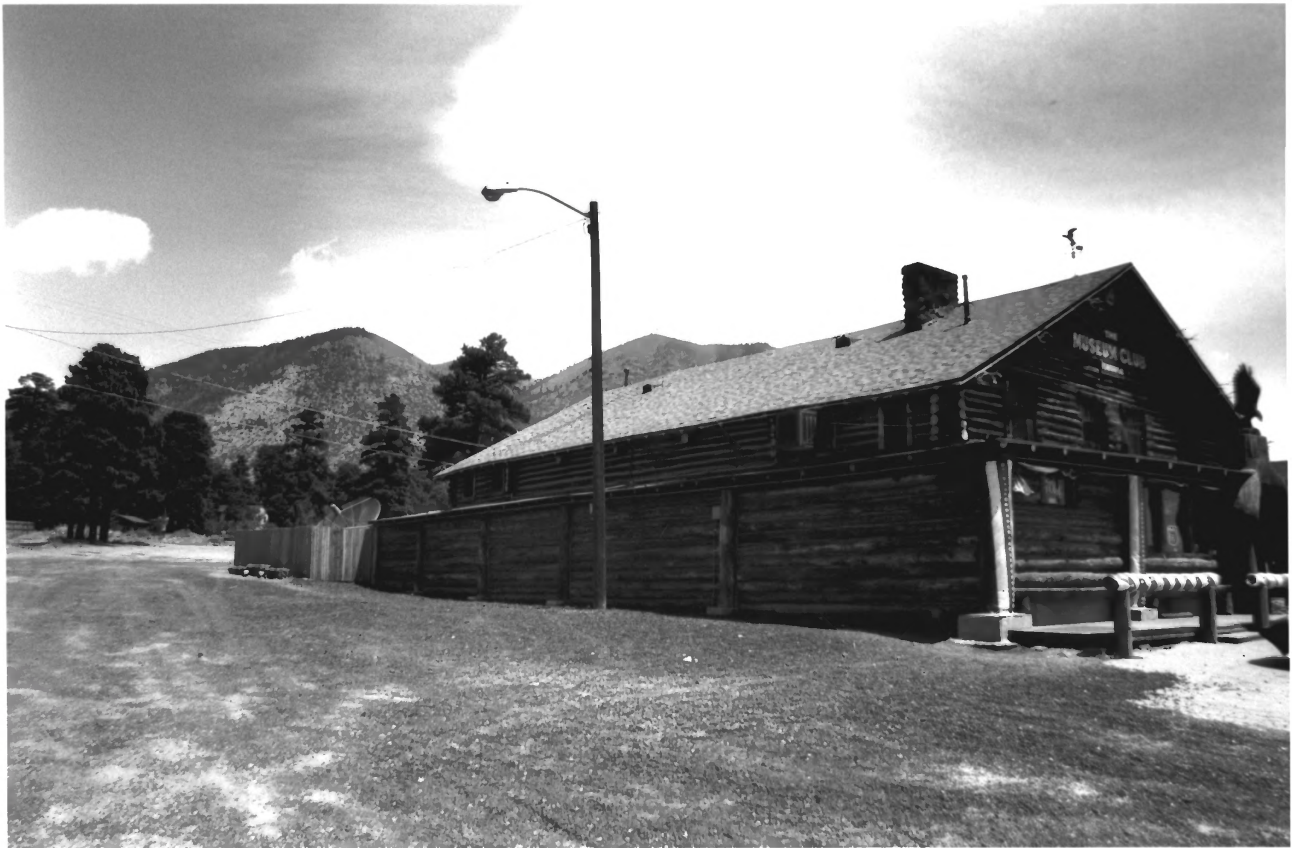
LOCATION The Museum Club
3404 E. Route 66, Flagstaff, AZ 86004
DATE July 3, 1993
PHOTOGRAPHER Steve Chambers
NEGATIVE AT The Museum Club
DIRECTION Facing west
PHOTO NUMBER 5

The Museum Club's existing windows are original, consisting of 4-over-1 casements on the second story (pictured here) and 3-over-1 casement units on each side facade. Antlers are used as exterior decoration just as they were in 1931.

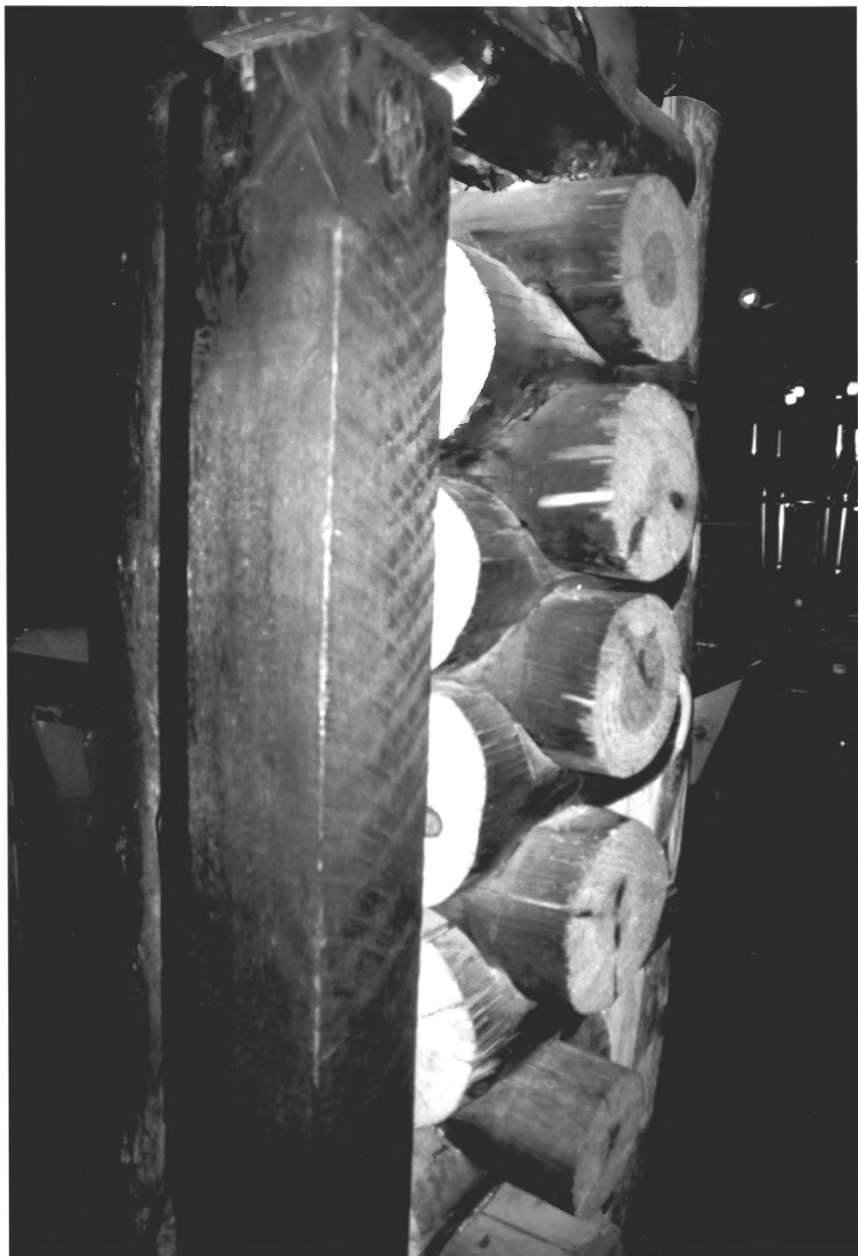
Log construction is visible throughout the interior. Corners frequently show the saddle notches used to stack the logs.

LOCATION The Museum Club
3404 E. Route 66, Flagstaff, AZ 86004
DATE July 3, 1993
PHOTOGRAPHER Steve Chambers
NEGATIVE AT The Museum Club
DIRECTION
PHOTO NUMBER 6

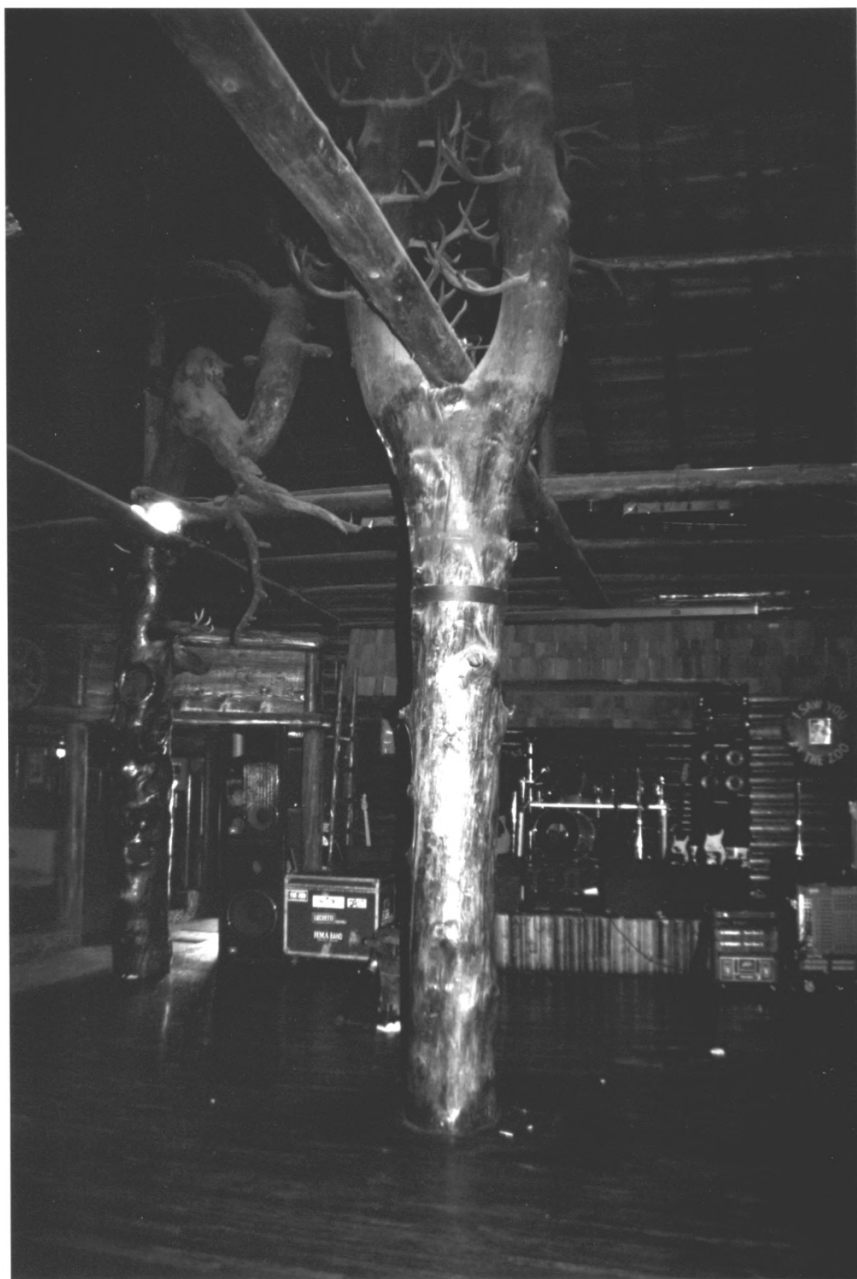
The dance floor is studded with five mature ponderosa pines that provide interior decoration and support.

LOCATION The Museum Club
3404 E. Route 66, Flagstaff, AZ 86004
DATE July 3, 1993
PHOTOGRAPHER Steve Chambers
NEGATIVE AT The Museum Club
DIRECTION Interior; facing east
PHOTO NUMBER 7
