National Register of Historic Places Registration Form

Historic name U.S. Inspection Station—Derby Line, Vermont
Other names/site number Derby Line Border Station and United States Post Office

*U.S. Inspection Station—Derby Line Orleans
County, Vermont*

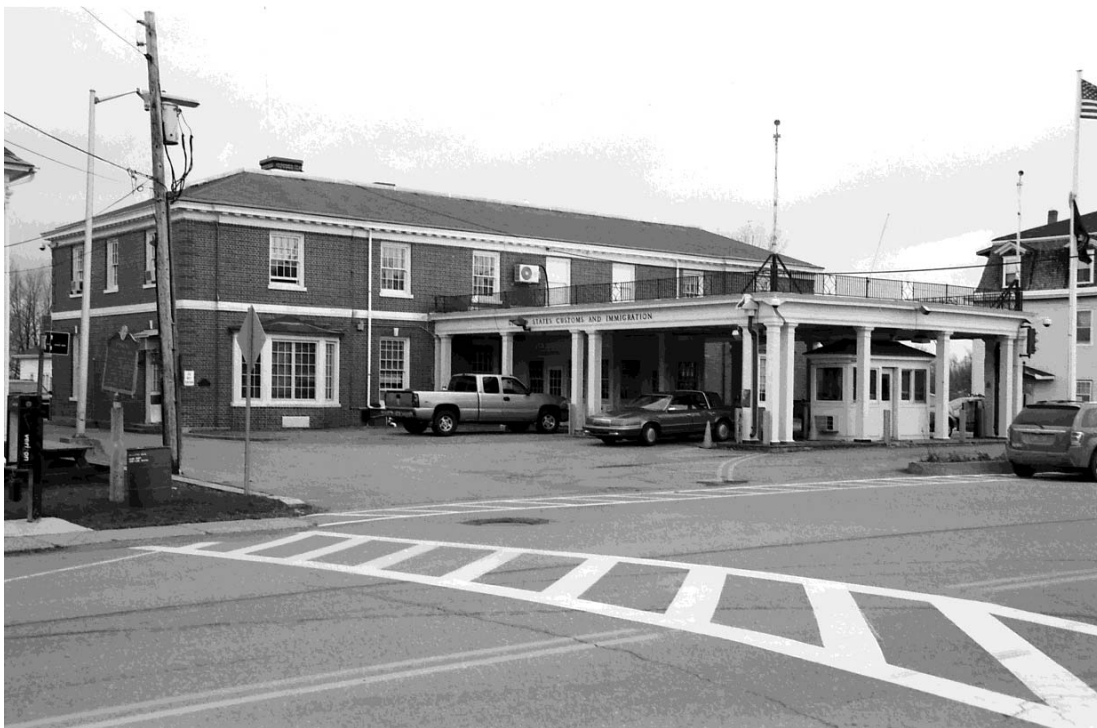
Photo number: VT_OrleansCounty_DerbyLineBorderStation2.tiff

Description of view: front (east) and side (south) elevations, view: northwest

The Derby Line Inspection Station is a Colonial Revival style, 2-story, rectangular plan inspection station with a hipped, side gable roof. The building is seven bays long and three bays wide. The Derby Line Station features English bond brickwork with a wraparound marble stringcourse between the first and second floors, and brick quoin work upon all four corners. The first floor windows are 12/12 wood-frame double hung with marble sills and flat jack arches with marble keystones at the heads. The two end bays of the front elevation protrude out slightly, and at the first level of these are two protruding 4-part bay windows, each with a canopied copper flat seam roof. The protruding end bays and the bay windows themselves further reinforce symmetry, which is a dominant feature of the exterior design. The east-facing entry doors are paired, glazed aluminum units that are an alteration from the original design and materials. However, the original wood frame and transom around them are still extant, and they feature Adamesque tracery. The second floor windows are 8/8 wood frame units that also feature decorative marble sills. Their headers run flush against a running cornice that is underscored by large dentil molding. The roof was originally clad in gray slate and is now covered in asphalt shingle. A low, square-shaped brick chimney is present at the southern portion of the roof's ridgeline.

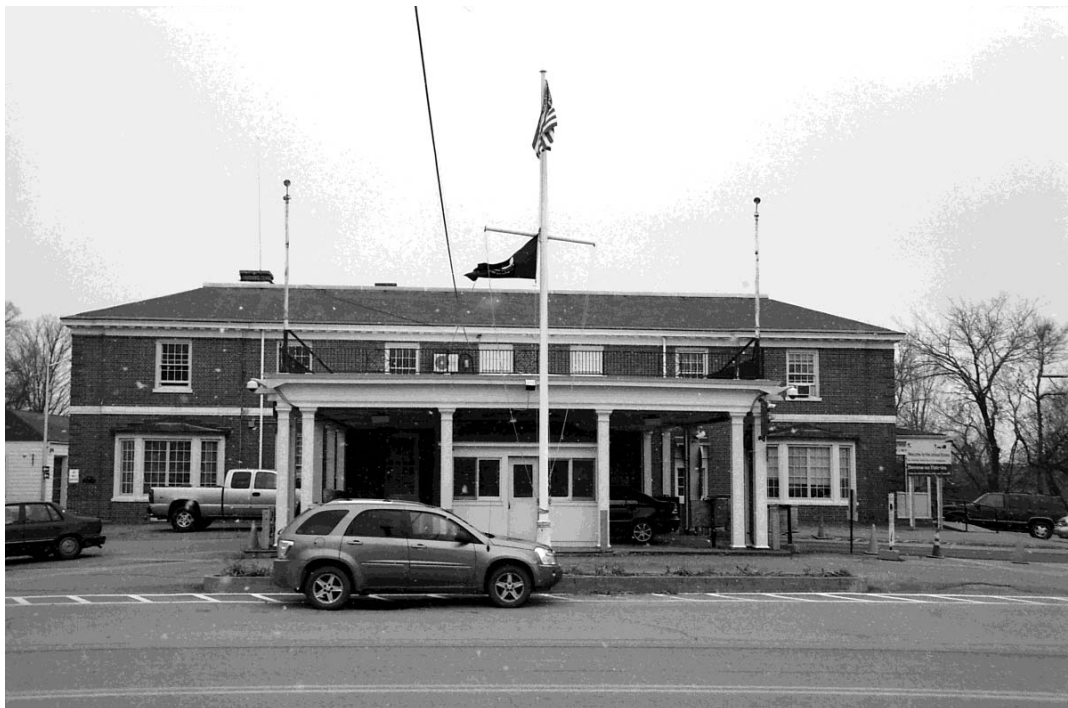
Photo number: VT_OrleansCounty_DerbyLineBorderStation3.tiff

Description of view: side (east) elevation, view: west

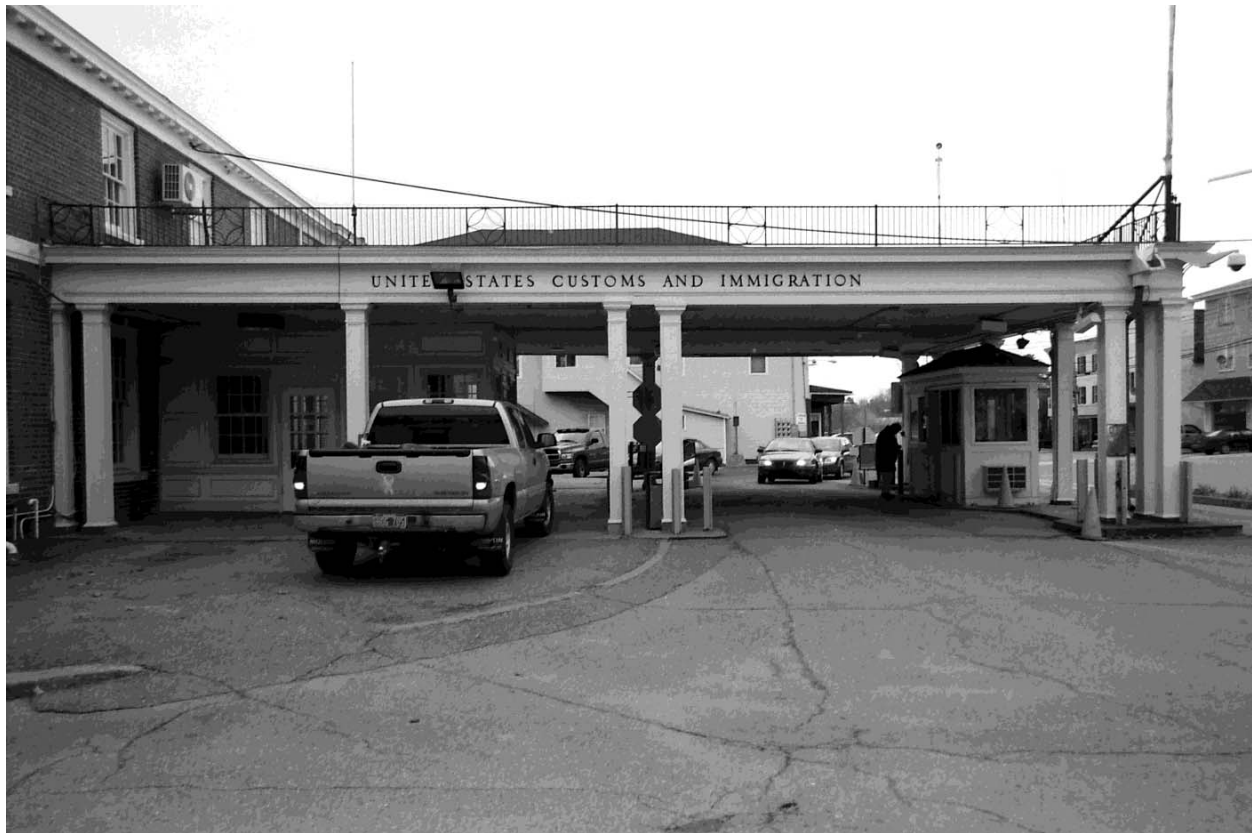
Photo number: VT_OrleansCounty_DerbyLineBorderStation4.tiff

Description of view: porte-cochere south elevation, view north

A steel and aluminum clad two lane porte-cochere is affixed to the front elevation. The porte-cochere is 3 bays long and 4 bays wide, and encloses three traffic lanes. Square shaped classical wood columns with inset paneling support the porte-cochere. A metal and glass enclosure is present under the canopy of the porte-cochere. The entry to the

Posts supporting the porte-cochere have been rearranged to accommodate a wider traffic lane, and installation of new lighting has required a slight covering of the canopy ceiling. The original front doors have been replaced, and the space immediately before them enclosed to form a glassed-in office area. The wooden inspector's booth is also a modern installation, although its form and use of materials are in keeping with the character of the station.

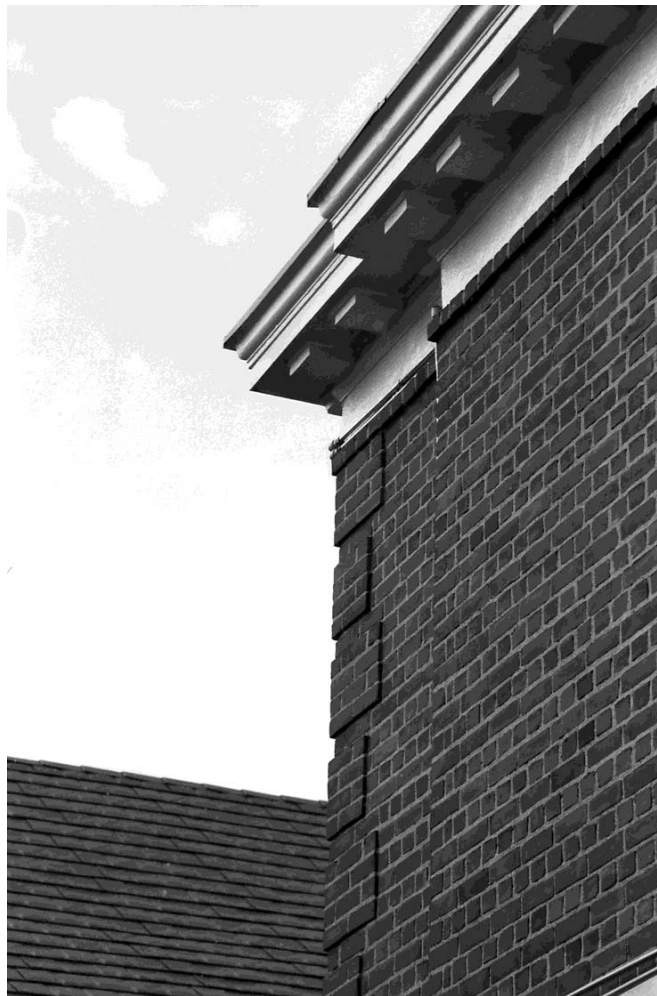
Photo number: VT_OrleansCounty_DerbyLineBorderStation5.tiff

Description of view: molding and quoin detail. View: southwest

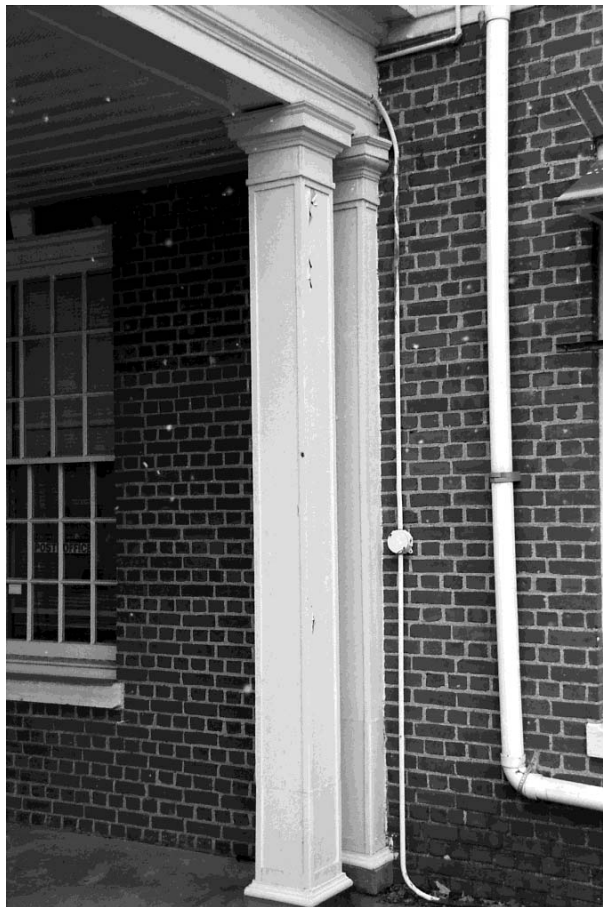
Photo number: VT_OrleansCounty_DerbyLineBorderStation6.tiff

Description of view: porte-cochere column detail, view: southwest

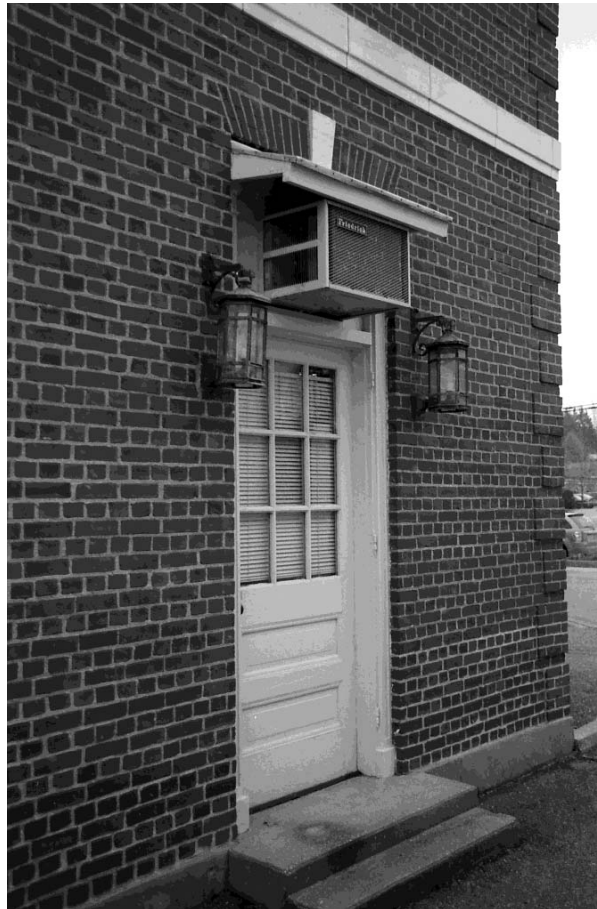
Photo number: VT_OrleansCounty_DerbyLineBorderStation8.tiff

Description of view: side (south) elevation entrance, view: northeast

A south facing entry door consists of four panels with the uppermost being a large glazing unit. It is framed by narrow, square, classical, engaged columns and is topped with a clerestory window. On either side of it is a pair of original, patinated bronze lanterns affixed to the building.

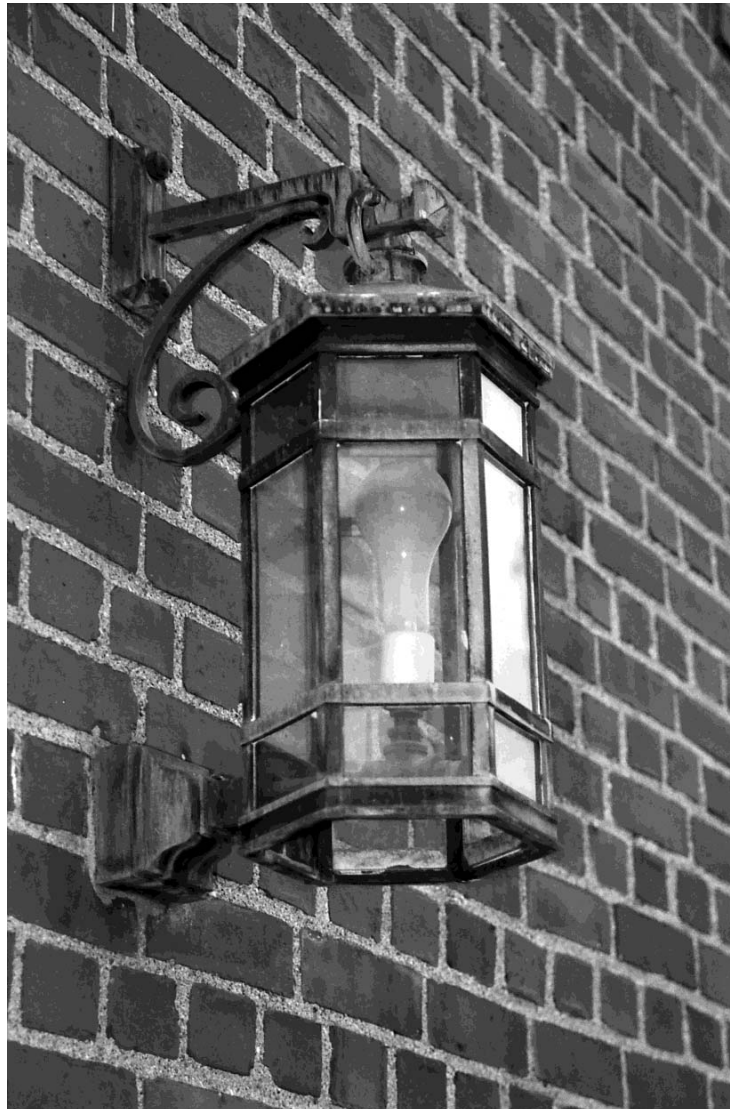
Photo number: VT_OrleansCounty_DerbyLineBorderStation9.tiff

Description of view: detail of original lantern, side entrance. View: northeast

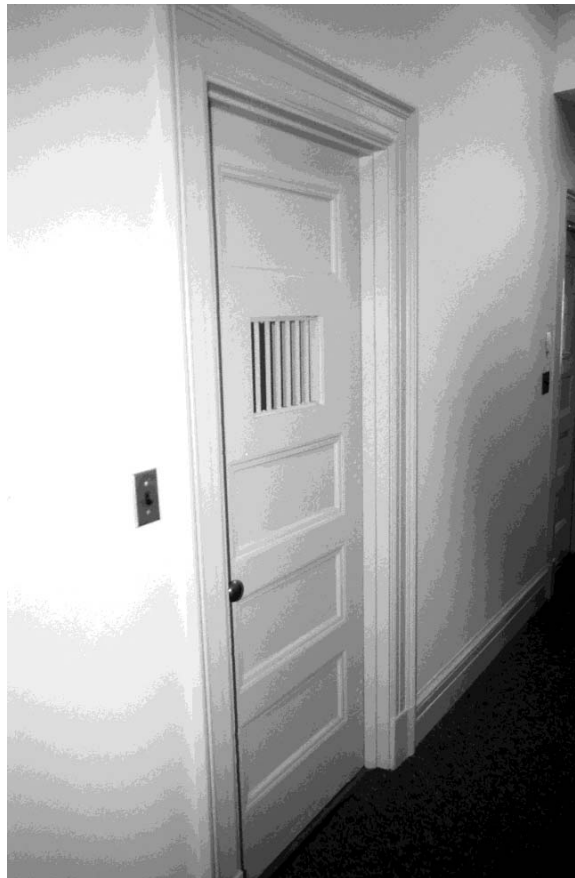
Photo number: VT_OrleansCounty_DerbyLineBorderStation10.tiff

Description of view: Original cell door. View: northwest

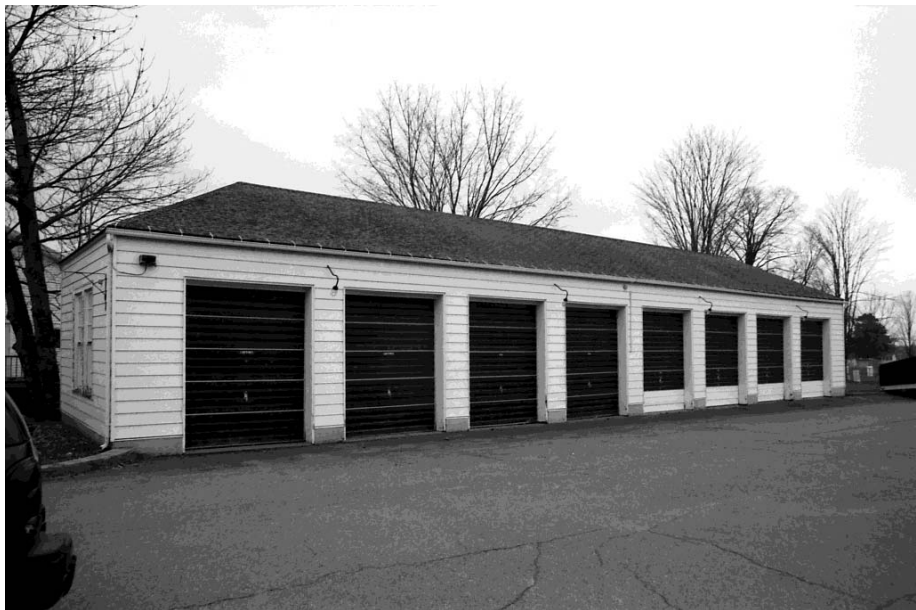
Photo number: VT_OrleansCounty_DerbyLineBorderStation12.tiff

Description of view: inspection garage, view: southwest

Located south of and behind the Inspection Station is a single story, rectangular plan, north facing 8-bay garage. Constructed in 1931, this structure predates the Inspection Station by one year. The garage has a hipped, side gable,

roof with small eaves, and is clad in composite shingle. A pair of 12/12 wood-frame double-hung windows is present at the east and west width elevations. Affixed to the front elevation above the garage bays are four original gooseneck light fixtures. The original clapboard siding is still extant underneath the recent clapboard cladding, and original paneled doors have also been replaced. A low wood barrier encloses the four westernmost bays of the garage. The garage is highly similar in design and use to the wings found on a variety of other inspection stations. An inspection pit is inside the building, as are original interior finishes.

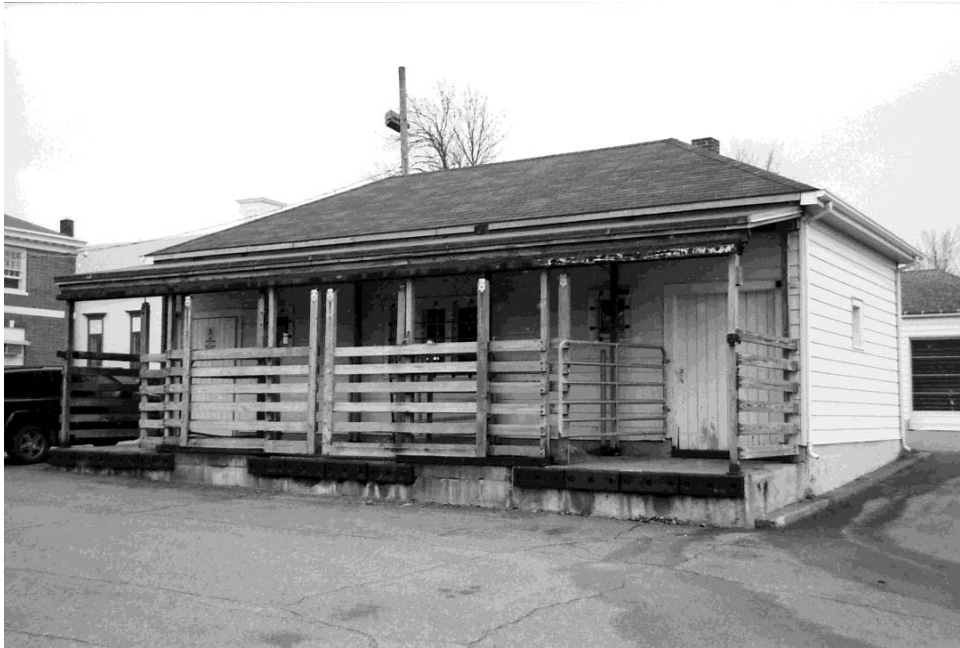
Photo number: VT_OrleansCounty_DerbyLineBorderStation13.tiff

Description of view: Livestock Inspection Building, view: southeast

At the south portion of the property behind the Derby Line Inspection Station is a single story, rectangular plan cattle inspection facility with wood clapboard cladding. The building is topped with a hipped, side gabled roof clad in composite shingle. A tall, narrow square chimney of brick is present atop the southwest portion of the roof. Wood frame 8-unit casement windows are part of the design, and are set in a row of three sashes at the north elevation, are in two pairs symmetrically arranged at either side of the centered rear door at the south elevation. One of these window bays is infilled with an air duct; a later alteration. Additionally, 4-unit wood frame hopper windows are also present at the east, west, and south elevations. A narrow strip of lawn is present parallel to the south elevation of the building. A full-length shed porch is present at the front elevation, which is enclosed by a fence and gate made of untreated wood plank. Both the porch and structure rest on an exposed concrete slab foundation. At the northern end of the front elevation are wood cattle doors, symmetrically placed at each end. The interior of the cattle inspection facility is unadorned, with a concrete floor, exposed ventilation ducts, air circulation machinery at the ceiling, and fluorescent lighting which all appear to be later additions. Within the Cattle Inspection Facility are also multiple inspection pens with partitions made of thick alloy pipe columns welded together.

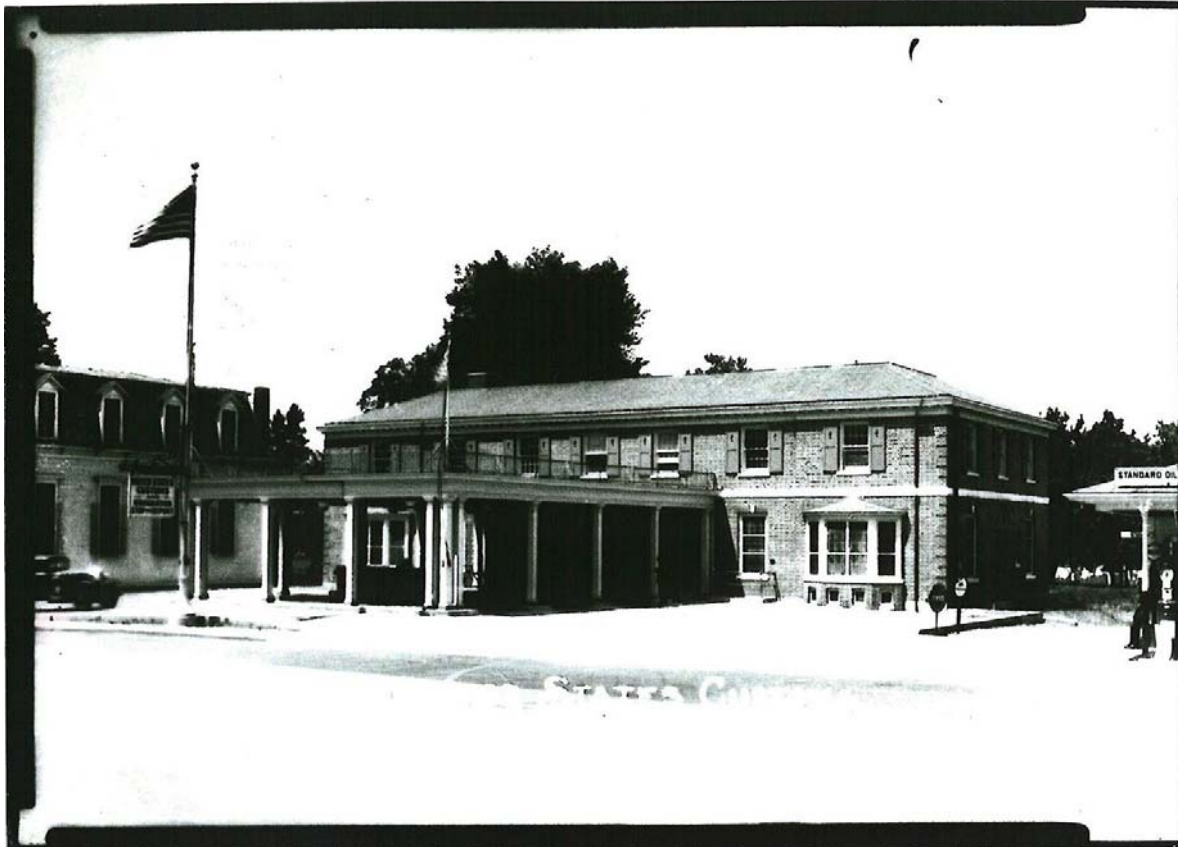
U.S. Inspection Station – Derby Line
Orleans County, Vermont
Courtesy: Memphremagog Historical Society of Newport
Description of view: front elevation. View: southwest

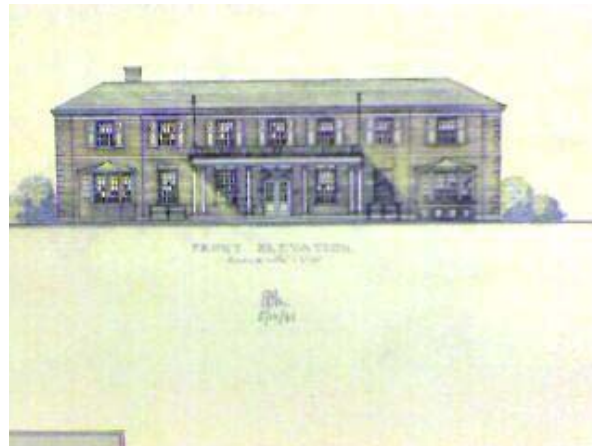
Description of view: front elevation

Renderings for the Derby Line inspection station found in the National Archives and Records Administration (NARA) formally identify it as a "U.S. Inspection Station."⁴ To this day, the finished building mirrors strongly the front elevation rendering that was found in the NARA files.⁵ Among the features rendered which the finished building still contains include copper canopied bay windows at the lower level, seven window bays at the upper level, slightly protruding end bays at each end of the front elevation, and a long, symmetrical, medium pitch hipped roof. Just as indicated in the rendering, the building is of strong and still unaltered symmetry. Other original details include brick corner quoining, multi-glazed, wood frame double hung windows with decorative marble sills and jack arches, running cornices underscored by dentil molding, squared columns with classically articulated bases and capitals, and Adamesque tracery around the main entry. The sum of all of these elements is a detailed, remarkably articulated expression of the Colonial Revival design system that was fitting to the Derby Line Inspection Station as the first, largest, and headquarters station for all of the Inspection Stations in Vermont.
