NATIONAL REGISTER OF HISTORIC PLACES
REGISTRATION FORM

historic name Bullard, Thomas, House
other names/site number N/A

Bullard, Thomas, House
Sampson County, North Carolina

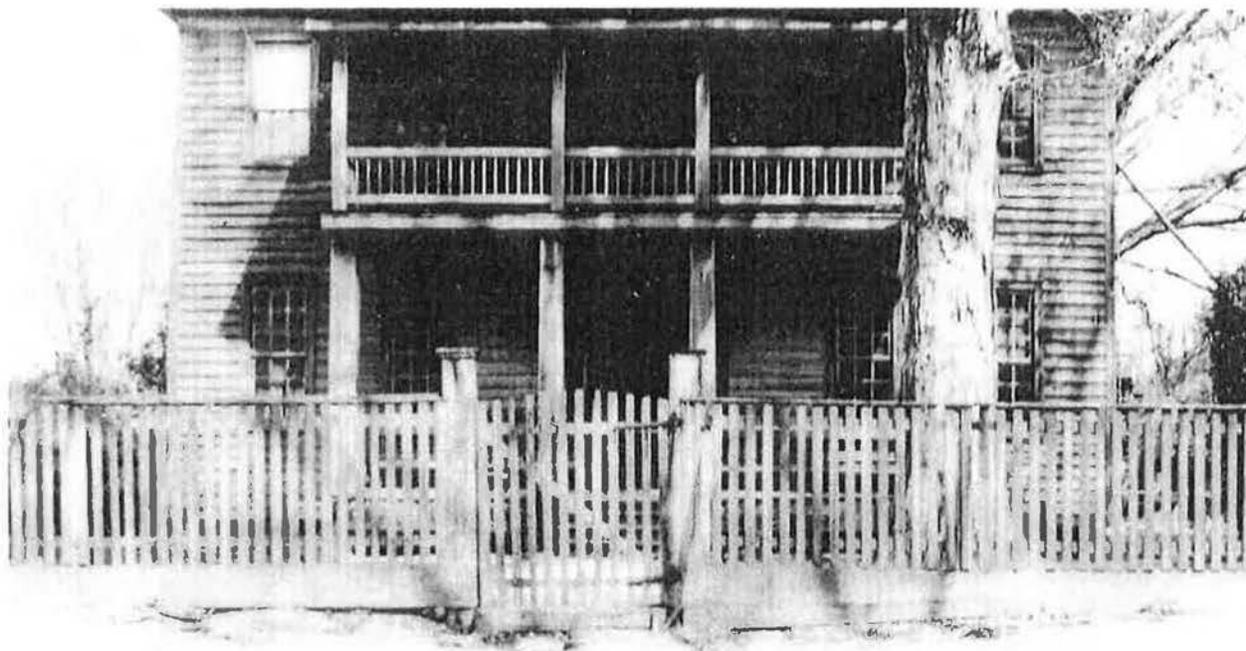
Section Number Documentary Photo Page 23

Documentary photograph of house, date unknown, with pre-Hurricane Hazel (1954) porch.
Courtesy of Margaret Sue Pahl Mills.

Hurricane Hazel destroyed the original front porch, and the present porch was built to replace it in the mid-to-late 1950s. What is presumed to be the original porch is seen in an undated documentary photograph of the house. It was three bays wide and had two tiers. The main level had four tapered-wood square posts with no balustrade, while the upper level had smaller, non-tapered, square posts and a plain balustrade. The porch roof cannot be seen in the photograph. The replacement, full-façade, one-story porch has a brick foundation and two brick

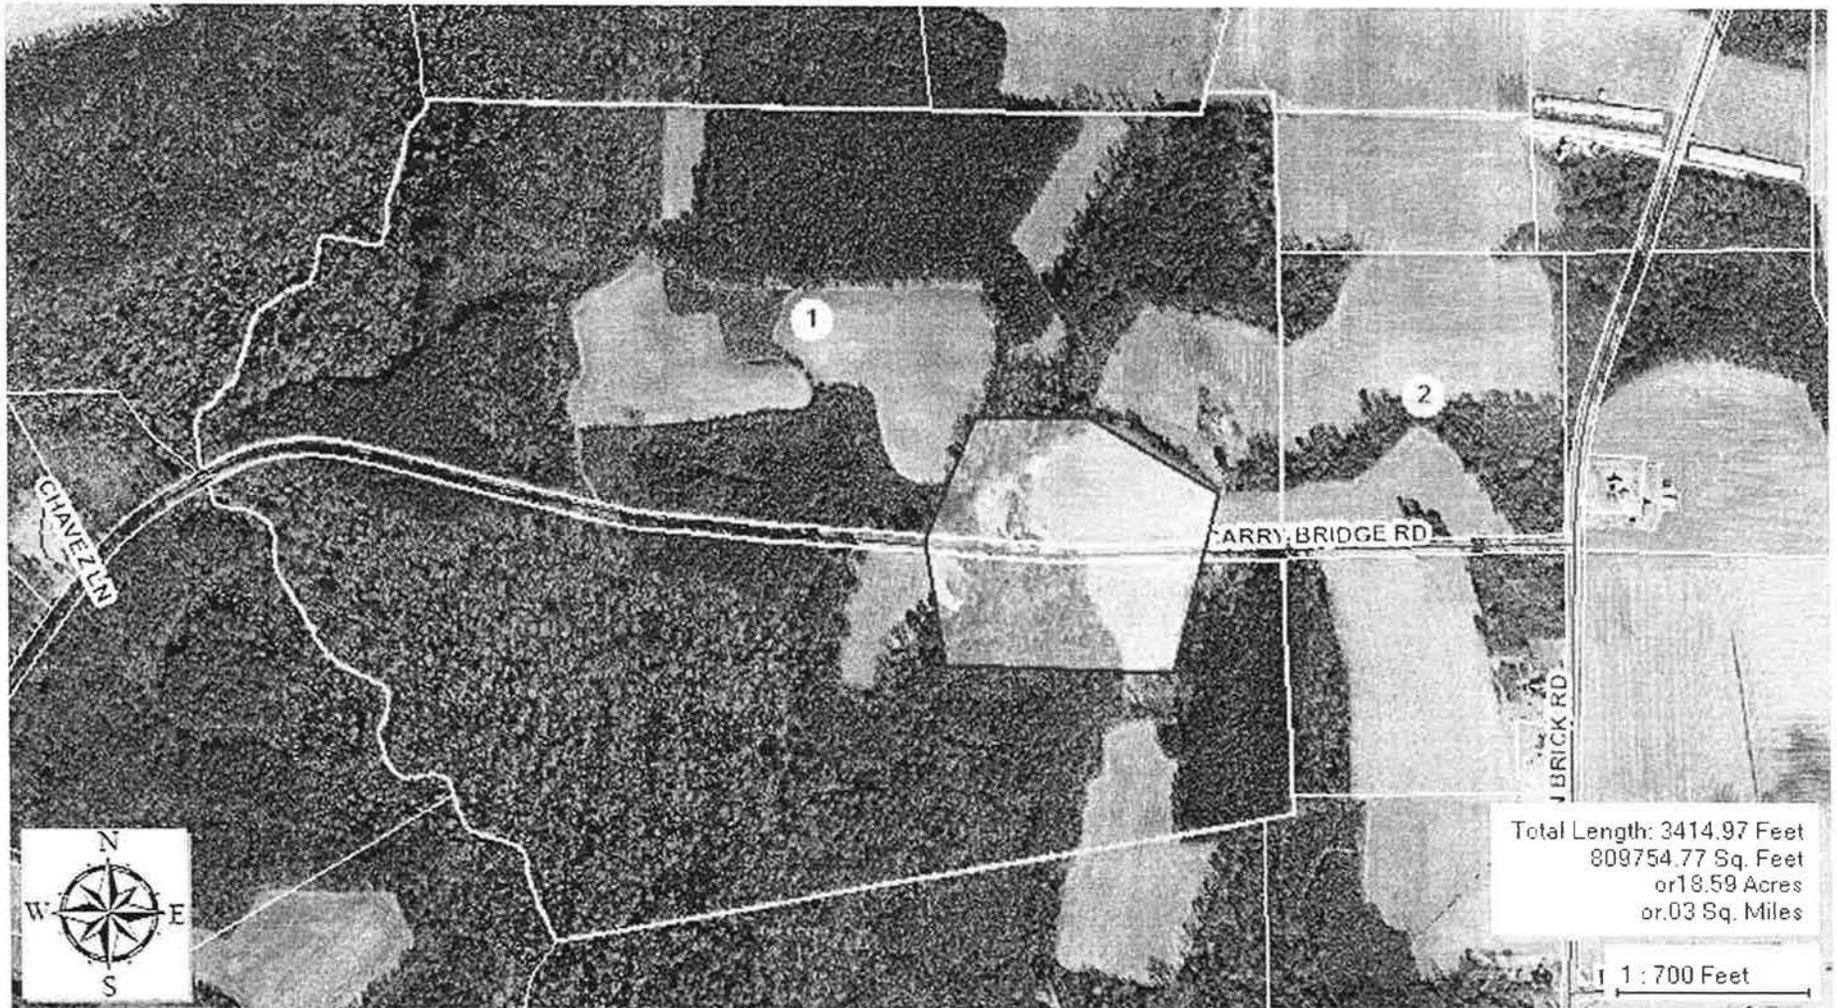
Tax Map

Sampson County Tax Parcel 08076952002 (Identified on map as No. 1)
Approximate boundary of nominated property shown as shaded block

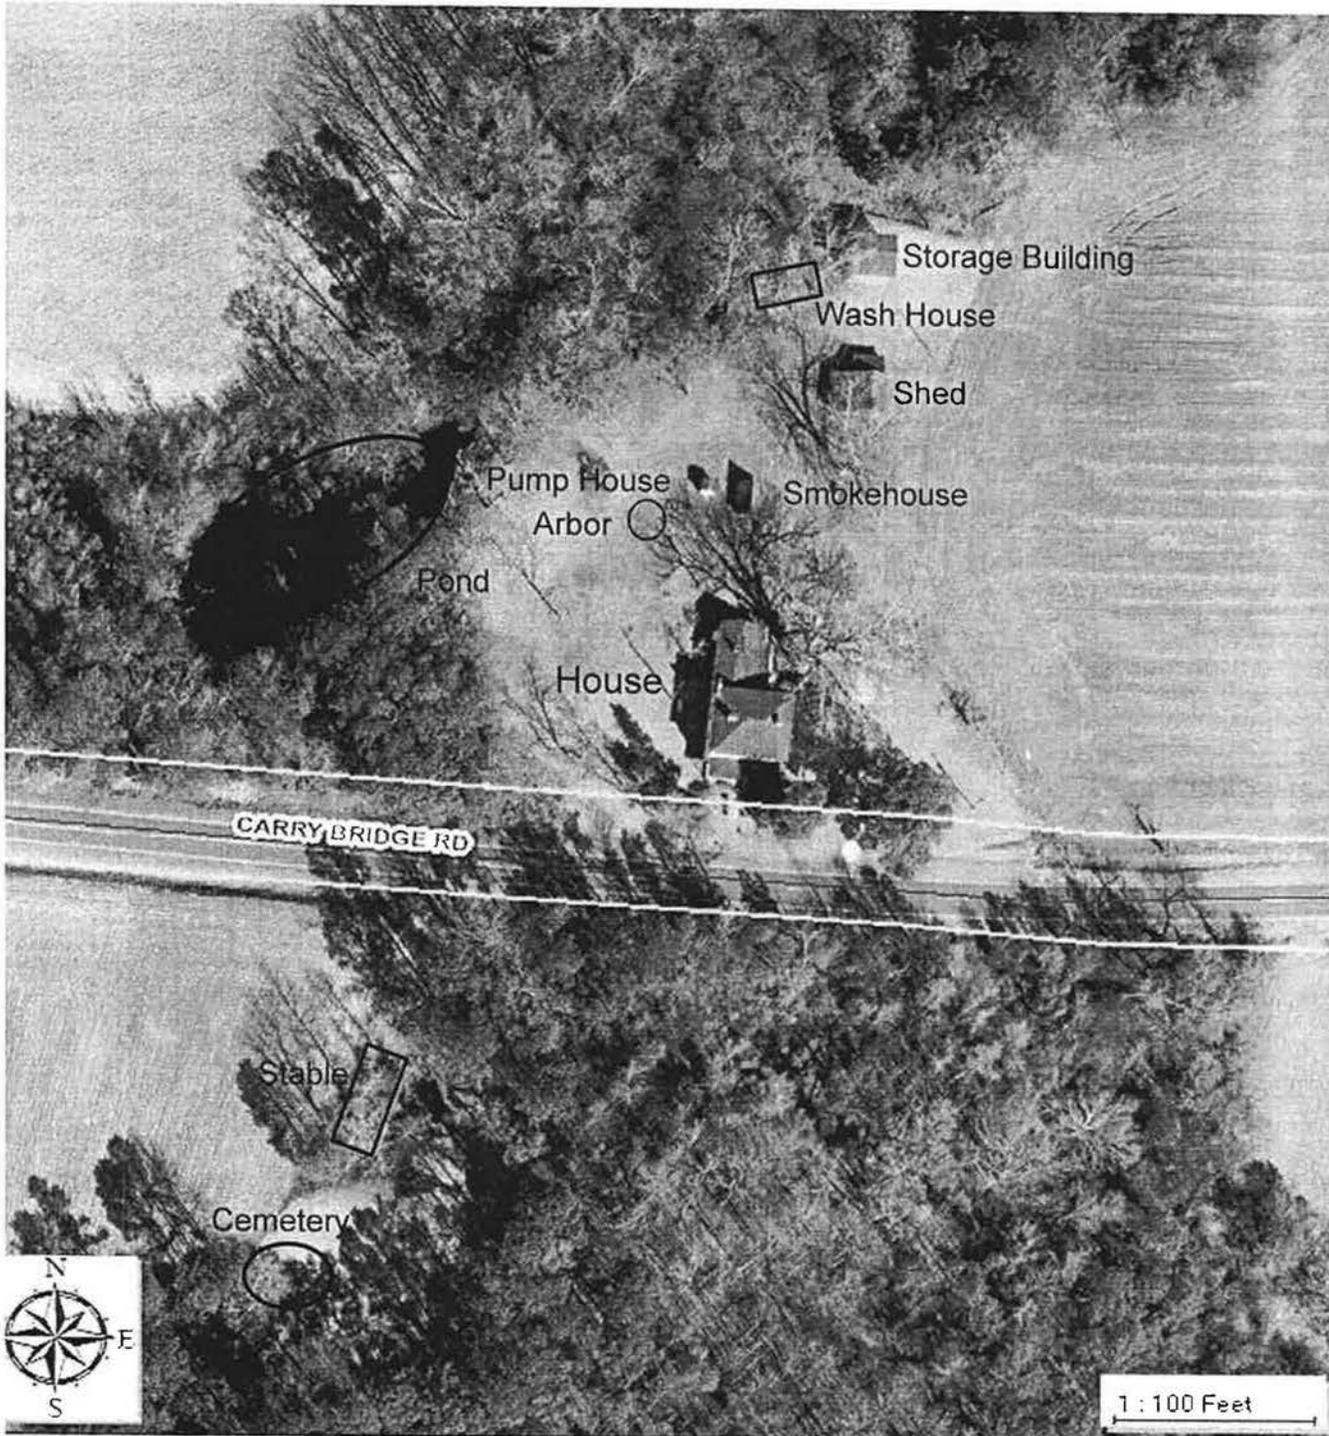
Map of Resources

Thomas Bullard House
386 Carry Bridge Road
Autryville vicinity
Sampson County, NC
