**NATIONAL REGISTER OF HISTORIC PLACES
PROPERTY PHOTOGRAPH FORM**

HISTORIC Octagon House Pair

Portland

Middlesex

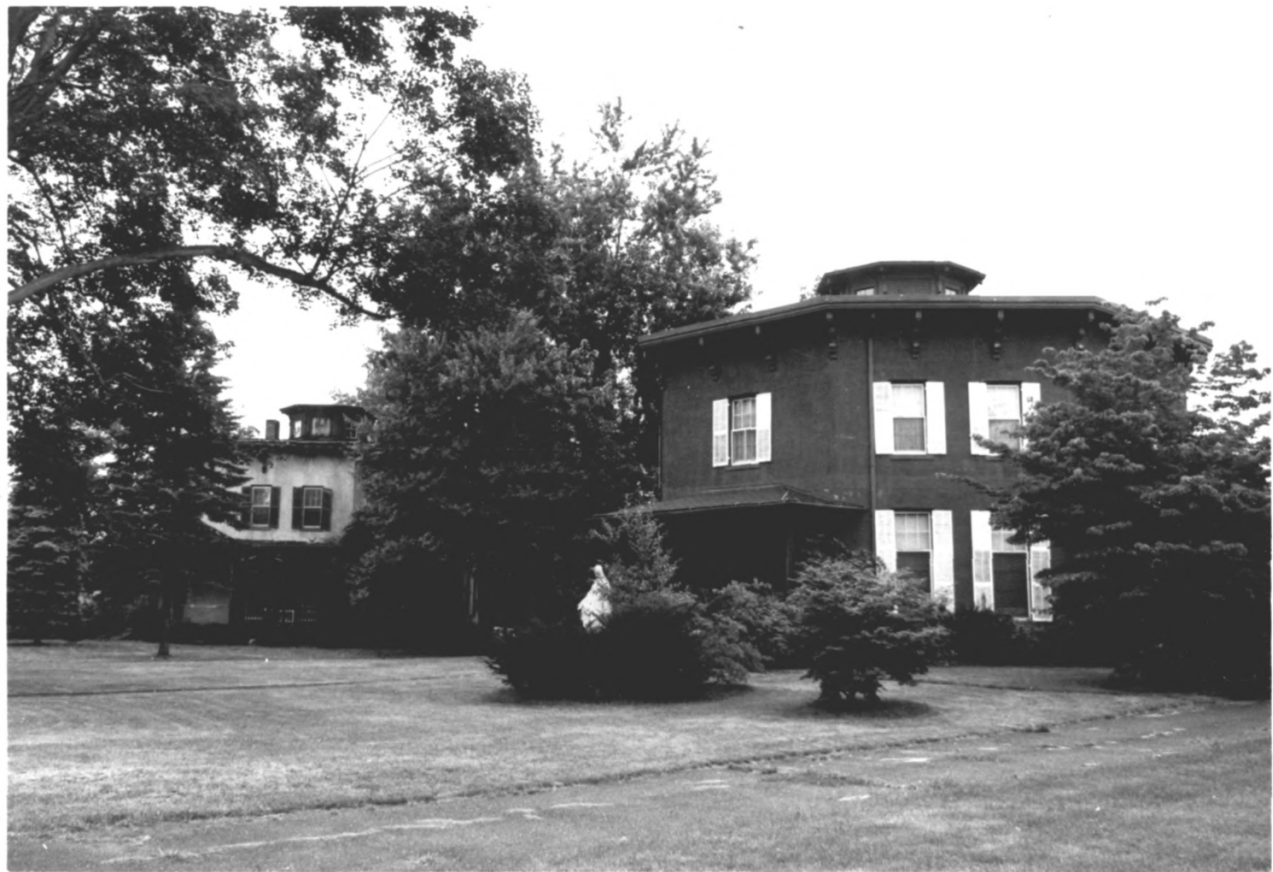
PHOTO NO.

View of Octagon House Pair showing massing and spacing of buildings;
view northeast. ¹

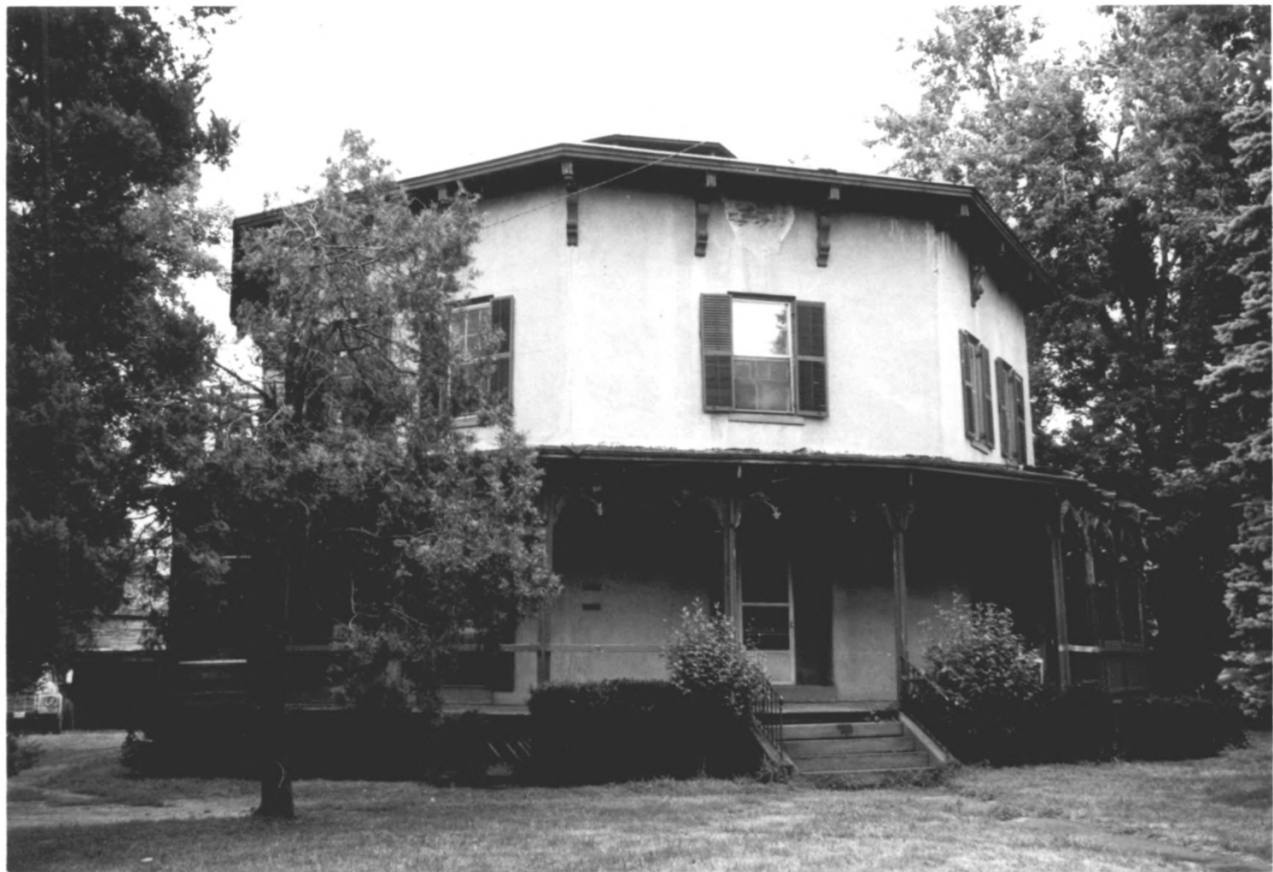
PHOTO NO. 2

North building, #26 Marlborough St. Facades treated in rusticated stucco, brownstone construction, porch intact (built on three facades only), cupola and cornice brackets intact; view east.

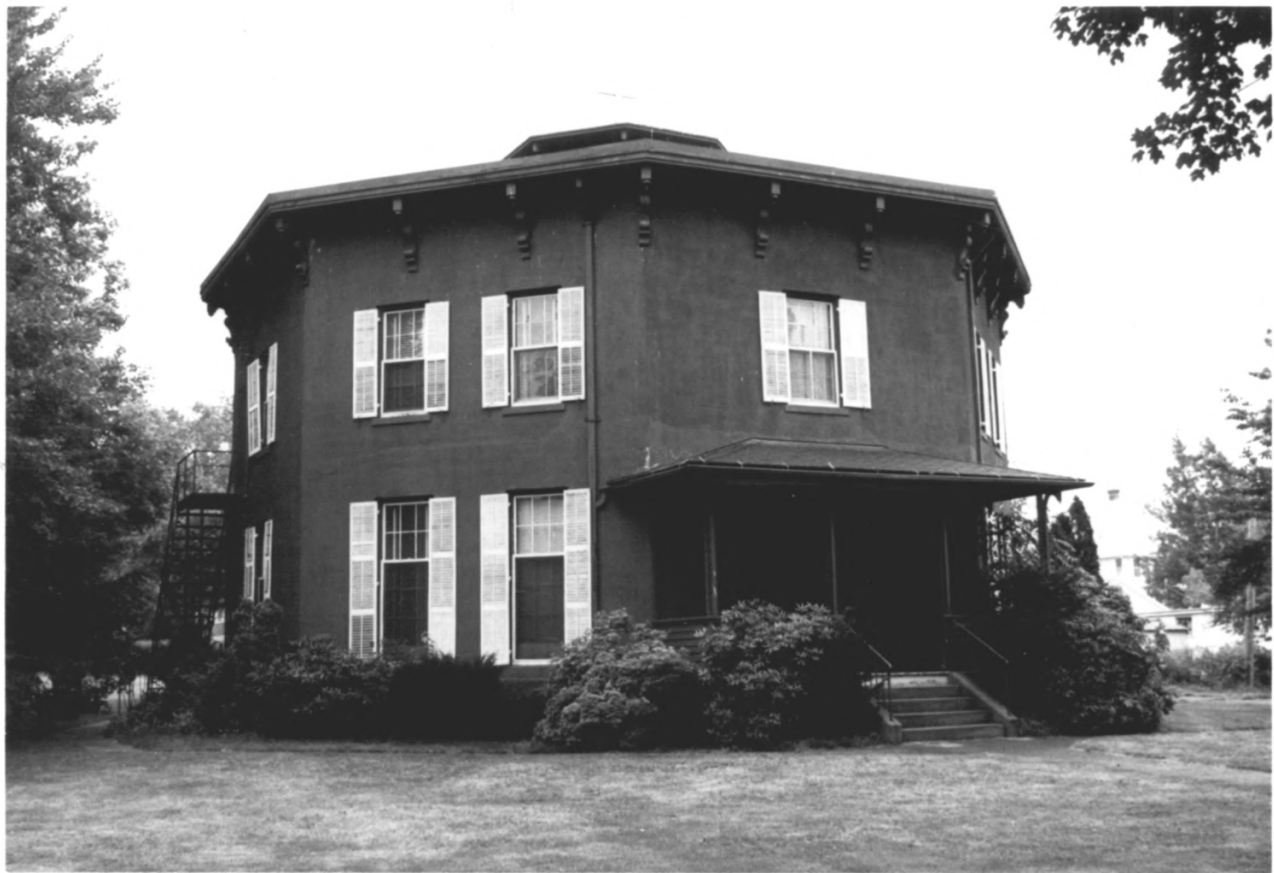
DESCRIBE VIEW, DIRECTION, ETC. IF DISTRICT, GIVE BUILDING NAME & STREET PHOTO NO.

South building, #28 Marlborough St., Main elevation; porch removed; house otherwise remains essentially unaltered; duplicate of #26 Marlborough St., view east. 3
