National Register of Historic Places Registration Form

Historic name: First Congregational Church

Street & number: 1887 Cecil Street

City or town: Waynoka State: OK County: Woods

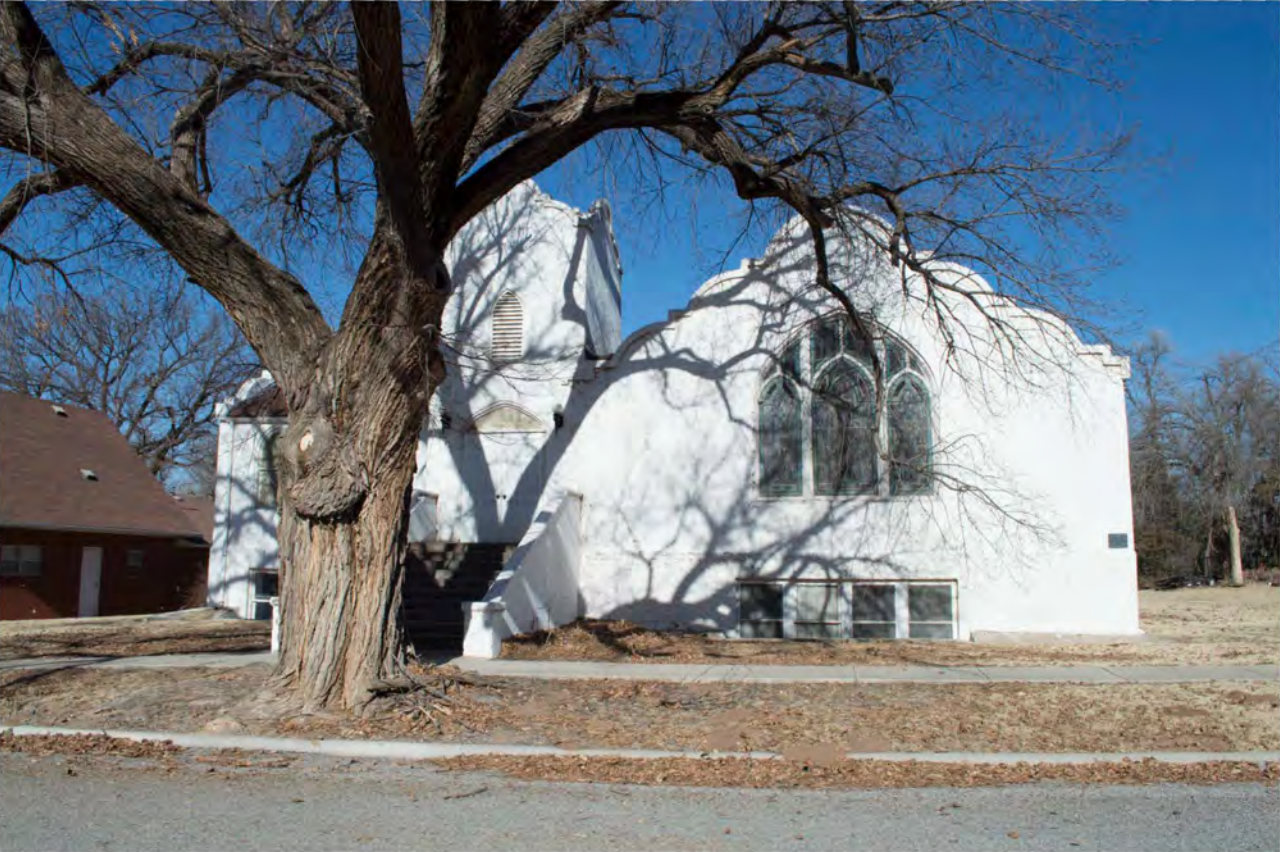
Photo 0001: South elevation, camera facing north.

East of the bell tower on the south elevation, is the rectangular, auditorium portion of the building (see photograph 2). Featuring a Mission-shaped parapet, the south elevation is highlighted by the symmetrical, triple, pointed arch, fixed, stained glass window. Below the stained glass window, there is a row of four, wood, double hung, basement windows with a large, concrete, window well. On the far east corner of the south elevation, there is a small, black, metal plaque which reads "ERECTED IN 1926/REV. GEO. K. GOODWIN/PASTOR."

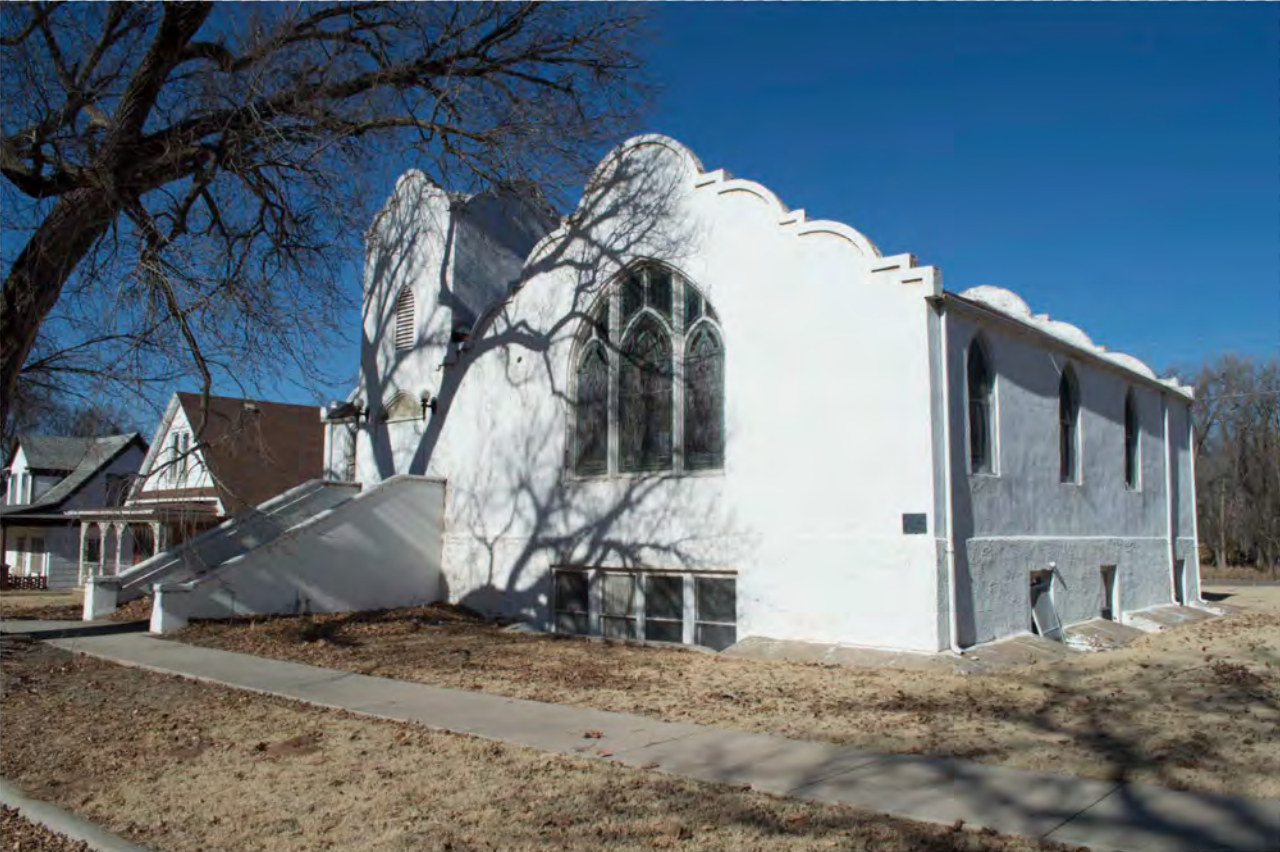
Photo 0002: South (left) and east (right) elevations, camera facing northwest.

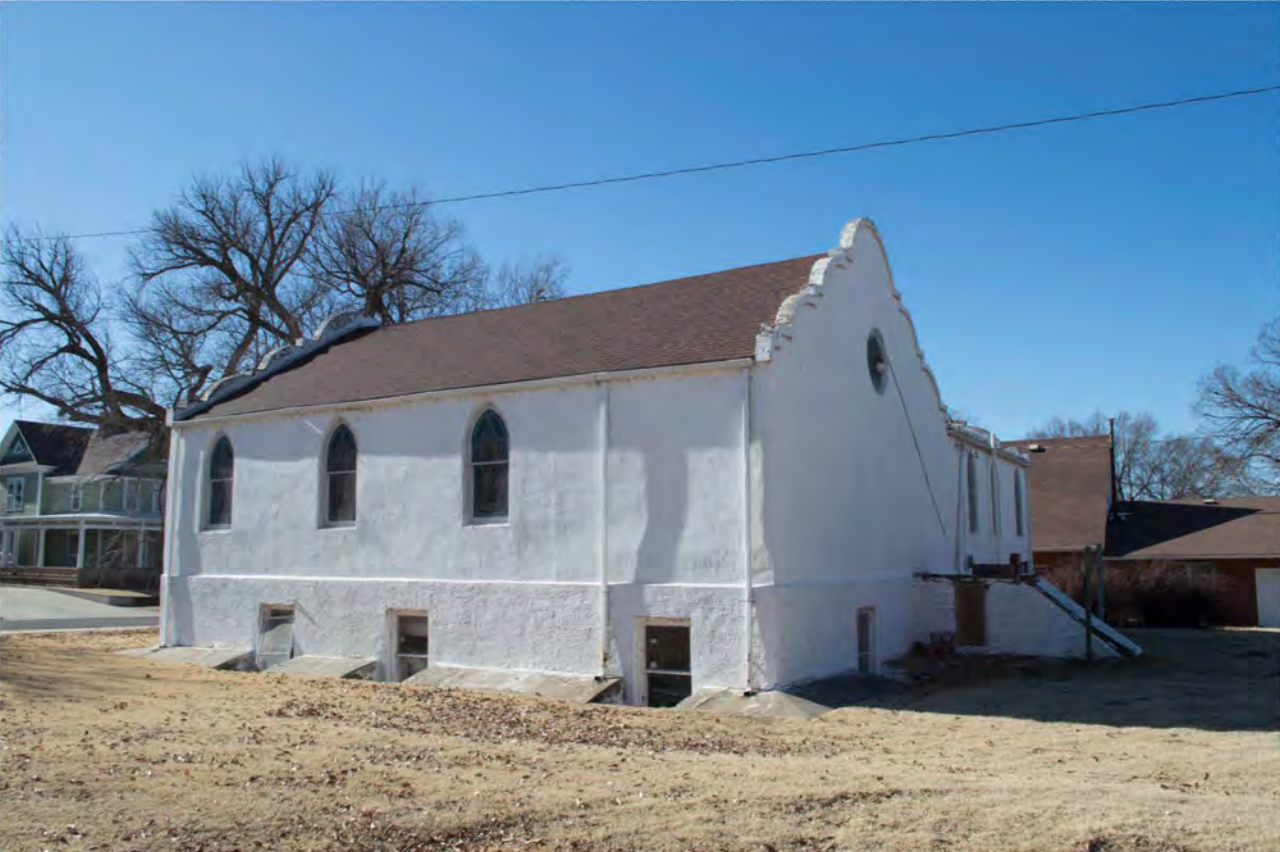
Photo 0003: East (left) and north (right) elevations, camera facing southwest.

The east elevation of the First Congregational Church features three windows on both the first and basement floors (see photograph 3). The windows are asymmetrical with the first floor windows set closer to the south and the basement windows located towards to the north. The first floor windows are of a matching stained glass to the art glass window on the south elevation; however, the east elevation windows are single, pointed arched, wood, double hung. Like the other basement windows, the lower east elevation windows are flat, wood, double hung windows with concrete window wells.

The north elevation of the church is composed of two sections (see photographs 3 and 4). The east section corresponds to the rectangular auditorium and features a Mission-shaped parapet. Centrally located towards the upper wall is a round stained glass window that is backlit by a metal light that has conduit extending diagonally across the west part of the north wall. Off center to the east, there is a single, basement, wood, double hung window with a concrete window well. To the west, there is a projected, basement entry with metal bulkhead doors.

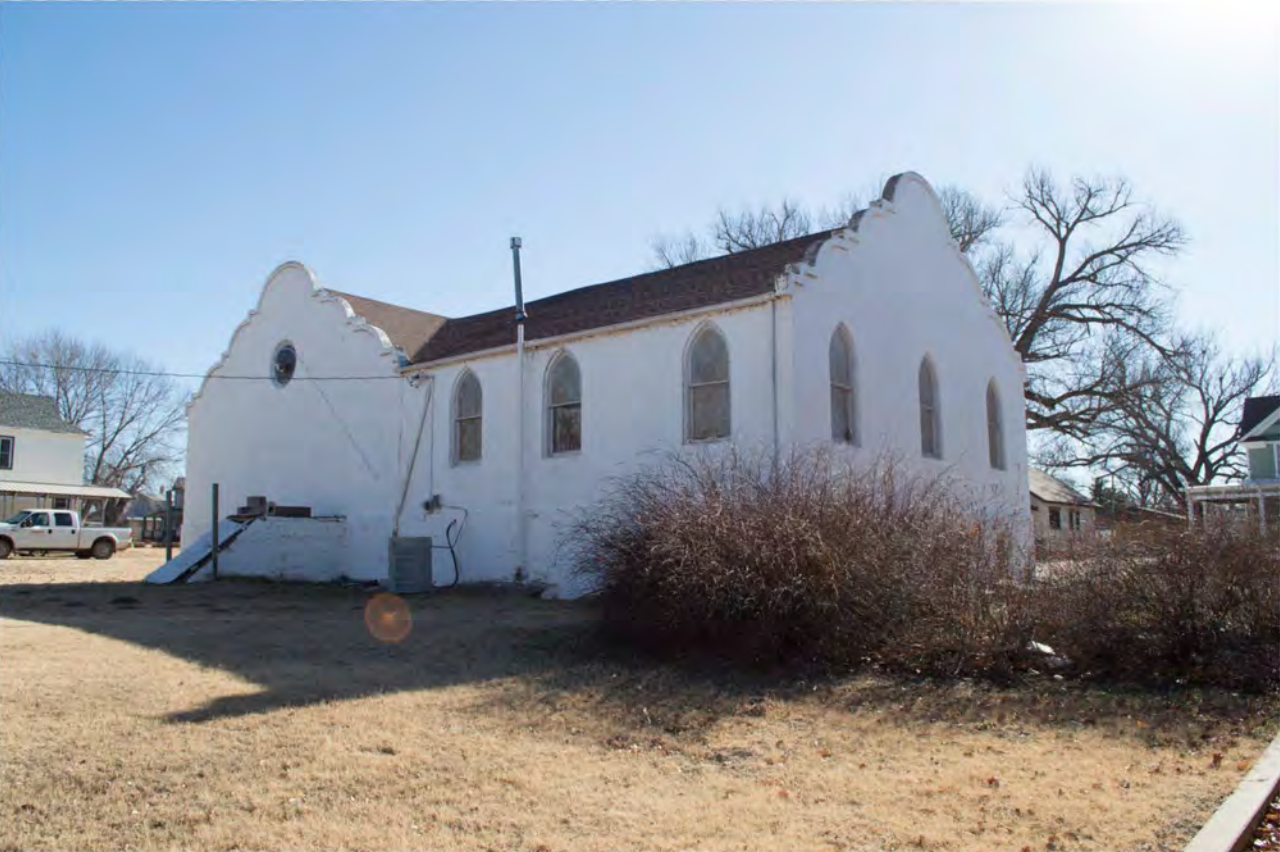
Photo 0004: North (left) and west (right) elevations, camera facing southeast.

The west section of the north elevation contains the classrooms. On the first floor, there are three single, pointed arch, wood, double hung windows with opalescent glass. Below the east window, there is a fairly modern, heating and cooling unit. This section of the building originally featured two basement windows corresponding to the separate interior bathrooms. Both windows have been removed and the opening on the exterior covered with stucco at an unknown time but the concrete window wells remain. On the far west side of the north elevation at the basement level, there is a small, squared, boarded, opening to the interior basement level coal bin.

The west elevation features a Mission-shaped parapet and three asymmetrical windows on the first and ground floors (see photographs 4 and 5). The first floor windows are single, pointed arch, wood, double hung with opalescent glass. The basement windows are single, wood, double hung with clear glass and concrete window wells.

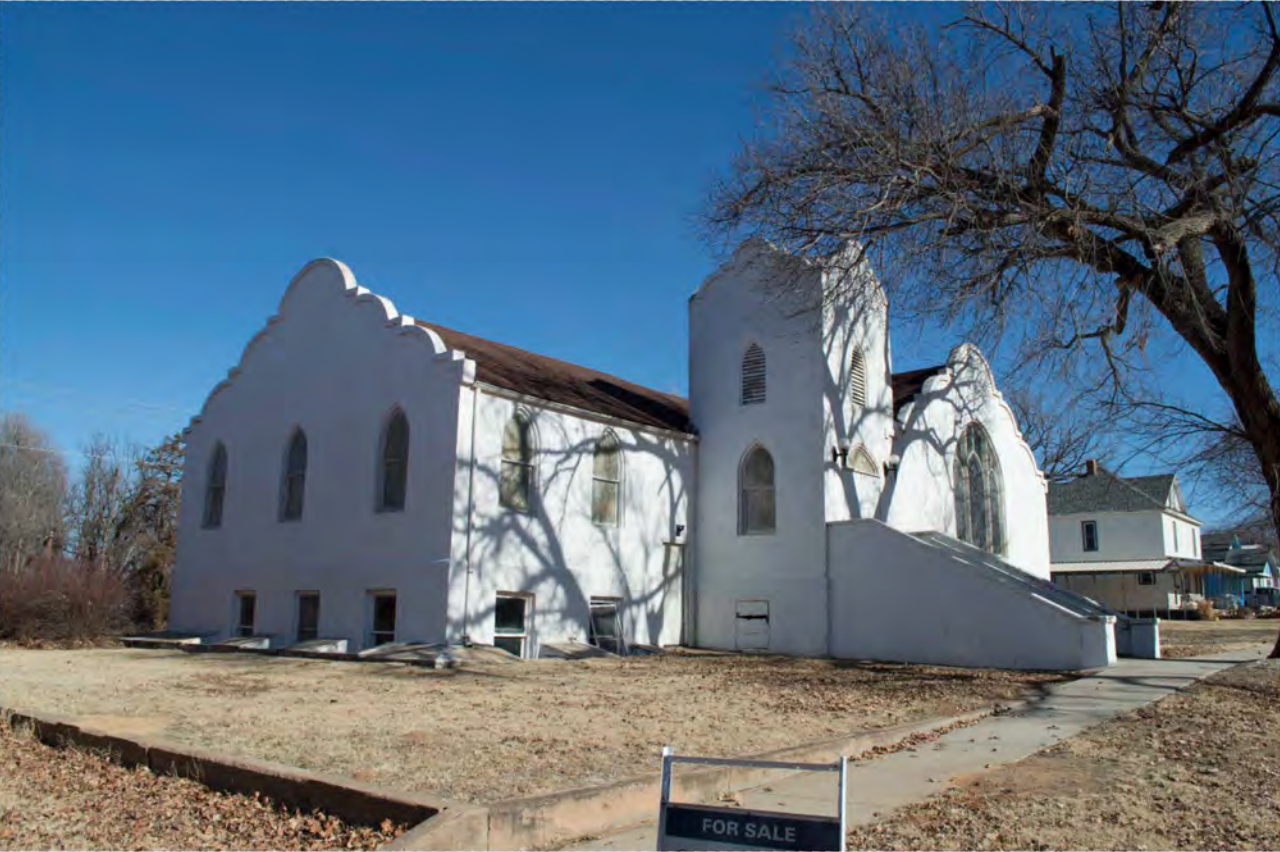
Photo 0005: West (left) and south (right) elevations, camera facing northeast

West of the bell tower, on the south elevation, there is a single, wood, slab, basement door that is topped by a single metal light (see photograph 5). West of the door, there are two single windows on both the first and basement levels. Both windows on the first floor are pointed arch, wood, double hung with opalescent glass. Symmetrically located on the basement level, are two single, wood, double hung windows with concrete window wells.

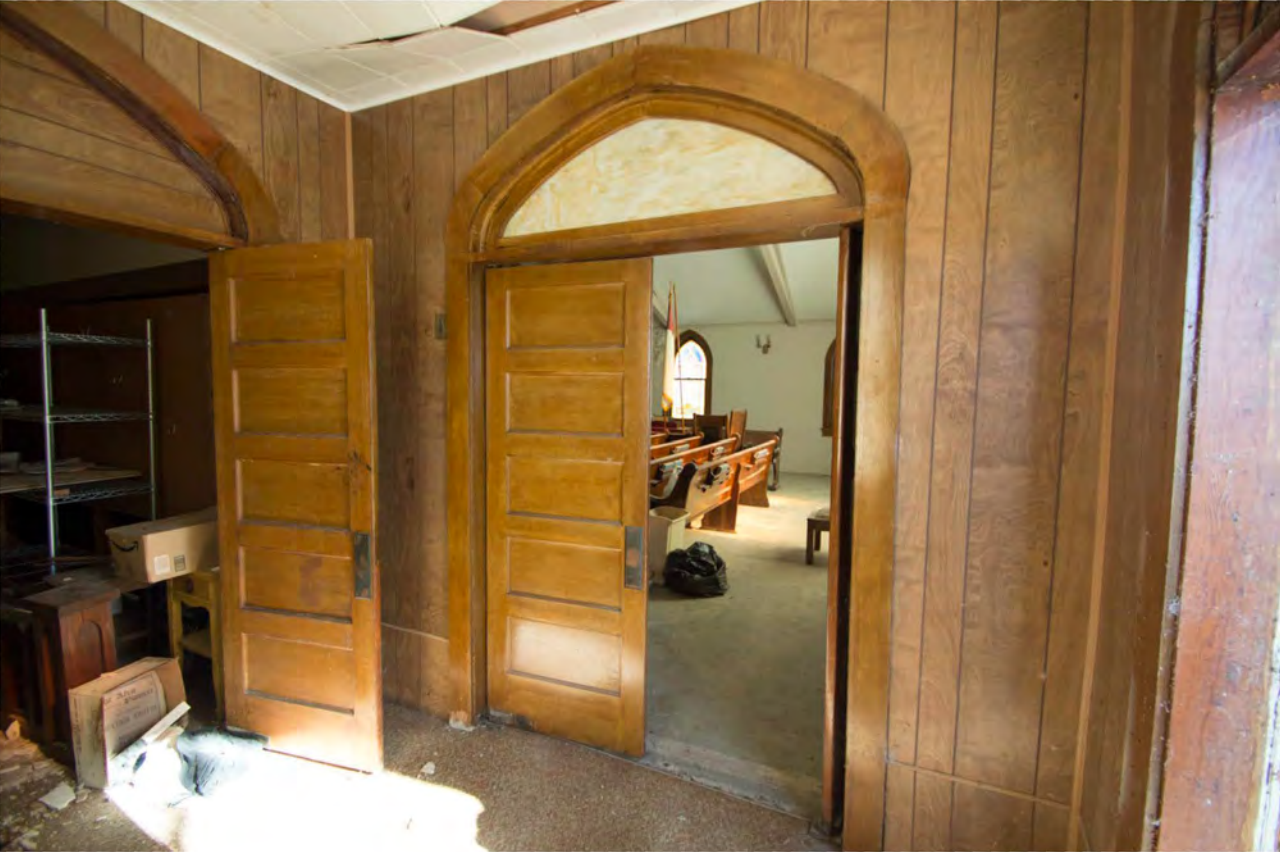
Photo 0006: Interior, looking northeast from entry, camera facing northeast.

The wood paneled vestibule opens on to two pointed arch, double entries (see photograph 6). The north entry leads to a hallway that goes to the educational rooms. The east entry opens on to the auditorium. A large, rectangular space, the auditorium features a wood beam roof and concrete floors (see photographs 7 and 8). On the north side of the room, there is a raised platform that extends the full width of the room. Centrally located on the north wall of the auditorium is the round stained glass window that prominently features the Holy Bible (see photograph 9). In the bottom of the circular window, there is an "E" within a larger "C" set within a circle. The "C E" stands for the Christian Endeavor, which was the youth group at the church that donated the stained glass window at the time of construction. The historic oak pews remain in the auditorium, as do the light fixtures, piano and other accoutrements. Along the west wall, there are a series of wood paneled doors which allow the auditorium space to be opened on to the hallway to the classrooms. The east wall of the auditorium features the three single pointed arch stained glass windows (see photograph 10). The stained glass window on the north side was dedicated to John and Margaret Hink. The matching center window on the east wall was dedicated to Hannah R. Flora and the south window to Irene E. Boice. The more elaborate, triple, pointed arch window on the south wall was dedicated in memory of the work of Fannie and Reverend Samuel Pearson, who served the church during World War I (WWI; see photograph 11).

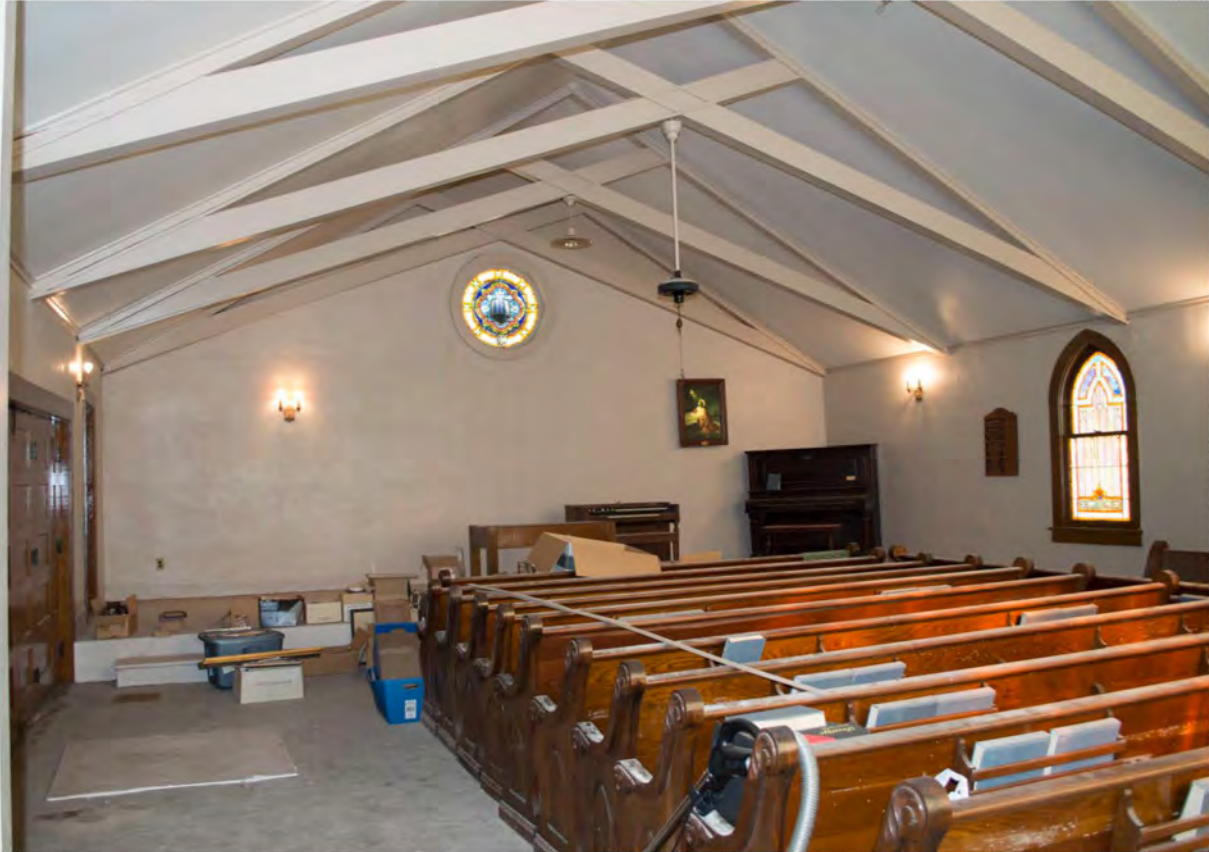
Photo 0007: Interior, Auditorium, looking northeast from southwest door, camera facing northeast.

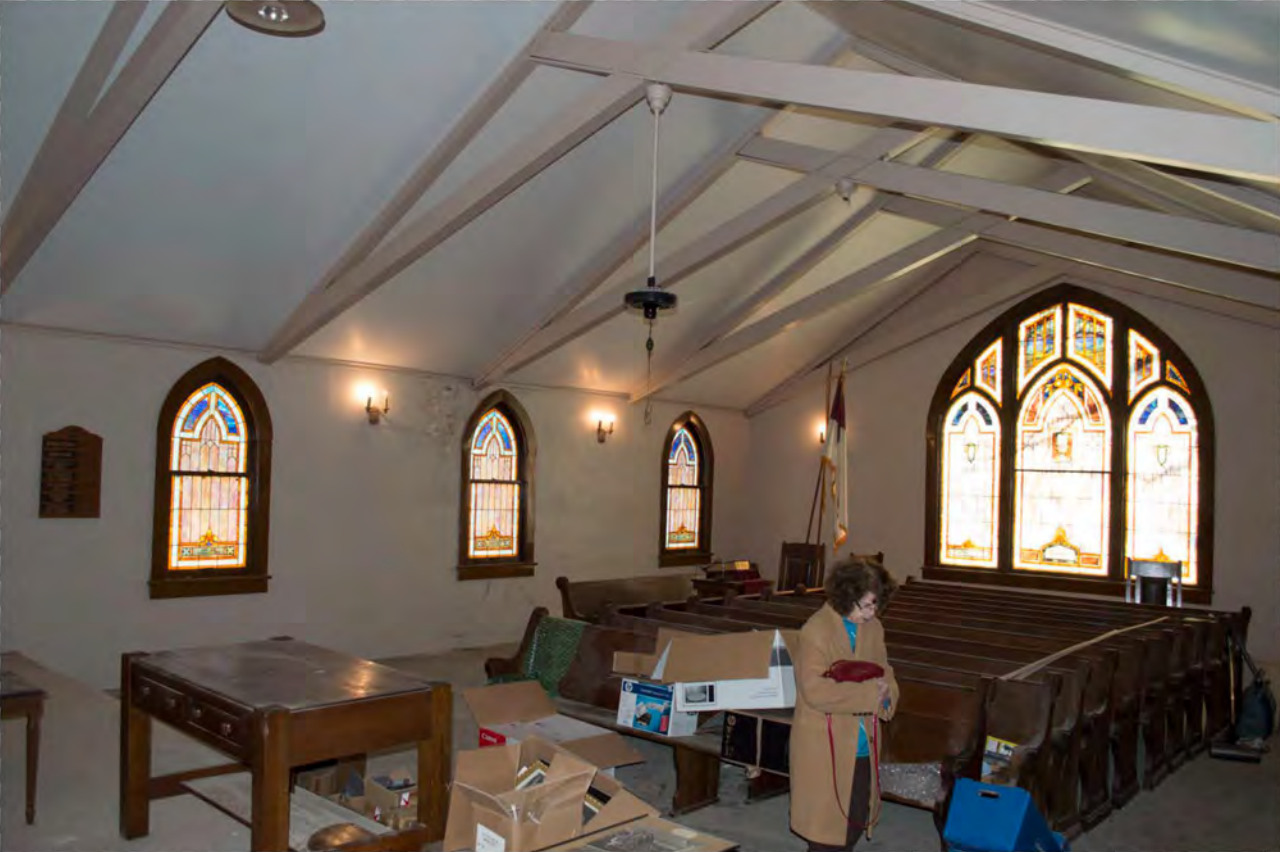
Photo 0008: Interior, Auditorium, looking southeast from the northwest door, camera facing southeast.
