National Register of Historic Places Registration Form

Historic name: Cover's Tannery

Other names/site number: CARR-1583

Street & number: 626 Francis Scott Key Highway

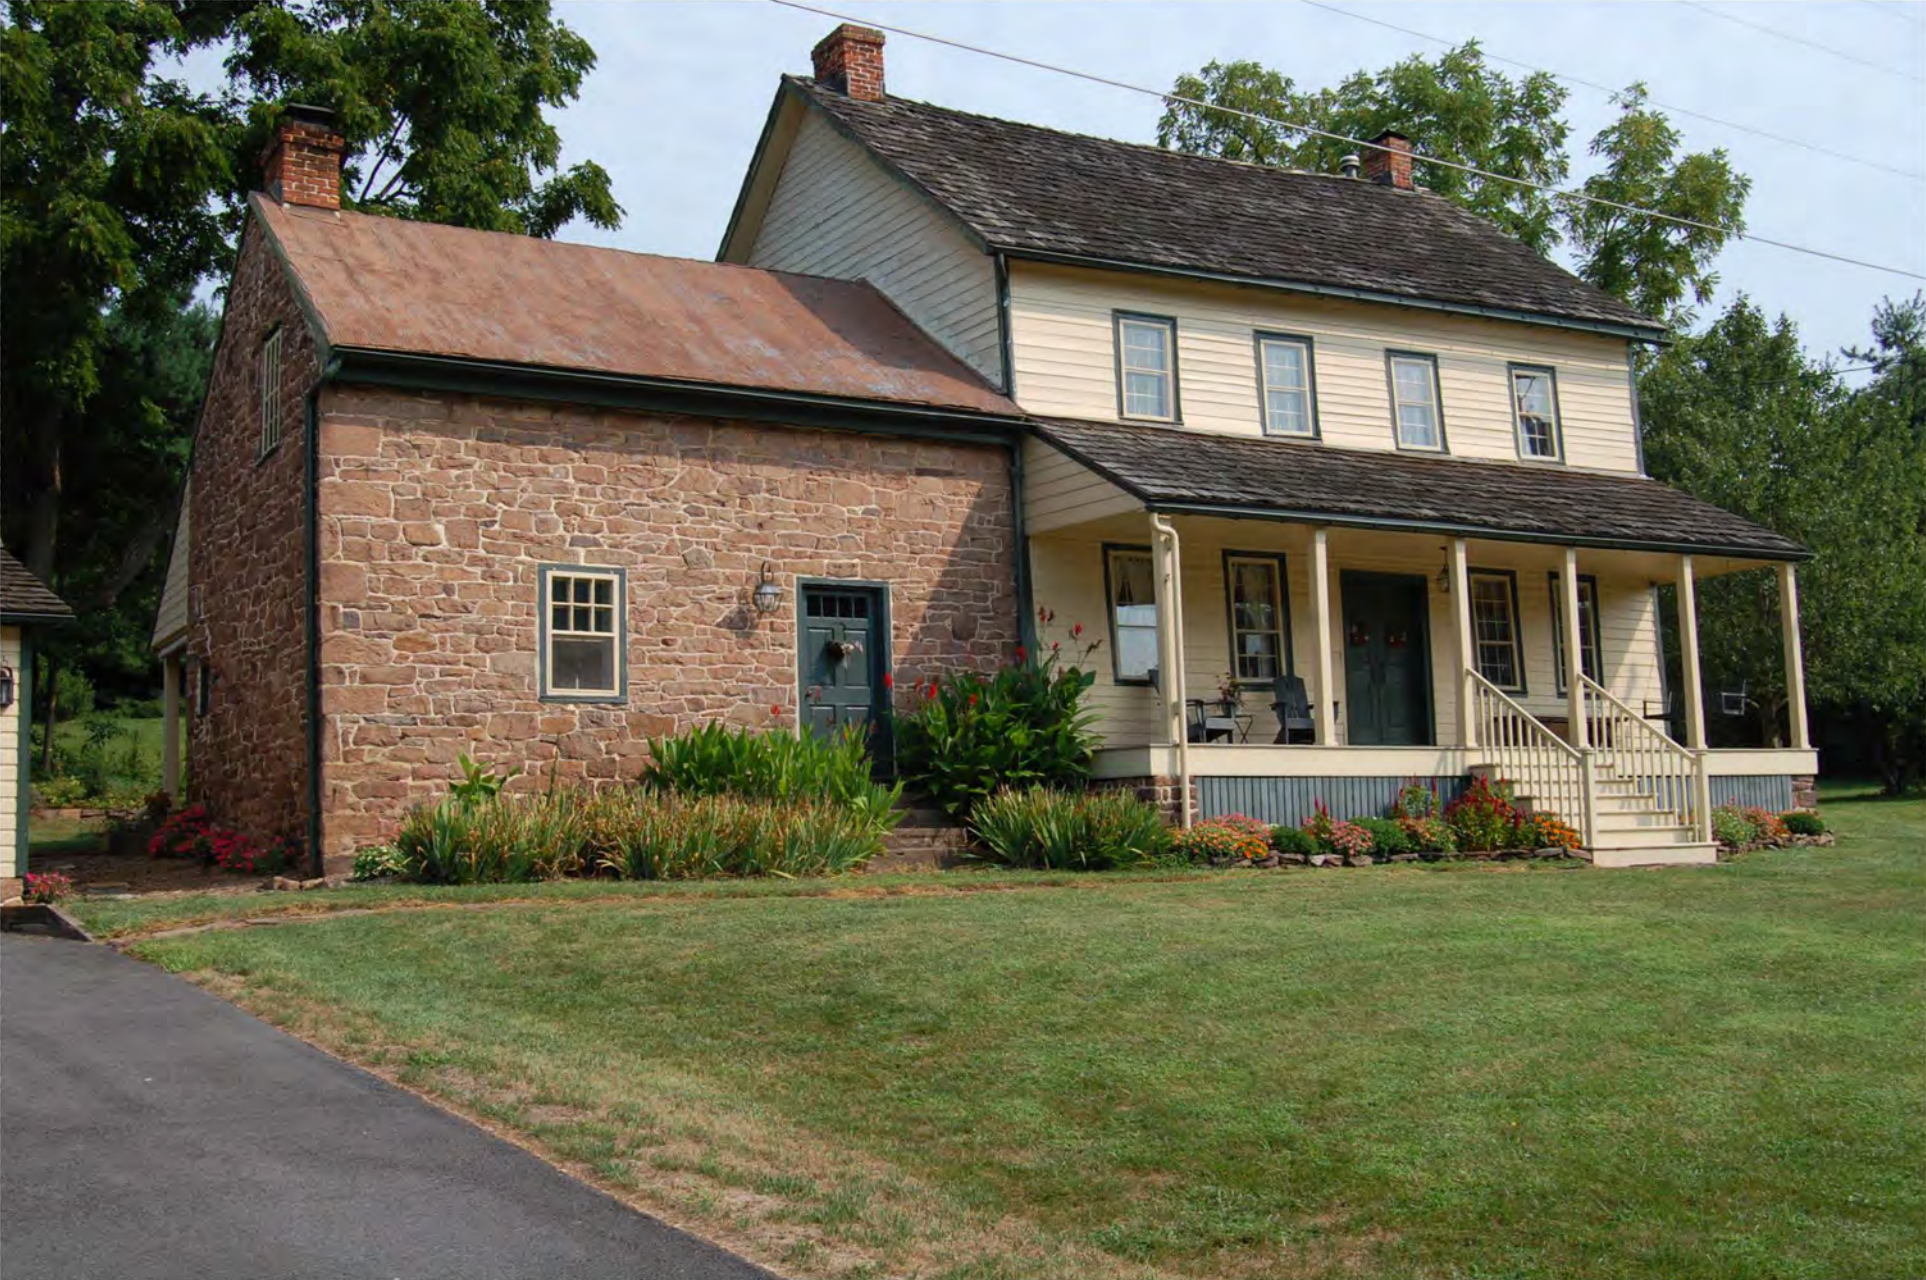
MD_Carroll County_Cover's Tannery_0001.tif
Front (east) façade, view from southeast
1 of 11.

The east elevation on the first story has a center entrance with a wide door frame and a new door set in it. The doorway has been narrowed with infill on either side of the door. There are two 9/6 sash on either side of the door that are old but not original to this structure. They are set in mortised and tenoned and pegged frames that have ovolo backbands. The first story has a one story five bay porch that has recently been rebuilt to match the remains of the earlier porch. The four bays of the second story do not align with the openings of the first story. Each bay has a 6/6 sash set in a wide frame that has an ovolo backband; these frames do not appear to be pegged. On the southwest end, flush with the east elevation is a 1-1/2 story 2 bay by 1 bay wing of rubble stone. The east elevation of the wing has a 6/6 sash with head cut trim in the south bay and a new door in an original frame in the east bay. There is a wood box cornice and an interior brick chimney on the southwest gable end.

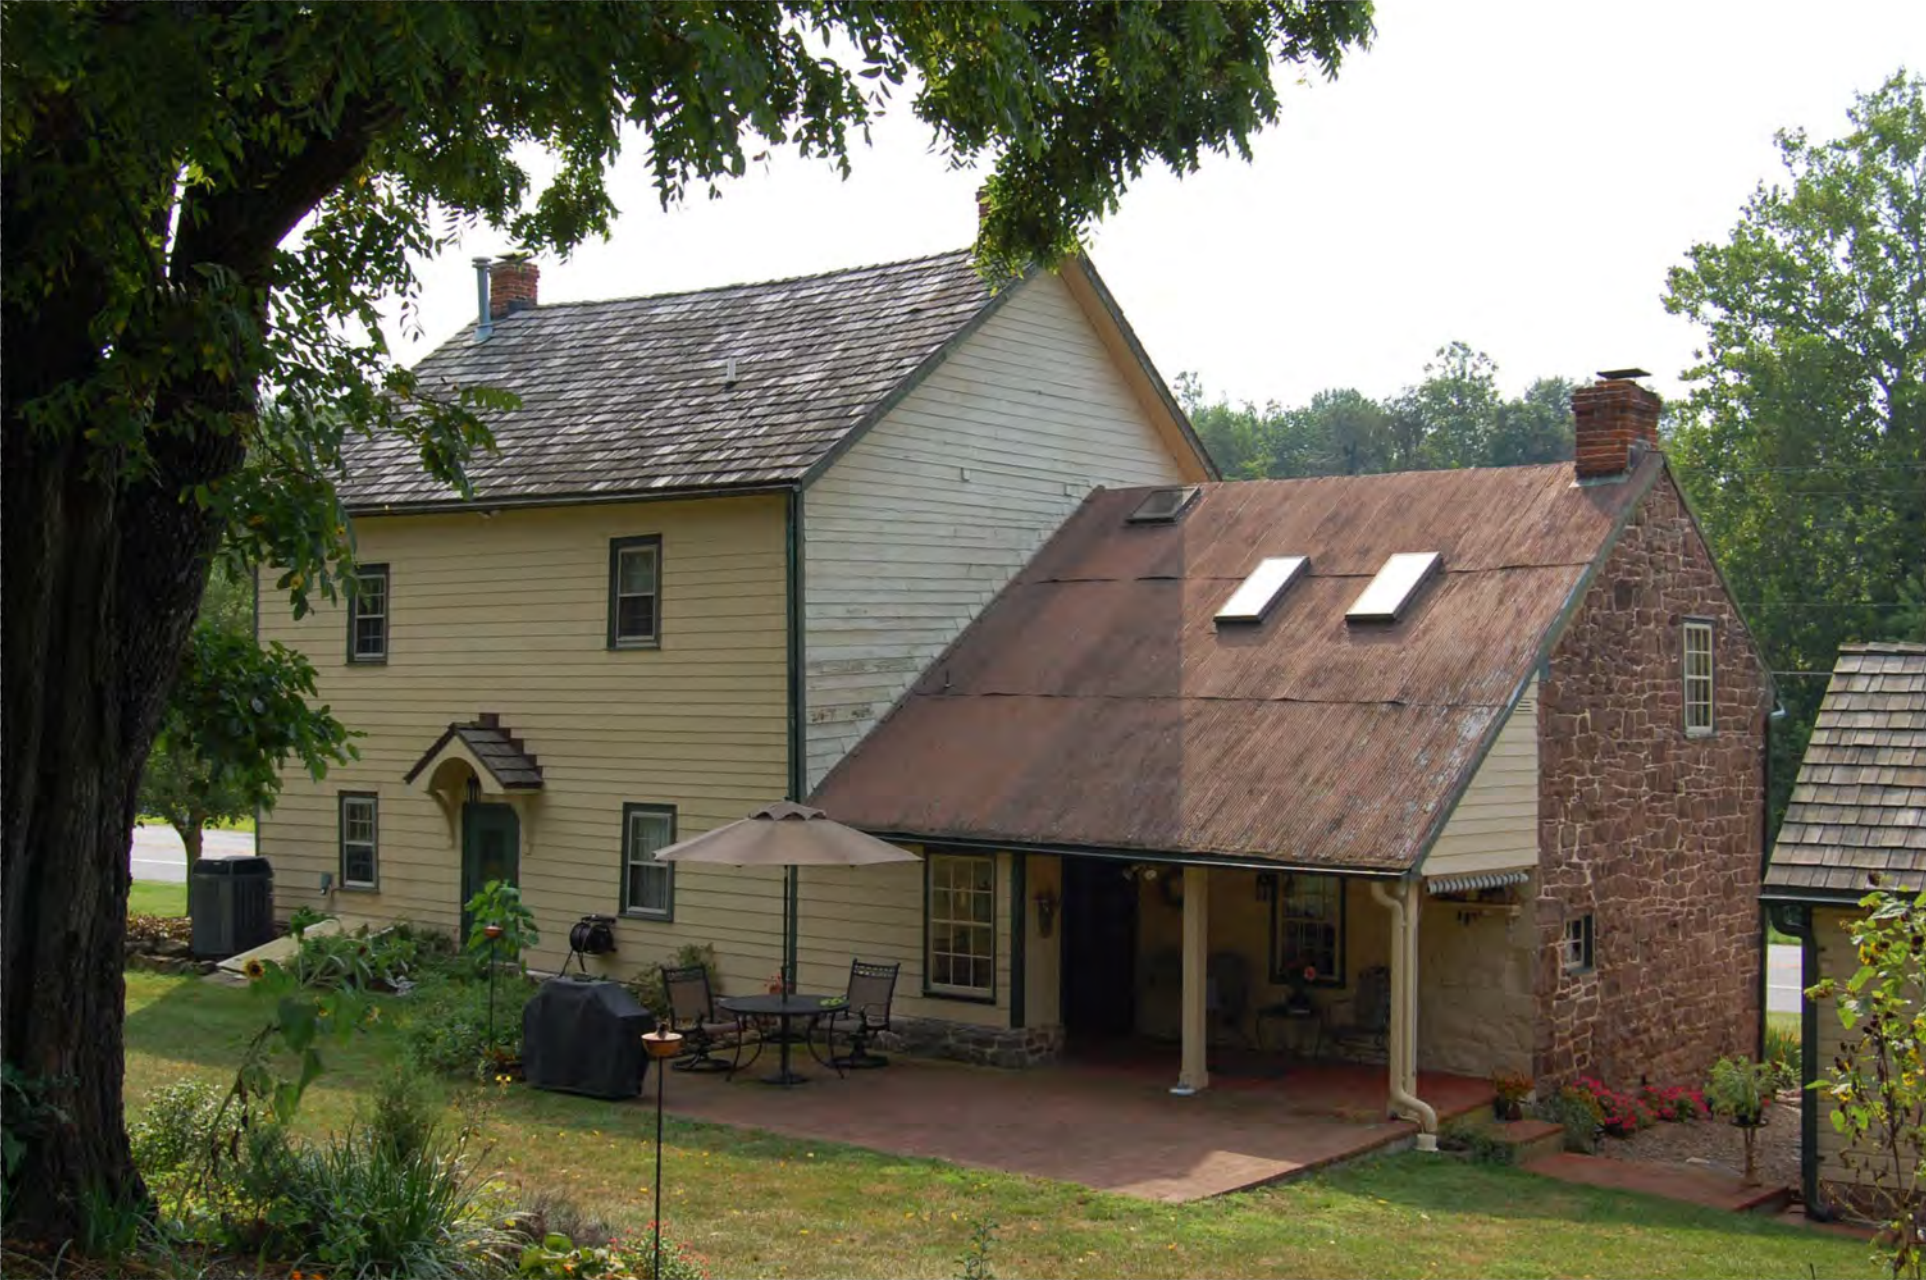
MD_Carroll County_Cover's Tannery_0001.tif
Rear (west) elevation, view from southwest
2 of 11.

On the west elevation of the main block, the first story is three bays wide, with a center entrance that has a beaded-edge-vertical-board door with a six-light sash set into it. The door frame is wide and has a cavetto-and-bead backband. There is a 6/6 sash to either side of the doorway and the frames match the door frame. There is a bulkhead cellar entrance below the north bay. On the second story the end bays have the same 6/6 sash and frames as the first story; there is no opening in the center bay. On the north elevation the first and second stories each have two 6/6 sash with replaced trim; the gable peak has two four-light sash.

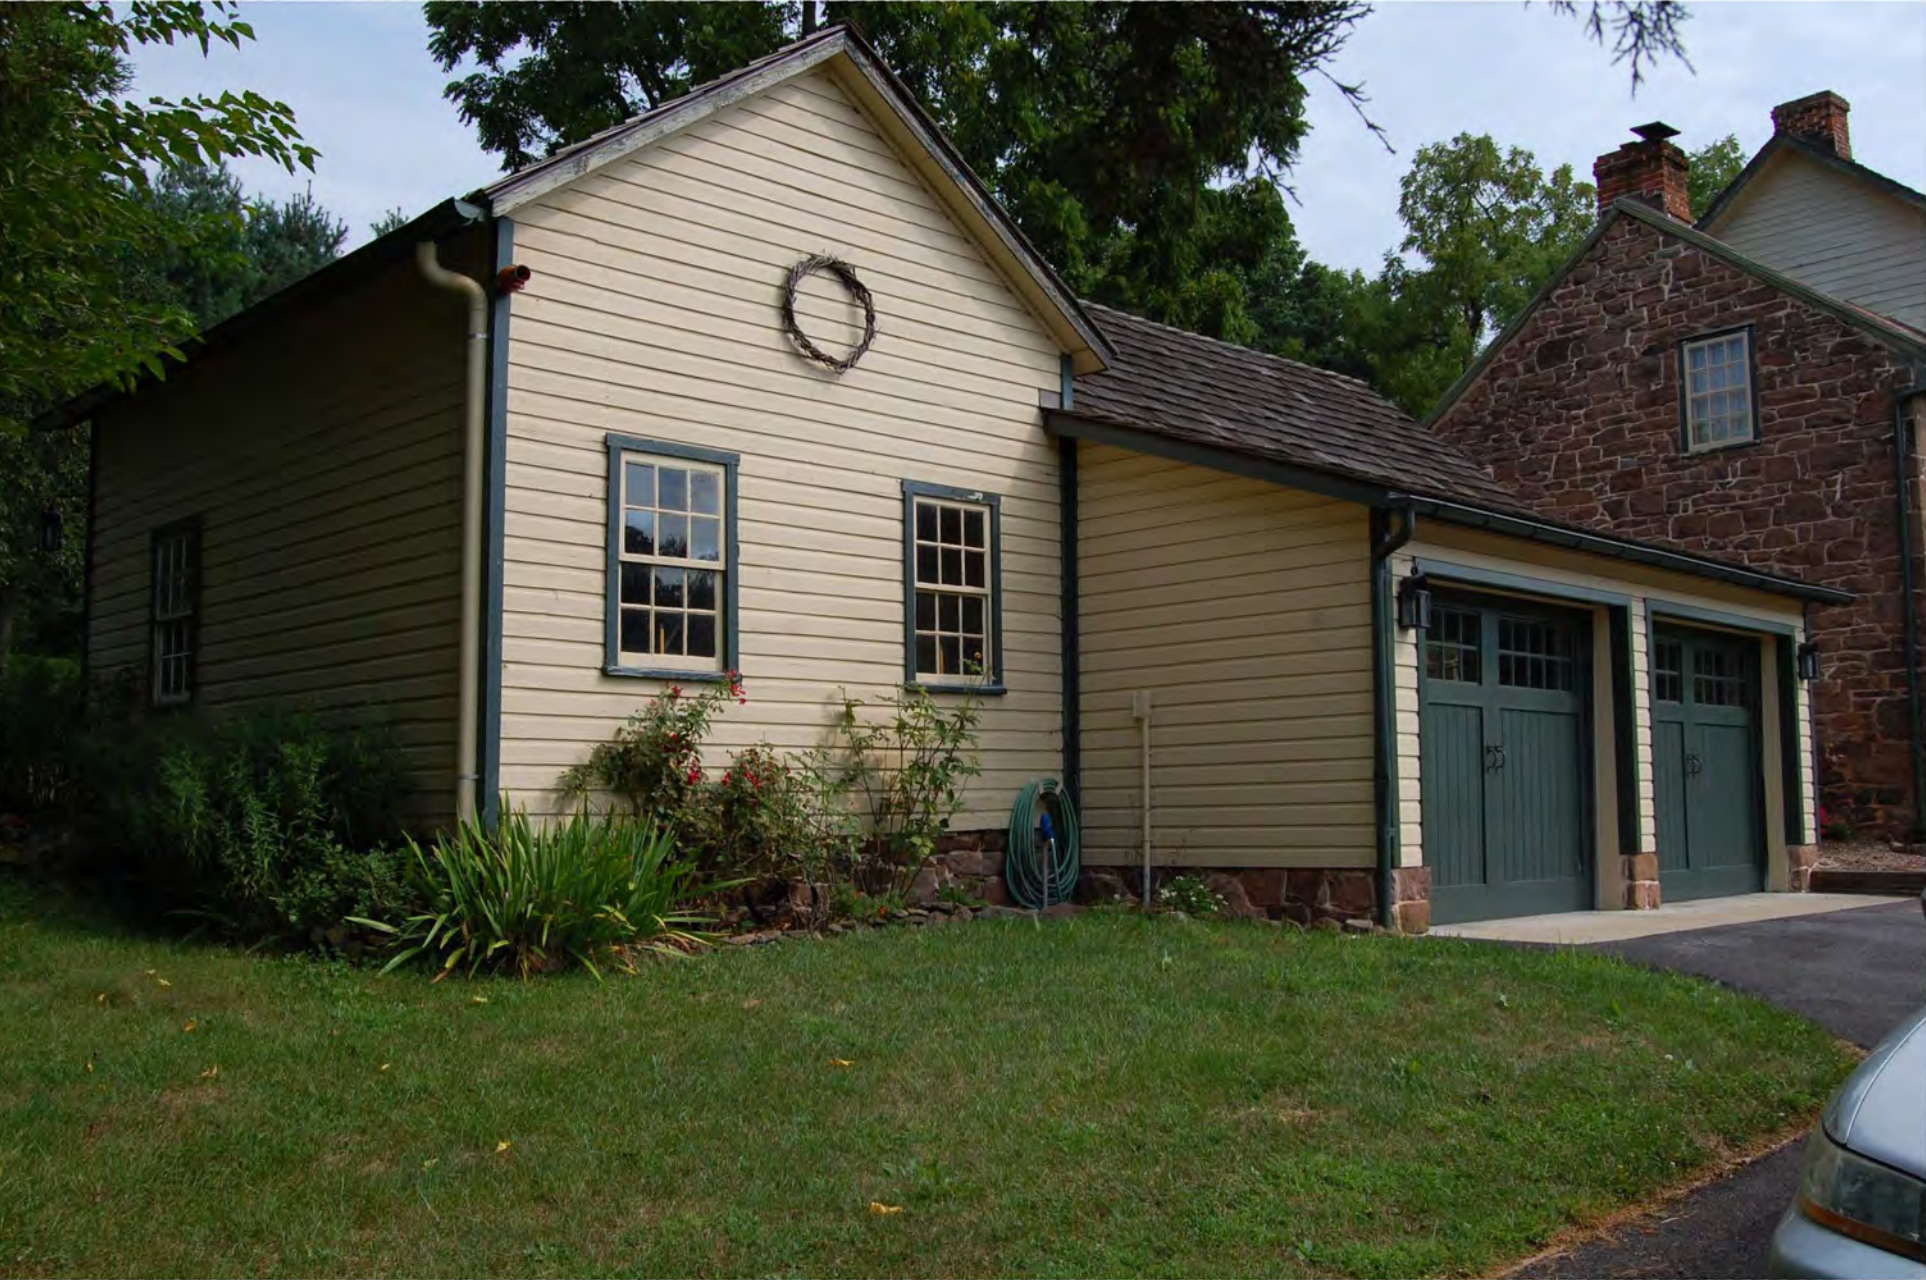
MD_Carroll County_Cover's Tannery_0001.tif
Summer kitchen, view from southeast
3 of 11.

The frame **summer kitchen** is about 30' south of the house. It is a 1-1/2 story 2 bay by 1 bay structure with German siding and corner boards and has a rubble stone foundation. The gable roof has corrugated metal and an east to west ridge. The north elevation has a window opening in the east bay and a vertical board door in the west bay. The west elevation has a window opening in the gable end. The south elevation has a window opening in the west bay. The east elevation has two 6/6 sash with head cut trim.

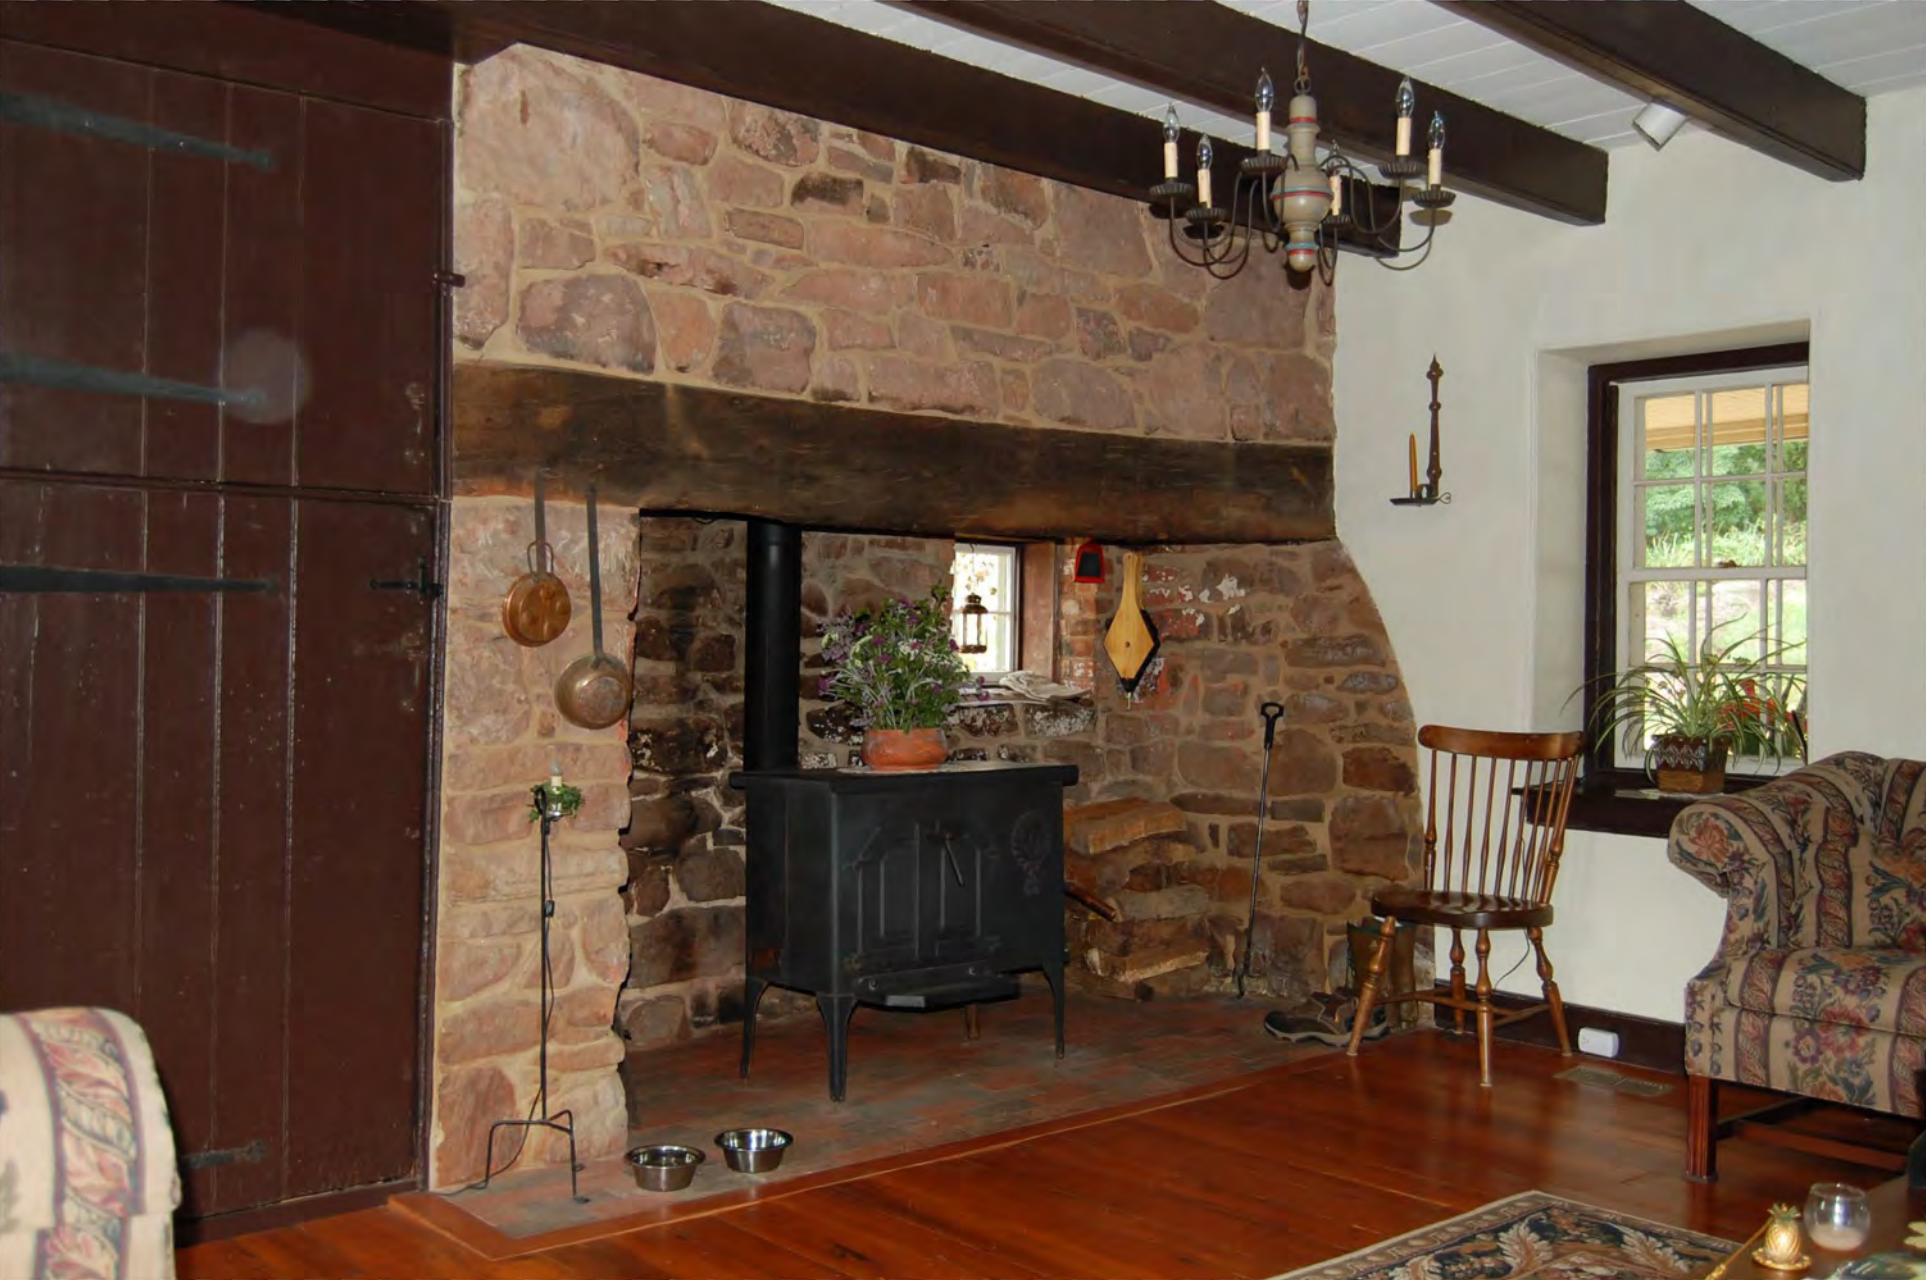
MD_Carroll County_Cover's Tannery_0001.tif
Fireplace in stone section, view from northeast
4 of 11.

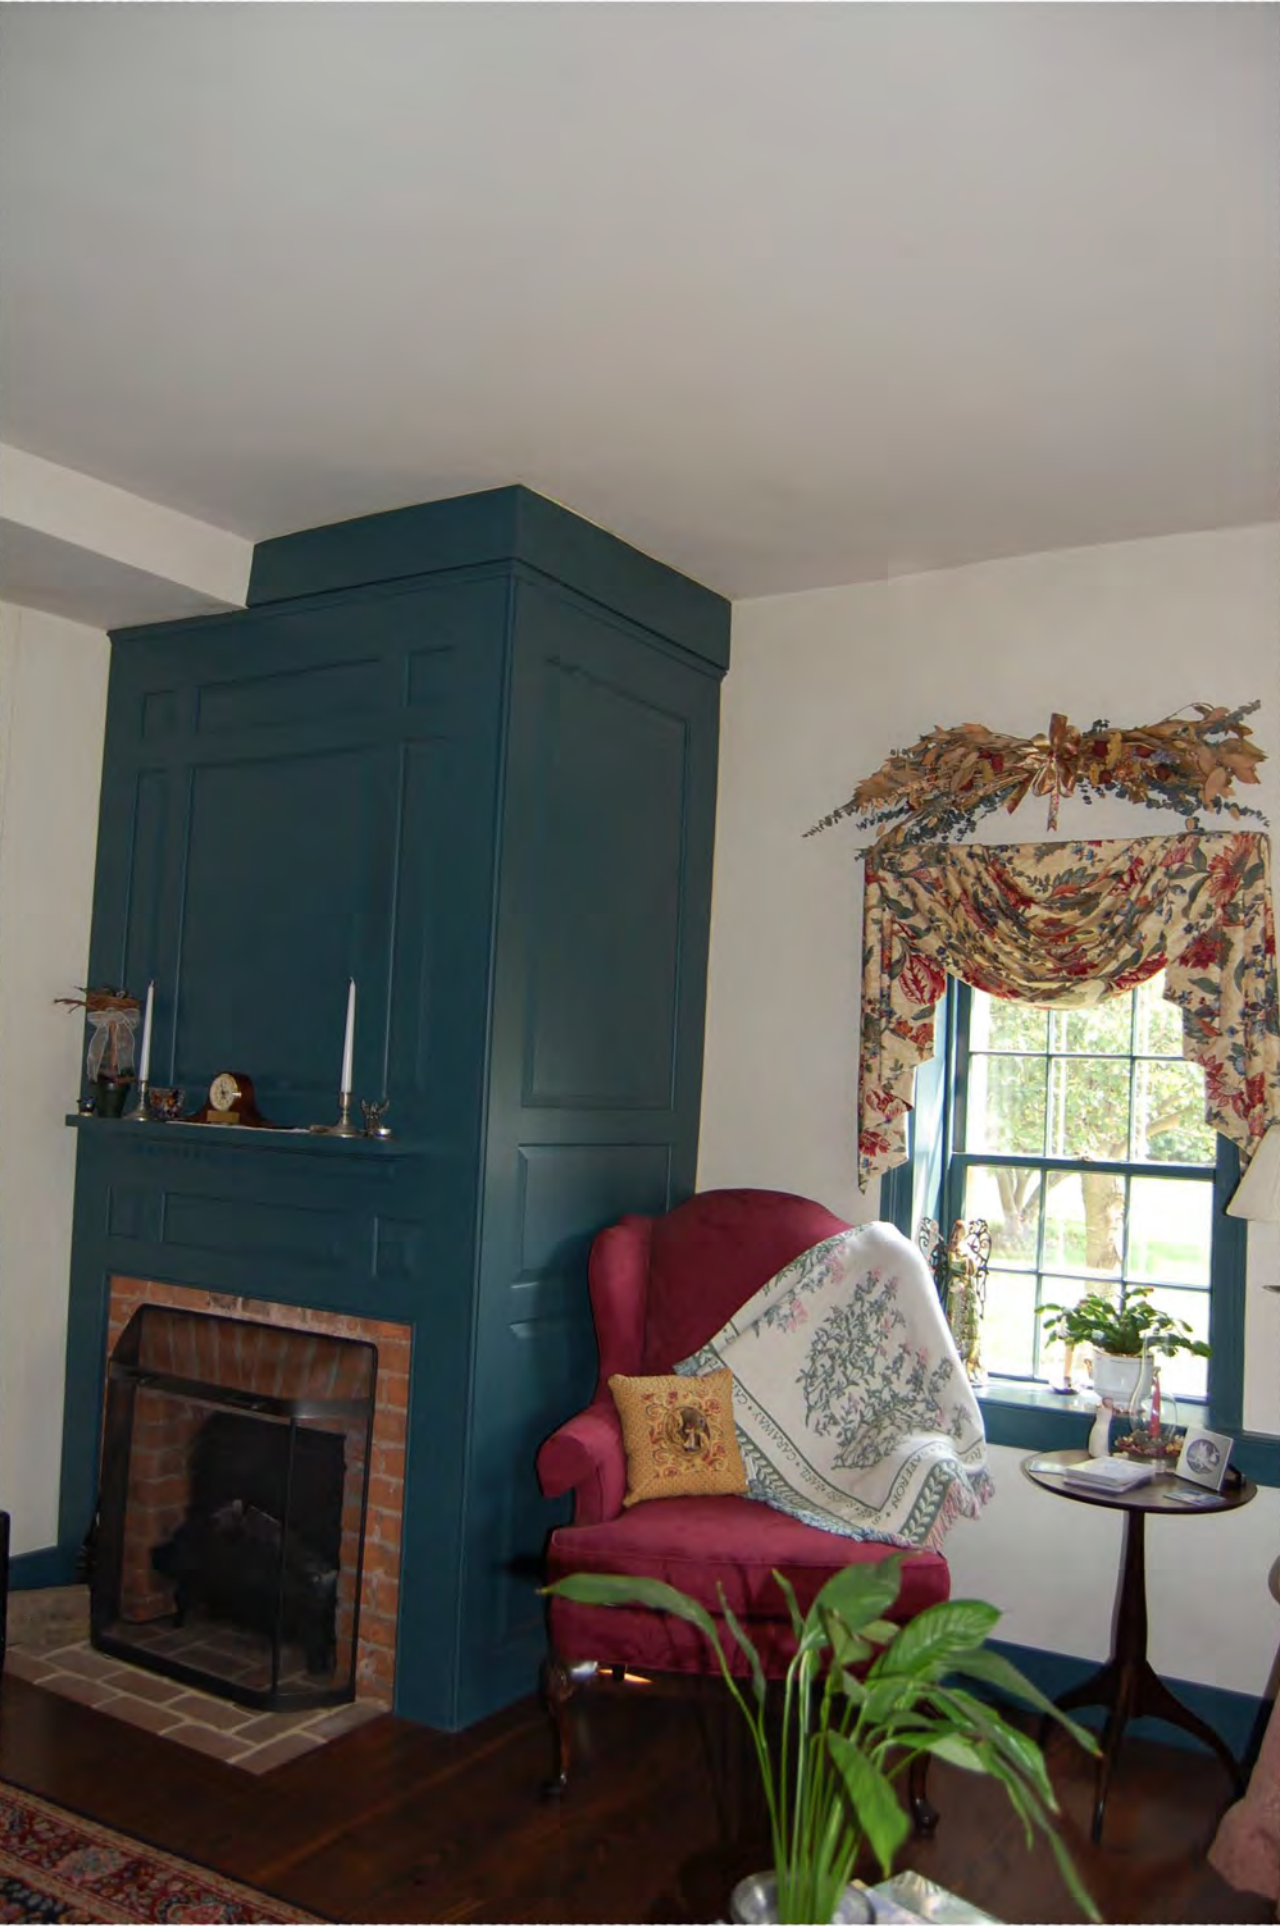
MD_Carroll County_Cover's Tannery_0001.tif
Fireplace in first floor north room, view from southeast
5 of 11.

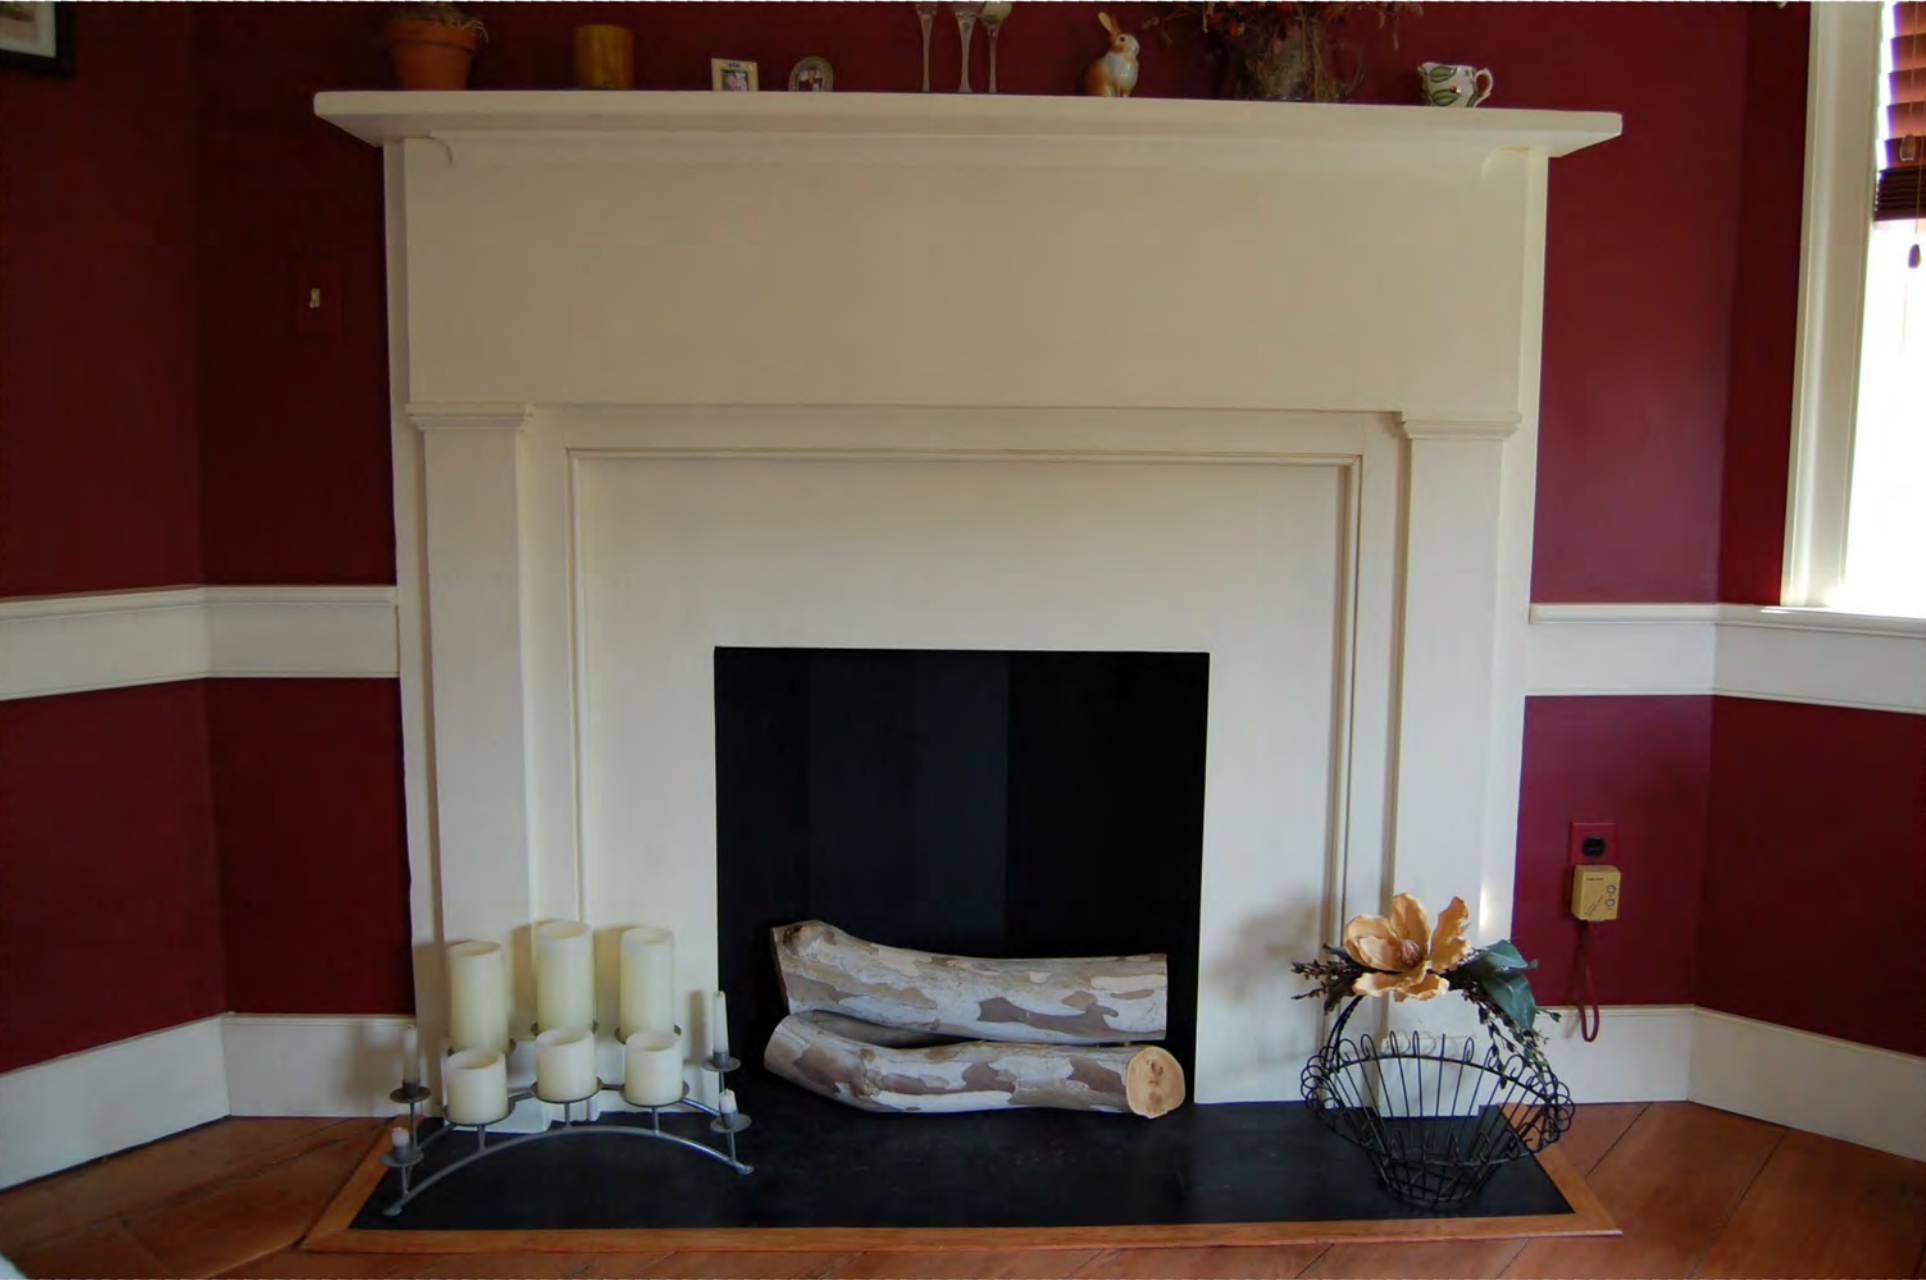
MD_Carroll County_Cover's Tannery_0001.tif
Corner fireplace, northeast chamber, view from southwest

The northeast chamber has a board wall on the south elevation and plaster walls on the north, west, and east sides. The summer beam runs through this room and is plastered and has a flush board on the soffit. A corner fireplace with a simple board mantel is located in the northwest corner of the room. The window on the north has architrave with mitered joints and an ogee backband, the jambs are covered with boards. The east windows have an ovolo applied to the jamb boards.

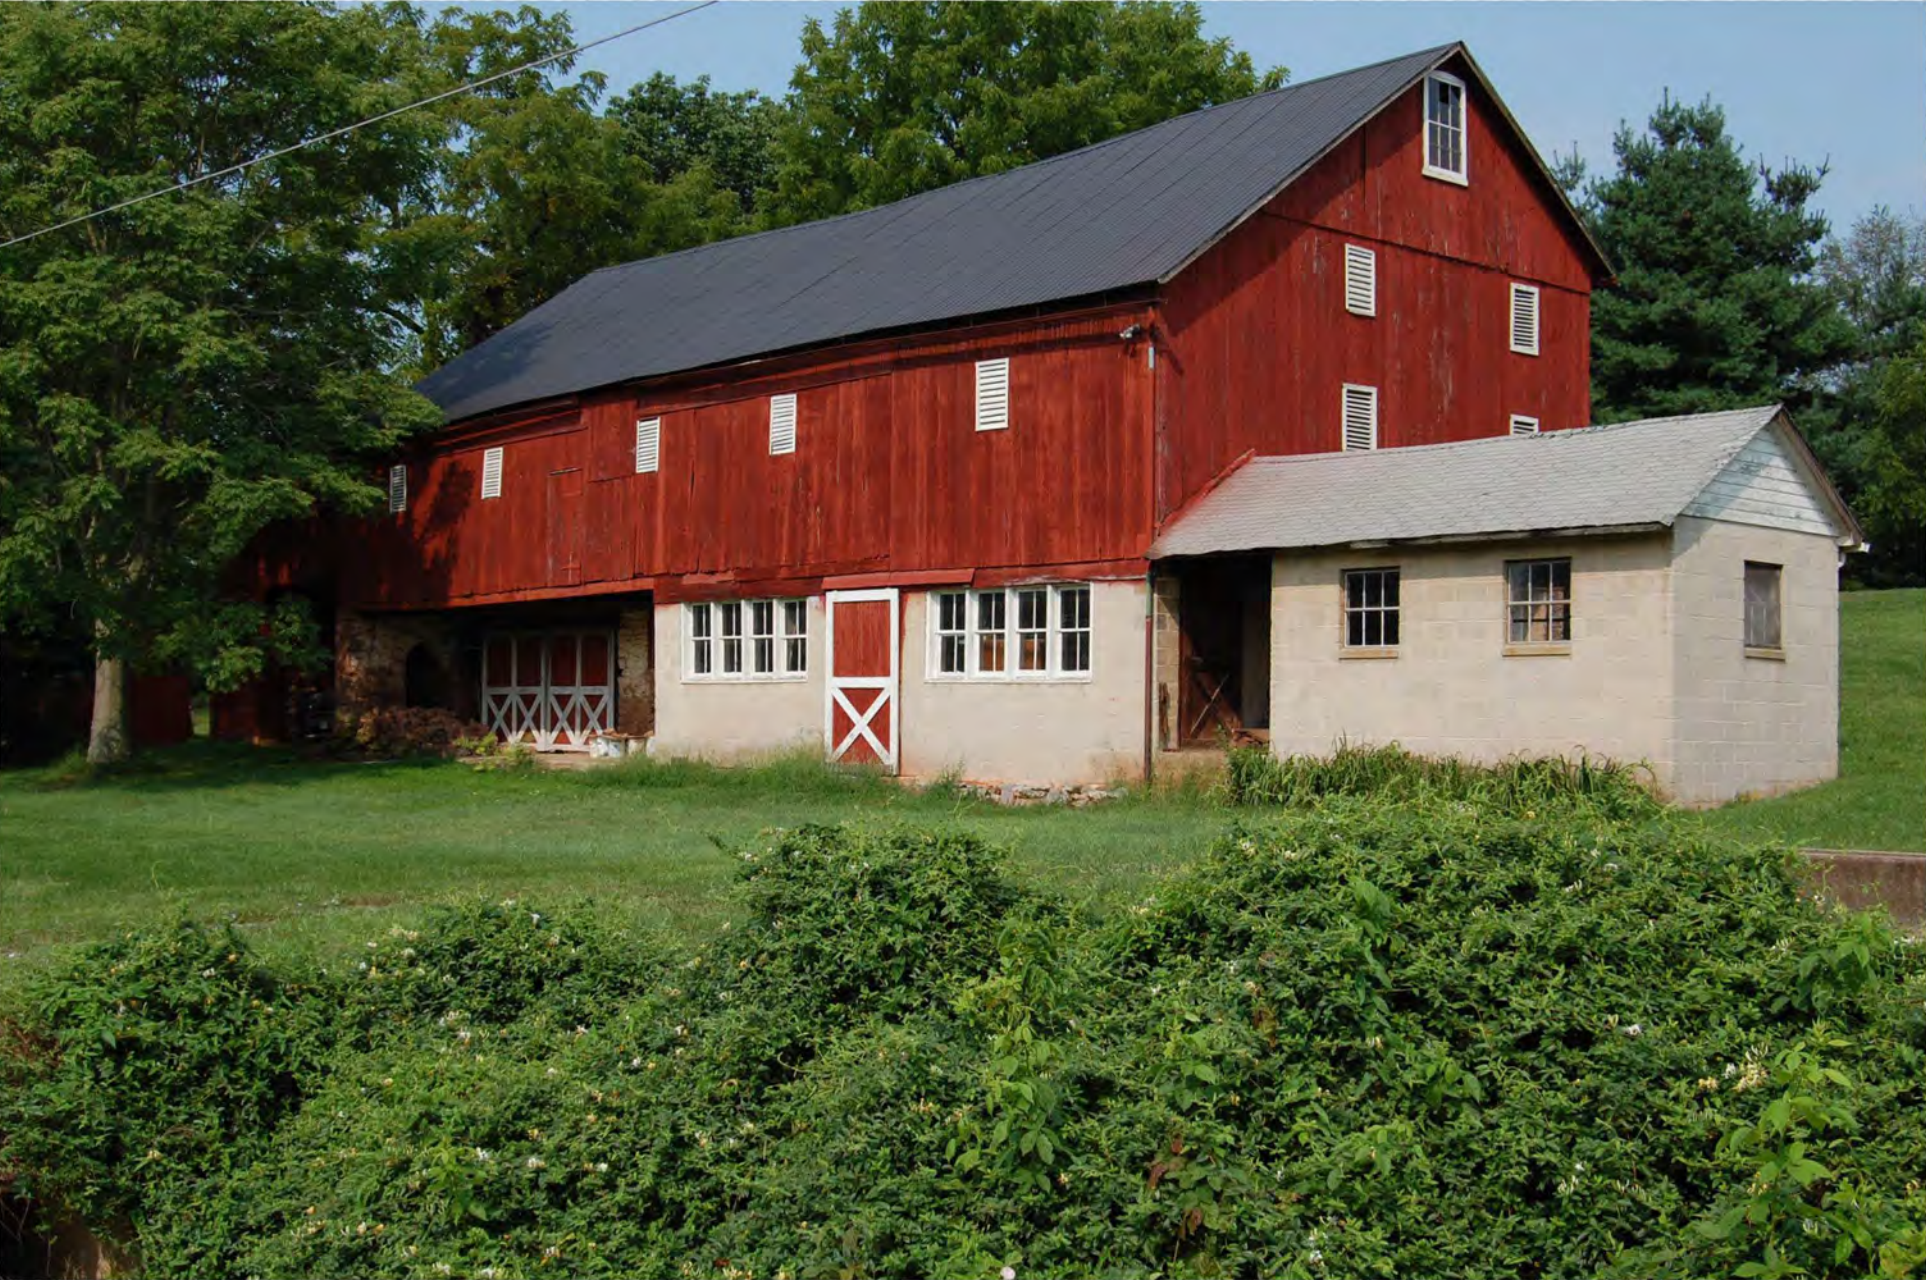
Barn and milk house, view from northeast

On the north elevation of the lower story, a concrete block milk room was added to the east bay in the early 20th century. This has an asphalt shingled gable roof with a north-to-south ridge. There are two six-light steel sash on the east and west elevations and one on the north elevation. To the west, an altered opening pierces the stone foundation of the barn and holds a

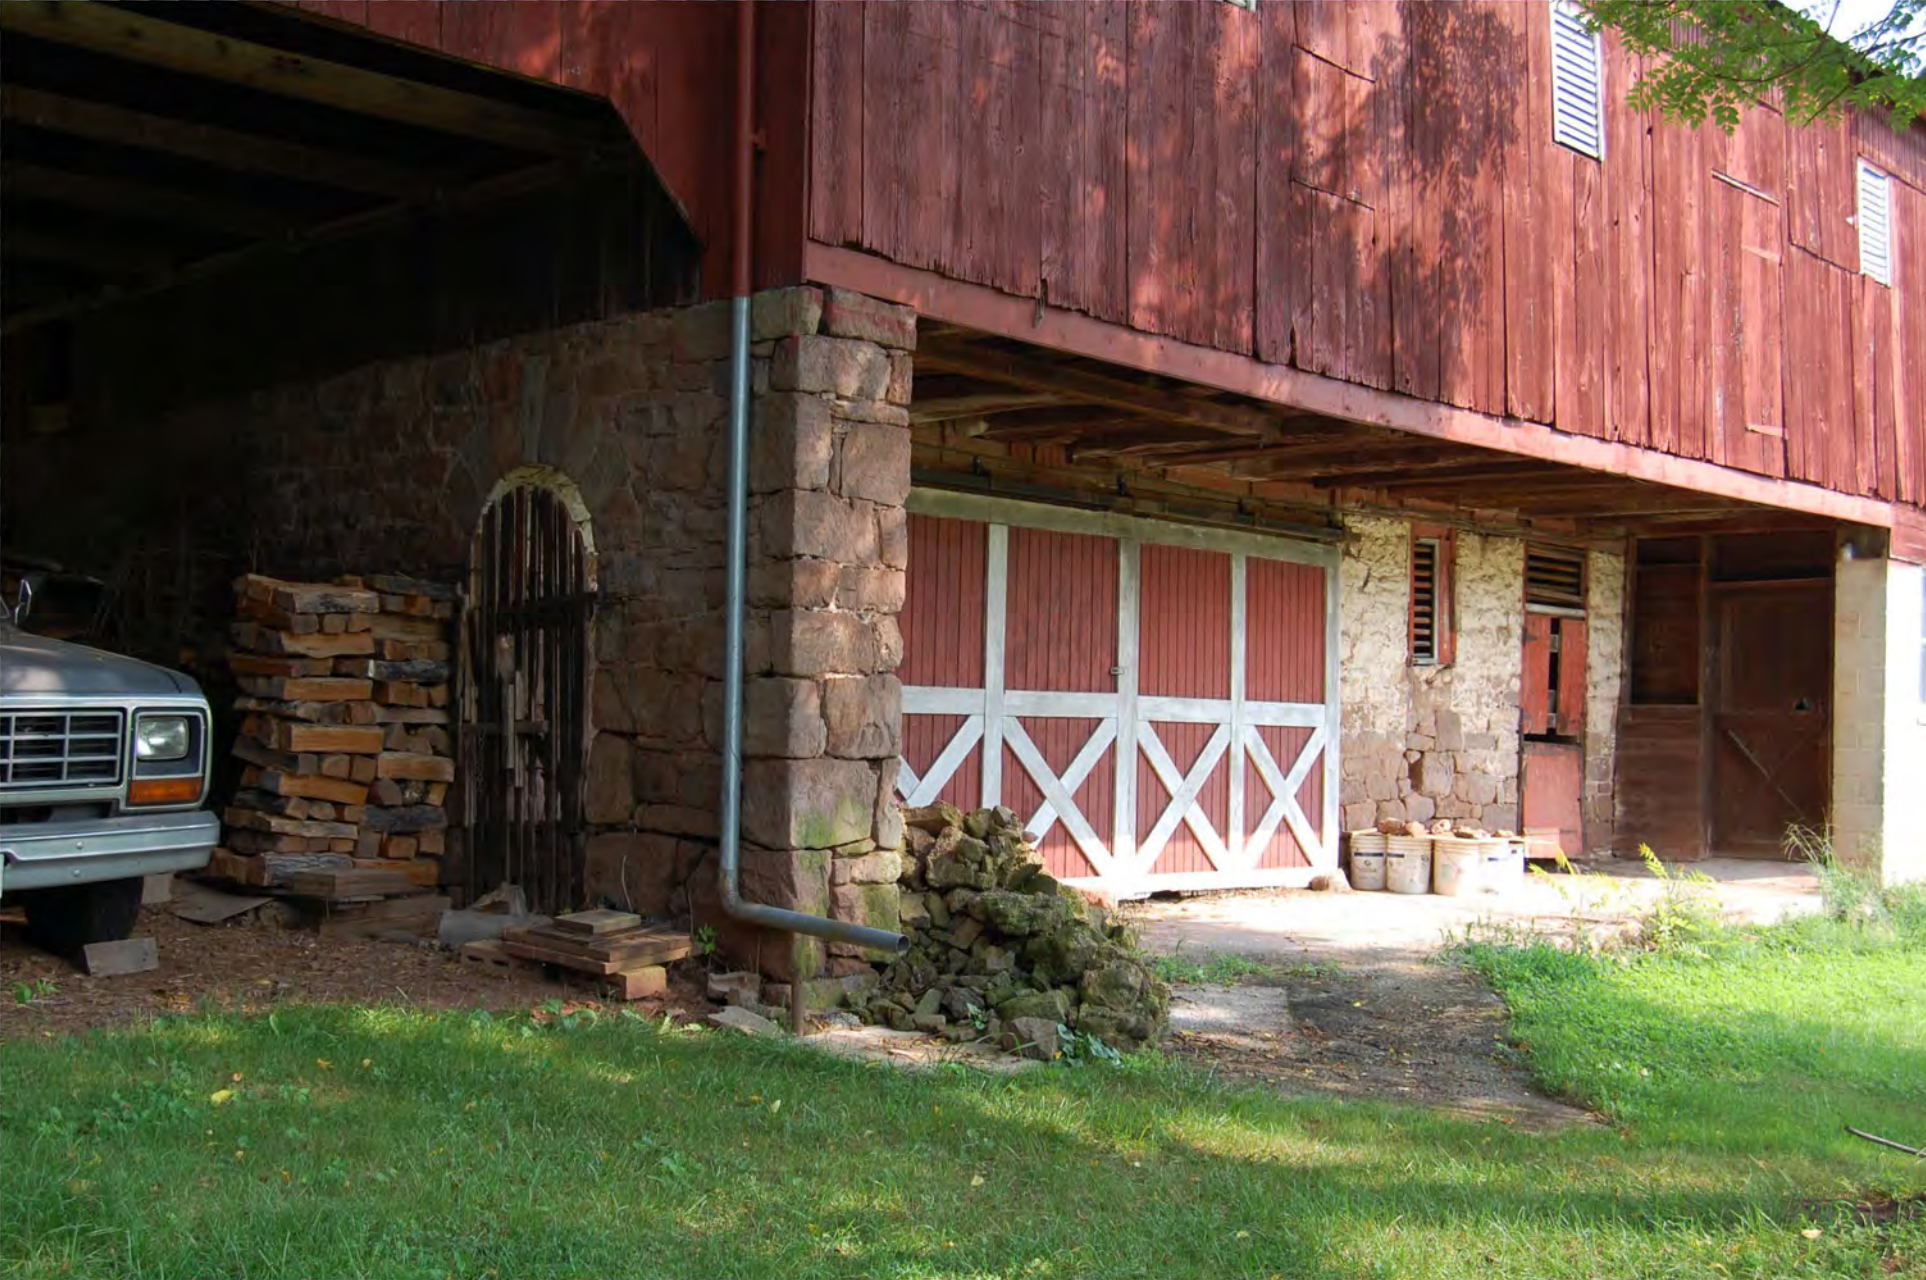
Barn, detail of masonry and forebay, view from southeast

About 110' north of the house is a bank **barn** with a forebay that faces east towards the road. The barn does not align neatly with the house, nor does it face in the exact same direction. The barn has an asymmetrical profile with a rubble stone lower story, portions of which have been removed on the southeast, and a timber frame upper story sheathed in beaded-edge-vertical boards. It has a gable roof of corrugated metal with a north to south ridge. On the east elevation the lower story has a door opening for a Dutch door with five wooden louvers above. To the north the wall has been removed and there are two mortises in the sill above which probably held the frame of a vent. Then a flush stone wall which was probably one side of a second doorway to the north. Set in the stone wall is a wooden louver vent, then a Dutch door hung on tapered strap hinges with round or tear drop ends. Above this doorway is another wooden louver. The north end of the lower story has been converted to a milking parlor. The stone wall was completely removed and a concrete block wall was constructed beneath the forebay; this wall has a center door on rollers and four 2/2 sash on each side.

The upper story on the east elevation has five plain wooden louver vents. Near the center is a vertical board door on strap hinges, probably set in an original opening. The northernmost bay and vent were added to the barn in the 19th century.
