National Register of Historic Places Registration Form

1. Name of Property		
Historic name: Tioga Mills		
Other names/site number: <u>NA</u> Name of related multiple property listing: <u>NA</u>		
Thumbourness manage property manage <u>and</u>

2. Location		
Street & number: 3475 Collins Street, also known as	•	
City or town: Philadelphia State: PA County: Pl	<u>hiladelphia</u>	
Not For Publication: <u>NA</u> Vicinity: <u>NA</u>

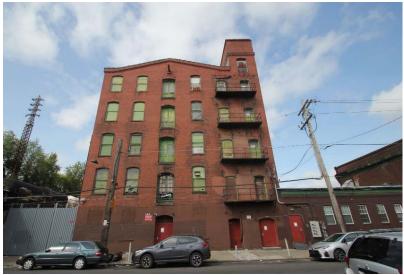
Photo 1 (left): East and north elevations of Mill #1, view southwest. **Photo 2** (right): North elevation of Mill #1, view south.

Located at the northeast corner of the site, Mill #1 is a five-story, red brick mill with six bays on the north elevation (facing Tioga Street), seventeen bays on the east and west elevations, and five bays on the south elevation. As shown in Figure C, the two southernmost bays were originally three stories tall, and were expanded around 1900 to five stories. The building, currently vacant, is typical of industrial architecture in Philadelphia during the late nineteenth century in its spare, vernacular style, heavy timber structure with brick exterior walls, corbeled brick cornice, and low gabled roof (Photos 1-3).

At the northwest corner of the building, there is a rectangular fire stair tower that rises well above the peak of the gabled roof (Photos 2 and 3). On all four elevations, nearly all bays (exceptions are explained below) have a consistent fenestration pattern of segmental arched window openings. Most of the openings are covered with metal panels on the exterior side or have been infilled with concrete block, however many of the original twelve-over-twelve, double-hung wood windows still remain and are visible on the interior (Photos 1-4).

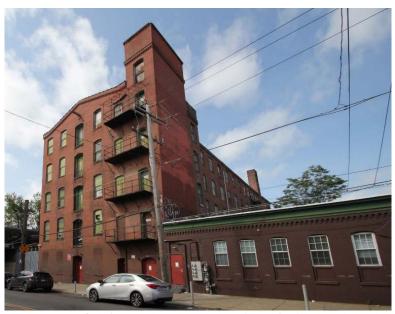
Photo 3 (left): North and west elevations of Mill #1 and the abutting Office building, view southeast.

Photo 4 (right): East elevation of Mill #1, view north. The open space to the right is part of the railroad right-of-way and is excluded from the National Register boundary. This area is accessible from 3475 Collins Street through an easement agreement. (As shown in Figure B, above, the east elevations of Mills #1 and #2 are at or nearly at the property line.)

On the north elevation, which is six bays wide, there are original wood loft doors on each floor in the bay directly below the peak of the gabled roof, with similar doors located in the southernmost bay on the west elevation (Photos 1-3). The two westernmost bays on the north elevation contain paneled wood doors that open from the fire stair tower onto iron fire balconies that were installed in 1890 on the second through fifth floors (Photos 1-3). Period advertisements suggest the stair tower historically supported a water tank.

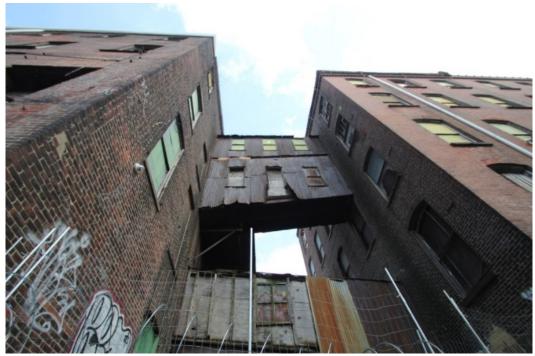
Photo 5: Bridges between Mill #1 (right) and Mill #2 (left), view west.

The south elevation is five bays wide. In the second bay from the east, wood framed bridges, which are clad in corrugated metal (possibly the original cladding material) and contain what appear to be original double-hung wood windows, connect the south elevation of Mill #1 to Mill #2 at the second, fourth, and fifth floors (Photo 5). The one-level bridge at the second floor was built with Mill #2 in 1892 and the two-level bridge at the fourth and fifth floors was built when those floors were added to Mill #2 in 1900. The bridges therefore are considered character-defining (though uncounted) features but are in very poor structural condition.

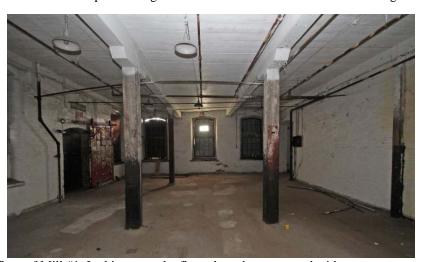
Photo 8: Third floor of Mill #1. In this space, the floors have been covered with a gypsum concrete surface. All other materials and structural features are original.

On the interior, the building is largely open in plan, containing mostly diagonally laid wood floors (some limited areas have been replaced with straight wood floors, or have been covered), heavy timber columns and painted beams on the first through fourth floors, painted heavy timber roof trusses on the fifth floor, and painted brick perimeter walls (Photos 6-8, 10-14). It is unknown when the brick walls and heavy timber structural features were painted. An original U-return wood stair is located in the stair tower at the northwest corner of the building (Photo 9). Just south of the stair, there is a freight elevator, which is

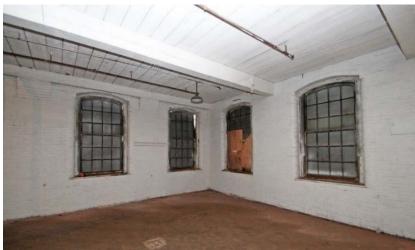
Photo 9 (left): Stair at the northeast corner of Mill #1, fourth floor, view south. This stair is original to Mill #1. **Photo 10** (right): Fourth floor of Mill #1, view northeast. The wood floors, brick walls and heavy timber beams in this view are all original.

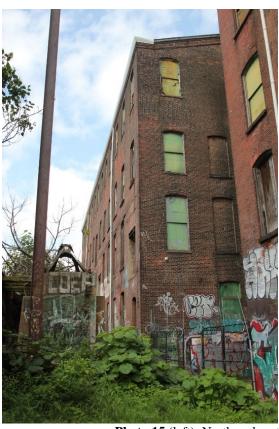
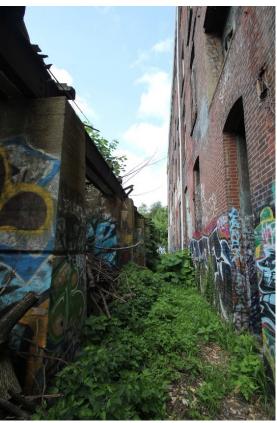
Photo 15 (left): North and east elevations of Mill #2, view south.

Photo 16 (right): East elevation of Mill #2, view south. The concrete piers at left are part of the former railroad siding located on the railroad right of way, no longer retain functional evidence of use by the mill buildings, and are excluded from the National Register boundary.

On the east, north, and west elevations, nearly all bays contain segmental arched window openings (Photos 15-18). Most of the openings are covered with metal panels on the exterior side, and some have been infilled with concrete block; however, many of the original nine-over-nine, double-hung wood windows still remain and are visible on the interior. There are no windows on the south elevation, which consists of a blank brick wall (Photo 17). At the north end of the west elevation, a one-story brick engine house extends into the former courtyard space but is now enveloped by the one-story infill additions that were built during the 1950s and later (each mill building had its own engine house). The engine house was built with Mill #2, to which it is internally connected, and is not counted as a separate resource. Above the first floor, the west elevation contains original wood loft doors on each floor in the third bay from the north and in the southernmost bay (Photos 17 and 18). The doors are similar to those in Mill #1. In the center of the west elevation, there is a rectangular tower that historically contained bathrooms and supported a water tank on top (Photos 17 and 18).

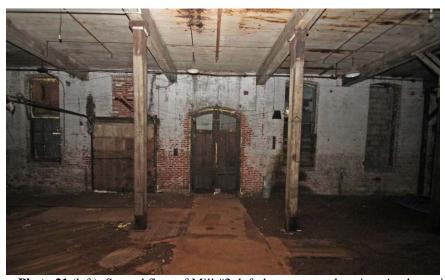
Photo 21 (left): Second floor of Mill #2, loft door on east elevation. As shown in this view, limited areas of the original diagonal wood floors have been patched with plywood and other materials. All other materials, such as the brick walls and heavy timber columns and ceiling, are original.

Photo 22 (right): Bridge between Mill #1 and Mill #2, third floor. The original six-over-six, double-hung wood windows are visible in this view.

On the interior, the building is largely open in plan, containing concrete floors on the first floor with mostly diagonally laid wood floors on the upper levels (covered in some areas), cast iron columns on the first floor, exposed heavy timber columns on the second and third floors, exposed heavy timber beams on the first through third floors, exposed heavy timber roof trusses on the fourth floor, and painted brick perimeter walls (Photos 19-25, 27). The brick walls are mostly painted; however, it is unknown when this change occurred. On the north wall on the second, fourth and fifth floors there are segmental arched openings into the bridges between Mill #1 and Mill #2. The openings are accessed via sliding metal fire doors (visible from within the fourth-floor bridge in Photo 25). In some locations, metal pendant fixtures,

which area electrical and appear to date from the early to mid-twentieth century, still hang from the ceiling (Photo 21).

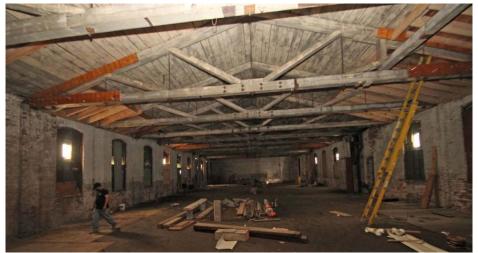
Photo 27: Fourth floor of Mill #2, view south, showing the recent reinforcement of the original roof trusses, however no other substantial changes have been made to the historic interior. Parts of the original wood floors are covered by plywood at left.

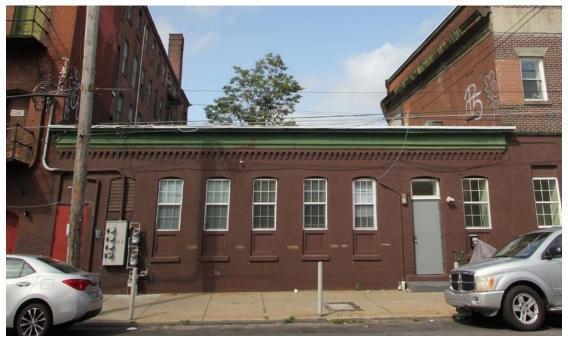
Photo 28: North elevation of the Office building, view south. The two westernmost bays (far right) were not part of the original building and were likely added shortly after 1920.

Located to the west of Mill #1 and facing Tioga Street, the Office is a one-story, painted brick building with a painted metal cornice above a corbeled brick band (Photo 28). (Although the building now has a flat roof, according to period advertisements (Figure E), at one point it had a gabled roof.) Only the north elevation, which faces Tioga Street, is visible; all other elevations abut adjacent buildings or infill additions. The building is nine bays wide, with six of the bays containing six-over-six, double-hung vinyl replacement windows with painted concrete infill panels below. Two of the bays contain replacement, hollow metal doors while the ninth bay is covered with metal panels and electric meters. According to the period advertisement referenced above (Figure E) and a 1920 Sanborn Map (Figure D) the two westernmost bays were not part of the original building. These two bays were added later, and the matching brickwork and cornice suggests this happened not long after 1920. The interior was not accessible at the time of survey; however, the building is currently being used as workshops and studios for artists and small businesses. As shown in the 1920 Sanborn map (Figure D), the Office and Mill #1 were at some point connected on the interior. As the connection was physically limited and not permanent, the resources are counted independently.

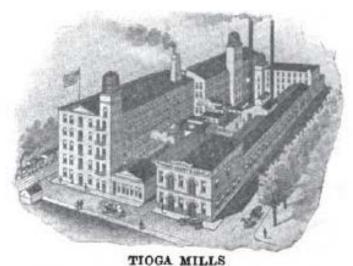
Figure E: Detail from a period advertisement, showing the gap between the Office and Warehouse Buildings along Tioga Street. *Textile World*, December 1918.

The complex appears much the same as it does in an image used in various Thomas Henry & Sons advertisements between the late 1910s and early 1920s (Figure E). This image depicts water tanks on top

of the stair towers on the west elevations of Mills #1 and #2 (later removed), signage on the Warehouse (later removed), a gap of two bays between the Office and Warehouse that was later infilled, and punched window openings rather than the existing garage doors on the west elevation of the Garage building. These minor changes have little impact on the overall integrity of the complex, which remains easily identifiable as a late-nineteenth and early-twentieth century industrial site and would be easily recognized by former workers.

The image used in the advertisements also includes a three-story, approximately 50' by 90' picker and winding building that extended from the west elevation of Mill #2 to Collins Street as shown in plan in the 1920 Sanborn map (Figure D). Built by Thomas Henry & Sons around 1900, this building was demolished in 1980, as was a small group of one- to three-story buildings at the south end of the site, also shown in the 1920 Sanborn map (these buildings are not seen in the advertisements because they are blocked from view by the picker and winder building). Built by the Reed Electric Company around 1900, the buildings were leased by Thomas Henry & Sons around 1920 for the processing of cotton and wool waste materials, a tertiary function in the overall yarn manufacturing process. The company acquired the buildings from the Reed Electric Company in 1923, only three years before Tioga Mills closed and Thomas Henry & Sons moved to Nashville; therefore, they were never essential to the company's operations. The absence of the buildings at the south end of the property has no meaningful impact on its integrity.

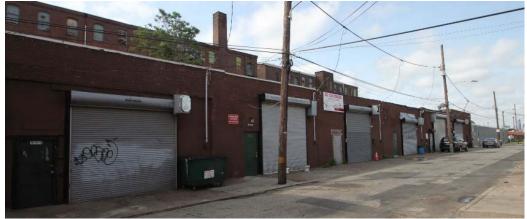
Photo 29: West elevation of the Garage building, view southeast. It appears, this elevation once contained smaller openings with windows rather than the garage doors that exist today (the doors were likely installed after 1950). As

the sidewalks in this area likely served as an extension of the loading areas or were within work areas, they are included within the National Register boundary.

Located parallel to Mill #1, the Garage building is a one-story brick building with numerous roll-down metal garage doors that open onto Collins Street (Photo 29). The interiors were not accessible at the time of survey; however, the building is currently being used as workshops and studios for artists and small businesses. According to the 1920 Sanborn map (Figure D), the Garage building historically contained a number of individual spaces that were separated by party walls and were not internally connected. These spaces were used for the storage of diverse materials or items, including raw cotton, coal, and automobiles. The period advertisement referenced above (Figure E) appears to show a row of windows on the Collins Street elevation rather than large garage openings. Although little evidence of these openings remains, it is possible that at the time the ad was published in 1918, the garage openings were located on the east side of the building, facing what was then the open center of the site. If so, it was only with the construction of the later infill additions in the 1950s that the garage openings were relocated, or reoriented, to the Collins Street side.

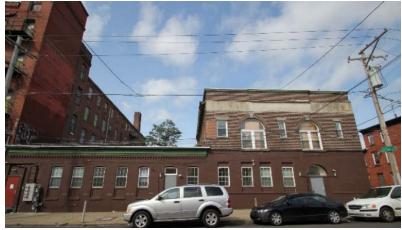
Photo 30: North elevation of the Warehouse, and the abutting Office. The stucco band above the second floor windows was historically the location of a cornice as seen in Figure E.

Located at the northwest corner of the property, the Warehouse is a two-story brick building reflecting the Georgian Revival style (Photos 30-32). The brick is painted on the first floor. On the north elevation, there is a hollow metal door with a single light arched transom and a number of double-hung, vinyl replacement windows on the first floor. On the second floor, there two large arched openings containing pairs of double-hung metal replacement windows with single light transoms and a concrete keystone. These openings are located between much smaller one-over-one, double-hung metal replacement windows with splayed concrete lintels. On the west elevation, there are a number of infilled window openings on the first floor as well as two double-hung vinyl replacement windows. The second floor contains irregularly arranged double-hung metal replacement windows, two with splayed concrete lintels. Above the second-floor windows on the north and west elevations, there is band of stucco where the metal cornice was historically located (the cornice remains intact only on the east elevation). Above the stucco band and cornice, there is a brick parapet with a smaller, secondary metal cornice on the north, east and west elevations. The building has a very low gabled roof that is not visible from the street. There are no internal connections between the Warehouse and the Garage building to the south; however, one opening between the Warehouse and the Office building to the east was created when the latter was extended westward after 1920. The Warehouse is counted as an independent resource.

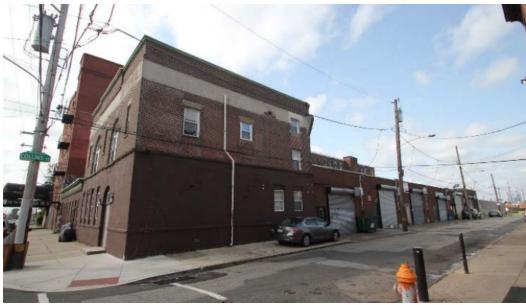
Photo 32: The Warehouse and garages, view southeast, from the Tioga-Collins Street corner.

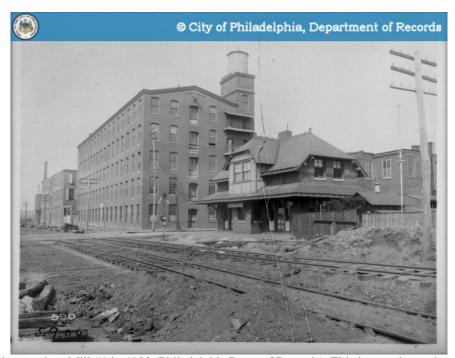
Figure 1: Looking south to Mill #1 in 1900 (Philadelphia Dept. of Records). This image shows the adjacent railroad at grade, prior to its elevation around 1909. Mill #2 also has yet to be expanded to four stories. The building in the foreground is a former Pennsylvania Railroad Depot, which was demolished when the railroad was elevated.
