**National Register of Historic Places
Inventory—Nomination Form**

historic Drummine Farm

Drummine Farm
Continuation sheet Frederick County, Maryland Item number 7 Page 1

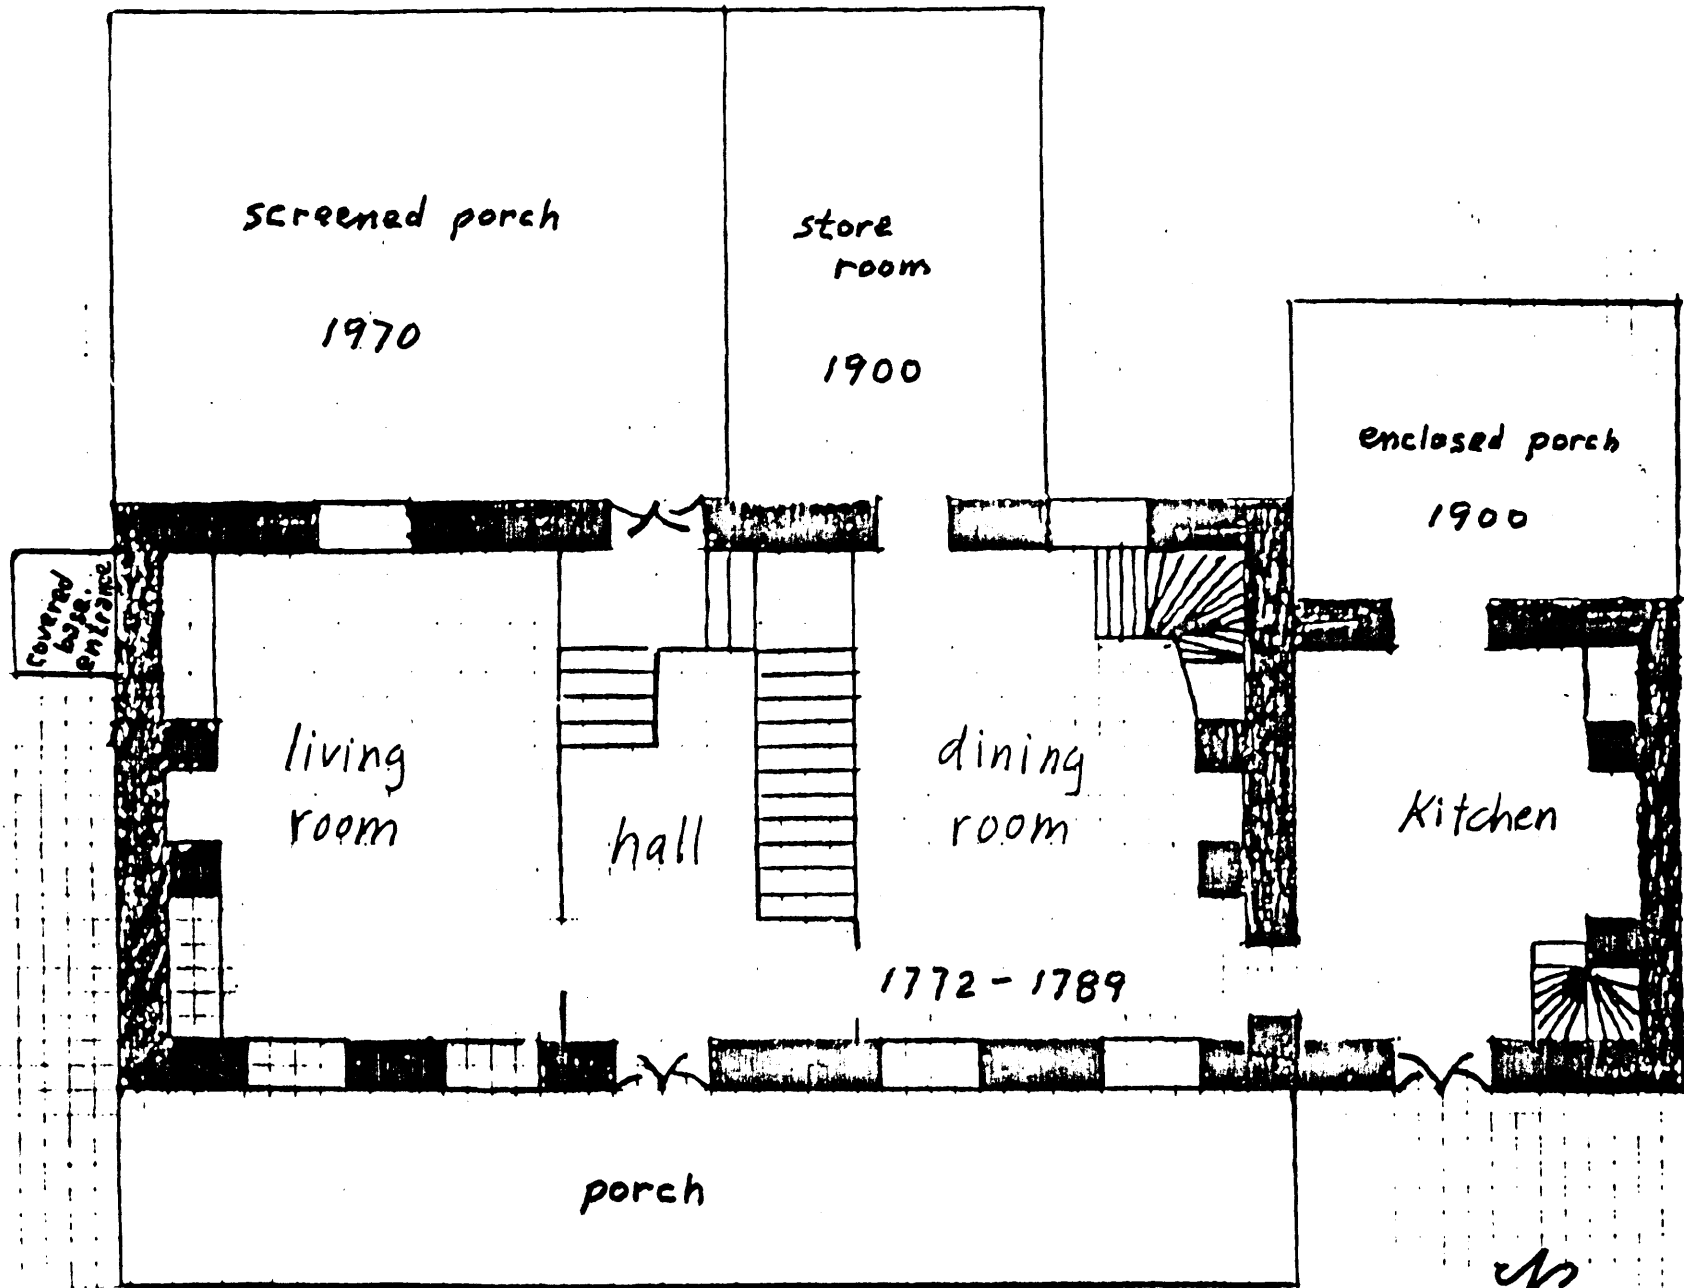
DRUMMINE FARM
 F-5-62
 Frederick County, Maryland
 main house
 first floor plan, 1986

The interior plan consists of a wide center hall in the main block with a single large room to the west (currently the living room) and the east (currently the dining room). The east room has access to the kitchen wing, to a second floor rear bedroom via a winder stairway and to the frame addition now housing a study and a powder room.

Rising against the east partition wall of the central hall, the staircase in the main block is characterized by a closed string and triple-run with an open well, which leads to the attic. The molded handrail is carried by turned newells and ballusters. The stairs are of poplar, as is all of the flooring of the second floor. The area under the staircase on the first floor is enclosed with paneling and architrave molding. The area at the top of the well is finished with vertical boards. Decorative chair rail molding placed at the same height as the hand rail, runs along the wall of the staircase to the second floor level.

The principal decorative detailing of the interior is the architrave molding raised-six panel doors, chair rail molding and elaborate cabinetry and paneling in the west and east rooms. The west room is the most elaborately decorated in the house. On the western wall, there are arched cabinets on each side of the mantel. The double doors for each cabinet have three-raised panels and the bottom doors have a single raised panel. The recessed paneling next to the cabinets is in four tiers. There is very complex architrave molding above the cabinets and mantel. The mantel shelf is supported by consoles and a center tablet with multi-stepped reversed curve molding underneath. The fireplace, set in a projecting chimney breast, has a rectangular opening with architrave surround and rectangular overmantel. The room probably contained chair rail originally, but it has been removed. All the window and door frames have architrave trim. The original pine flooring is still exposed in the west room, whereas the same flooring has been covered with newer flooring in the hall and east room. The fireplace in the east room is similar in design to the one in the west room. On the northern side of the fireplace is a corner cabinet with glazed doors and an architrave surround. In the northwestern corner of the room are the first four steps of a winder staircase leading to the second floor. The raised six-panel door closing off the staircase is on the northern side of the corner cabinet. This room has chair rail and architrave molding surrounding the doors and windows.

The ceiling height diminishes with each of the three floors of the house: the first floor ceiling is ten feet, the second floor is nine feet and the third floor is six feet. The second floor is divided into three rooms, a master bedroom on the western side and two smaller bedrooms on the eastern side separated with vertical board partitions. A bathroom has been added directly to the south of the staircase area on the second floor level. The flooring throughout the second floor is the original poplar. The chair rail on the second floor is on the outer masonry wall only, not on the vertical board walls separating the rooms. The fireplaces in the master bedroom and

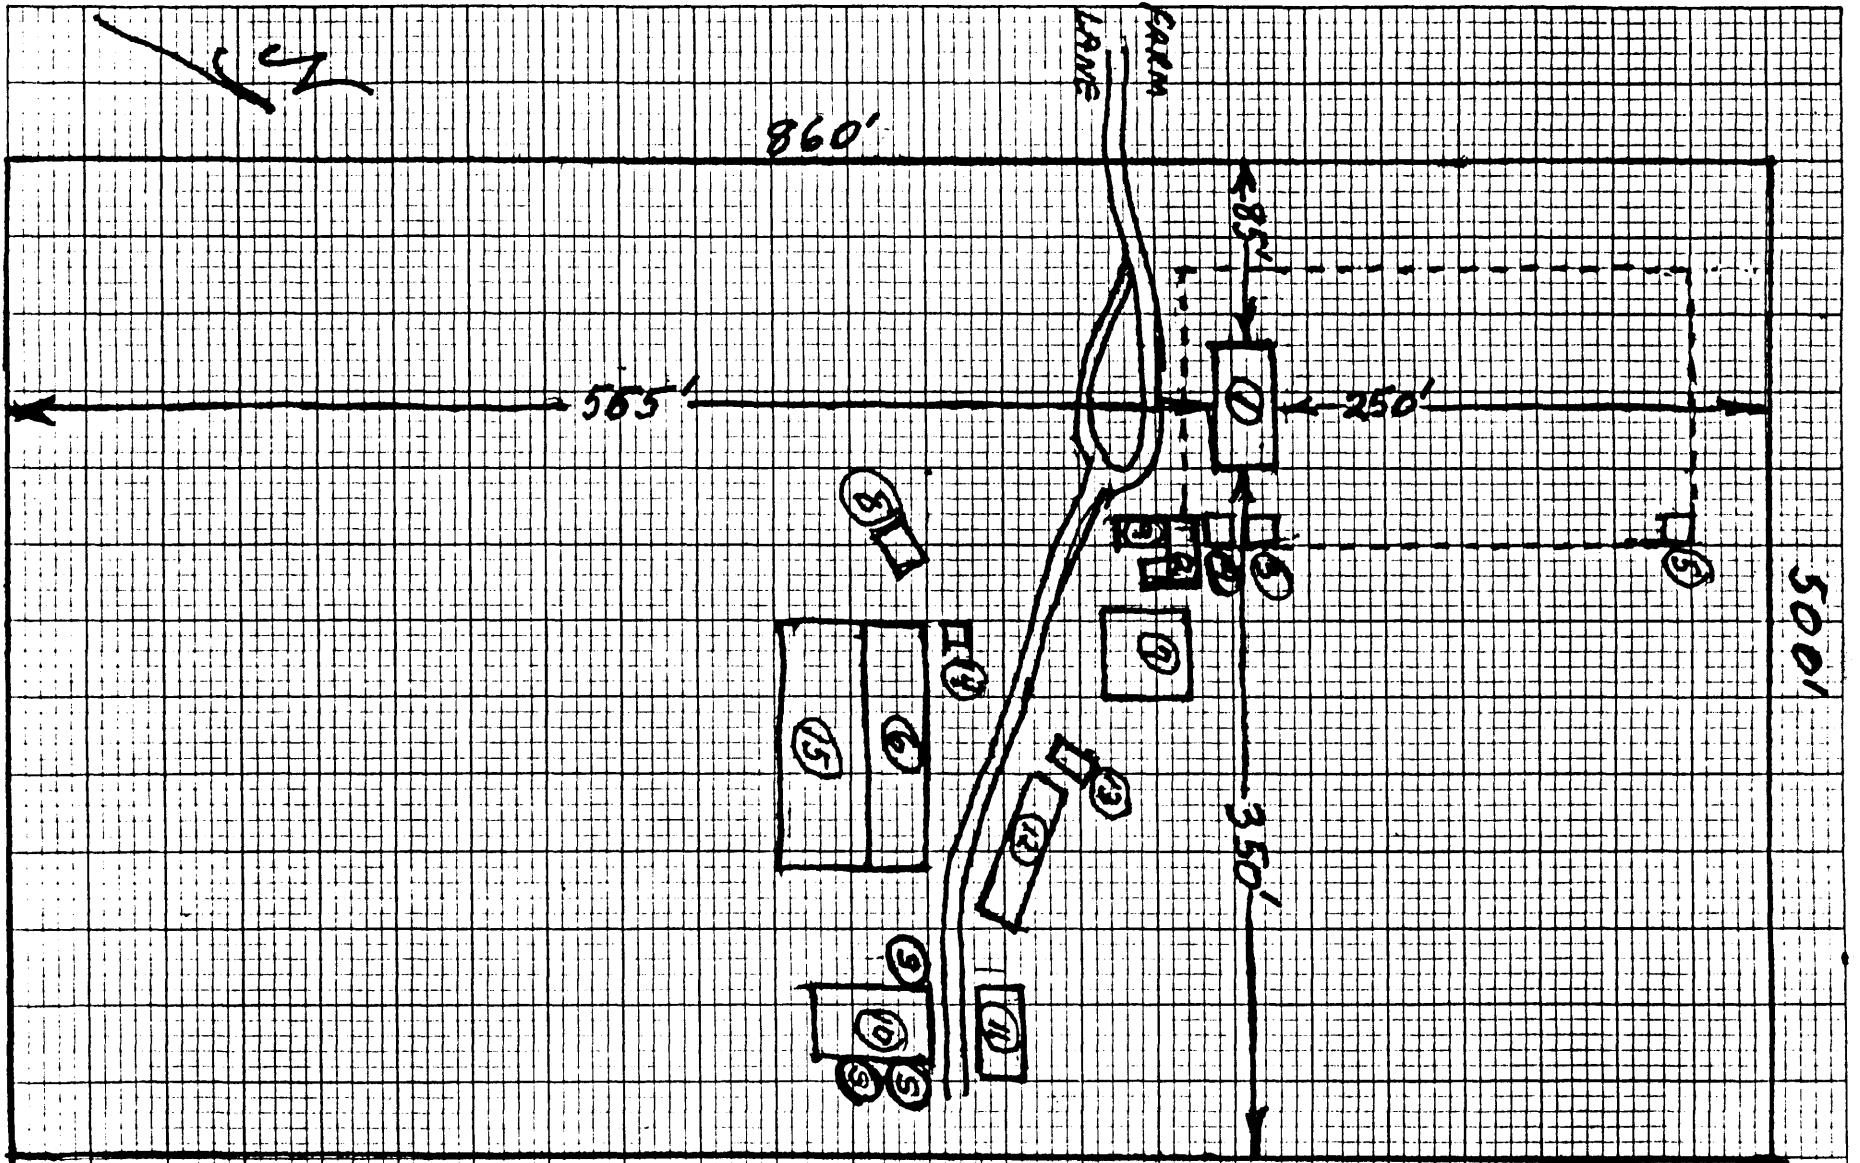
DRUMMINE FARM
 F-5-62
 Frederick County, Maryland

Boundary Description: The nominated property comprises a rectangular area measuring 860' north-south by 500' east-west. The sides of this rectangle are drawn parallel to the north, east, south, and west elevations of the main house. The north boundary lies 250 feet north of the north elevation; the east boundary lies 350 feet east of the east elevation; the south boundary lies 565 feet south of the south elevation; and the west boundary lies 85 feet west of the west elevation. Boundaries are depicted on the attached sketch map.

boundary map, 1986
