National Register of Historic Places Registration Form

Historic name: Beck, William Henry & Clara Singer, Farm

Street & number: 950 Snyderstown Road

City or town: Howard State: PA County: Centre

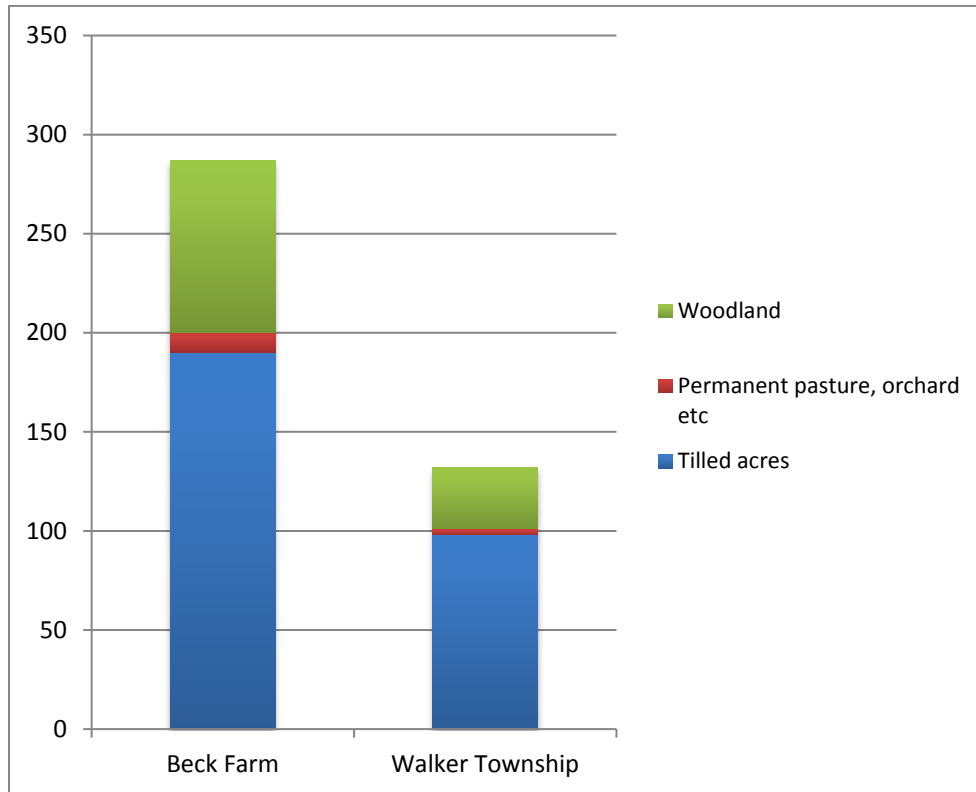
1880 census: the property was still part of Henry Beck's farm and would be subdivided the following year. Though the acreage is larger than average, the proportion of tillage, pasture, and woodland is similar.

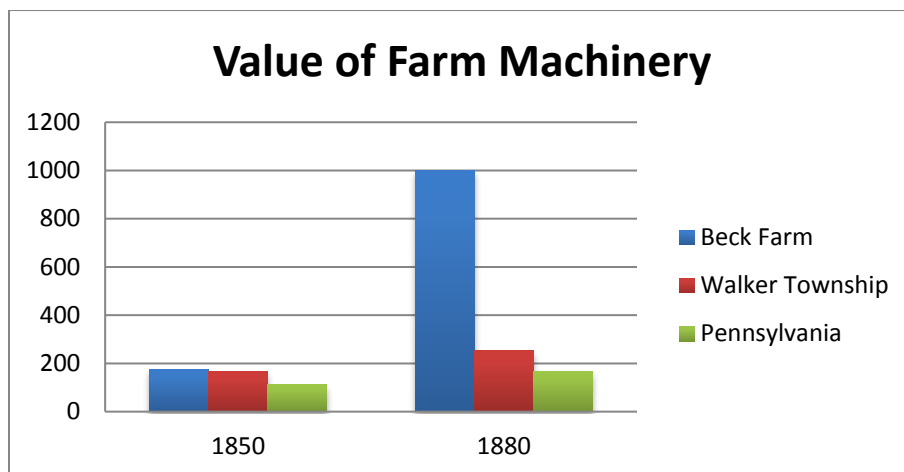
Farm Machinery: the Beck Farm was slightly above average in 1850 and well above average in 1880.

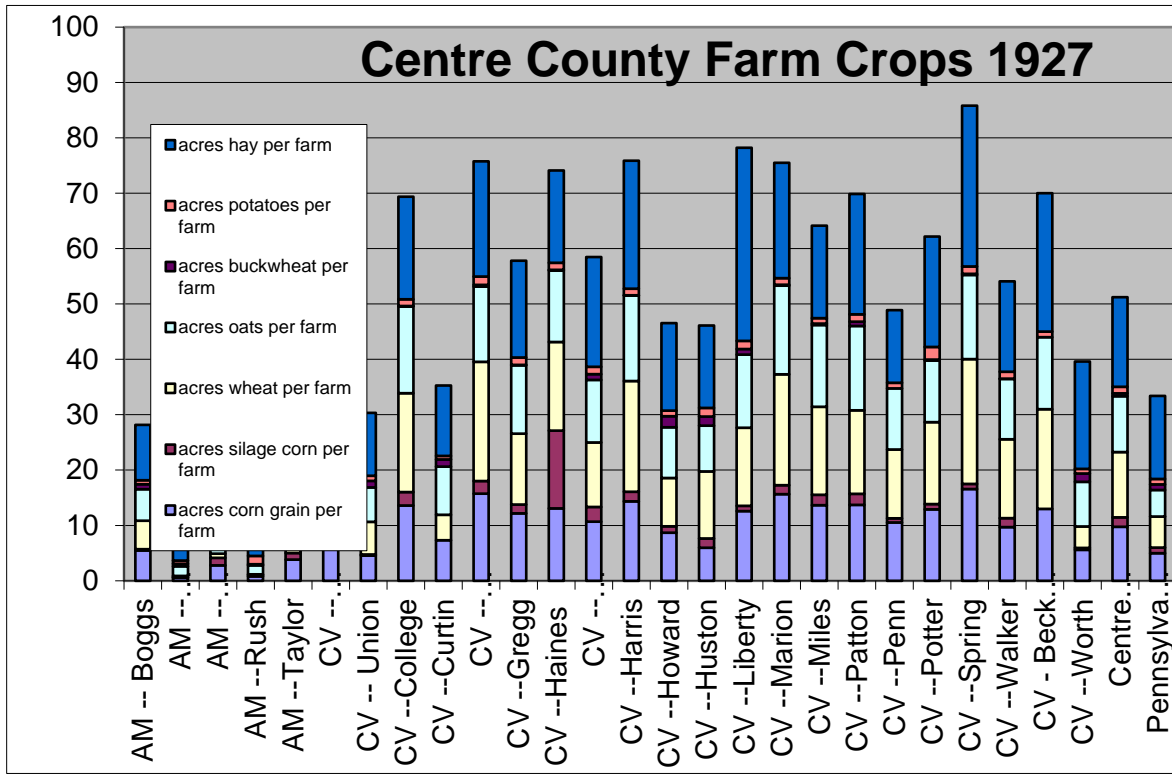
The Beck Farm never had a silo, so neither did they grow corn for silage. Otherwise the mix is typical for the Central Valleys. (Townships marked "CV" lie in the Central Valleys agricultural region.)

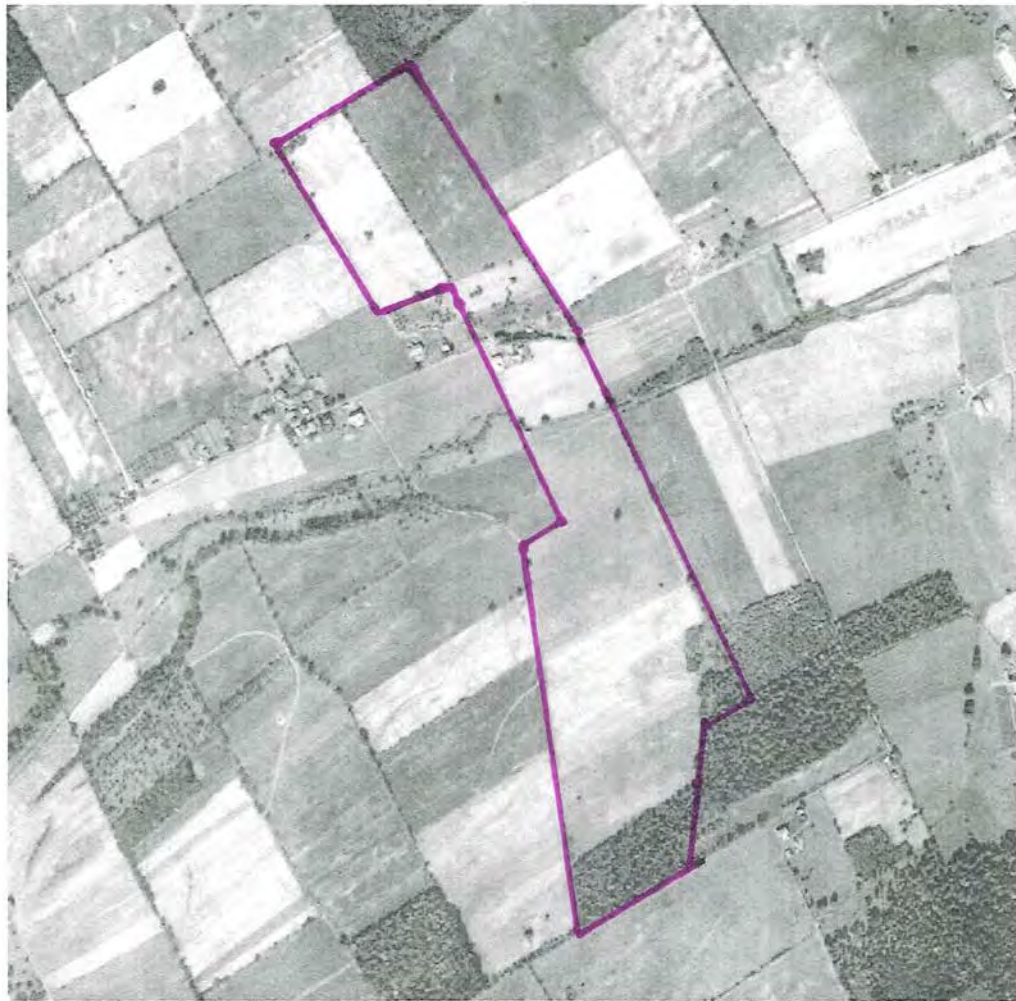
Figure 1. 1938 Aerial with property lines

Most of the 100 acres are devoted to crops. Aerial photographs from 1938, 1957, and 1968 show a strong consistency over time in shape and size down to the present. Even the orientation of cropping lines (roughly parallel to the two roads) has remained constant. At the southeast end of the parcel, two woodlots remain precisely as they were in the historic aerials. Little Fishing Creek runs along Route 64 where it crosses the property. A recent woodlot has developed along the north side of Route 64 between it and the farmstead. At the northwest corner of the property, an "L" shaped tree line shows on historic aerials and remains today. In 1938 the tree lines extended further, wrapping around the entire property line as far as Snyderstown Road. In addition, a line of fruit trees ran northwest to southeast through the middle of two farm fields; this linear orchard disappeared in bits after 1957, as did a few more apple trees just north of Snyderstown Road.

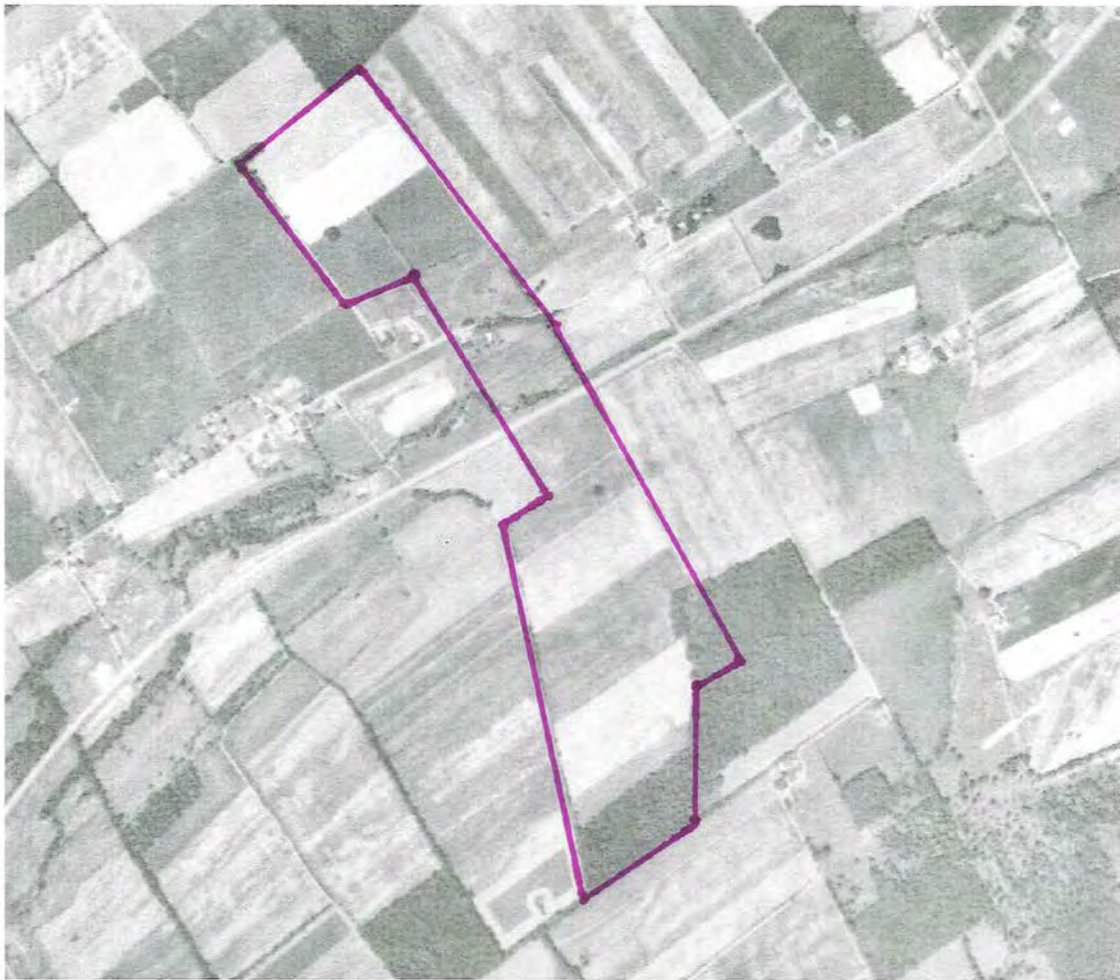
Figure 3. 1968 aerial with property lines.

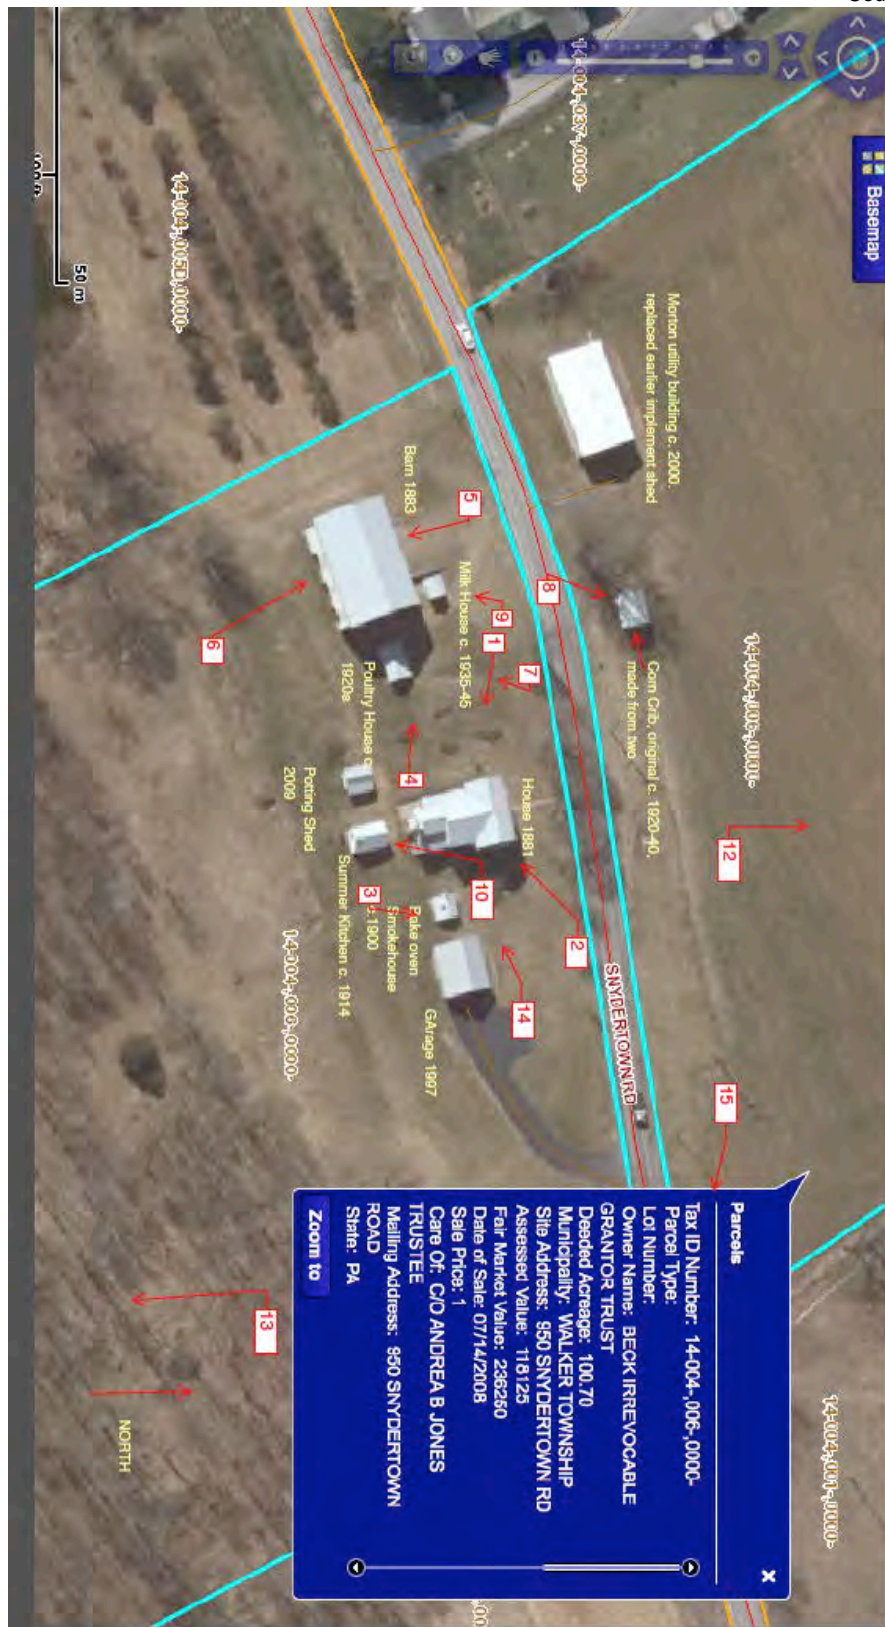
Figure 5. Beck Farm farmstead site plan with photo key

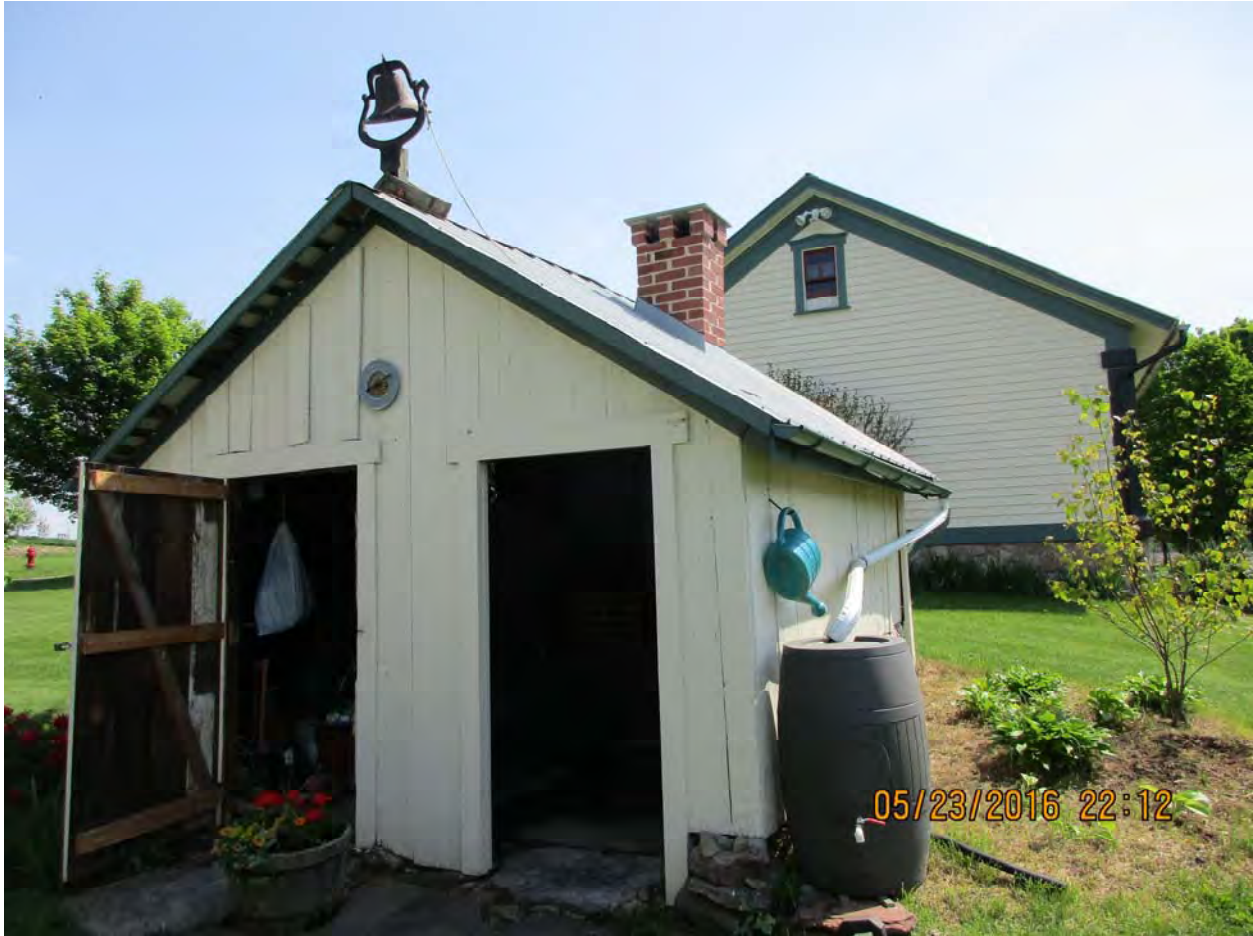
Photo 3: SMOKEHOUSE AND BAKE OVEN

A combination bake oven/smokehouse building stands just to the rear of the house, off to the east. Based on function and construction and photographic evidence, it probably dates to the late 19th or early 20th century. This gable-front building is built of vertical boards. There is no door and loose construction on the oven side and tight-fitting door and battened construction on the smokehouse side. This visible difference nicely reflects the two functions. On the smoke house side, there are hooks for hanging meat, and a fold-down shelf for cutting. The smoke house side of the building was in use until about 1950. The brick masonry beehive oven is a "squirrel tail" type.

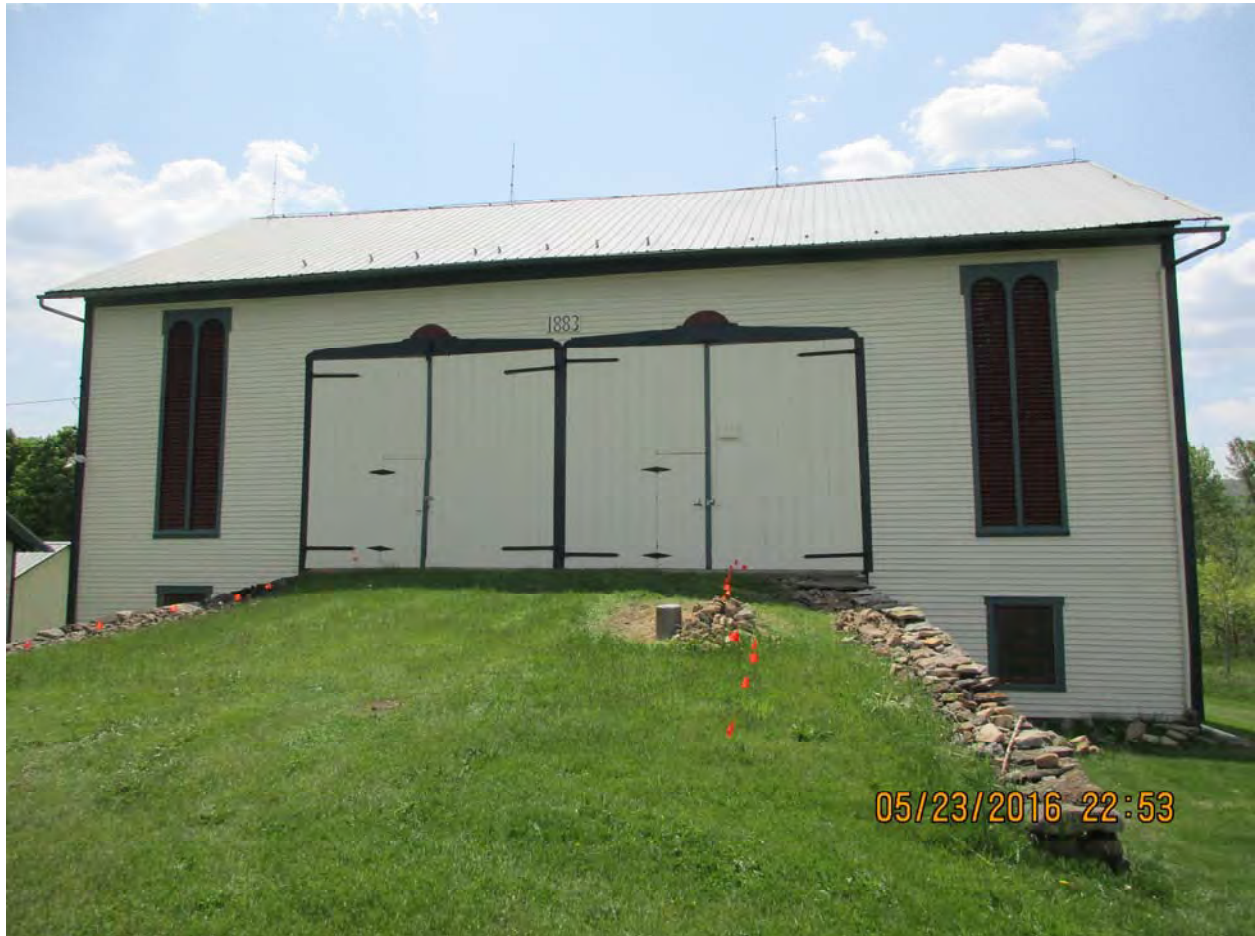
Photo 5: BARN BANK SIDE

The barn, built 1883, is a typical Pennsylvania bank barn built with post and beam construction and horizontal board cladding. Long regularly spaced louvered openings pierce the bankside and gable end walls; these have wood trim that closely matches the house window surrounds. On the upper level interior are a large forebay-side granary with eight bins; an "overden" over one threshing floor; eaves-side doors for threshing; and a gable-end side door in the granary for offloading. The upper level layout has two gable end mows and two interior

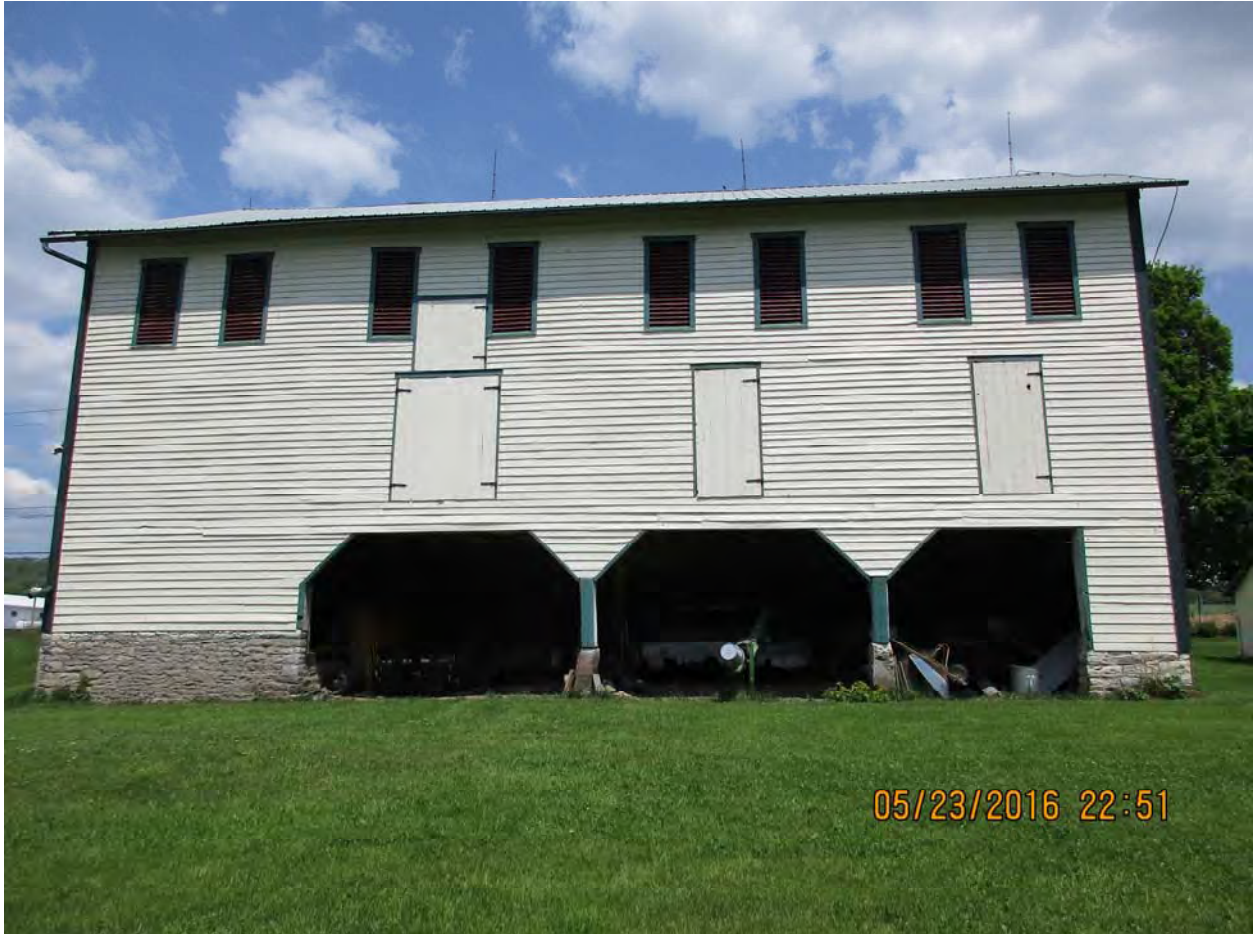
Photo 6: BARN FOREBAY SIDE

floors. This barn has an unusually deep forebay, enclosed at the ends and supported by posts, that incorporates a pen for steers at the west end of the lower level. The lower level contains horse stables and cow stalls, probably at least from the early 20th century and likely earlier. Around 1950 the cow stalls were expanded by three, taking room away from the horse stable area. Overall the barn interior is an unusual example of a 19th-century Pennsylvania Barn that was never extensively altered for large-scale dairy production. Stanchions were never installed.

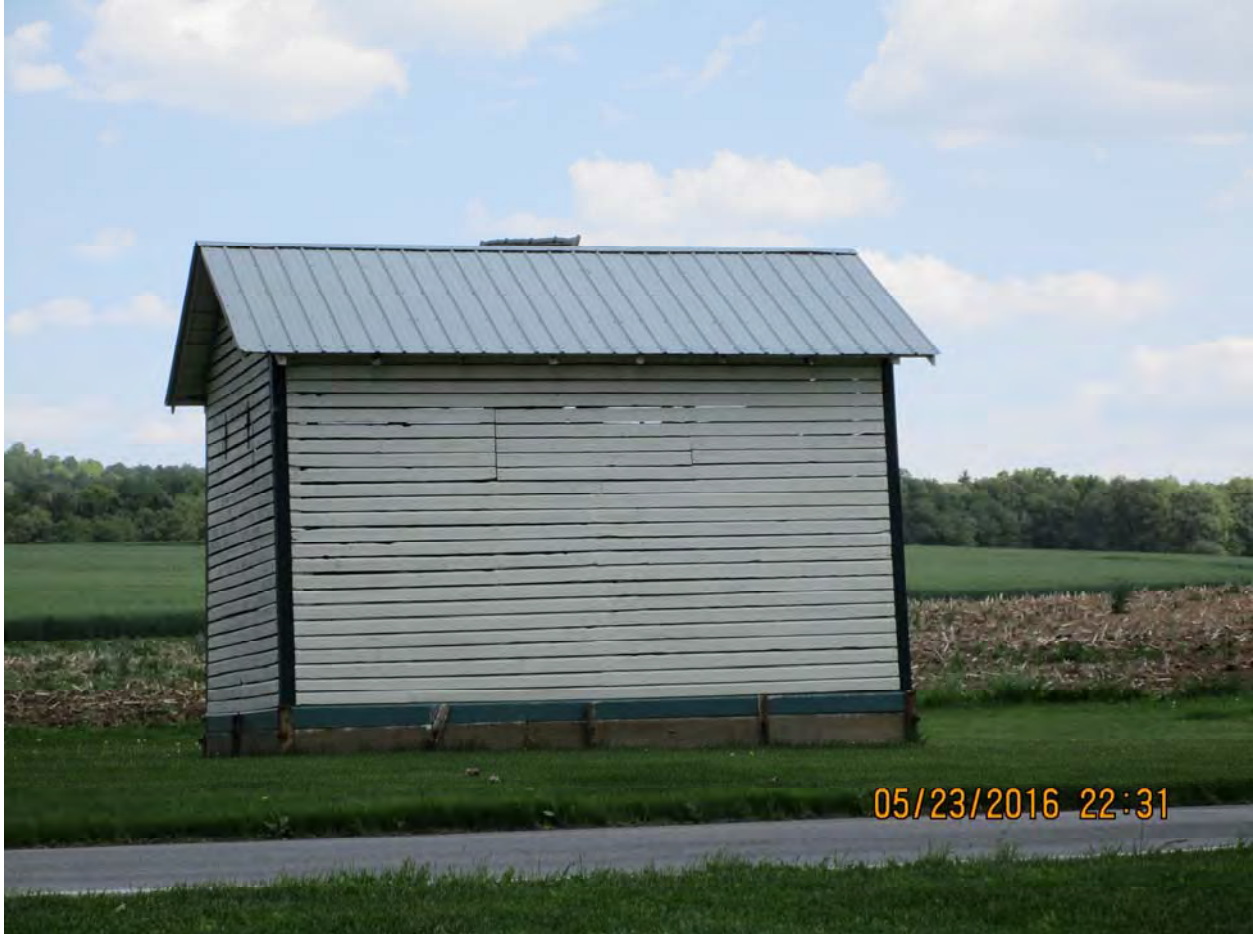
Photo 8: CORN CRIB

Three modern buildings complete the farmstead ensemble: a garage, metal Morton storage building, and potting shed. Across the street sits a typical corncrib made of narrow wooden slats on a concrete foundation, with a hatch in the roof for loading. This building was created after 2000 from the remnants of two separate cribs that originally stood here. These are all noncontributing.

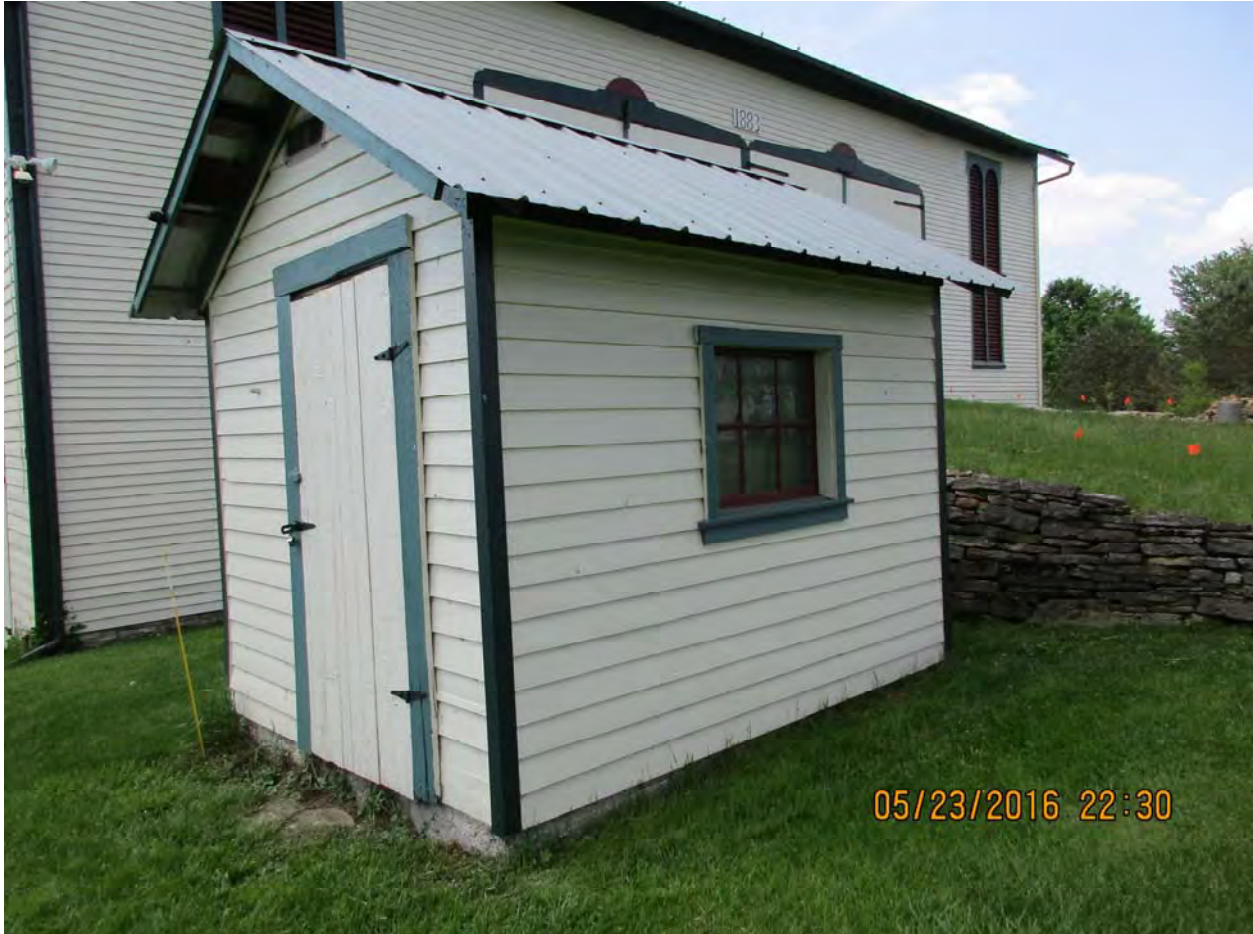
Photo 9: MILK HOUSE

The milk house was probably built in 1938; among the family papers from September of that year is a credit to T. A. Orr for \$10.00 for "Building Milk House." (It is notable that we can identify the builder.) This is a small gable-entry balloon frame building with horizontal board cladding, set on a concrete foundation. According to the owner it was moved about eleven feet in 1946 to get it further from the barn drip line. The entire interior is lined with tightly joined beaded board, probably reflecting sanitation regulations. The building has one fixed six-light window. The original cooler that held the water supply, and the condenser that cooled it, are no longer extant.

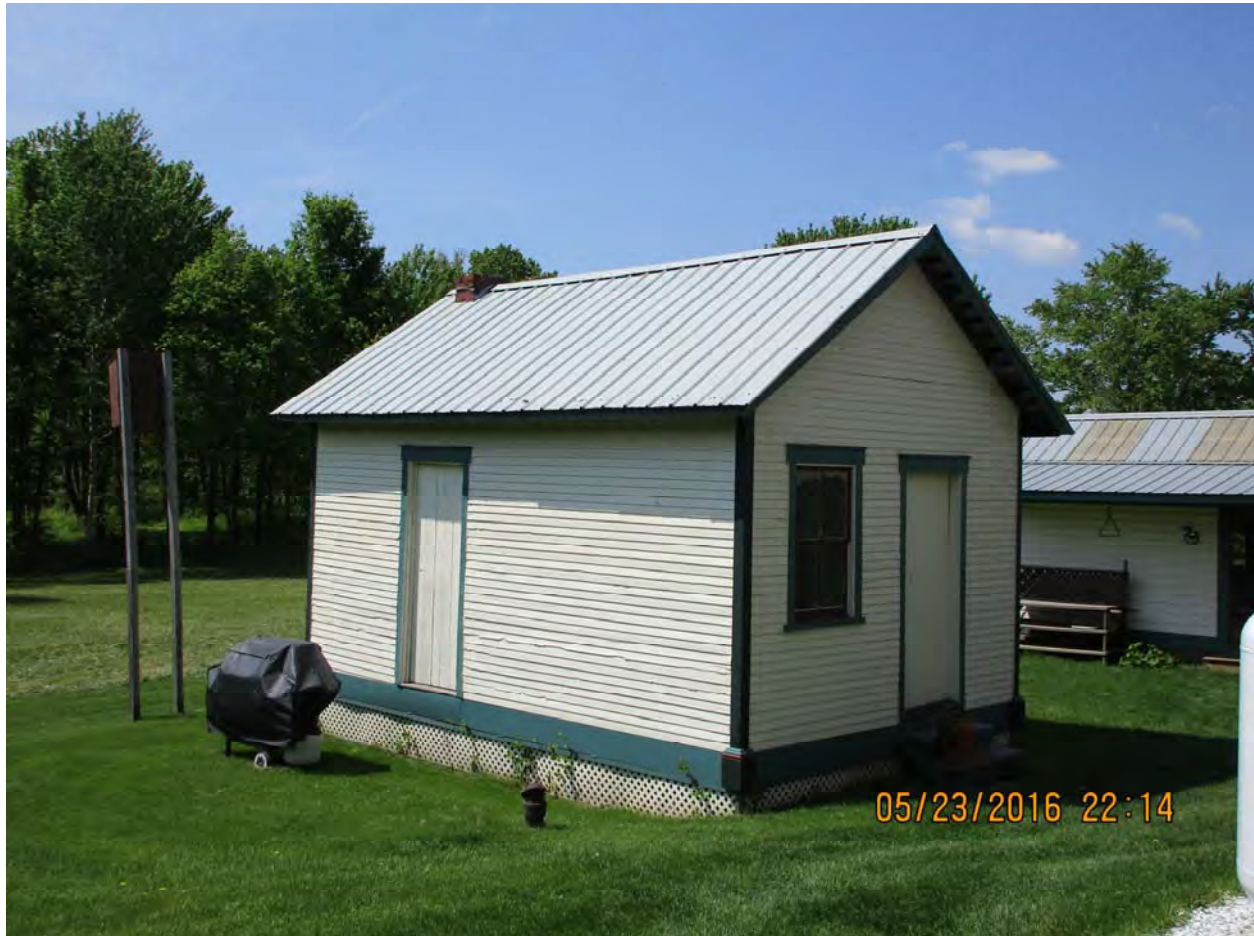
Photo 10: SUMMER KITCHEN EXTERIOR

The summer kitchen has entrances in the gable end and on the east eaves side, and three 2/2 sash windows. It stands directly in line with the house extensions, just a few yards away. Its construction (vertical planks and narrow horizontal siding) plus family documentation suggests a construction date of c. 1914. The underpinning has been repaired with concrete blocks and with wood elements from the demolished tenant house. A simple one-room plan features the brick masonry housing for two large set-kettles at the south gable end.

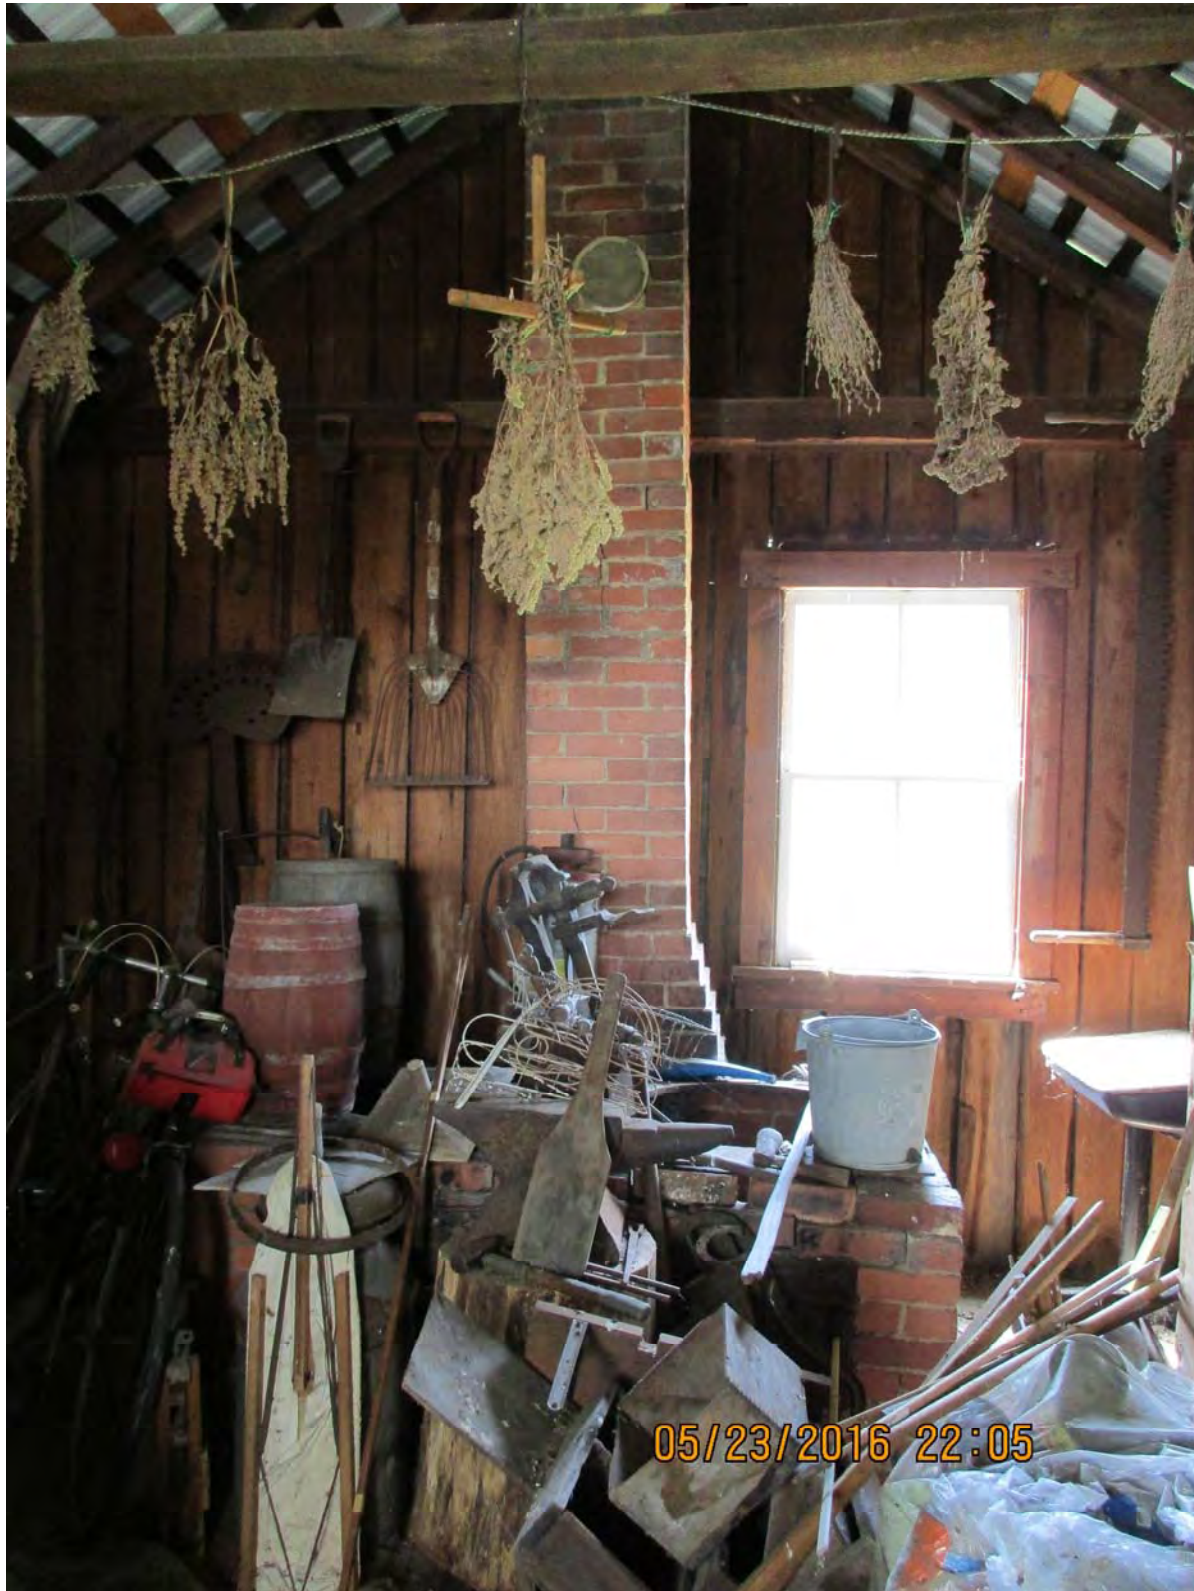
Photo 11: SUMMER KITCHEN INTERIOR SHOWING SET KETTLE HOUSING

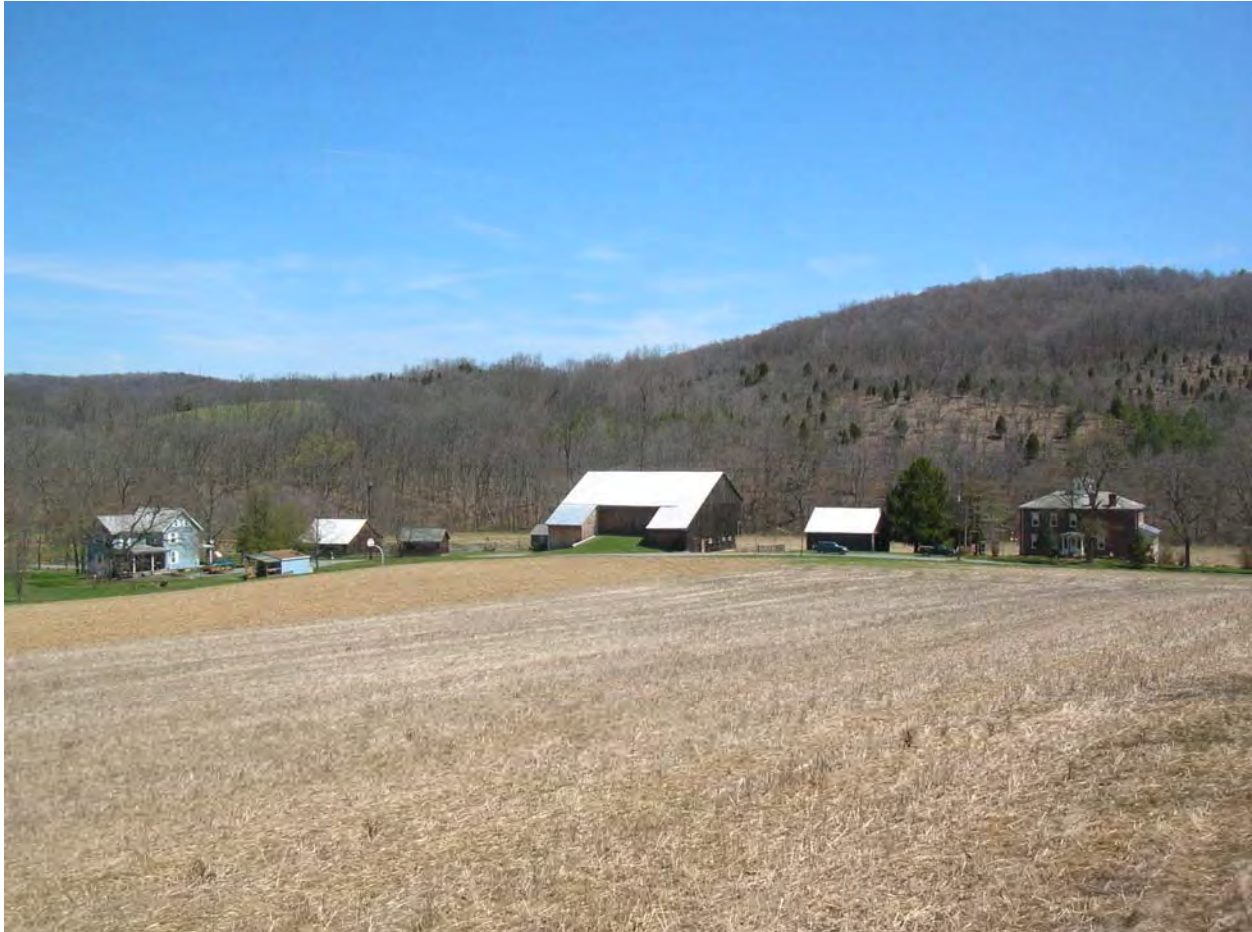
Robb Farm, Huntingdon County, 2011, for comparison. This farm has comparable resources in terms of buildings and landscapes. Note the topographical similarity with flat valley croplands with wooded ridge in the background and farm buildings distributed linearly along the road.
