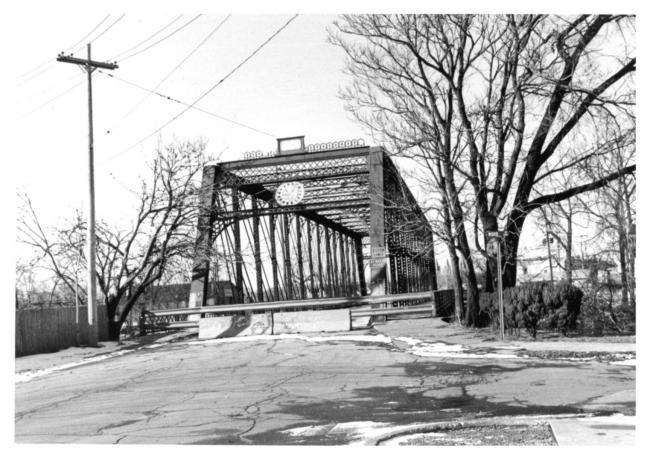
Photo 3

General view looking north on the south end of the bridge, showing approach and traffic barrier

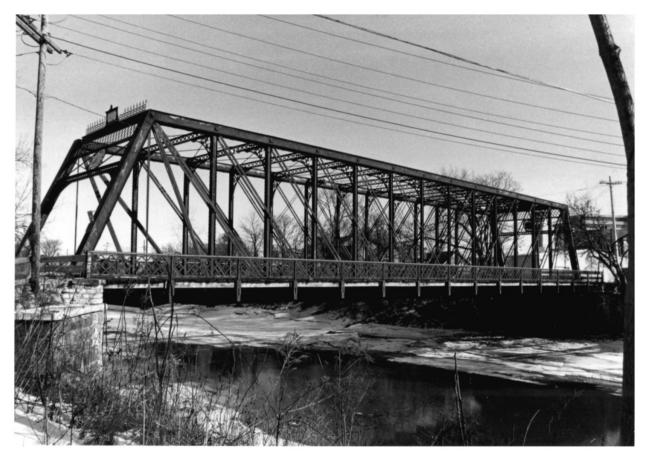
Photo 4

General view looking southeast showing truss configuration

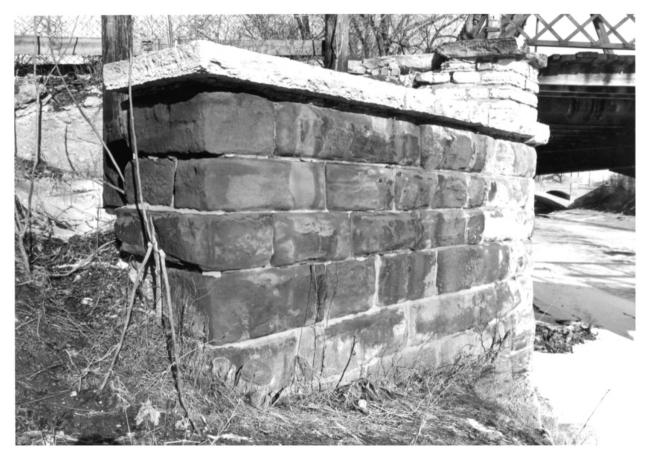
Photo 5

Detail view looking east of the north abutment wall

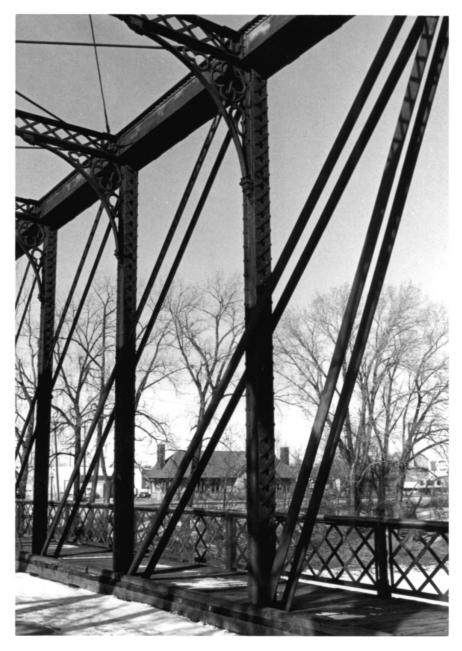
Photo 6

Detail view looking northeast of brackets, uprights, and handrail

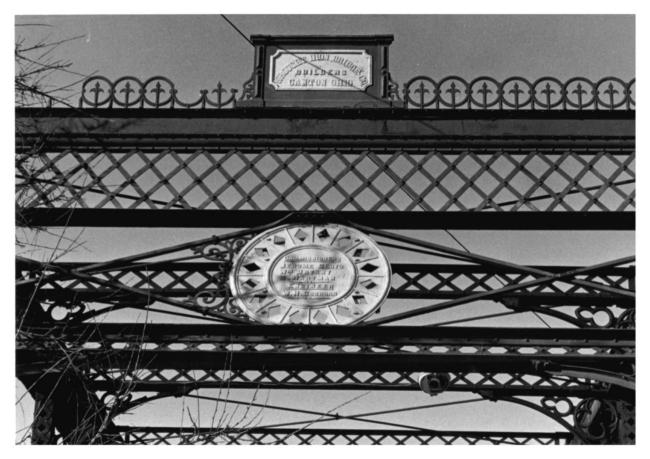
Photo 7

Detail looking north of portal detailing, including medallions, plaque, and cresting

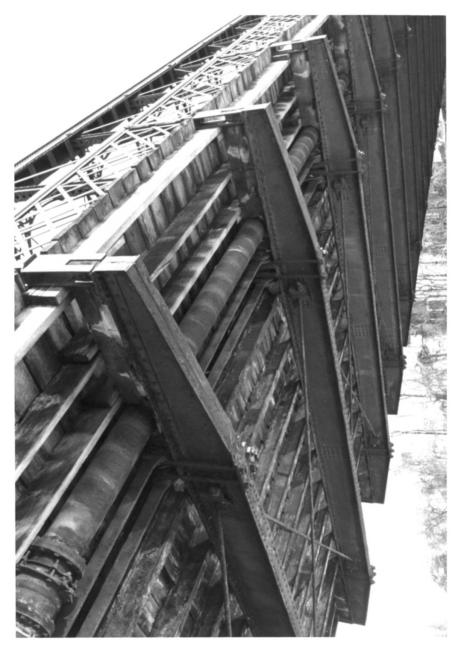
Photo 8

Detail looking southeast of floor beams supporting walkway

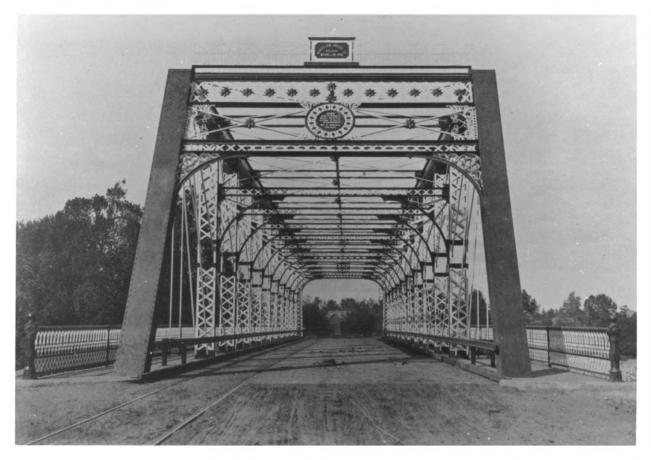
Photo 9

Historic view of 1888 Spy Run Bridge from Fort Wayne Illustrated, 1889. Note similarity of detail above the portal to that of Wells Street Bridge Collection Allen County Historical Society.
