National Register of Historic Places Registration Form

historic name J. S. Hollinger Farmstead

Dickinson County, Kansas
County and State

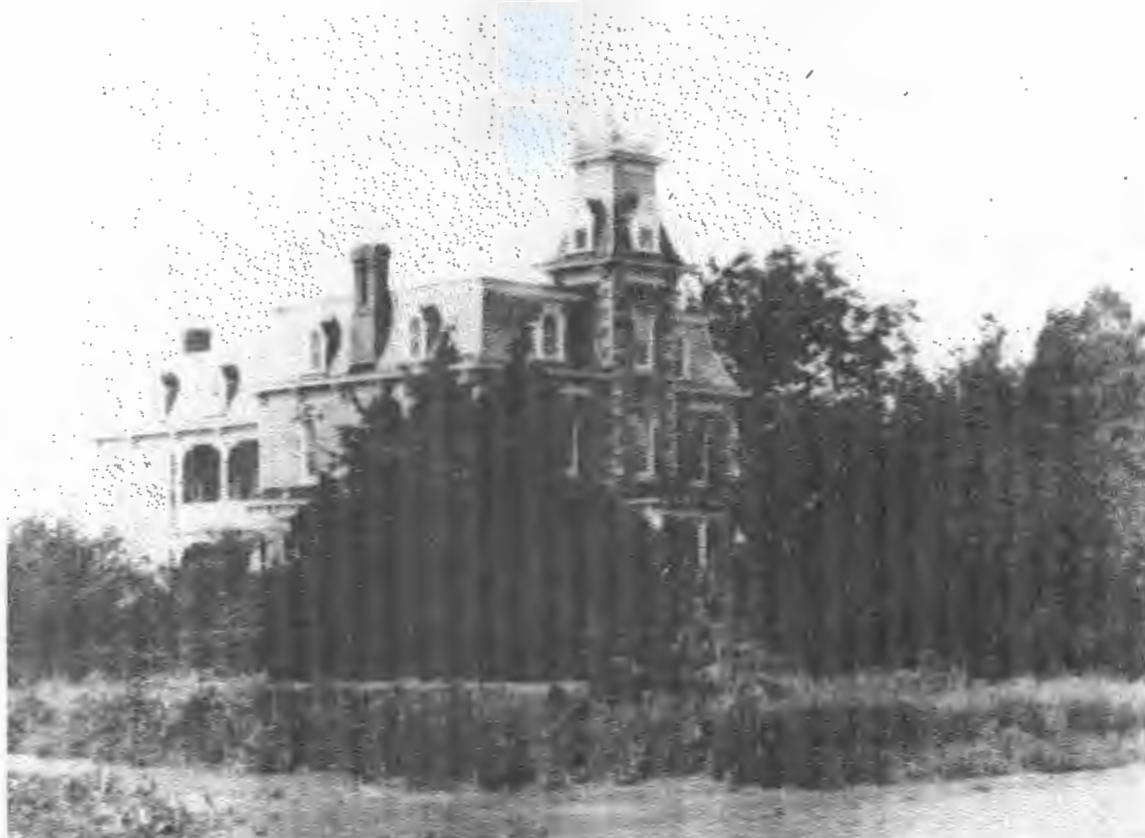
Figure 1: Historic view of Hollinger Farmhouse, note the extended rear wing, date unknown, provided by former owner Jan Rusch.

The east elevation is similar to the west with two bays on each floor, widely spaced and vertically aligned. A decorative brick chimney tower on the roof is centered between the lower bays and flanked by dormer windows on the Mansard roof. The first floor openings differ from the west elevation; the north bay is a door and the south bay is a rectangular triple window. This elevation also exhibits several notable alterations. Historically there was a decorative one-story wood porch surrounding the door and the triple window was a projecting bay window. There are clearly visible ghost marks on the brick that indicate where these features were and they are also extant in historic photos. The extant rear porch has also been altered. It has been enclosed on the first floor and the second floor is lacking original detailing such as the columns. The roof above the rear porch features a single dormer window and historic photos indicate that there were once two dormers in this location (Figures 1,2).

It is likely that the silo was constructed after the period of significance and it was definitely constructed after J.S. Hollinger's death in 1900. It does not appear in the historic sketch (Figure 1). Therefore, it is considered non-contributing.
