# National Register of Historic Places Registration Form

. Name of Property
Historic name Rocky Springs Presbyterian Church
Other names/site number N/A
Name of related multiple
roperty listing N/A
(Enter "N/A" if property is not part of a multiple property listing)
. Location
treet & Number: 2656 Boyds Creek Highway
City or town: Sevierville State: TN County: Sevier
Not For Publication: N/A Vicinity: X
. State/Federal Agency Certification
as the designated authority under the National Historic Preservation Act, as amended,
hereby certify that this X nomination request for determination of eligibility meets the documentation tandards for registering properties in the National Register of Historic Places and meets the procedural and profession equirements set forth in 36 CFR Part 60.
n my opinion, the property X meets does not meet the National Register Criteria. I recommend that this roperty be considered significant at the following level(s) of significance:

# Rocky Springs Presbyterian Church (contributing building, 1891, 1982)

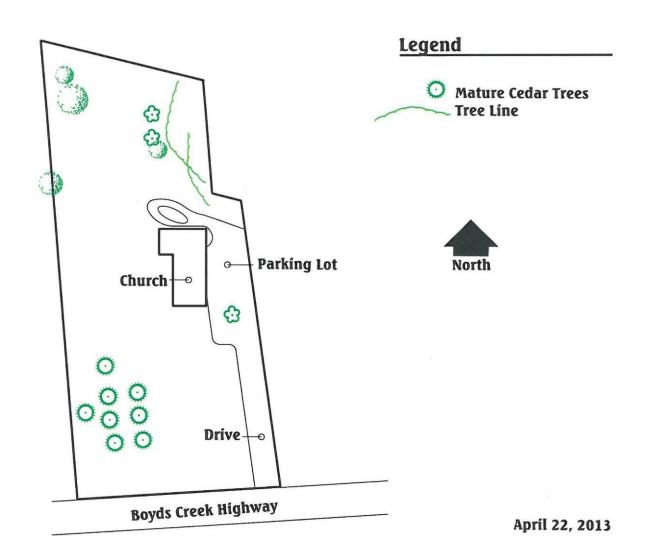
# Rocky Springs Presbyterian Church Site Plan Not to Scale

The church parcel is an irregular polygon with trees interspersed. The land gradually slopes up from the roadway and levels off in the area where the church building rests in the middle of the parcel. A paved driveway runs from Boyds Creek Highway on the south and along the eastern border of the property to a small parking area located on the eastern side of the church building. The drive continues to the north side of the building where it forms a loop. At the southwest corner of the property are two rows of mature cedar trees, delineating the former location of the other half of what once formed a half-circle drive up to the church building (Photo 0015).

The church property retains its rural setting, although the traffic flow through the property has changed over time. Historically a half-circle drive ran through the perimeter of the lot, but the configuration has evolved and now there is a single drive and parking lot on the eastern edge of the property. However, paired rows of cedar trees still delineate where the former drive was located on the western edge of the property.

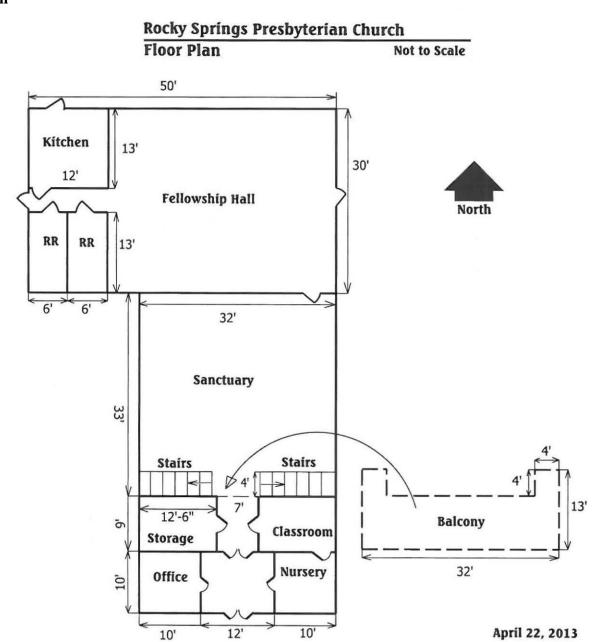
# Floor Plan

The south end of the sanctuary space contains a room on either side of the entrance. The room to the west serves as storage, and the room to the east serves as a children's classroom, which is also accessible from the nursery (Photo 0011). Above these rooms is a 1959 balcony, accessed by a double stair (Photo 0013). The stairway and the balcony have a wood railing with simple white-painted wood spindles. The balcony contains two rows of pews. The central portion of the sanctuary space is characterized by rows of wood pews, painted tongue-and-groove wood walls with wood wainscoting, a vaulted tongue-and-groove ceiling, and ca. 1940 pendant lights interspersed with more recent ceiling fans with pendant lights (Photo 0012). The altar area features a raised dais and a choir area on the west, enclosed with a wainscot railing. On the east end of the north wall is the original brick chimney and a wood door that leads to the 1982 fellowship hall. The original wood flooring in the historic building is only visible in the office, but remains extant under the present green carpeting that is found throughout the rest of the building.

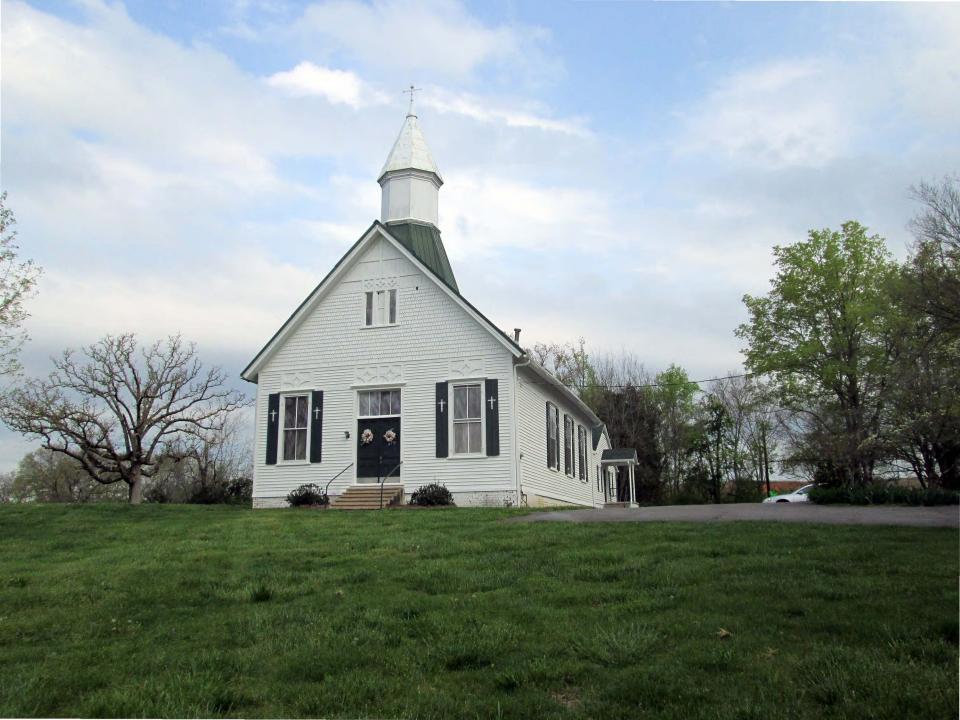
The south elevation (primary) is the most ornamented with numerous elements evocative of the Half-Timbered subtype of the Queen Anne style (Photo 0002). The continuous brick foundation is white washed and visible. Poured concrete steps with a simple metal railing lead to a centrally located entranceway. The entrance features wood double doors with a four-light transom window above, containing the same streaky sheet stained glass as the windows. This is then topped by a decorative lintel. There is a ca. 1940 metal sconce to the west of the entrance. On both sides of the entrance are two-over-two double-hung wood sash windows, each flanked by fixed shutters and topped by a decorative lintel. The wall cladding is weatherboard. Above the windows and entrance is a decorative band affixed over the weatherboard siding. This area is framed with half timbering and each window is topped with a decorative panel that features a scroll-sawn ornament in a diamond pattern over vertical siding. A pair of similar panels is centrally located over the entrance. The gable is broken into two sections: The lower section features scalloped wood shingles with a central tripartite wood window piercing the upper area, while the upper section features vertical wood siding with a decorative band framed by mock half timbering and contains three diamond-shaped scroll-sawn decorative panels that are located directly above the tripartite window. At the apex of the gable is mock halftimbering designed to provide the appearance of a two-tier king-post truss affixed over vertical siding (Photo 0005).

The east elevation is identical to the west elevation with the exception of a pipe vent piercing the roofline to the south, and a capped stone chimney piercing the roofline to the north (Photo 0002).

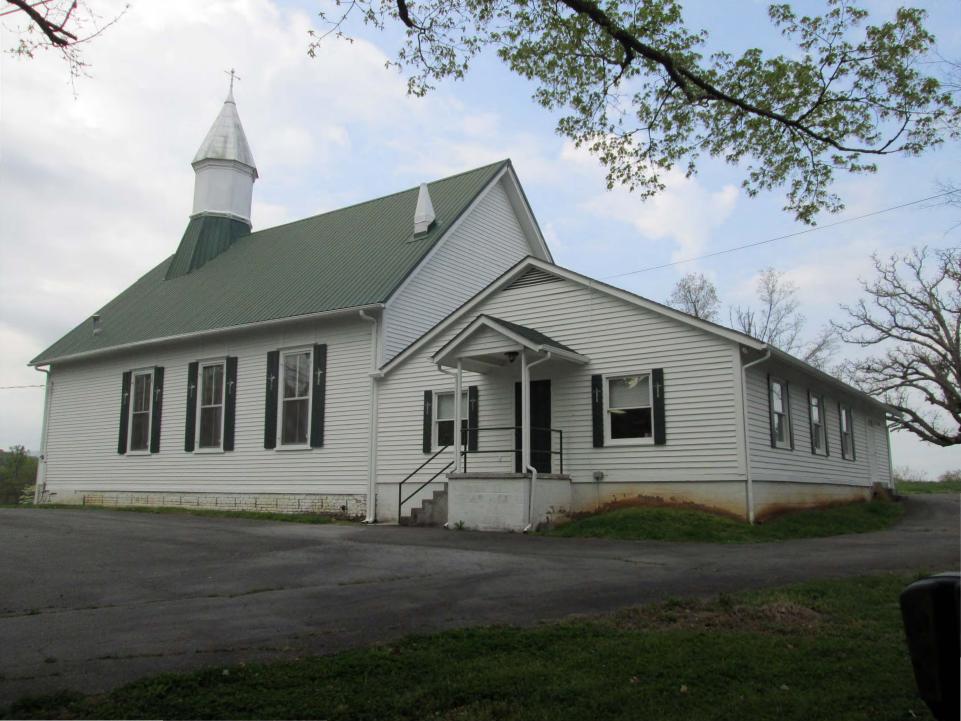
The west elevation features a whitewashed continuous brick foundation and horizontal weatherboard siding (Photo 0003). The walls are pierced by three windows with flanking shutters that are identical to those on the south elevation. A restrained decorative band tops the windows and is framed with mock half-timbering, and above each window is a mock half-timbered box. This is differentiated from the primary elevation in that there is no ornamentation within the boxes.

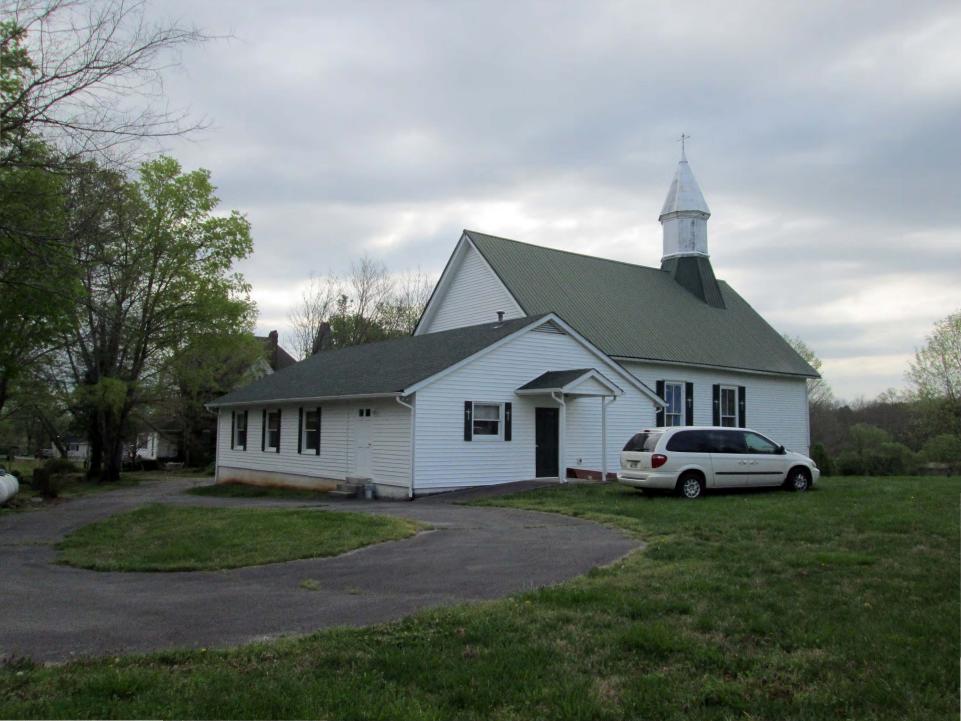
The south elevation is largely covered by the 1982 fellowship hall. The gable end of the original building is visible and contains unornamented weatherboard siding (Photo 0004).

The north elevation of the addition is pierced by three windows with flanking shutters in the same style as those on the east elevation, and a green-painted metal door on the western end of the elevation is accessed by concrete steps (Photo 0004).

The west elevation of the ell has a central entrance with a gable roof porch in the same style as that on the east, except that it rests on a poured concrete pad (Photo 0004). The door is green-painted metal. To the north of the entrance is a window with shutters in the same style as those on the east and north elevations. At
