National Register of Historic Places Registration Form

Historic name: Provident Savings Bank & Trust Co.

Street & number: 630-632 Vine Street

City or town: Cincinnati State: OH County: Hamilton

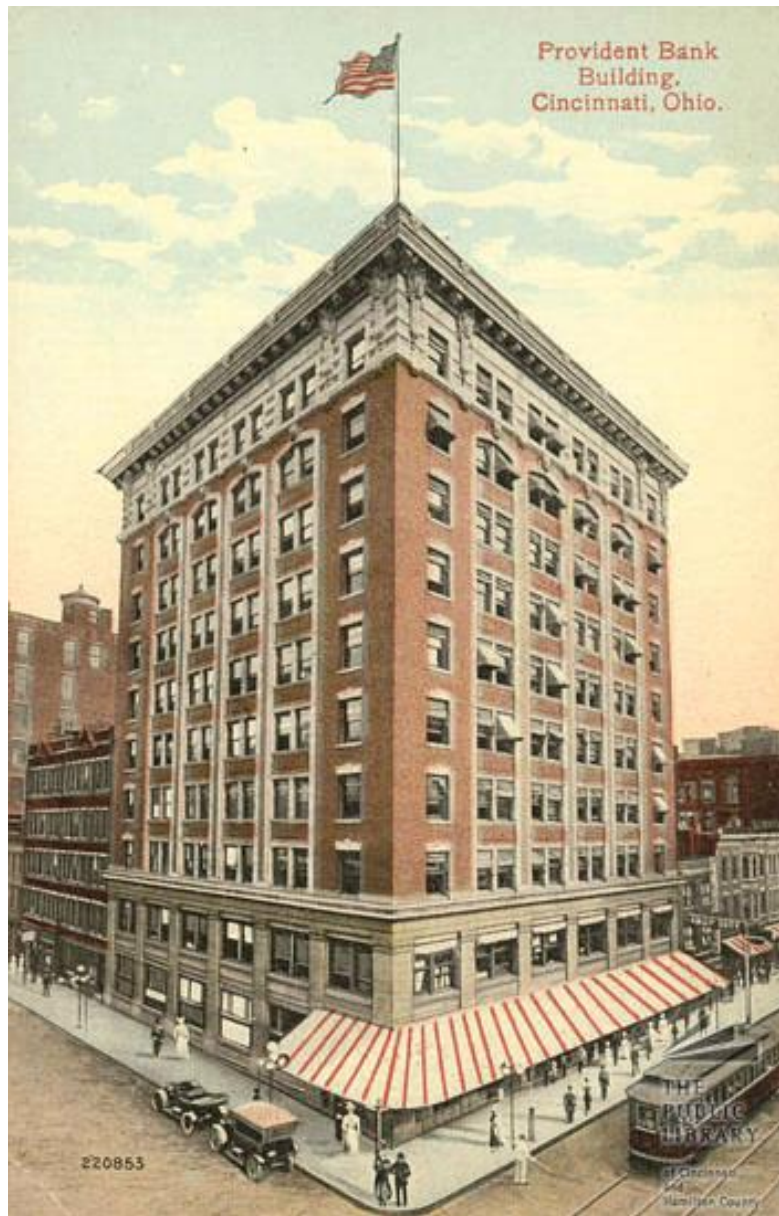
Original building, between 1908 and 1916

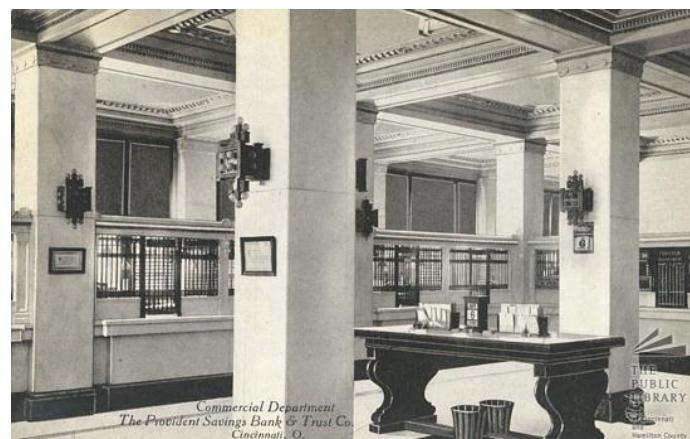
Banking hall interior, 1908

Materials of the historic banking hall were removed in the late 20th century and the footprint of bank has been reduced. Historic images show that the banking hall had a decorative, coffered plaster ceiling and capitals on the pilasters. It was a single story space, with a fairly open floor plan. The present bank branch does maintain the same height and open flow of space (Photo 14). A small, vacant restaurant is in a single storefront bay between the vestibule and bank. It retains most of the 1908 plaster ceiling, seen in historic images. It is unknown if any more of this plaster ceiling is intact above the bank's drop ceiling. The Madonna bar, which takes up two storefront bays on W. 7th Street, was constructed within space that was previously in the banking hall (Photo 15). The bar does not retain any historic materials and currently contains vinyl composite flooring, a drop ceiling, and bead board walls. A remaining column has also been wrapped in bead board.

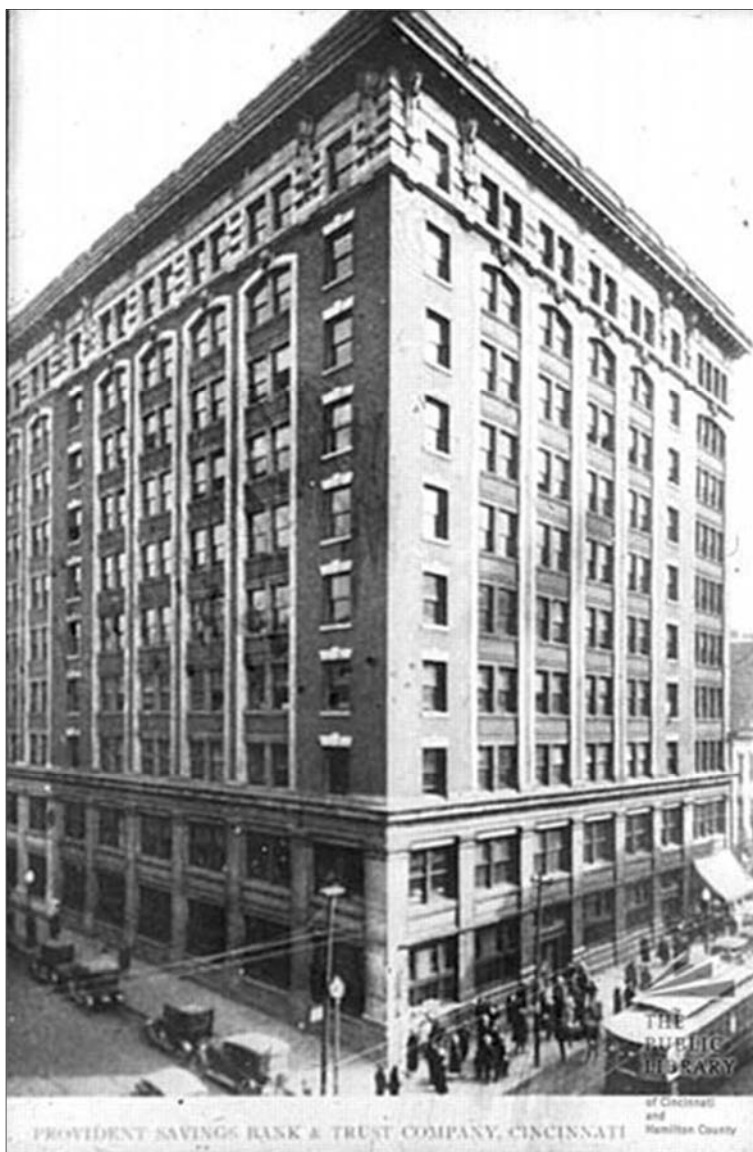
After both additions added, post 1923

The Provident Bank was constructed in three phases, all designed by the same local architect, Harry Hake (Photo 1). The original building was constructed in 1908, and the two additions were added in 1916, and 1922-23. Located on the corner of Vine and W. 7th streets, the original Provident Bank has two primary facades. The single-storefront 1916 addition was added to the south end of the building on Vine Street (Photo 3), and the six-bay 1920s addition was added to the east end on W. 7th Street (Photo 2). Utilizing the same materials and design, the two additions contain the same features as the original building. For example, the base, window surround treatment, cornice, and parapet walls are all identical, resulting in a unified single building. Except for some windows on the secondary elevations, windows throughout the building have been replaced within the original opening. Provident Bank is a nearly U-shaped building.

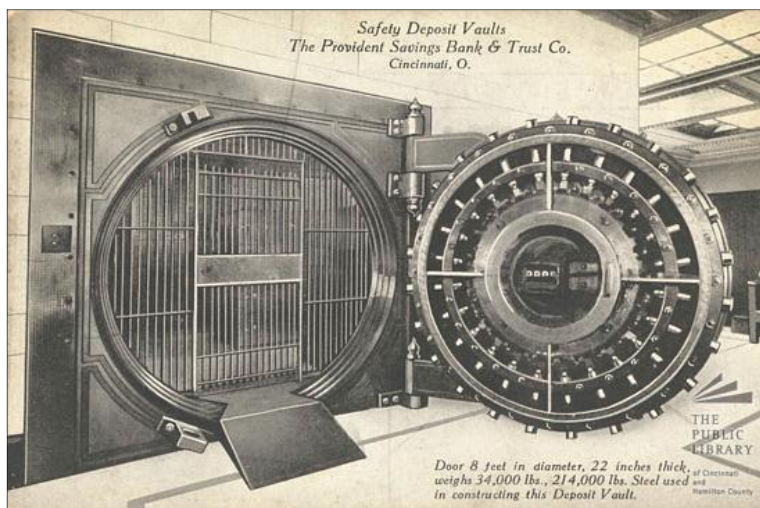
Safety deposit vault, 1923 addition

An important space for Provident Bank, included in the 1920s addition, was the safety deposit area in the basement. Shortly after its completion, the *Commercial Tribune* reported, "The safe deposit department of the Provident Savings Bank and Trust Company is one of Cincinnati's show places; its patrons are given absolute privacy and protection against burglary and fire for the securities lodged therein."² This area is largely intact, including the elaborate stairwell from the first floor. The stairwell retains fluted columns, decorative plaster ceiling, and the marble stairs with ornate metal railing. The safe deposit department contained a marble lobby (floor, walls, counter), which is mostly intact with only the counter partially missing. Metal gates still define the safety deposit vault entrance lobby. The vault is intact, including marble walls, but the small private rooms and coupon booths have been removed. The space is still evident, however, with the dominant vault, bulkhead wrapping around the perimeter, and decorative cornice.
