National Register of Historic Places Registration Form

historic name Main Street Friends Meeting House
other names/site number Medford Hicksite Meeting House

street & number 19 South Street not for publication
city or town Medford Township vicinity
state New Jersey code NJ county Burlington code 005 zip code 08055

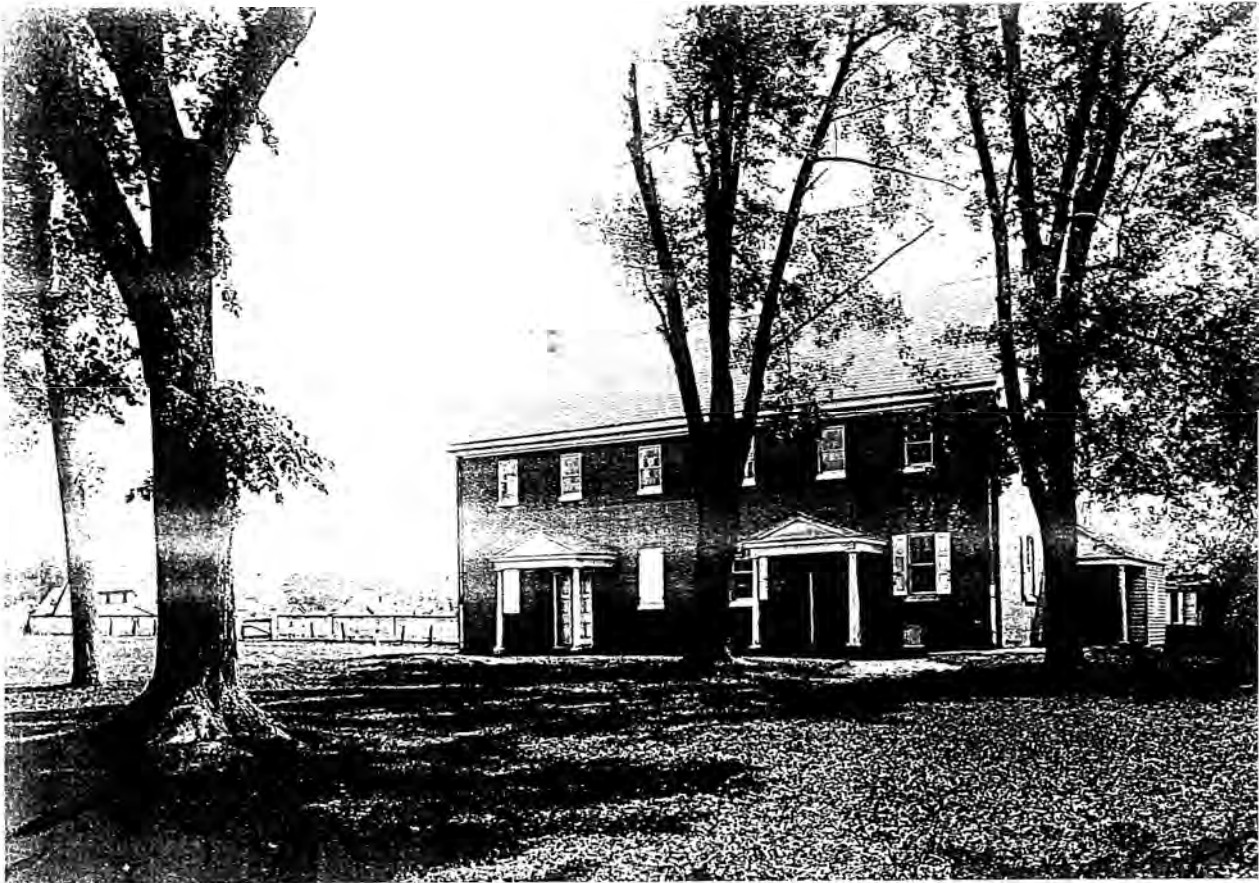
Figure 2: (above) ca. 1905 view looking northeast: this view is one of the earliest found to date and shows the building as it appeared about 1905. Note that the south restroom ell has not been fully enclosed as it is today. [Swarthmore College archives]

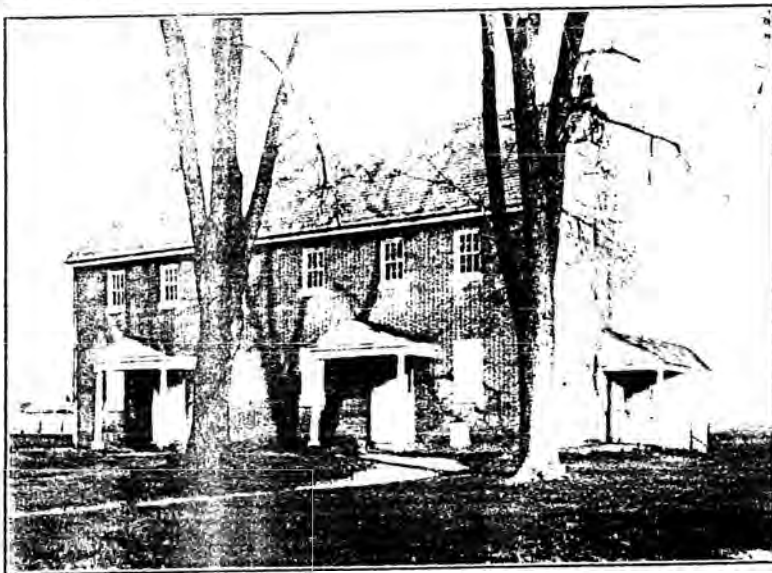
Hicksite Friends' Meeting House, Medford, N. J.

Figure 3: (above) ca. 1905 post card view: This view is almost the same as that above, except the school house behind the southernmost side door appears to have airbrushed out of the photograph. H.P. Thorn, seller of the postcard, is cited in the census and various directories as a druggist on South Main Street; his name is shown on the 1876 map (fig. 1), on South Main Street. C.J. Kingdon may be Carrie J. Kingdon, a single woman (b. ca. 1874) who lived in Mt. Holly, Burlington County; her father was editor of the *Mt. Holly News*. The post card's style on the back dates it from 1901 to 1907. [Swarthmore College archives]

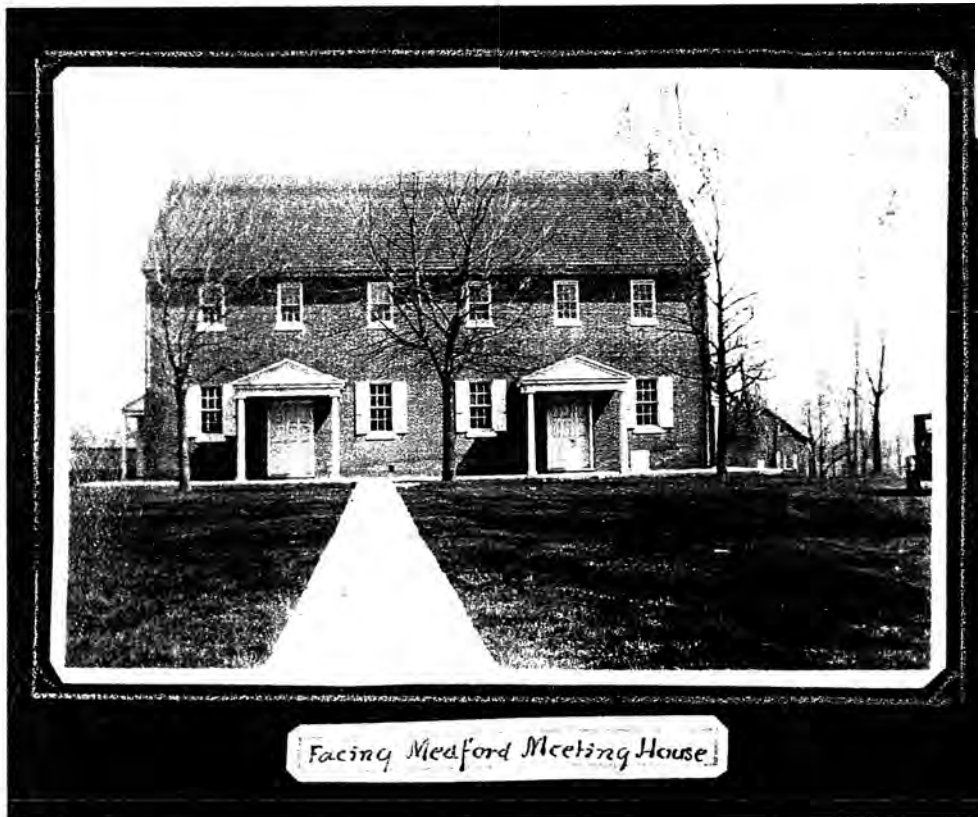
Figure 6: ca. 1930 view of the meeting house

This view, looking directly east, shows the facade. [T. Chalkey Leeds Collection, Historical Society of Pennsylvania]

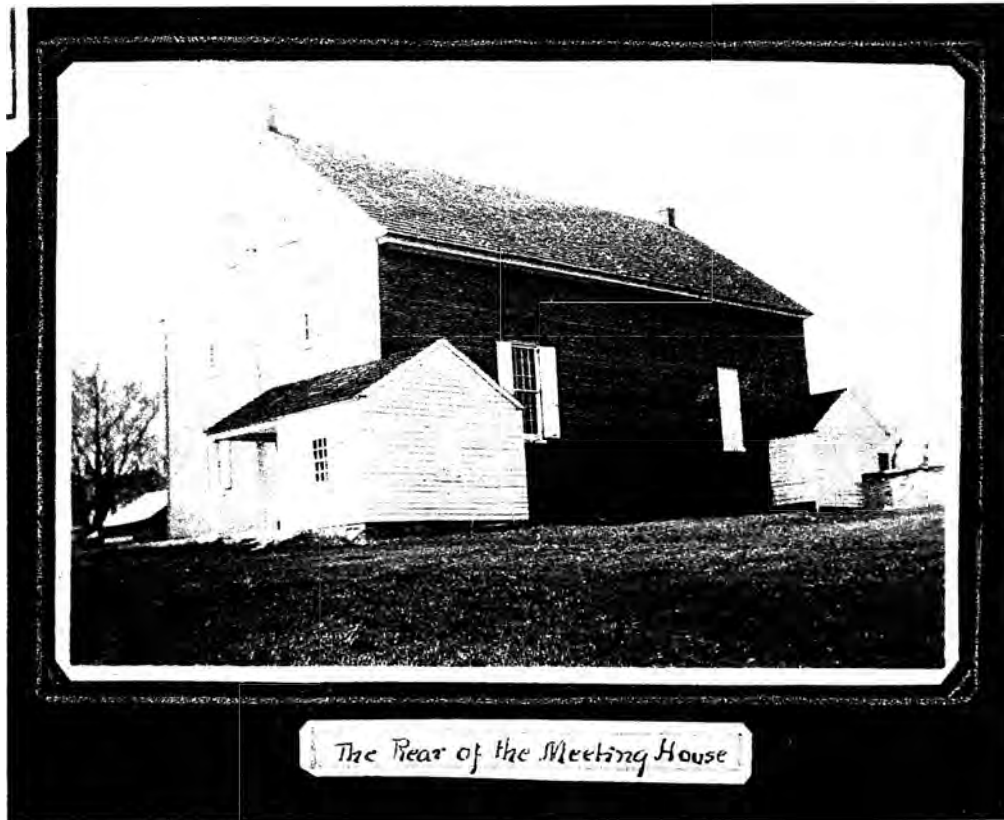
**Figure 8: ca. 1930
view, looking
northwest**

This view shows the rear of the two restroom ells. Note the discoloration of the bricks along the south side where the chimney stack runs. [T. Chalkey Leeds Collection, Historical Society of Pennsylvania]

Meeting minutes inform that in December 1863, the treasurer reported there was "outstanding against the meeting an account of the committee to alter the chimneys of the meeting house..."¹ There were no further details given and it is not clear exactly how the chimneys were altered, or why, as no evidence of alteration is seen on the interior. However, the north and south exterior side walls both show an area of lighter color bricks, about two bricks wide, which runs up the middle of the side walls and ends at the attic level. These re-worked areas suggest that the original bricks may have failed for unspecified reasons and had to be replaced at this time. This same area appears dark-colored in the early 20th-century photographs of the meeting house, suggesting the problem was chronic.

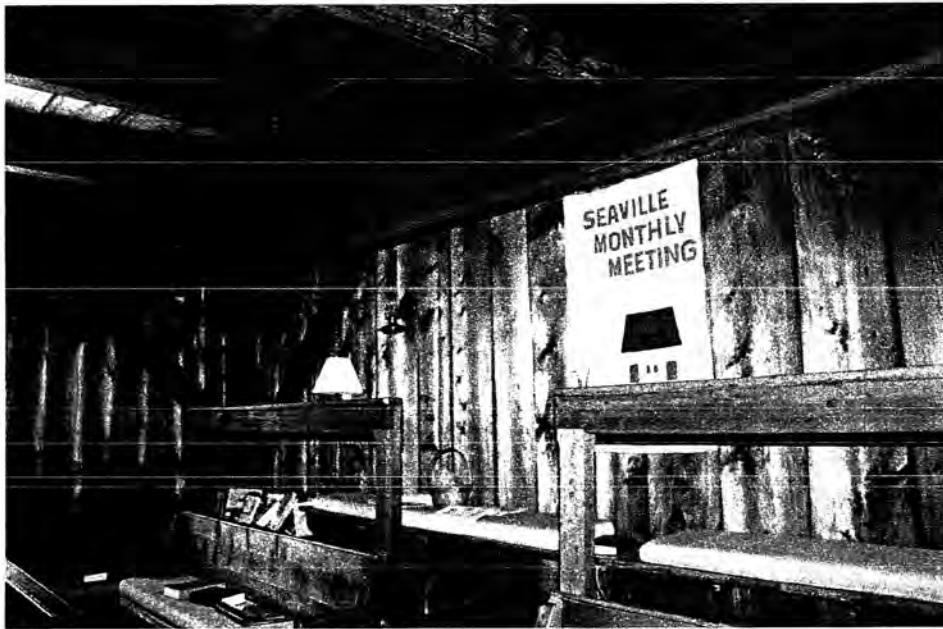
Figure 14: Seaville Friends Meeting House, built ca. 1727

This one-room meeting house was moved to its present location in Upper Township, Cape May County, in 1767.

The earliest meeting houses, like that extant in Seaville, Cape May County (built ca. 1727⁶), New Jersey, were small structures, one-story tall, with a single room on the interior. In fact, Seaville Meeting House measures only 24' wide by 20' deep. [see *Historic Images* section, fig. 14 and 15] Most references describe them as being of comparatively primitive construction, either crude frame or log structures. Historic images show a central double doorway located symmetrically between two windows, a fenestration pattern extant in the Seaville Friends Meeting House.⁷

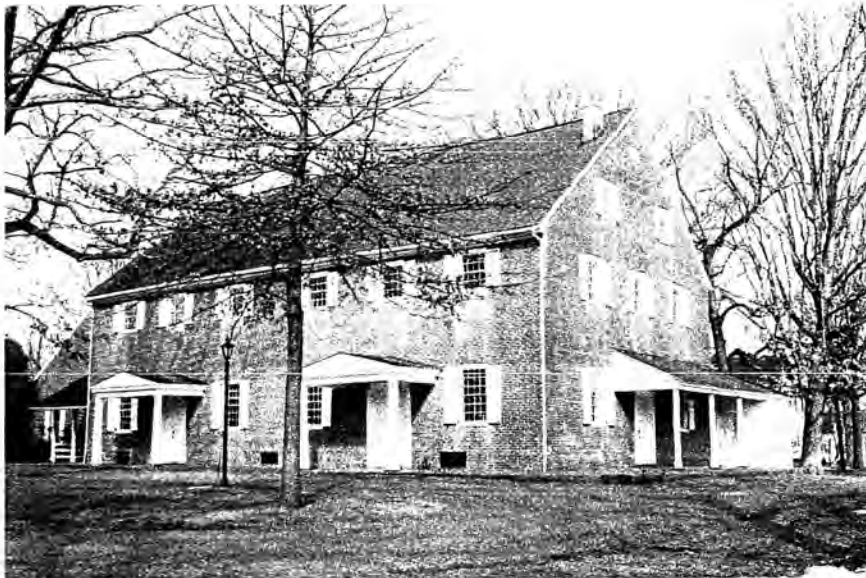
Figure 19: Mount Laurel/Evesham Meeting House

The original section, built in 1760 and represented as that portion to the right of the arrow above, has two front doors asymmetrically placed on the façade.

The earliest, 2-story double-plan meeting house known to have been built in New Jersey is the Mount Laurel or Evesham Meeting House erected in 1760 with an addition in 1798. [*Historic Images*, fig. 19] The fenestration of the façade shows that it was conceived as a single structure with two main doorways, but it lacks the exterior symmetry that would characterize later double-plan meeting houses. The Chesterfield Meeting House (also known as Crosswicks) was built in 1773 and represents the first of the true double-plan structures in New Jersey. Minutes show that Chesterfield Quakers visited the Buckingham (PA) Meeting House, erected in 1768 and the earliest known Delaware Valley meeting house to have been constructed from the start as a true double-plan meeting house.¹⁶ [*Historic Images*, fig. 17 and 18] Later meeting houses modeled after Mount Laurel, but with symmetrical facades, include Salem (1772), Mickleton (1789) and Burlington (1784).

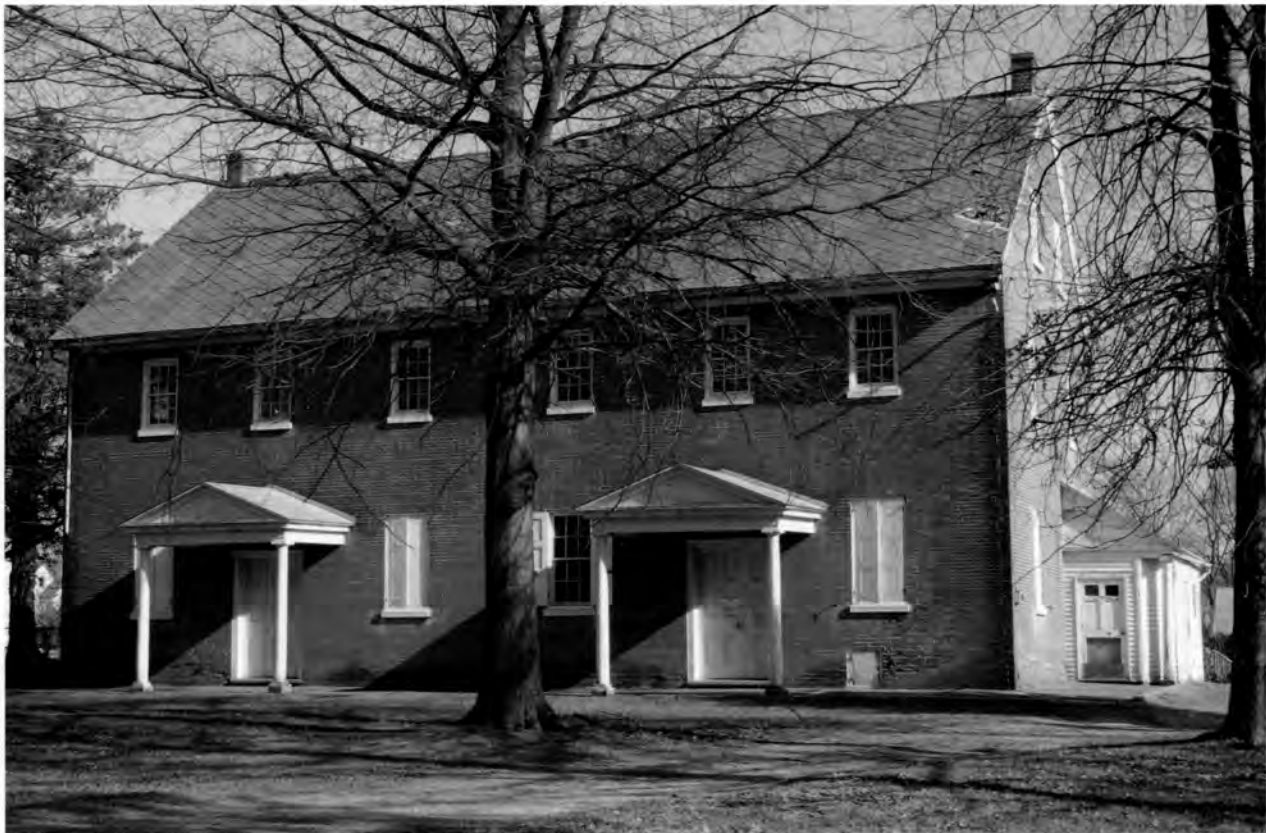
Main Street Friends Meeting House Burlington County, NJ #2

The Main Street Friends Meeting House, built in 1843, is a two-story tall red brick building erected with Flemish bond on the façade (west elevation) and common bond on the side (north and south) and rear (east) elevations. [photos 2 and 3] The gable roof runs parallel with the façade and is pierced at each gable end by a narrow brick chimney that appears to be original; the roof is covered with ca. 1950 asbestos shingles laid over wood shingles. At the time of this writing (March 2010), the asbestos and old wood shingles were being removed and replaced with a new wood shingle roof. The façade and rear elevation have a simple, boxed cornice with no returns and the gable ends have modest, tapered rake boards that are covered with vinyl. The meeting house stands on a brick foundation supported by rubble stone below grade.

The portico of the south restroom ell has been enclosed and its southwest corner wall is cut back on an angle to accommodate the Doric column that supports the roof structure. [photo 2] There is a single, 6-panel (2/2/2) wood door on the west elevation that appears to date to the late 20th century. The south (side) elevation has two doors: the easternmost one consists of a large pane of glass (missing) over two panels; it appears to date to ca. 1950. The westernmost one, which leads into the entry of the enclosed portico, consists of 6 raised panels (2/2/2) and appears to date to the last half of the 20th century. There is a small, covered-over window between these two doors. A break in the clapboards shows that the front half of the restroom ell was originally open (like that on the north elevation), but was enclosed probably in the 1920s as the narrower clapboard siding suggests. There is a single original 6/6 double-hung wood window on the rear elevation. The roof is covered with modern asphalt shingles.

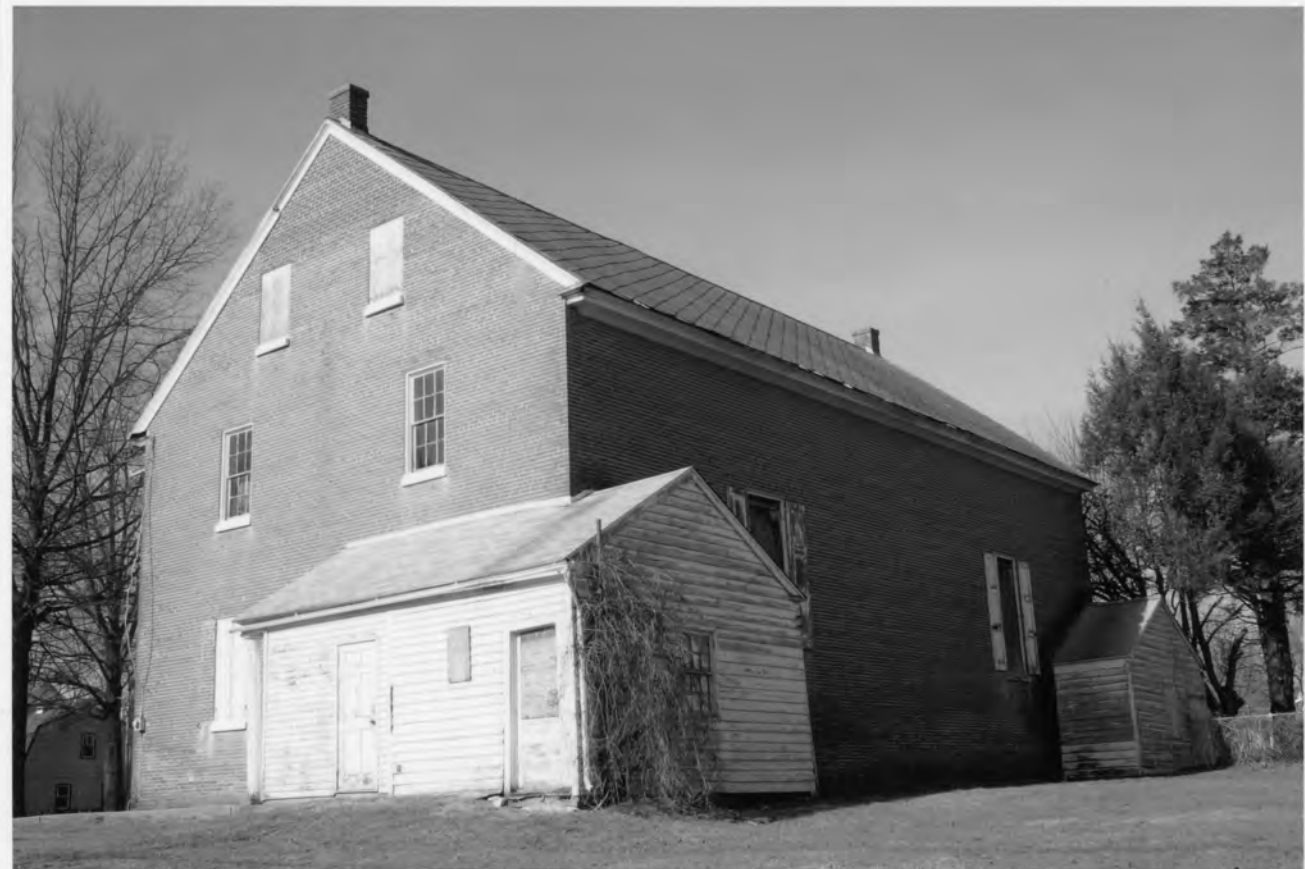
#3

On each side elevation, toward the rear, is an original one-story wood frame restroom ell covered with wood clapboard and standing on a brick foundation. [photos 3 and 4] Each has a portico, supported by an original Doric column that shelters the side elevation door openings on the main block. They have L-shaped footprints with a shed roof along the side elevation that merges with a gable roof along the rear elevation.

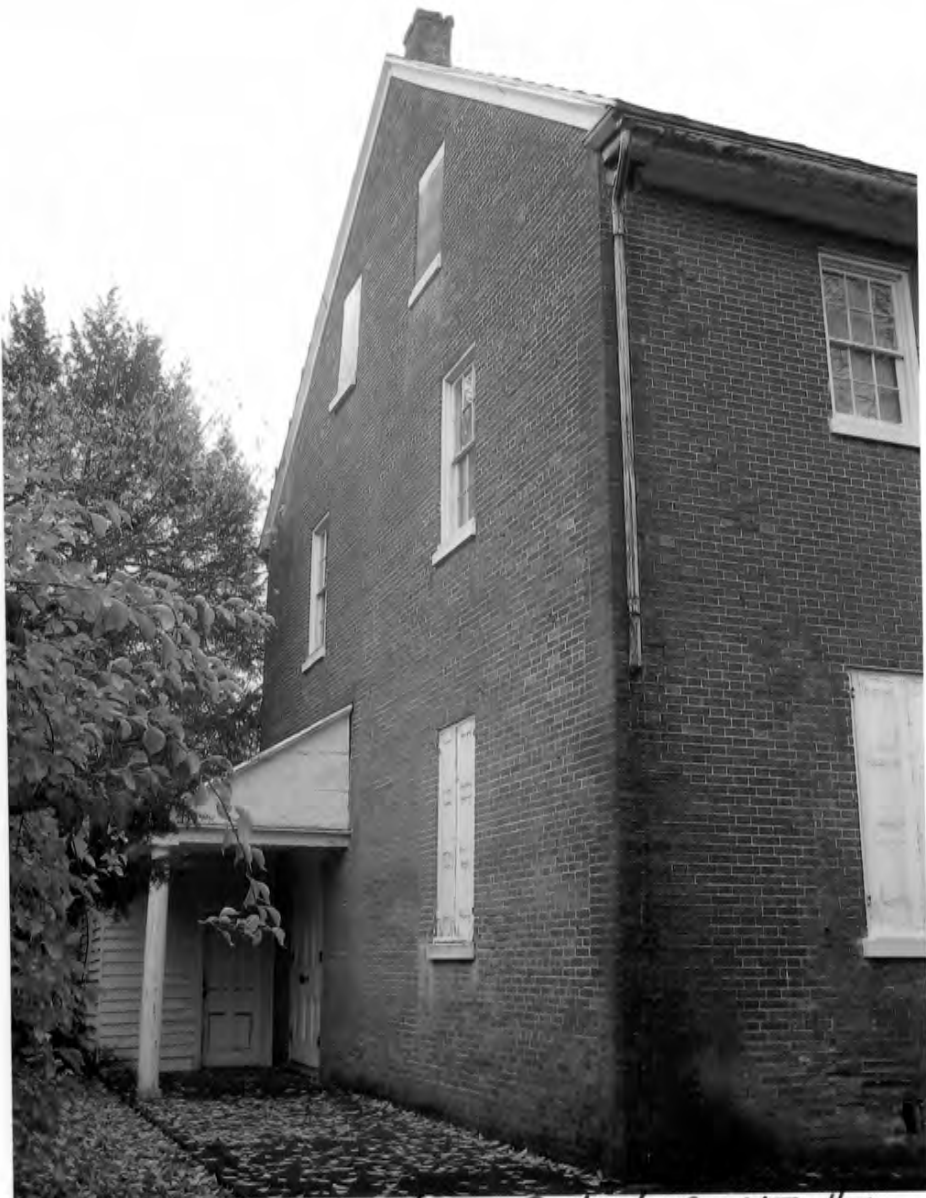
main Street Friends meeting house Burlington Co., NJ #4

The restroom ell on the north side elevation retains its original appearance and its original open portico. [photo 4] The restroom is accessed by an original 4-panel (2/2) wood door with applied moldings on the west wall. There is a boarded-over window on the north side elevation and the rear elevation has a boarded-over window opening to the south and a board door of indeterminate age to the north. The roof of the side elevation merges with the gable roof of the rear portion; this roof is covered with modern asphalt shingles on the rear slope (being replaced with wood shingles in March 2010) and ca. 1950 asbestos shingles on the north side slope.

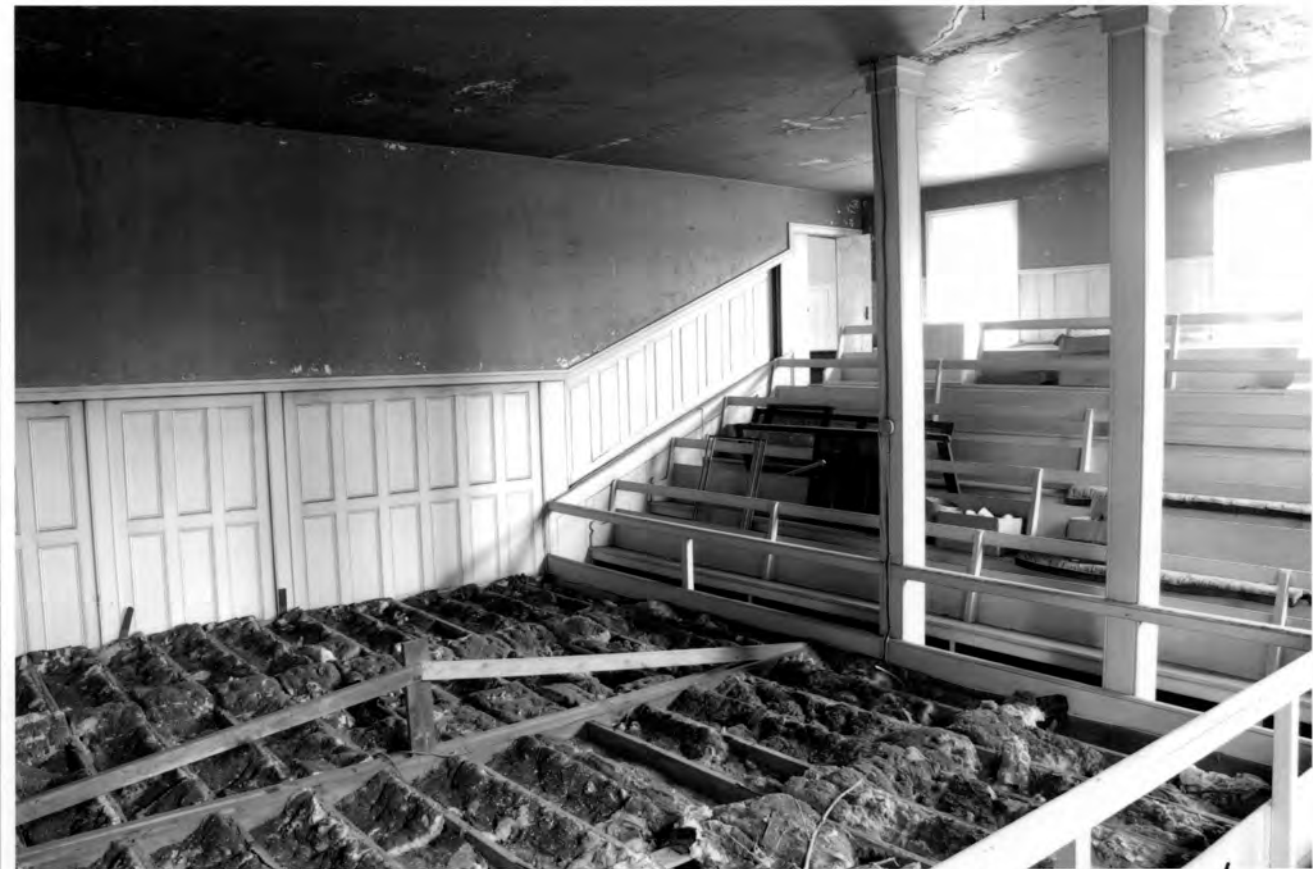
#13

The balcony level of the men's section is identical to that of the women's section and features original wood benches (some broken), original wood wainscot, and original plaster walls and ceiling. [photos 13 and 14] The benches and woodwork are painted white, and there is a circular plaster medallion for a light fixture (not used) in the center of the ceiling. Original floorboards are of hard pine and are random in width. The top of the ca. 1950 tiled ceiling, with the joists that support it, is exposed between the balcony and the rear wall.
