NATIONAL REGISTER OF HISTORIC PLACES
REGISTRATION FORM

historic name Oregon State Fair Stadium and Poultry Building Ensemble

street & number 2330 17th Street NE not for publication _____

city or town Salem vicinity _____

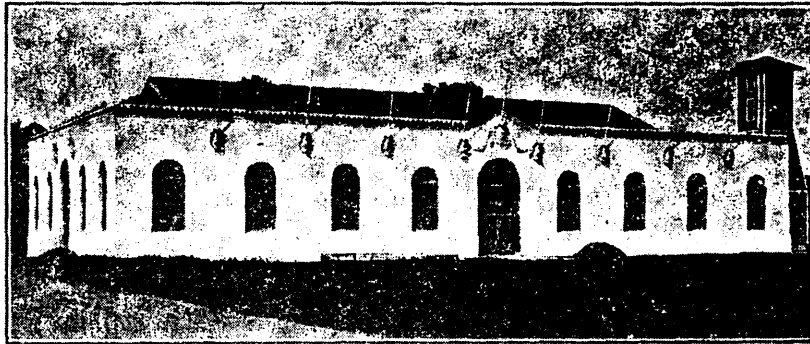
Oregon State Fair Poultry Building
 From *The Northwest Poultry Journal*, September 1921

The new poultry pavilion on the Oregon State Fair grounds at Salem. It is constructed of hollow tile, stucco finished and has a tile roof. The main gable roof is about four feet higher than the platform roof surrounding it, permitting of a high row of windows from which an excellent sky light effect is secured. This building is 80x140 feet and has 31 foot pillars. There are large double door entrances on its four sides, concrete floor with a very artistic fountain and pool in the center of the building. The ornaments shown over the windows and entrances are large busts of roosters, above which are flag staffs. It is fire proof and no doubt the finest poultry pavilion in the West.
