National Register of Historic Places Continuation Sheet

1. Name of Property		
historic name <u>Rohrbaugh</u> Cabin		
other names/site number <u>Allegheny Cabin</u>		
2. Location		
Smokehole Road. SR 28/11, 3 mi street & number <u>Monongahela National Forest</u>	les South of inters	section with SR $28/55$ \Box not for publication
city or town <u>Petersburg</u>	·	I vicinity
state <u>West Virginia</u> code <u>WV</u> county <u>Gr</u>	ant c	ode 023 zip code 26847

The Rohrbaugh Cabin is a freestanding, two and one half story, "double pen" plan log house built of 6" hewn tulip poplar logs. It has stone foundations, an exterior stone chimney base, and a gable roof with corrugated metal roofing. The interiors are unfinished with the exception of one space on the main floor level which is clad with vertical t&g paneling. It was built about 1880 and was home to several generations of the Rohrbaugh family who farmed on the property until 1962. Several generations of additions to the house were removed after the property was purchased by the Federal Government in 1971.

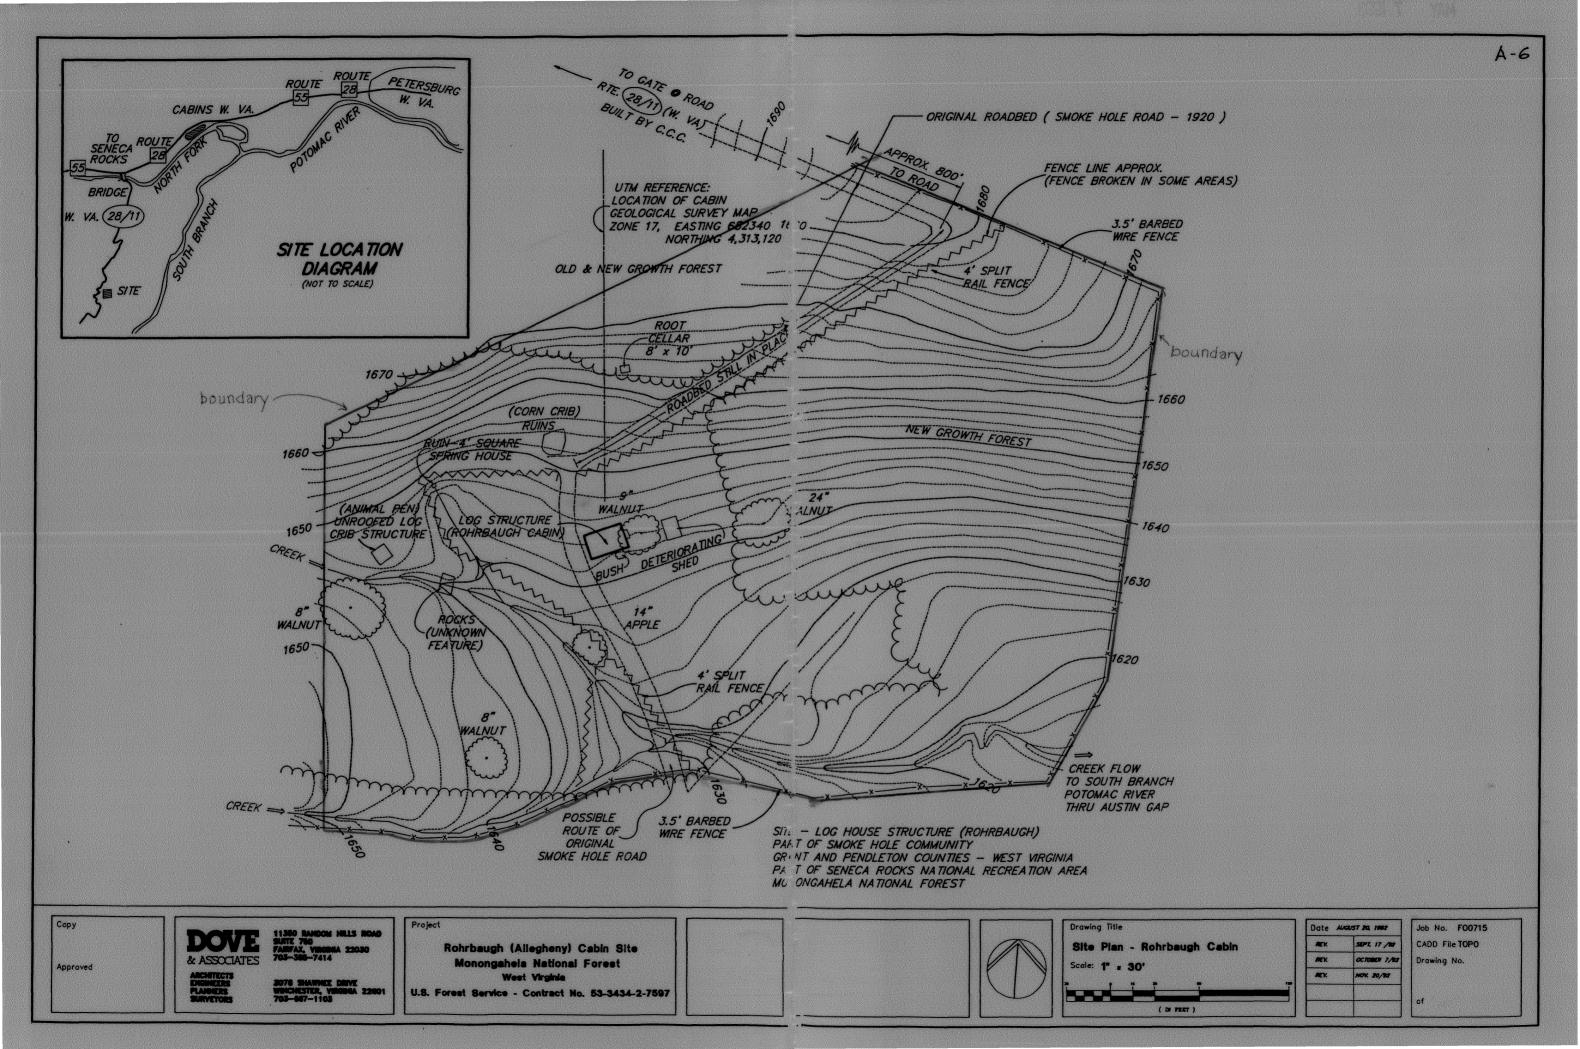
ROHRBAUGH CABIN GRANTCO. WV # 10

#10. Aerial photo - U.S. Army Air Corps (1943) government archive photo of Rohrbaugh cabin site and farmstead shows original Smoke Hole road, and new (CCC-built) logging road (now 28/11).

Surviving sections of the original Smokehole Road on the site include the distinctive profile and portion of roadbed on the north side of the house which descend the hill from the switchback to the new road, as well as the fainter trace of road which turns to the southeast to cross the stream in front of the house on its original path toward Redman Gap to the south.
