Hendricks Building (1897) (New York Store) 369 South Main Street Pendleton, Umatilla County, Oregon

Sommerville House Research Photo, August 1981 104 SE 5th Street Pendleton, OR 97801

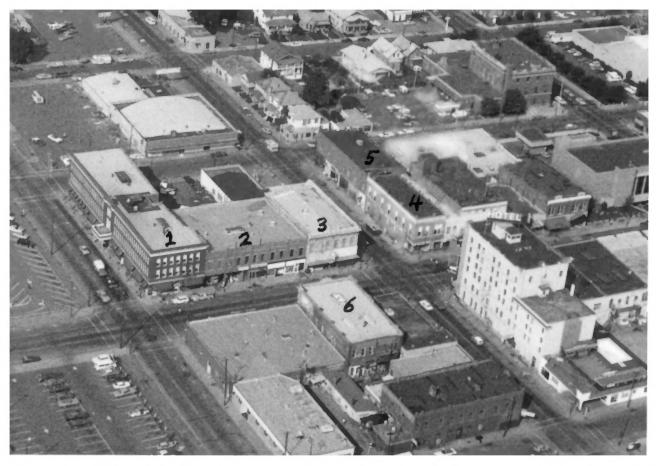
1 of 7 - Aerial View

Looking northwesterly over the central business district.

1. Bowman Hotel (a National Register property)

Matlock-Brownfield Building
 Masonic Temple
 Hendricks Building
 Empire Block

6. St. Elmo Hotel

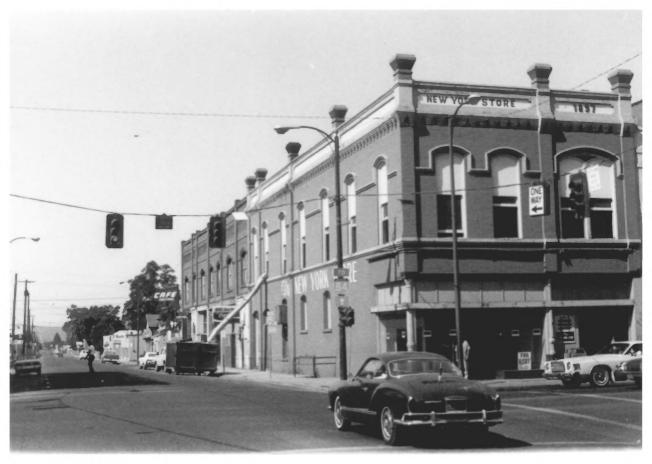
2 of 7

Looking southwesterly along SW Emigrant Avenue showing continuity of the Emigrant Street (south) facades of the Hendricks Building (foreground) and Empire Block.

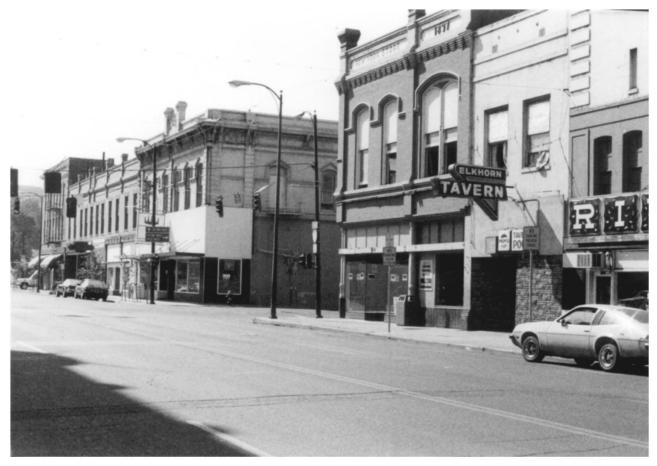
3 of 7

Looking southeasterly along South Main Street, showing Hendricks Building on North side of SW Emigrant Avenue and the Masonic Temple, Matlock-Brownfield Building and Bowman Hotel to the south.

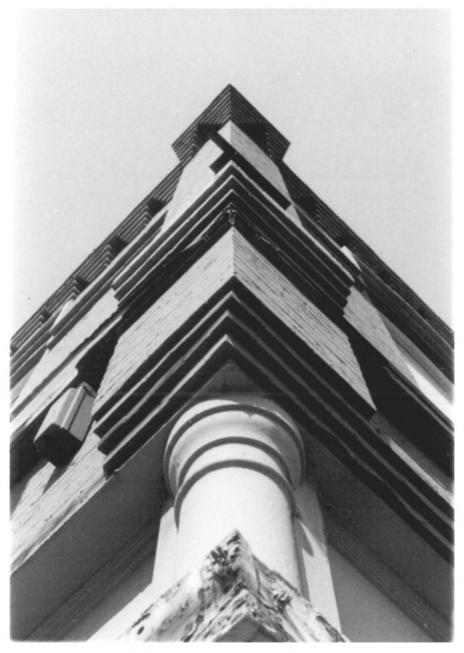
corner of building.

Detail of cast iron corner column, SE

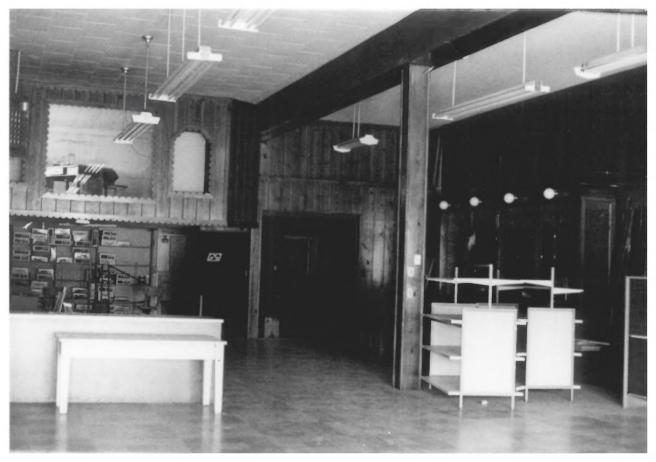
Hendricks Building (1897) (New York Store) 369 South Main Street Pendleton, Umatilla County, Oregon 5 of 7 Ground story interior prior to rehabilitation. Sommerville House Research Photo. August 1981 104 SF 5th Street Pendleton, OR 97801

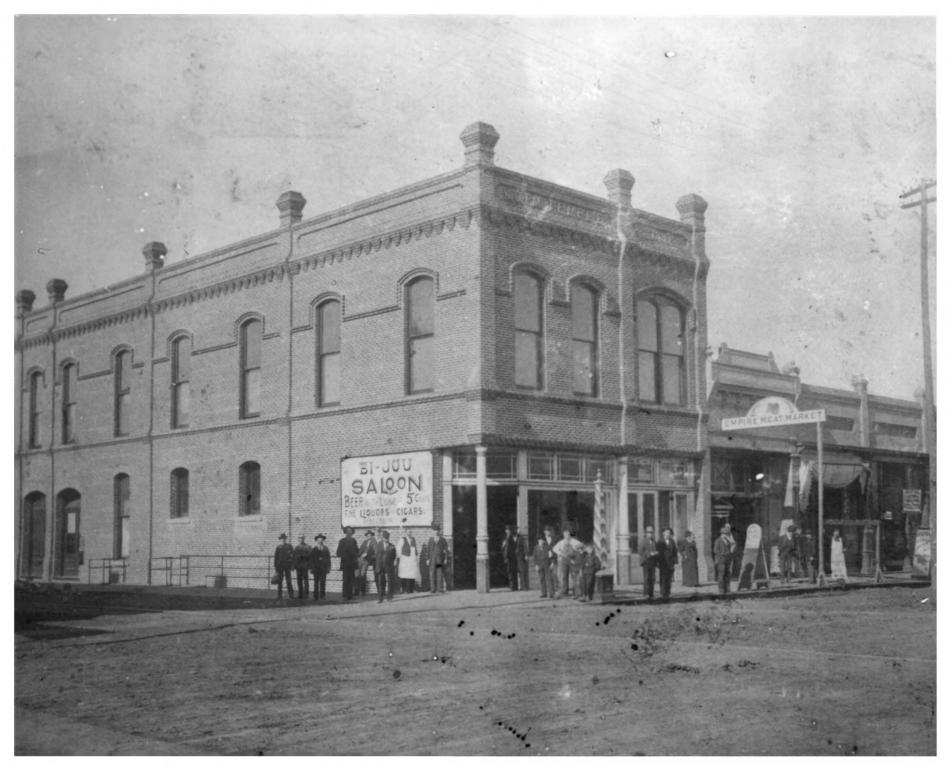
South and east (principal) facades

Historic view, ca. 1900.

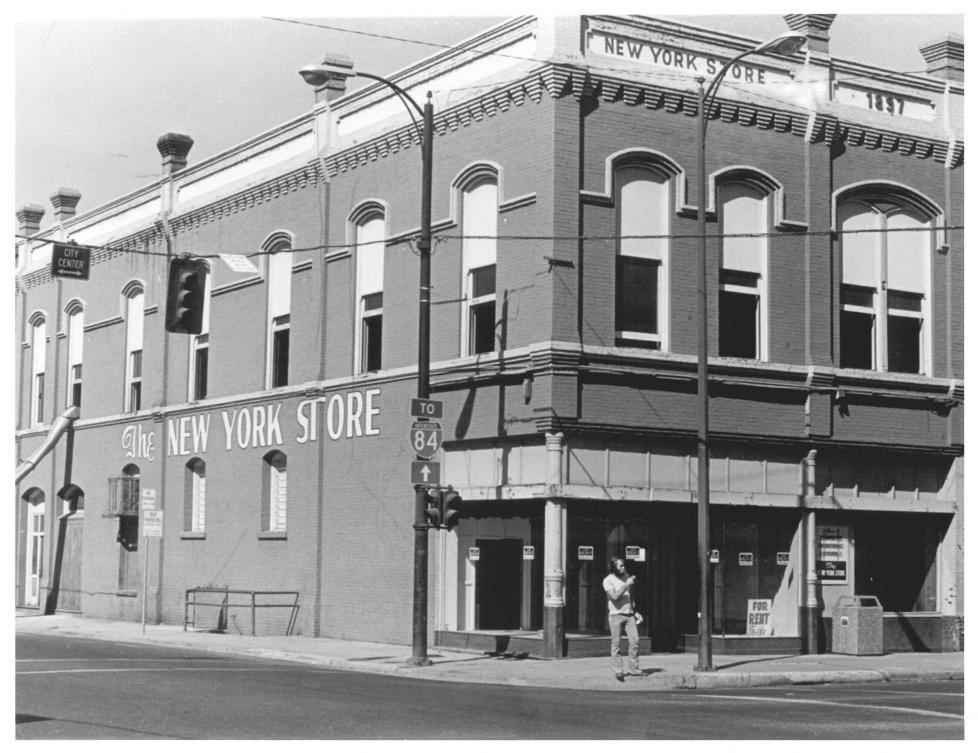
7 of 7

South and east (principal facades), showing remarkably little external change since the 1900 view. The face brick has been painted, and the beveled corner entry has been replaced

by display windows, but the cast iron columns are intact and each of seven corbeled brick flues stand above the parapet.
