KENTUCKY HISTORIC RESOURCES
Individual Inventory Form

Resource # 109
Shelby County

1. Name of Resource: Montgomery House		16. Date: Original Building 1830-1840 [7] Addition see Item #45 []	
2. Original Owner: Unknown		17. Style: Greek Rev. [] Settlement Vernacular [2V]

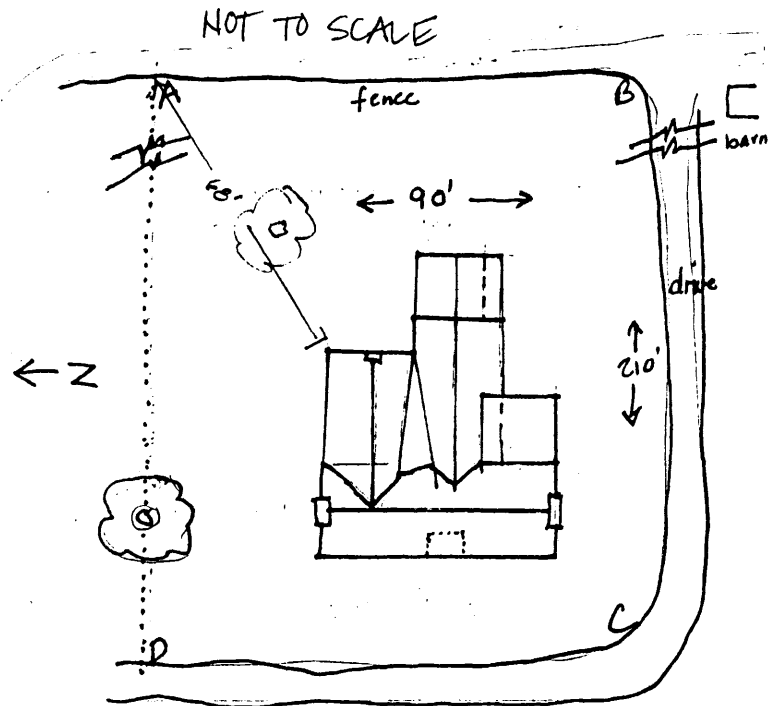
44. Site Plan (and boundary description and justification for N.R. sites):

Beginning at A, south along a fence 90' to B, thence west 210' along the north side of the drive to C, thence north 90' continuing to follow the drive (on the east side) to D, thence east 210' along a property line to the point of origin. The boundaries were chosen to encompass the house and its domestic-related space defined by a fence, property line, and the drive. Included in the boundaries is a non-contributing frame, board and batten shed in a very poor state of repair. Outside the boundaries and also non-contributing is a frame barn.

Point A is the intersection of a treeline and fence-line in the northeast corner of the yard and is 68 feet northeast of the northeast corner of the dwelling's northernmost ell.

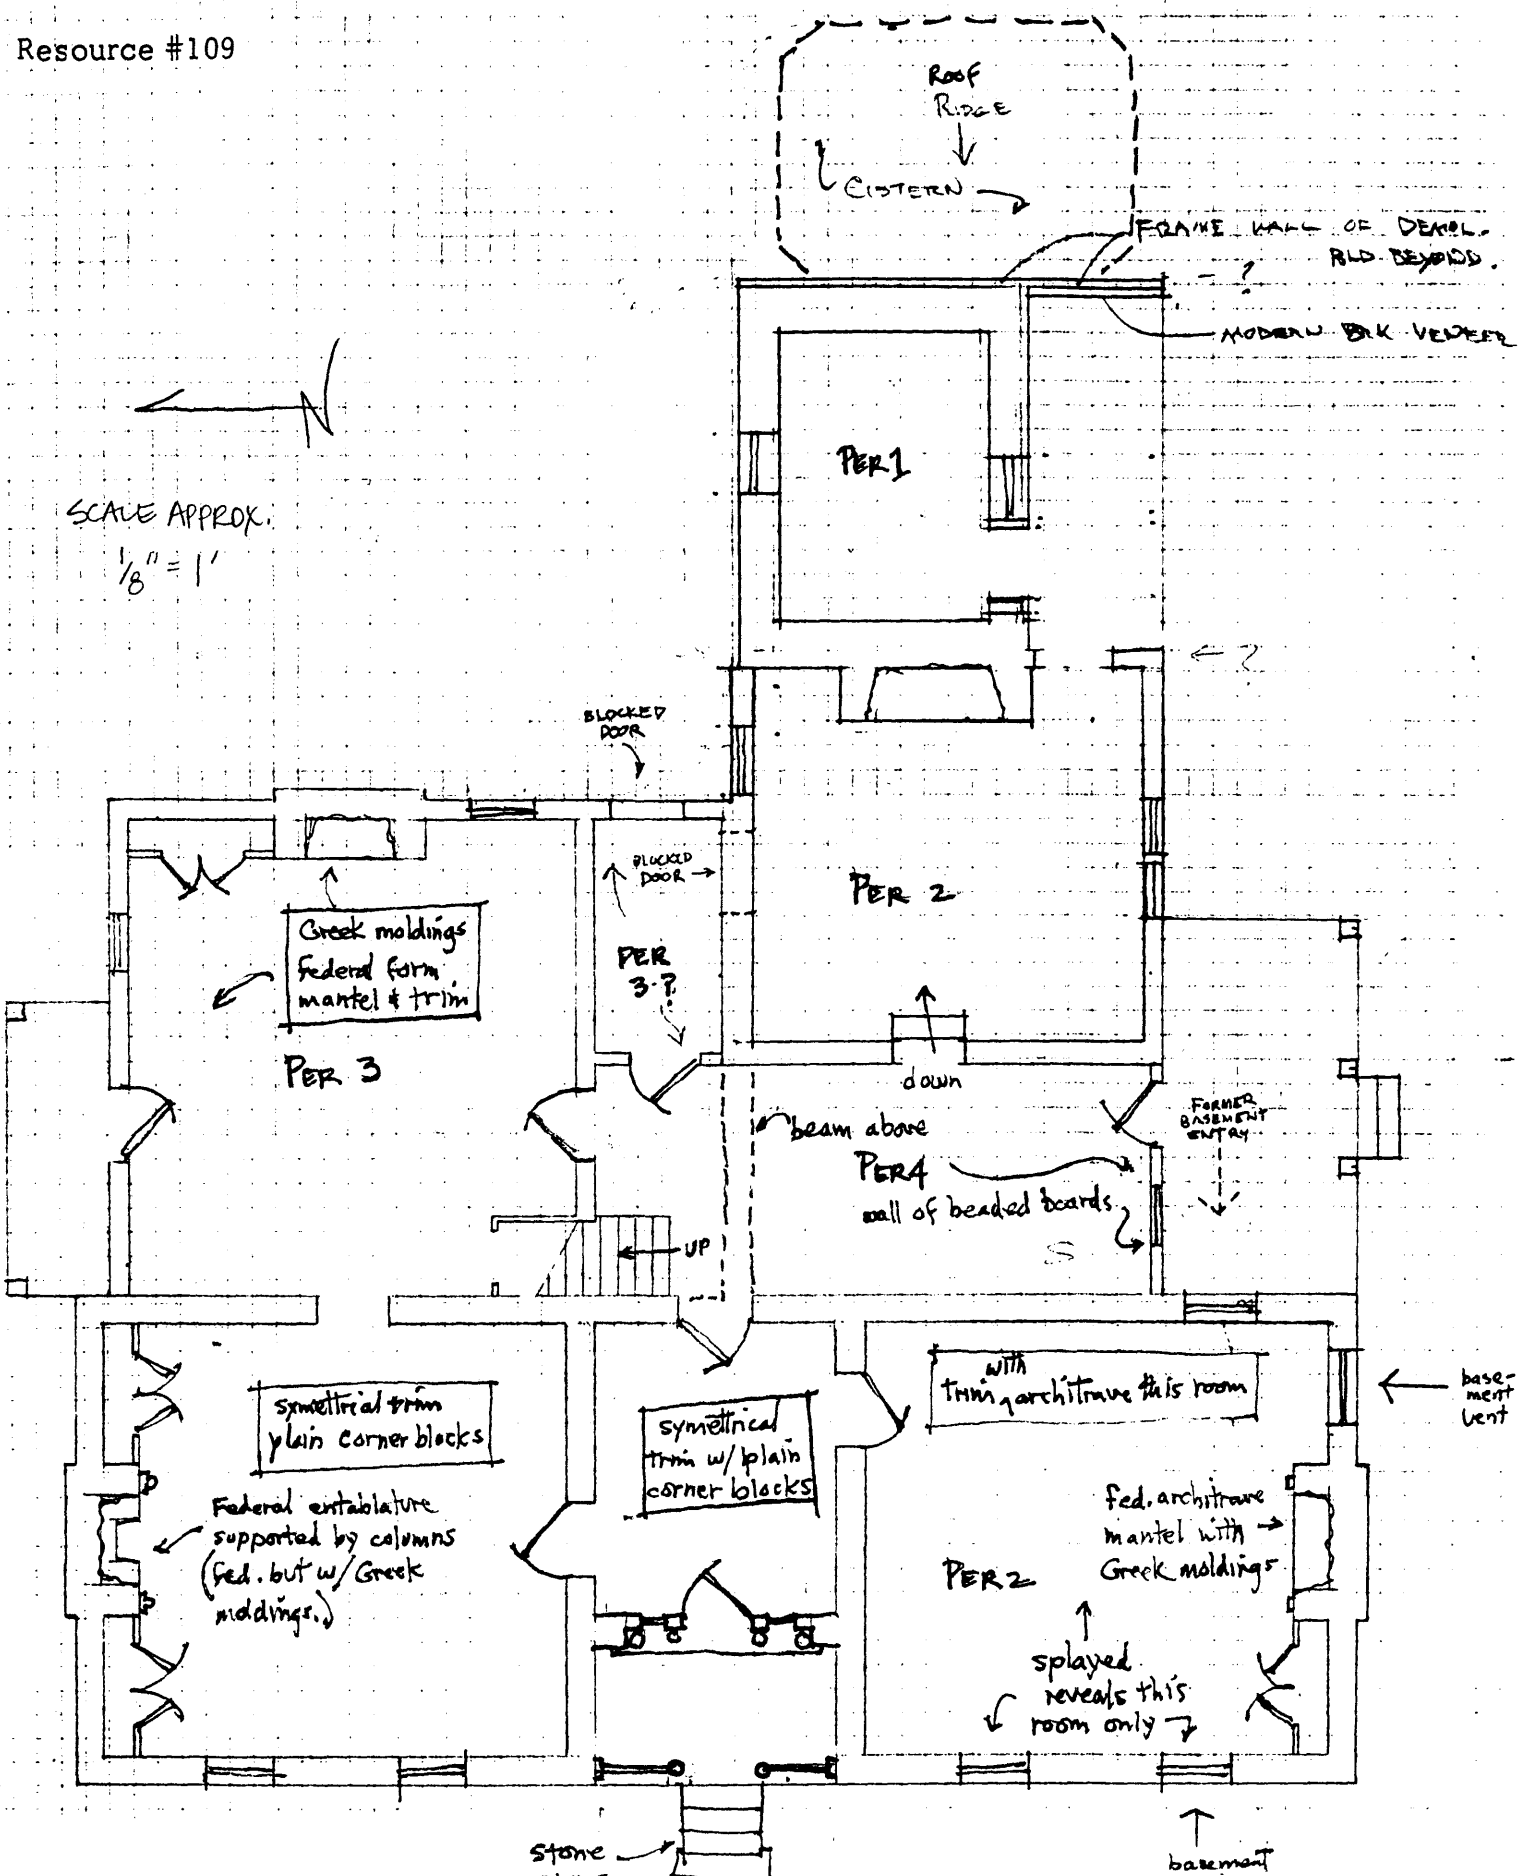
45. Description and House Plan: (for plan see page 4)

1-story, 5-bay, brick, center-passage, single-pile plan, Flemish bond principal (west) facade, common bond sides and rear, original recessed central porch: semi-circular fanlight set in flushboard supported by slender Doric wood columns, wood spandrels between columns and sides of porch opening, wood balustrade, horizontal and vertical panelled door with symmetrical trim and plain corner blocks, 3-pane sidelights with symmetrical trim and plain corner blocks have panelled aprons beneath and are flanked by attenuated engaged colonnettes on plinths, molded cornice and plain frieze which are recessed between colonnettes, doorway is framed by symmetrical trim with plain corner blocks, molded chair rail around sides of porch with panelled wainscot, plastered walls above chair rail, new wood benches; gabled roof, 3-course advanced brick cornice on principal facade, partially exterior end chimneys, jack arches, 9/6 sash, coursed stone foundation, brick appears to have been repointed ? on south gable end.

1-story, 1-room stone section now attached to east of the center passage section appears to be the oldest structure on the site, pre-dating the brick portions; a 1-story, 1-room brick unit is appended to the west end of the stone building and appears to have been built at the same time as the center-passage section (it has a molded brick cornice) and probably served as a semi-detached kitchen, evidence suggests that a porch ran along the north side of the kitchen abutting the east side of the center-passage section and possibly opening into the passage, later a 1-story, brick ell was added to the east side of the north room of the center-passage section (north of the brick kitchen) and the porch was then enclosed; finally the space between the south room of the center-passage section and the brick kitchen was framed in. A cistern is located at the east gable end of the stone room.

Center passage has symmetrical trim with plain corner blocks, south room of center passage has trim with architrive, a federal architrave mantel with Greek moldings, cupboards on the west side of the fireplace, and is the only room with splayed window reveals (in the west wall), north room of the center passage has symmetrical trim with plain corner blocks, a mantel with federal entablature supported by columns, but with Greek moldings, cupboards flank both sides of the fireplace, ell to the east of north room has federal form mantel and trim with Greek moldings; stair from former porch up into northeast ell, door made into window at east end of former porch, wall of beaded boards in framed-in section connecting south room to kitchen.
