National Register of Historic Places  
Registration Form

historic name Wilmarth, Lewis C. and Caroline, House  
other names/site number Ashland General Hospital

street & number	622 Chapple Avenue	N/A	not for publication
city or town	Ashland	N/A	vicinity
state Wisconsin	code WI	county Ashland	code 003
			zip code 54806

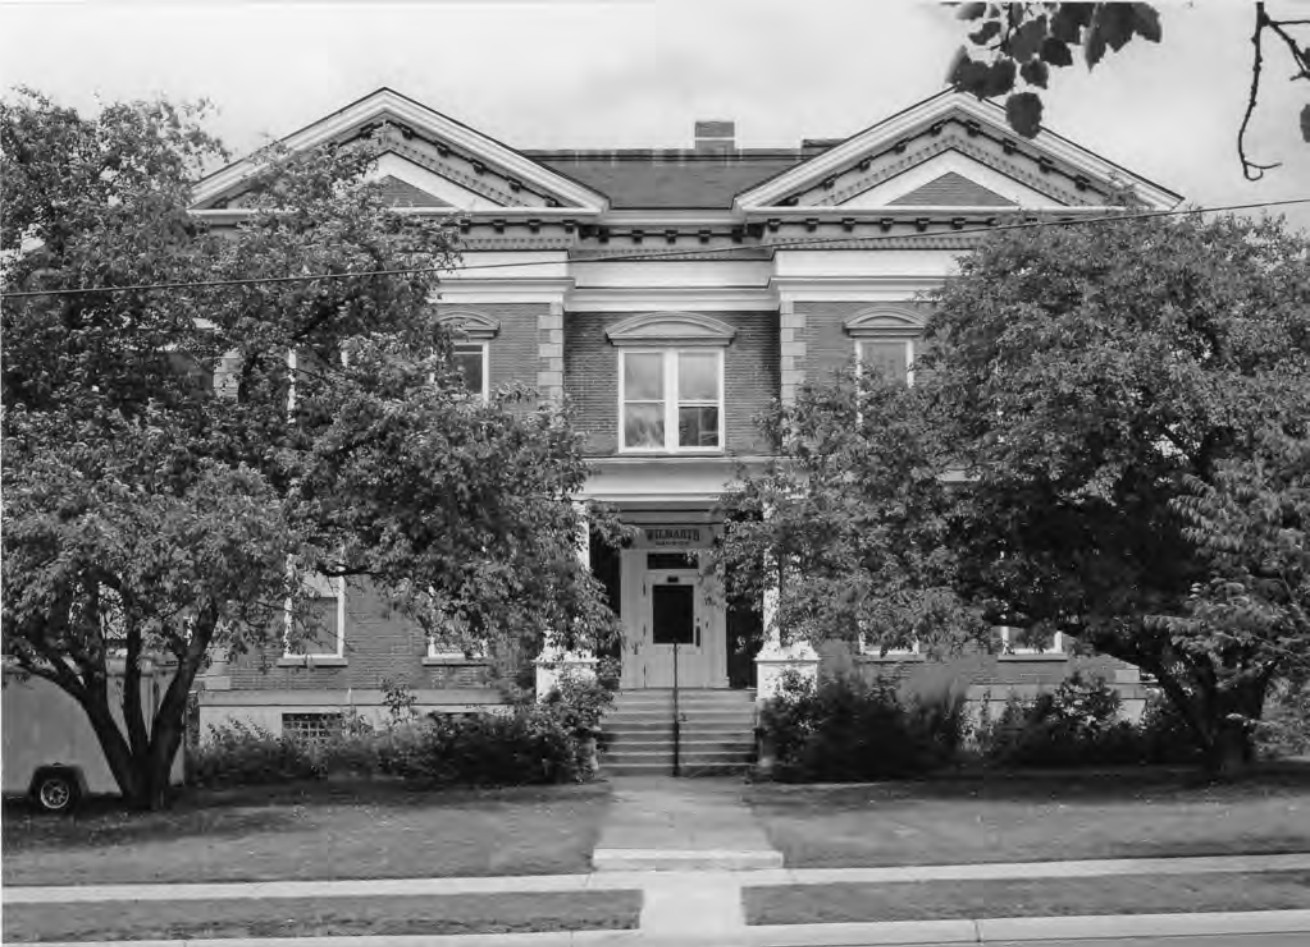
WI - ASHLAND COUNTY - WILMARTH MANSION, ASHLAND GENERAL  
HOSPITAL - 0001

987 west.jpg 30.08.11

Southwest Façade: The main entrance to the house is on the southwest side, fronting and parallel to Chapple Avenue. This façade is composed of a set-back center bay, flanked by twin pedimented bays.

The central recessed bay contains the front door, set within a larger surround. On the second floor is a pair of one over one double hung windows set below a large segmental arch pediment. The entry is through an open porch with a poured in place concrete base with a set of seven steps, three of which are engaged. The porch roof is flat with a simple flat frieze supported by twin sets of paired, fluted columns with capitals of the Corinthian order, set upon a single boxed plinth, which returns to the building in the form of a balustrade, ending with a single column. The paneled door is wide with a single rectangular light in the upper 60%, centered between fluted pilasters with a transom window above the door and within the surround. Above, there is a simple painted sign that reads "Wilmarth Mansion," presumably placed there when the building was used as a museum and replacing the cartouche that would have likely matched those on the northwest.

The two side sections are identical. Each has two evenly spaced windows per floor. Those of the first floor have triangular pediments; those on the second have segmented pediment. Here, as in all changes of projection around the house, the difference in wall plane is emphasized by quoins.

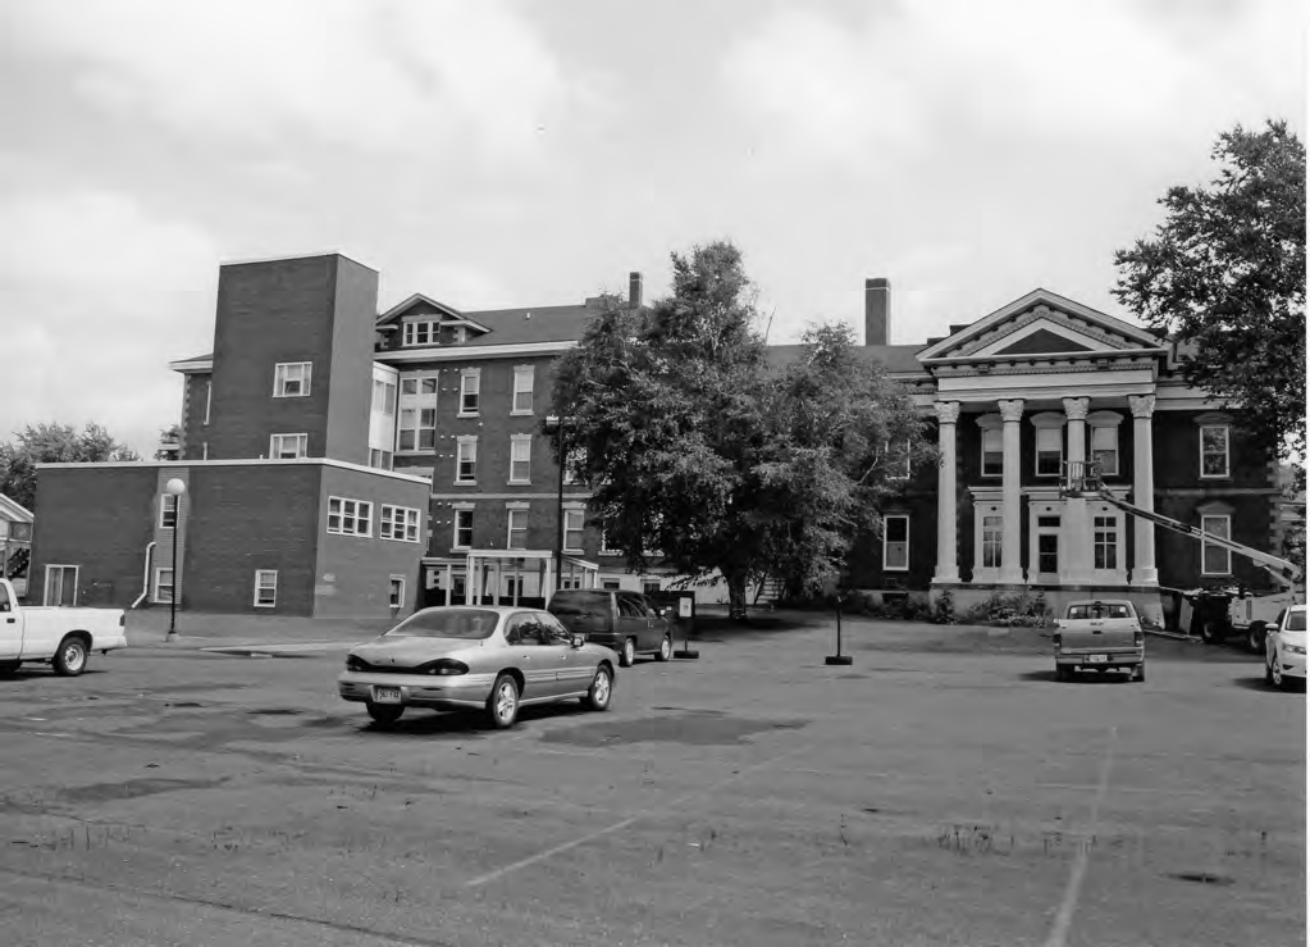
WI - ASHLAND COUNTY - WILMARTH MANSION / GENERAL HOSPITAL - 0002

987 north. jps 30.08.11

Northwest Façade: This elevation consists of a three bay, slightly projecting central portion defined by a pedimented portico with a single bay to each side. This tetraprostyle porticoed façade originally provided what can only be supposed to have been an unobstructed, panoramic view of Lake Superior from this elevated point five blocks away.<sup>1</sup> There is a ten-foot deep, two-story pedimented portico across the center bay. The portico floor was at some unknown date replaced by painted wood planks. Four colossal columns of the Corinthian order atop concrete plinths support the roof. There is presently no railing between these columns. It may be supposed that the original plinths and surrounding balustrade would have mirrored the wood construction of the entry porch on the Chapple side, but no evidence has yet been forthcoming.

The dominant central portion projects forward three feet. The first story windows and central door within the portico have transom windows with a cartouche above, the surrounding aedicule is composed of fluted pilasters, atop boxed plinths, surmounted by an entablature at the level of the surrounding stone stringcourse. Above each of the first floor openings is a second floor window set under a segmented pediment. Each of the flanking bays has a single centered window on each floor.

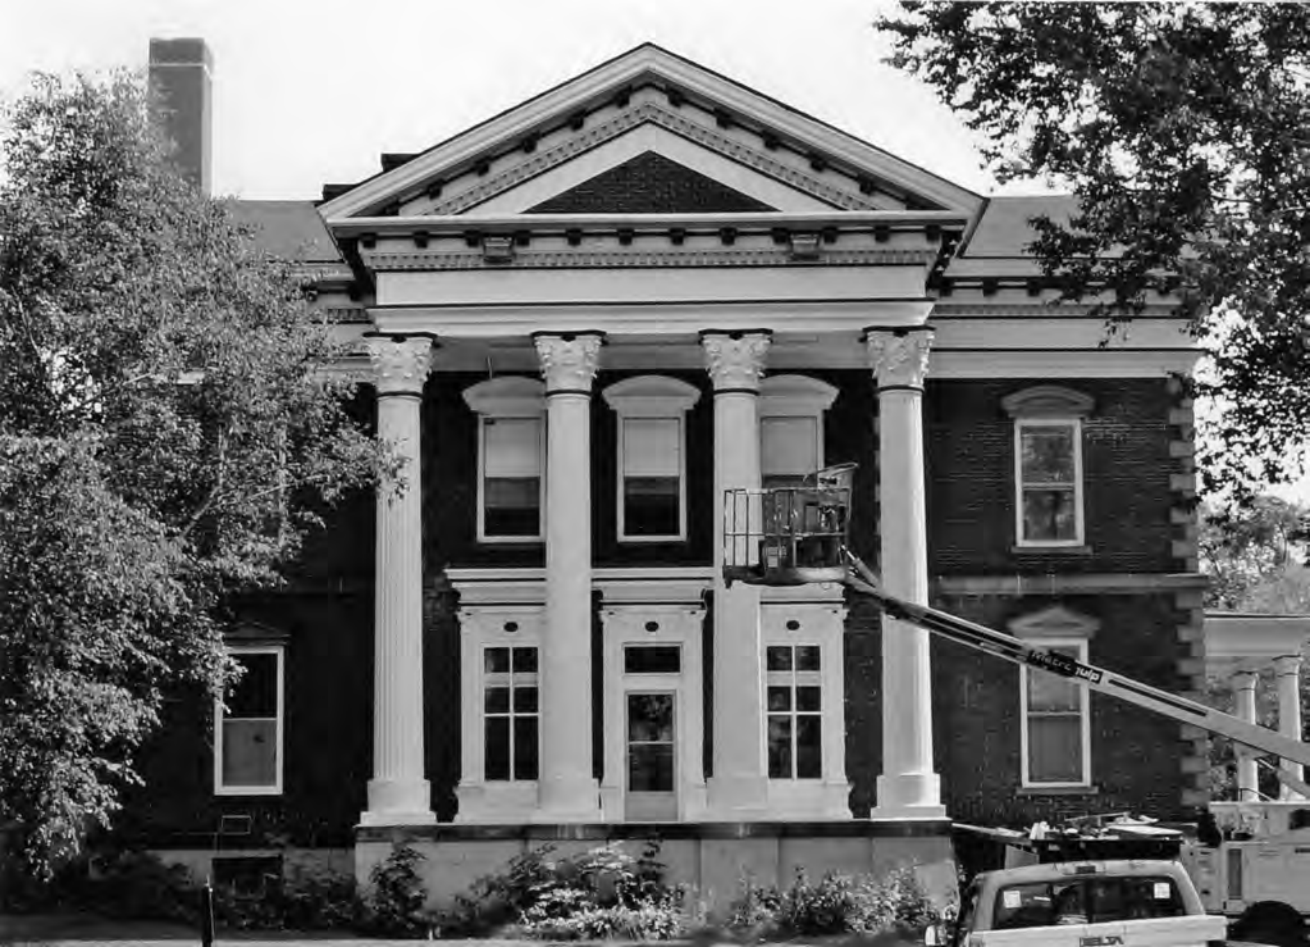
WI - ASHLAND COUNTY, WILMARTH MANSION ~~GENERAL~~ HOSPITAL - 0003

987 Portico.jpg 30.08.11

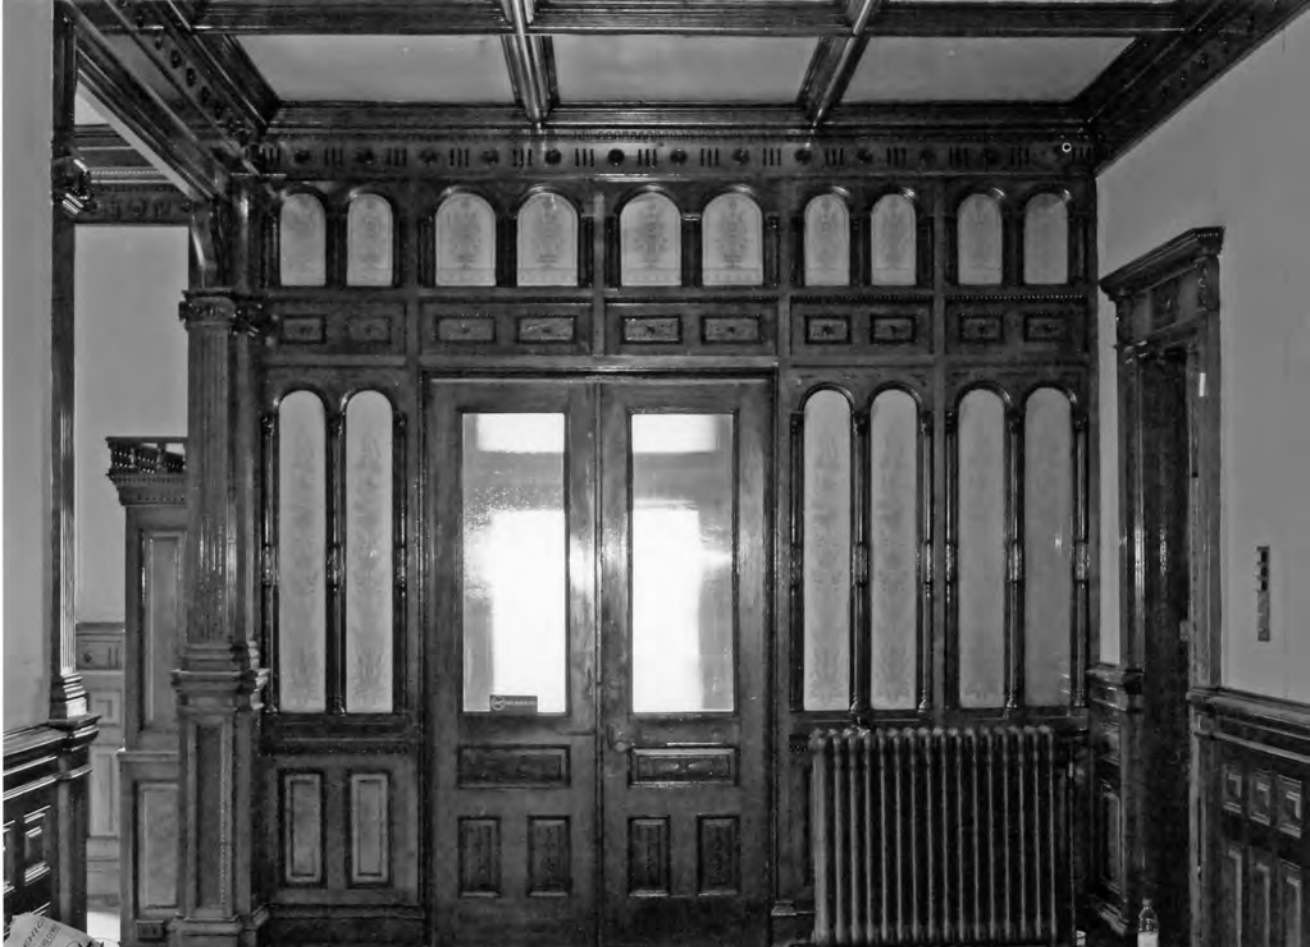
WI - ASHLAND COUNTY - WILMARTH MANSION / GENERAL HOSPITAL - 0006

987 entrescreen.jp9 30.08.11

Vestibule - 101: Entry begins in a 4'-6" deep by 12' wide vestibule, which served as a place of shelter while waiting for entry into the home. The interior wall is an impressive paneled screen containing a stilted arcade with glass inserts etched in a foliated pattern and matching clerestory. Only two of these glass panels have even minor damage. The paired doors have large waterglass panels and incised fans and flowers. These doors have moderate damage from the retrofit and removal of several locking systems.

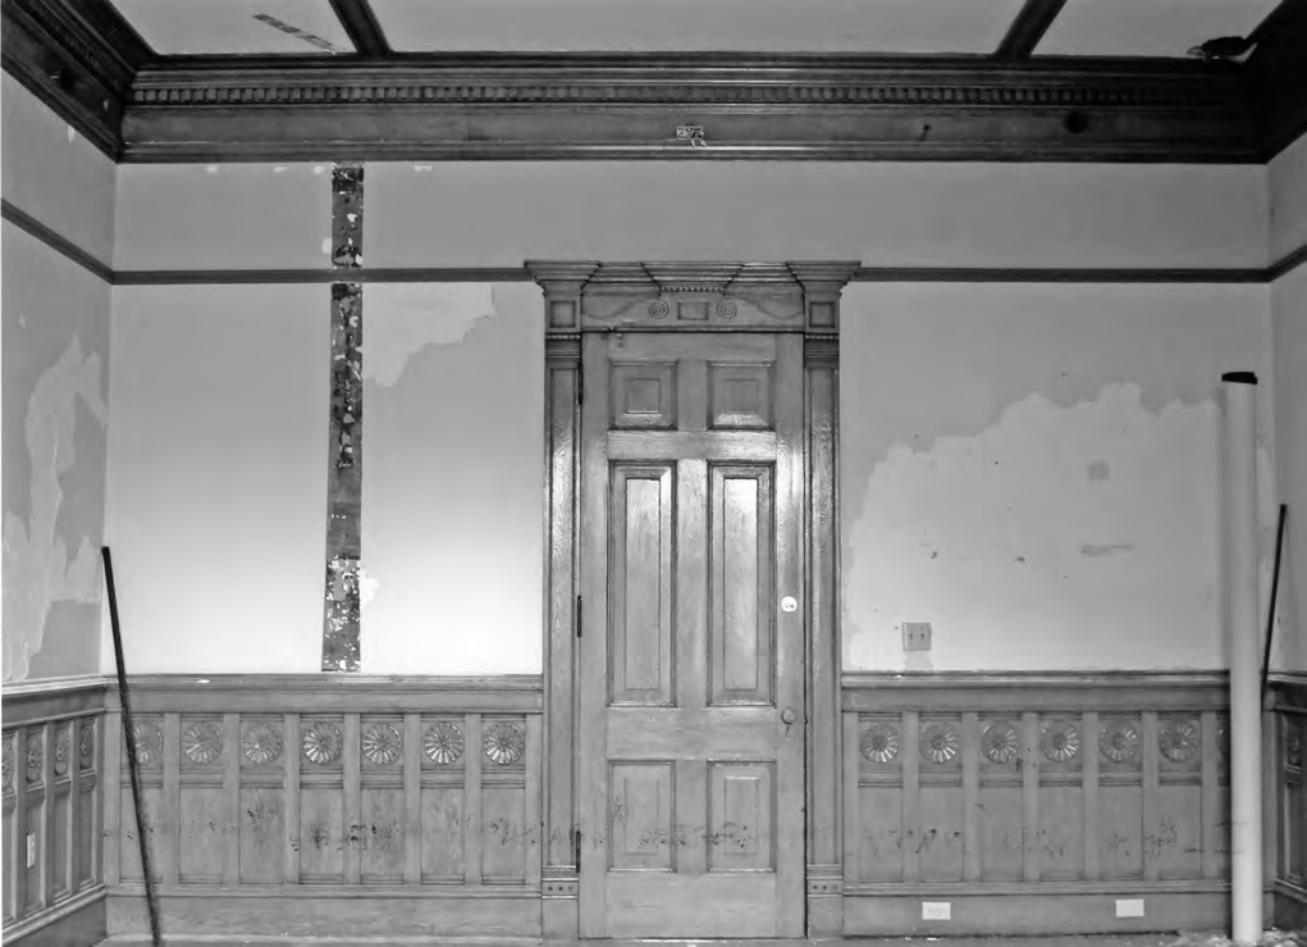
WLI-ASHLAND COUNTY-WILMARTH MANSION/GENERAL HOSPITAL-0014

11:08:11 30.08.11 dining.jpg

Dining Room - 106: The original fireplace surround and hearth in this 16' x 23' room has been replaced with a non-conforming design. The cornice is a wood entablature and the ceiling is coffered. The wood-paneled dado and the door and window trims are of a higher style in this room.
