# National Register of Historic Places Registration Form

Historic Name: García/Espinosa/Garland Ranch Headquarters  
Other Names/Site Number: 5CN.1919  
Name of related multiple property listing: n/a

Street & Number: 7527 County Road 16  
City or town: Antonito State: CO County: Conejos  
Not for Publication:  Vicinity:

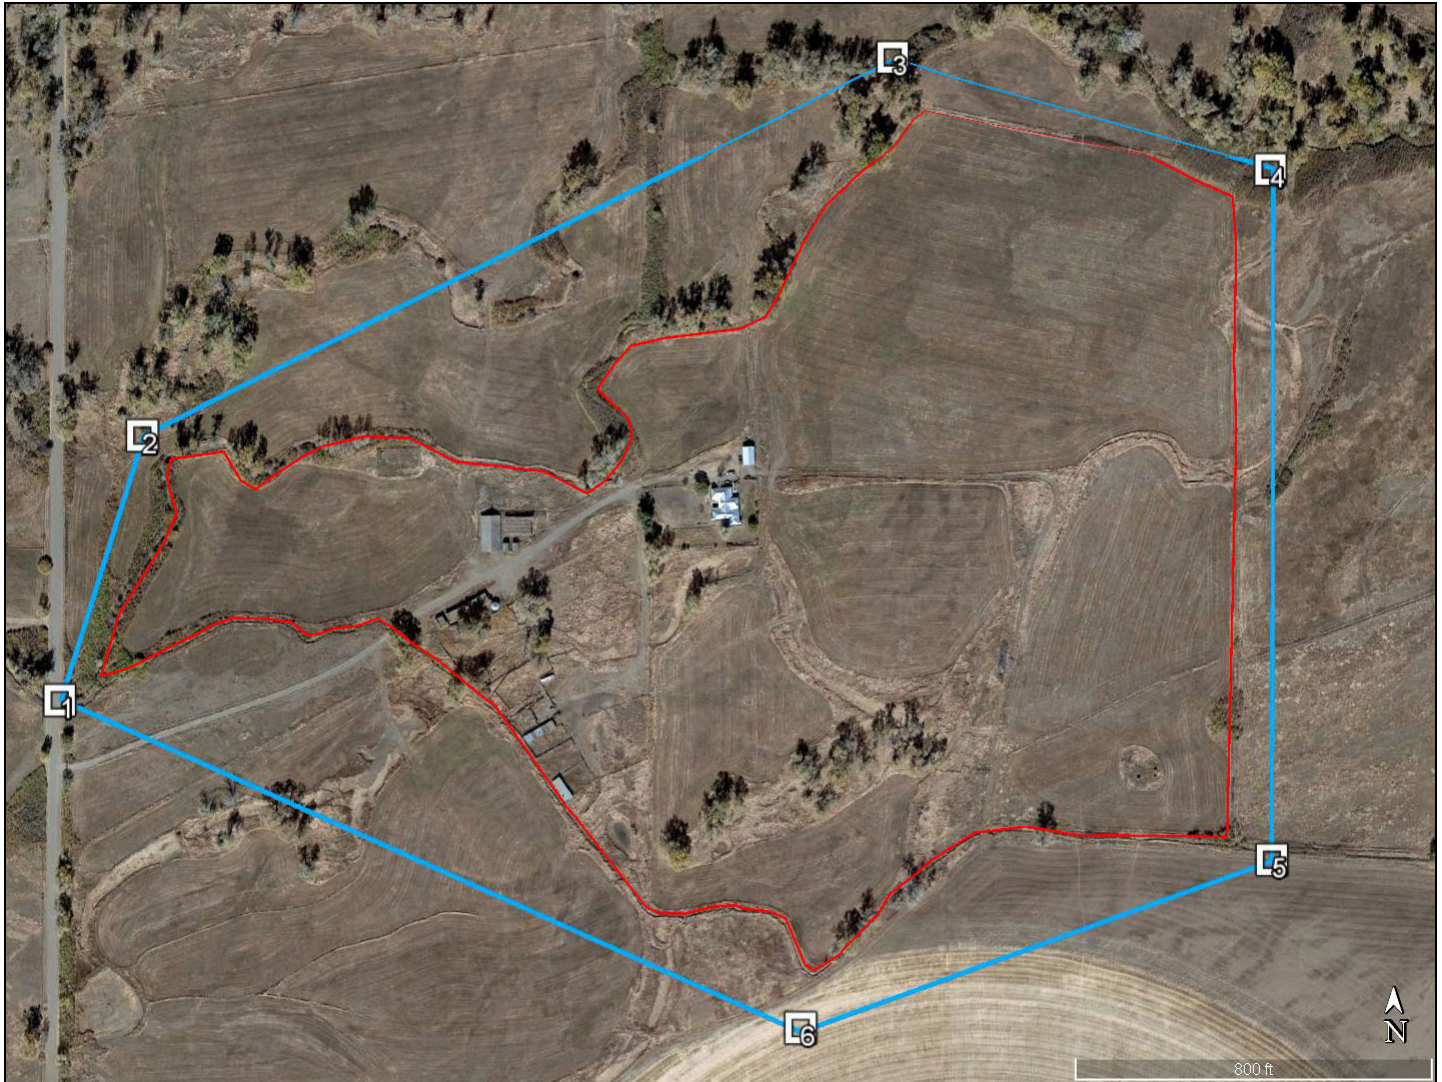
**Location Map**

The outside figure with thicker line (blue) and numbered vertices (shown in table below) is the bounding polygon; the inner polygon with the thinner line (red) is the nominated area boundary. Image Date: 14 October 2016

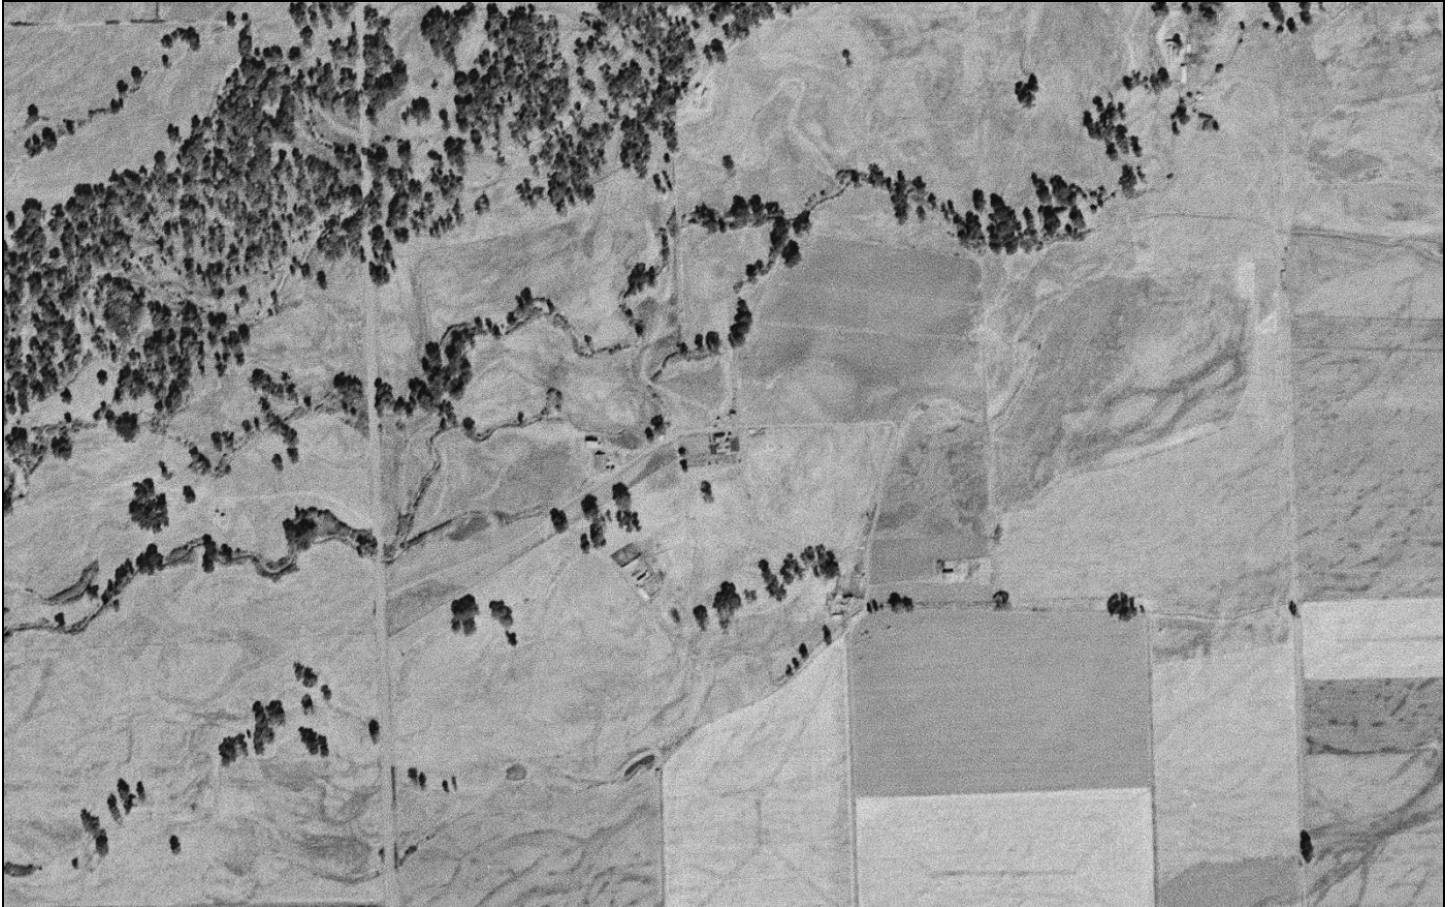
Figure 5. The ranch headquarters is shown near the center of this extract from a 1953 aerial photograph. The garage is present north of the house, and the Lafayette García house is still standing to the southeast. Hay appears to be stacked northwest of the potato cellar. Aerial photograph VV BE M2 AMS 133, 29 September 1953. Courtesy of Colorado School of Mines, Golden, Colorado.

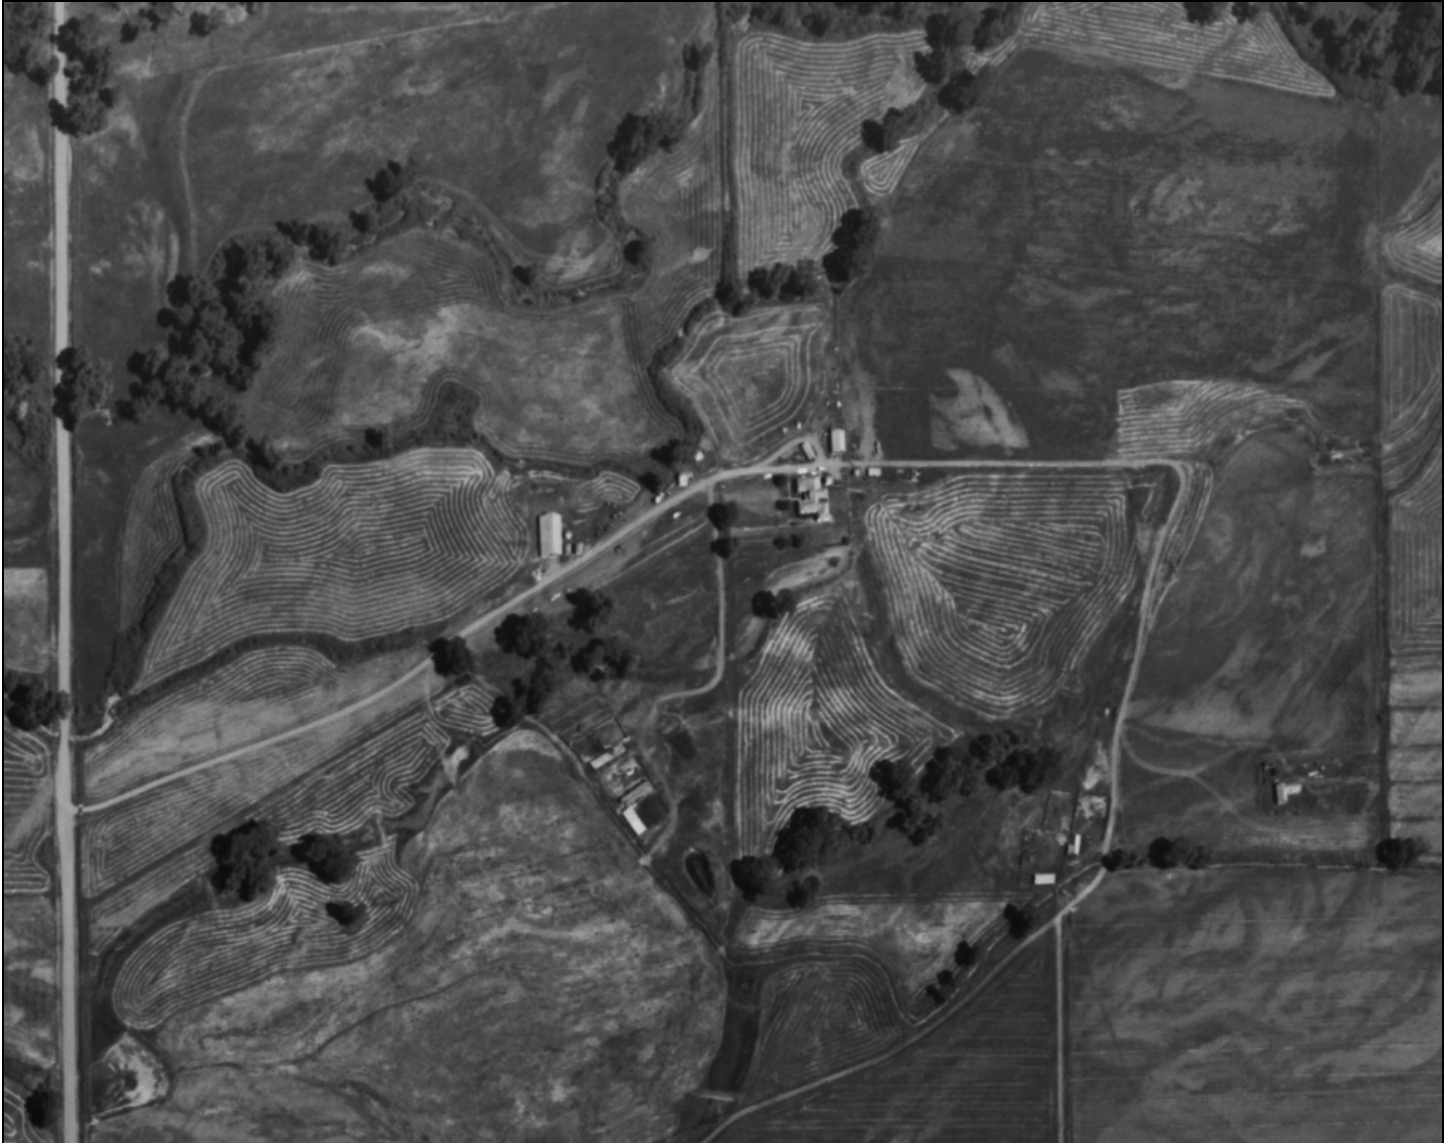
Figure 6. This August 1965 aerial photograph provides a good view of the headquarters area and surrounding hayfields. North is toward the top, and County Road 16 extends along the west edge of the photograph. The house is slightly above the center of the image with the large rectangular potato shed to the west on the north side of the access road. The Lafayette García house, near the right edge of the image is still standing. Aerial photograph VBB1 00050 70, 25 August 1965 (extract). Courtesy of Colorado School of Mines/U.S. Geological Survey.

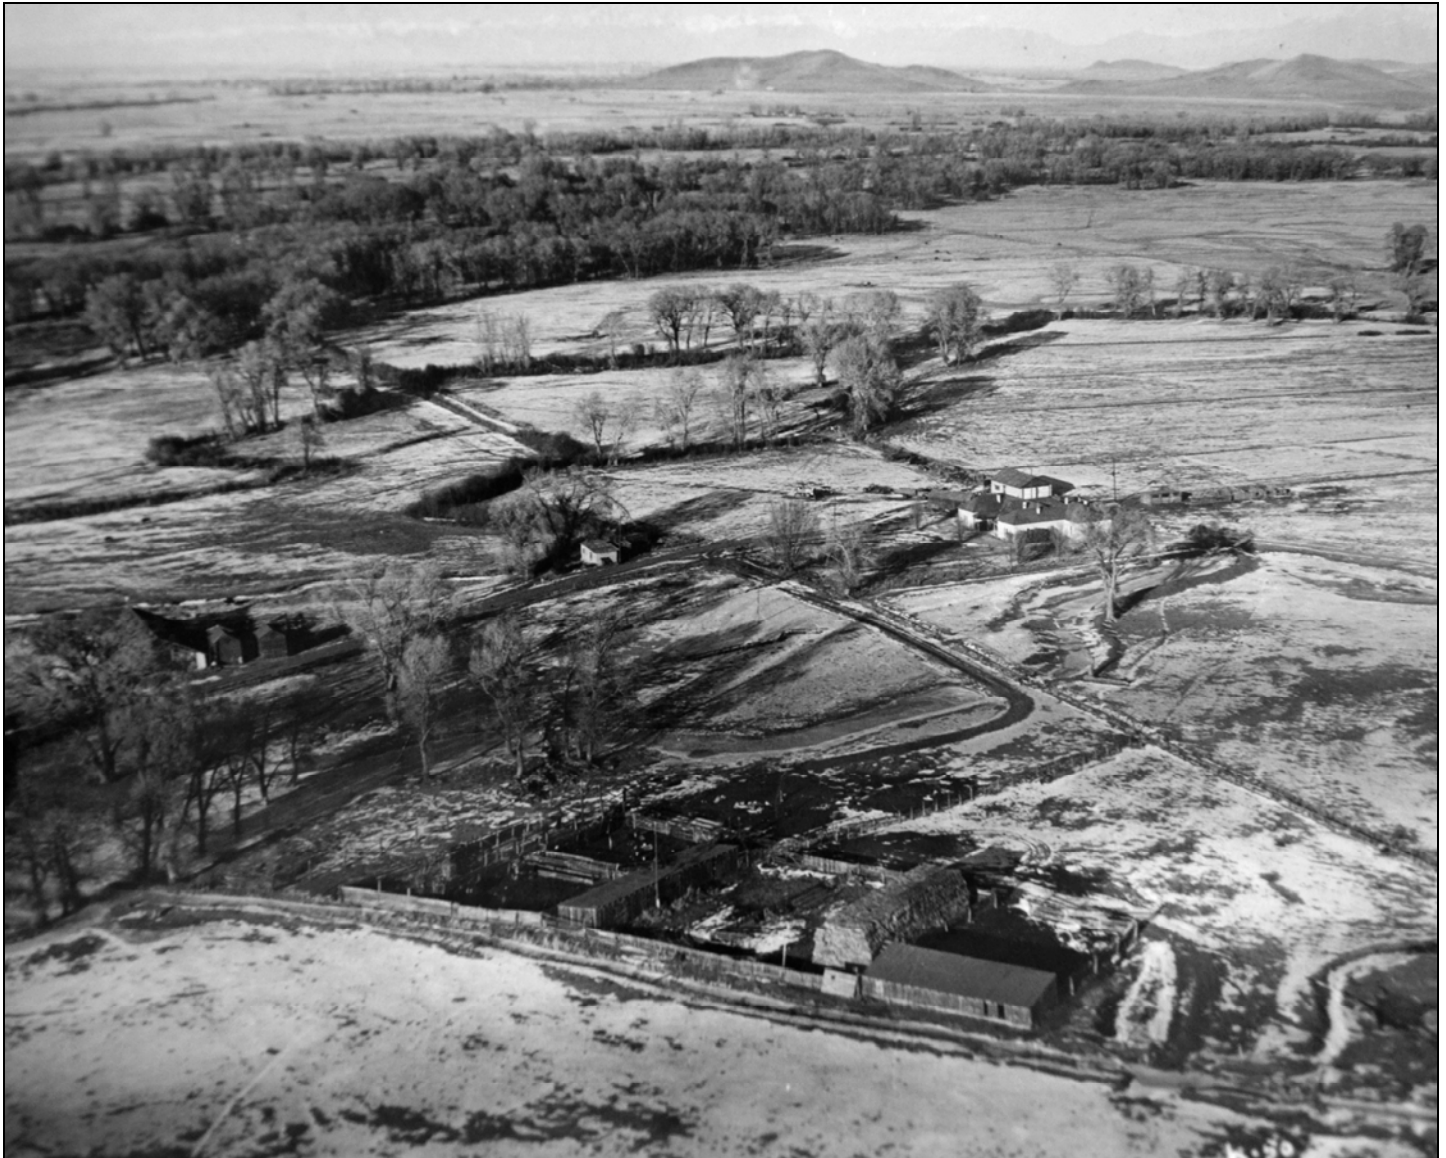
Figure 7. This undated pre-1968 oblique aerial (view northeast) shows the access road from County Road 16 arcing from the center left edge of the image to the house and garage at the right center of the image. The frame milk separator house north of the house and milk shed to the east are no longer extant. West of the house on the north side of the access road stands an adobe tack shed (now in ruins). Farther west are the two frame granaries and the potato cellar (partially screened by trees). In the foreground is the corral area with the two sheep sheds and a tall rectangular haystack. The band of trees to the north marks the course of the Conejos River. Courtesy of Erik Daniels, Manassa, Colorado.

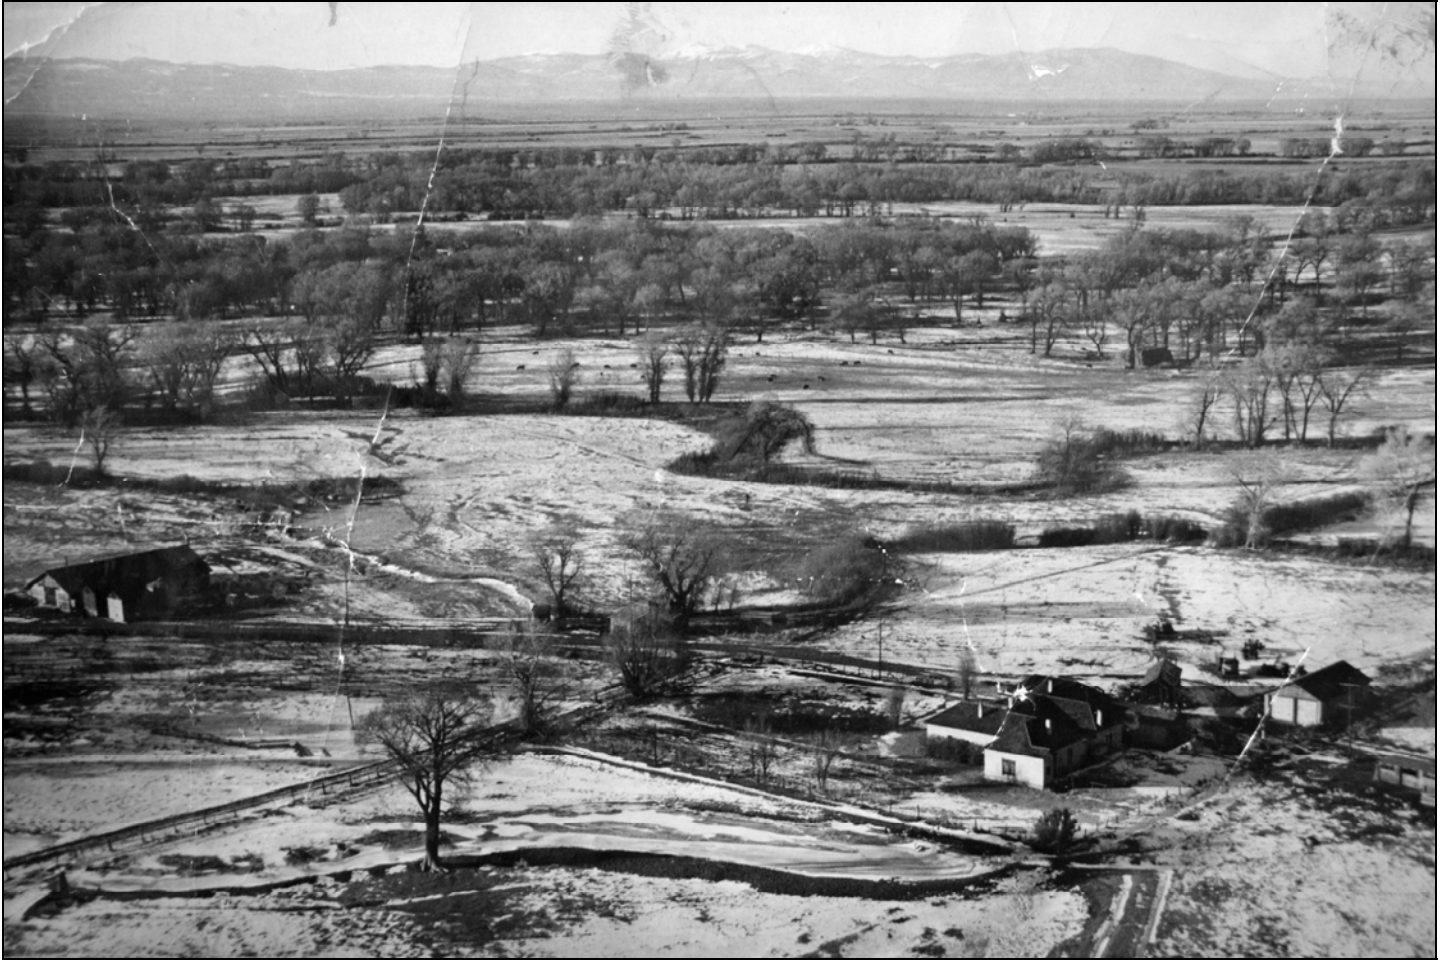
Figure 8. This undated pre-1968 oblique aerial provides a north-northwest view of the ranch. The access road from County Road 16 arcs from the center left edge of the image to the house and garage at the lower right. The frame milk separator house lies between the house and garage with the milk shed to the east. West of the house on the north side of the access road stands an adobe tack shed (now in ruins) with the privy to the west. Farther west are the two frame granaries and the potato shed. Courtesy of Carolyn Garland Daniels, Manassa, Colorado.
