United States Department of the Interior
National Park Service
National Register of Historic Places
Registration Form

historic name Notch Mountain Shelter

other names/site number Notch Shelter; 5EA.906

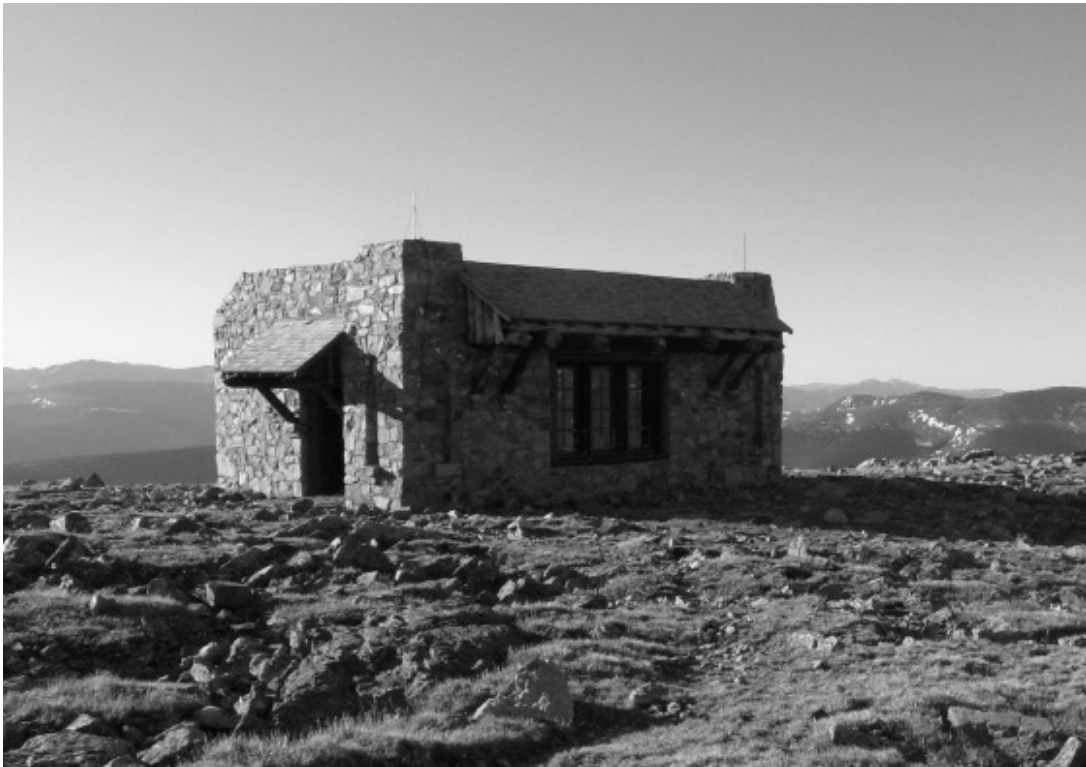
Photo 1. View of north and west sides of Notch Mountain Shelter, Patrick Uphus, 2011.

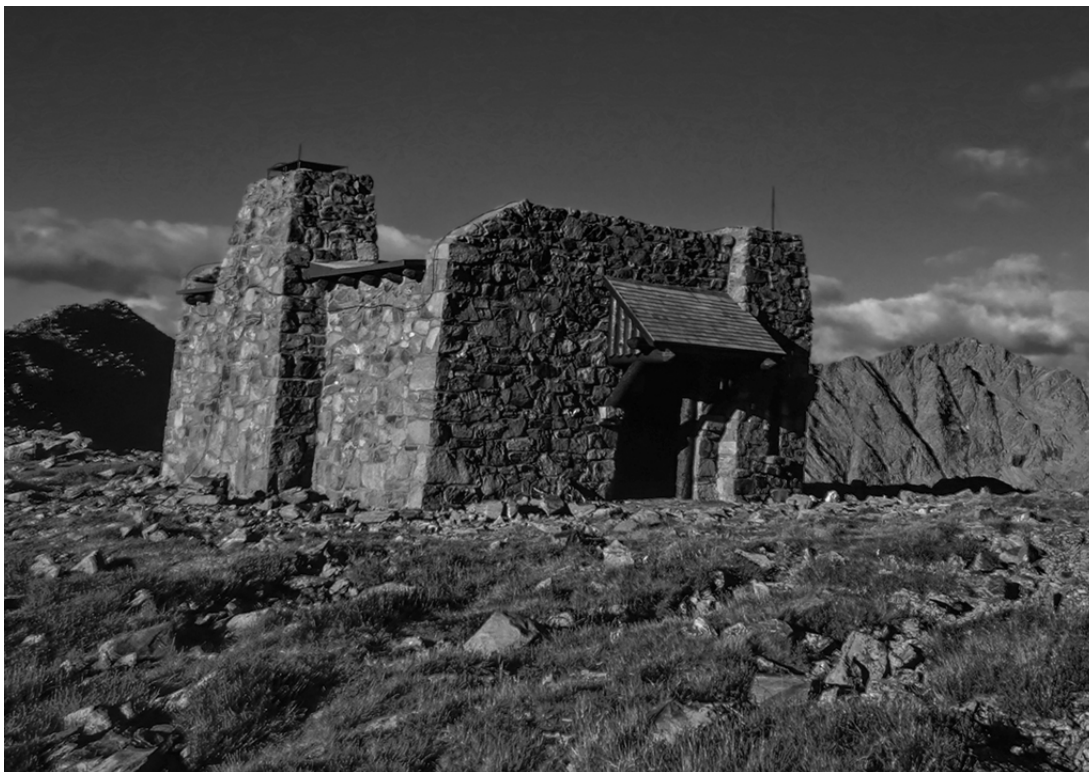
Photo 2. View of north and east side of Notch Mountain Shelter, Patrick Uphus 2011.

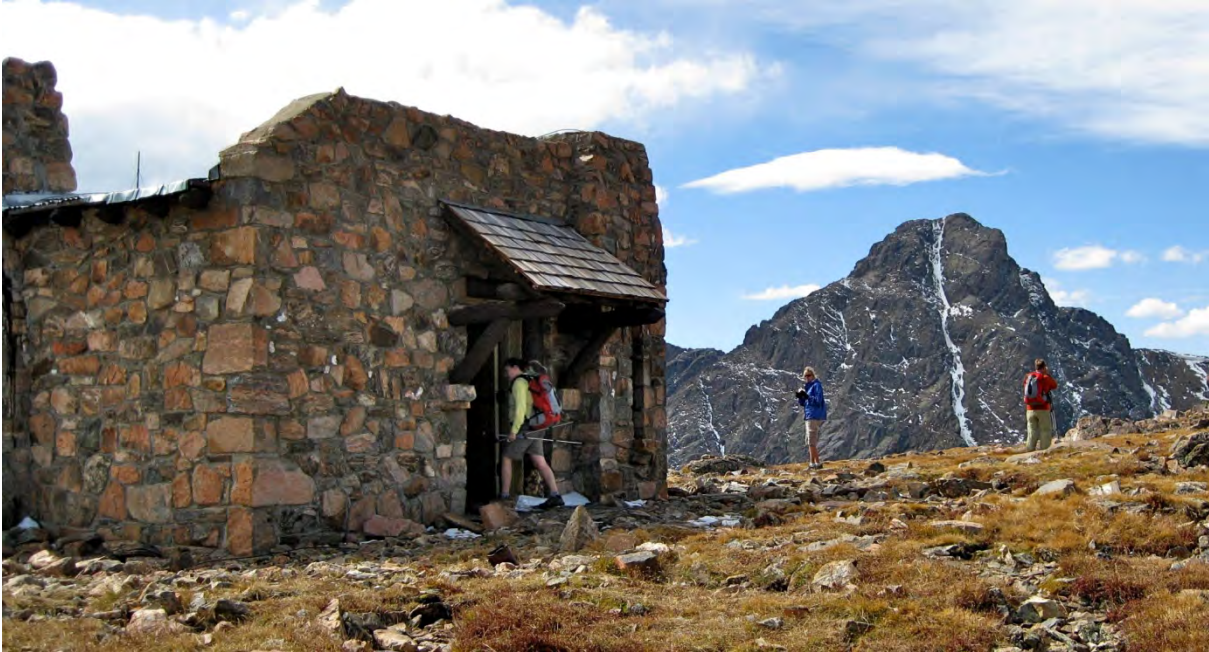
Photo 3. View of the north side of building with Mount of the Holy Cross in background, David Frey 2011.

Photo 3. View of the north side of building with Mount of the Holy Cross in background, David Frey 2011.

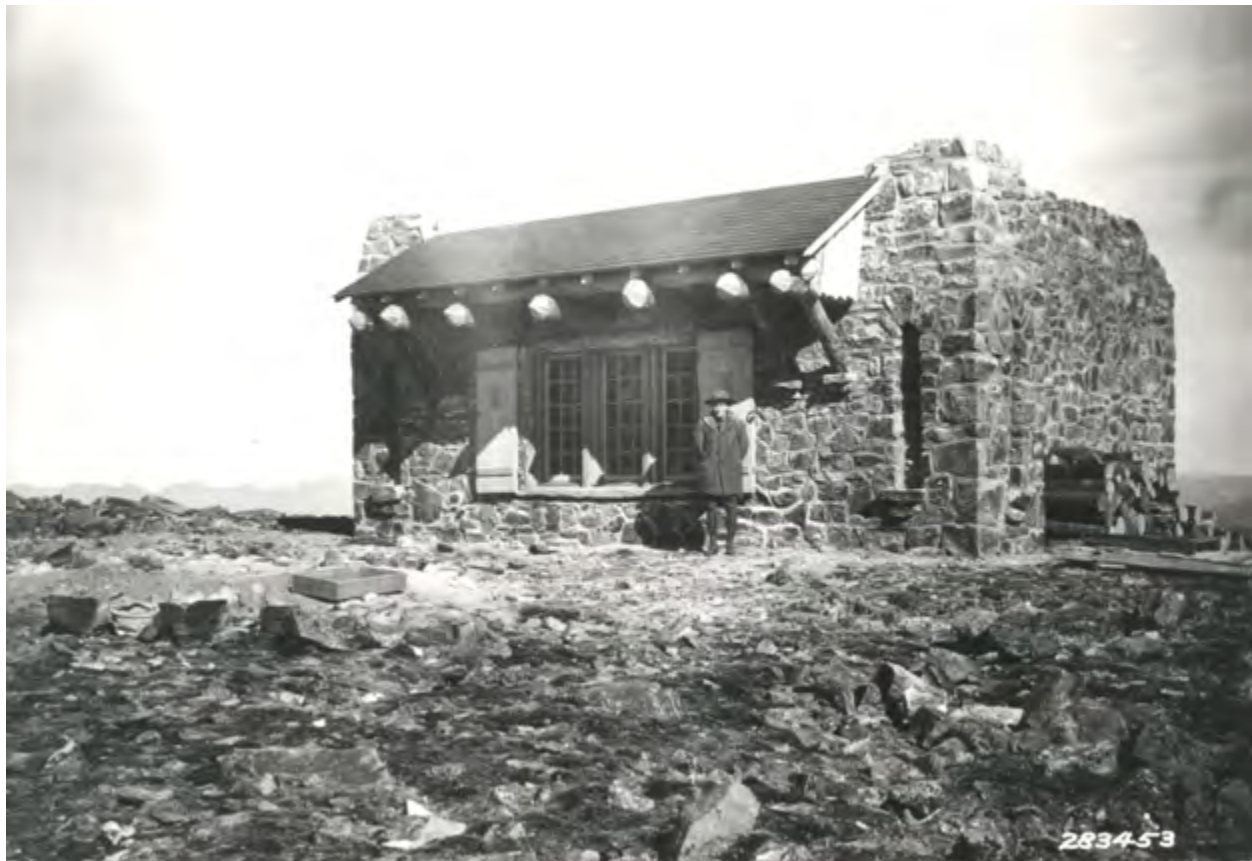
Photo H1. West and south sides of Notch Mountain Shelter, 1934, White River National Forest. Source: White River National Forest Supervisor's Office, Glenwood Springs, CO.

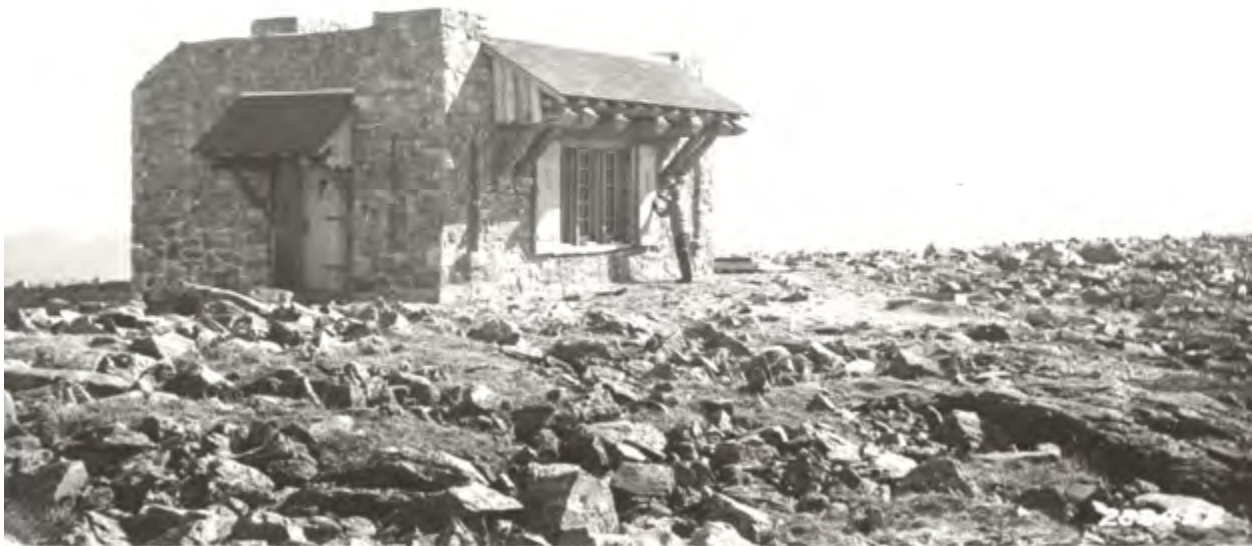
Photo H2. North and west sides of Notch Mountain Shelter, 1934, White River National Forest. Source: White River National Forest Supervisor's Office, Glenwood Springs, CO

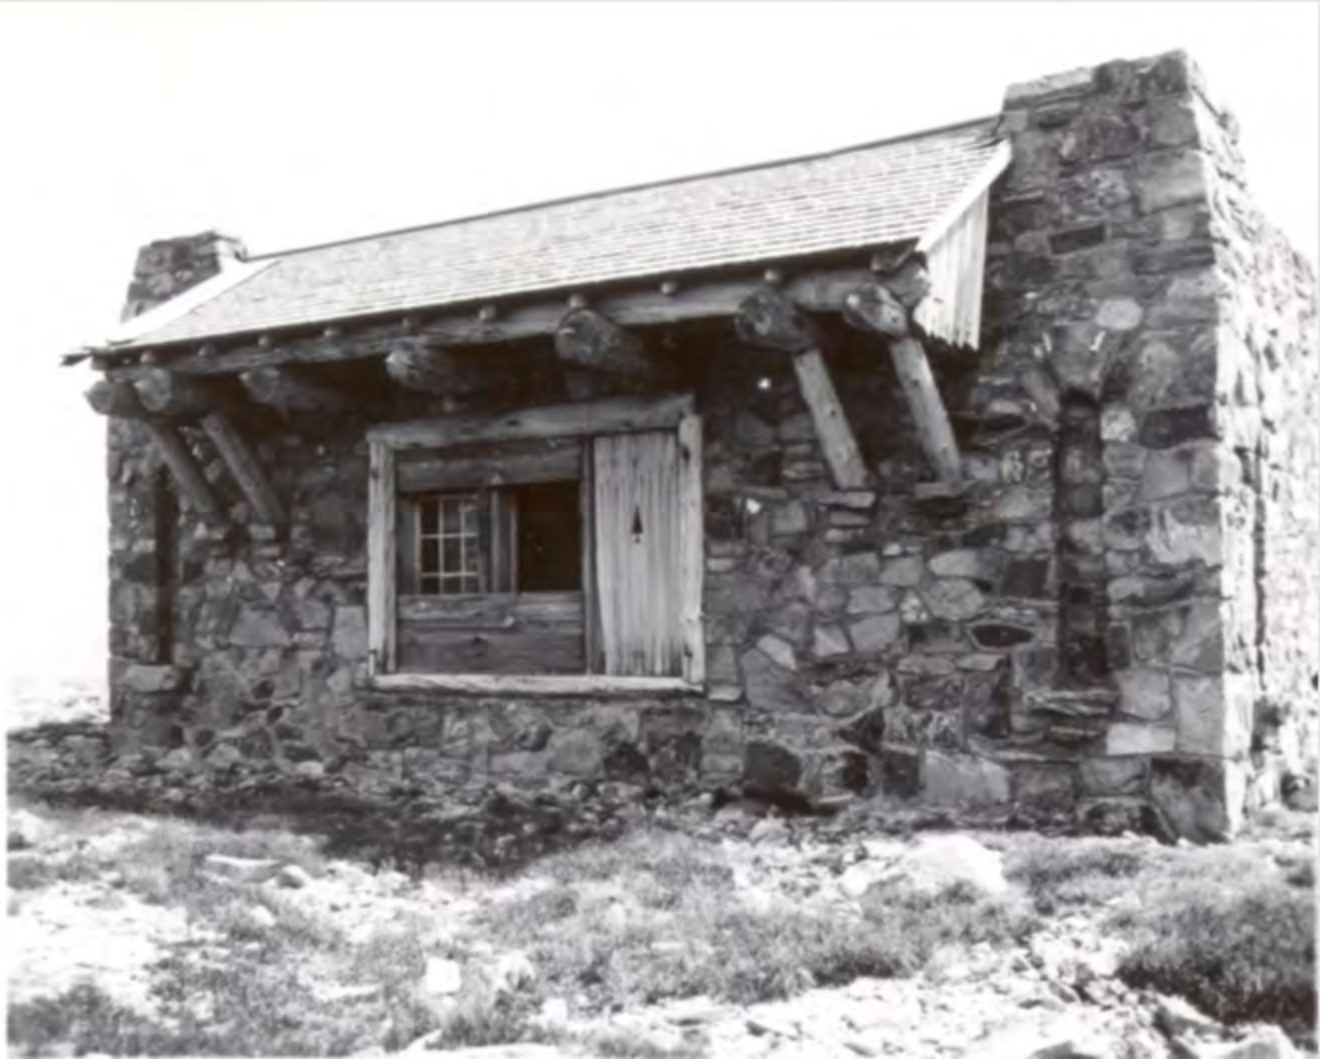
Photo H3. West side of Notch Mountain Shelter, 1950, White River National Forest. Source: White River National Forest Supervisor's Office, Glenwood Springs, CO

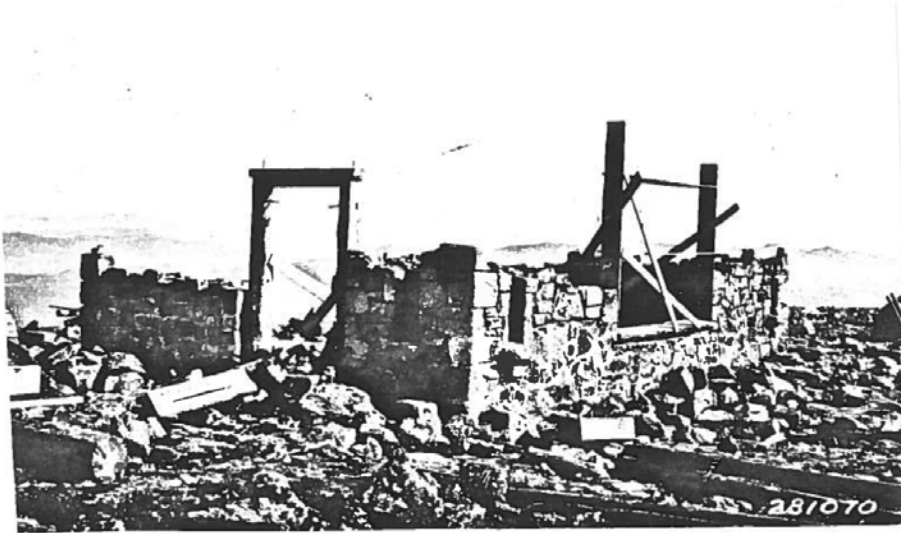
Photo H4. "Shelter House at Summit Notch Mountain (WR761)." Source: White River National Forest Supervisor's Office, Glenwood Springs, CO. Photo 281070. August 1933.

Photo H4. "Shelter House at Summit Notch Mountain (WR761)." Source: White River National Forest Supervisor's Office, Glenwood Springs, CO. Photo 281070. August 1933.
