National Register of Historic Places
Registration Form

historic name Denver & Rio Grande Western Railroad Caboose No. 0578

Denver & Rio Grande Western Railroad
Caboose No. 0578
Jefferson County, Colorado

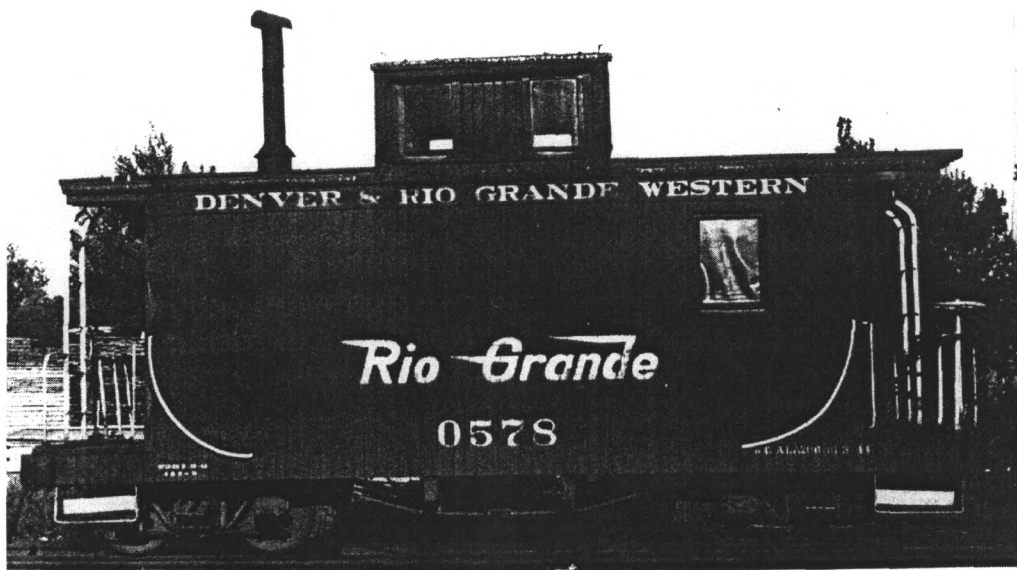
Figure 10 Caboose No. 0578 in Montrose; photographer Vollrath; September 1946.
Source: Robert L. Grandt, *Narrow Gauge Pictorial, Volume V, Caboose of the D&RGW*. Robert L Grandt, 1987.

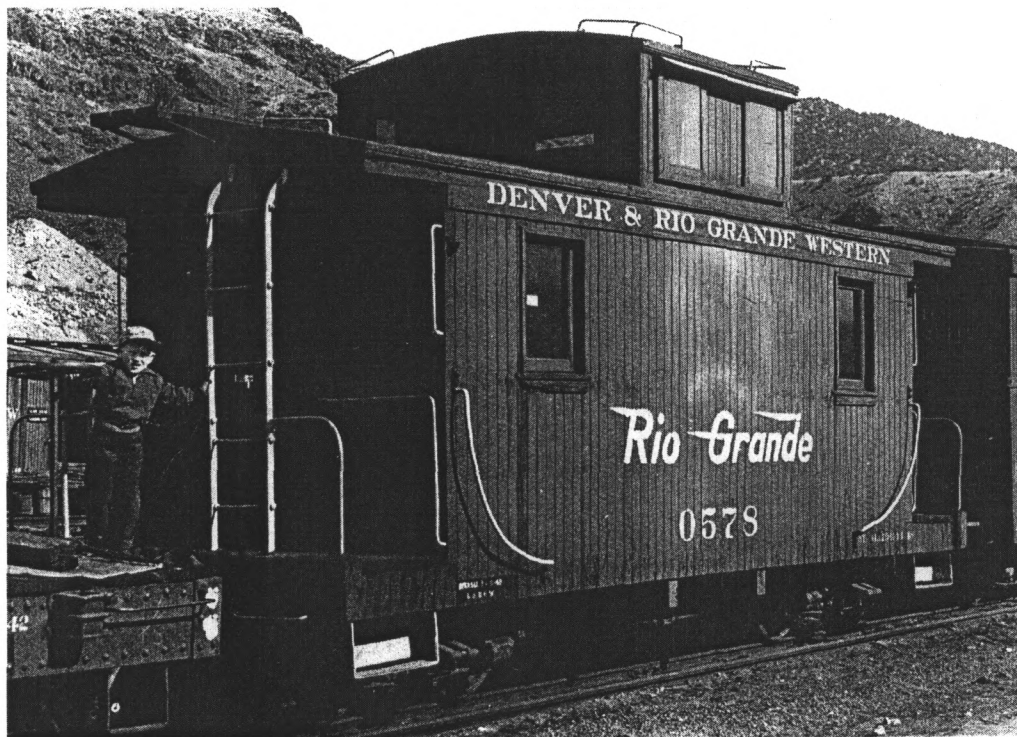
Figure 11 Caboose 0578 in Salida; photographer Maxwell; February 1952.
Source Robert L. Grandt, *Narrow Gauge Pictorial, Volume V, Caboose of the
D&RGW*. Robert L Grandt, 1987.
