National Register of Historic Places Registration Form

Historic name Teske Farmstead
Other name/site number _____

Teske Farmstead
Pottawatomie County, Kansas

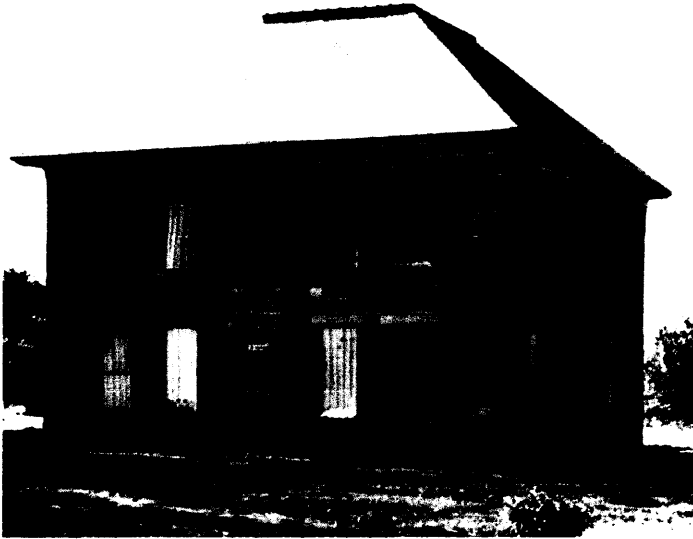
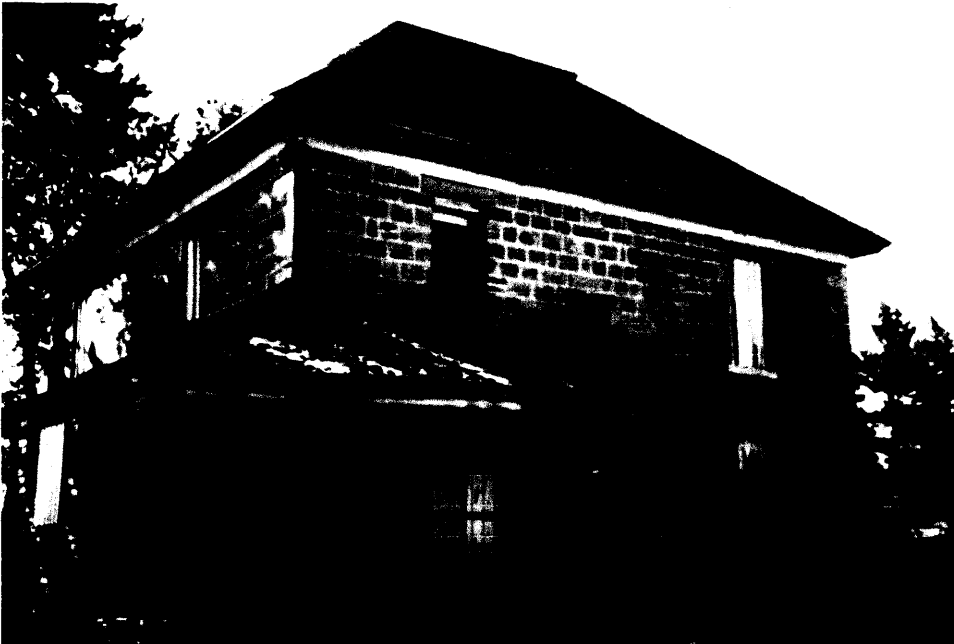
*View of Farmhouse when current owners purchased farmstead in 2002, before renovation.
Upper- North and West Facades
Lower – South and East Facades*

The existing farmhouse pre-dates the barn by more than thirty years. The two-story house is constructed of native limestone. The plan form is square and the house has a hip roof and a entry porch in the center of the north, front facade. The central entry is flanked by regularly-spaced double-hung windows creating a formal symmetry typical of the Georgian Revival style. Dressed stone quoins at the corners frame each facade. Bolts extant on the front of the house and reflections of Teske descendants indicate that the original porch was wider (but not full-width) and had a sleeping porch on the second floor.

The house retains its original form and roof shape although twin chimneys have been removed. The existing metal roof is a contemporary replacement; the original roof was likely wood shingles. A one-story shed porch wraps around the southeast corner of the house. A bathroom, which was formerly enclosed on the west end of the south porch, was removed in the recent remodeling. The porch is now screened but maintains its historic configuration. The house had been vacant for approximately fifty years and was in deteriorated condition when it was purchased by the current owners in 2002. It has undergone extensive repair and remodeling to return it to a livable home. The doors and windows were deteriorated and many missing. The openings had long been boarded up. The remodeling maintained the original openings with few exceptions and reused original interior trim where possible. The existing windows are replacement 1/1 double-hung windows. The only openings that have been modified are a second-floor window on the east facade that had been converted to a door to provide access to the roof of the east porch. This opening was returned to a window. A doorway that formerly led to the south porch was infilled to accommodate cabinets in the kitchen. The interior configuration is a standard four-square plan with kitchen, dining room, living room and parlor on the ground floor and four bedrooms upstairs. The stairway is centrally located and accessed in the center of the south side of the home, aligned with the front entrance in the center of the north facade. Formerly enclosed, the stairway has been opened at the foot of the stairs, between the kitchen and dining room, and opened on the second floor creating a sitting room in the southwest corner in place of the fourth bedroom. Interior bathrooms were added to the first and second floors in the center of the east half of the house. Although the interior was in very poor condition after standing vacant for years, some original features were salvageable such as the original flooring on the second floor, some interior trim, and special features such as the double-doors between the living and dining room. The structure of the ground floor was collapsed and had to be reconstructed. A small cellar was originally located in the center of the south side of the house and a new crawl space was added beneath the entire house to accommodate mechanical systems.
