Name of Property			
	tood Wistoria District		
	tead Historic District		
er names/site number Resour	ce #WH1545		
Location			
et & number County Road	56		not for publication N/A
y, town Garner		X	vicinity
Arkansas code	AR county White	code 145	zip code 72052
Classification			
vnership of Property	Category of Property	Number of Resource	s within Property
private	building(s)	Contributing N	oncontributing
public-local	X district	6	buildings
public-State	site		sites
public-Federal	structure		structures
	object		objects
		6	0 Total
ame of related multiple property list	ing:	Number of contribut	ing resources previously
istoric and Architectura		listed in the Nationa	
f White County, Arkansas		110100 111 1110 110110	Thogastor
State/Federal Agency Certific	cation		
Signature of certifying official	* Ingra		1-/3-90 Date
Arkansas Historic Pr	eservation Program		
State or Federal agency and bureau			
In my opinion, the property me	ets does not meet the National	Register criteria. See cont

PROPERTY Walker Homestead Historic District

NATIONAL REGISTER OF HISTORIC PLACES REGISTRATION FORM ______ 1. Name of Property ______ historic name: Walker Homestead Historic District other name/site number:

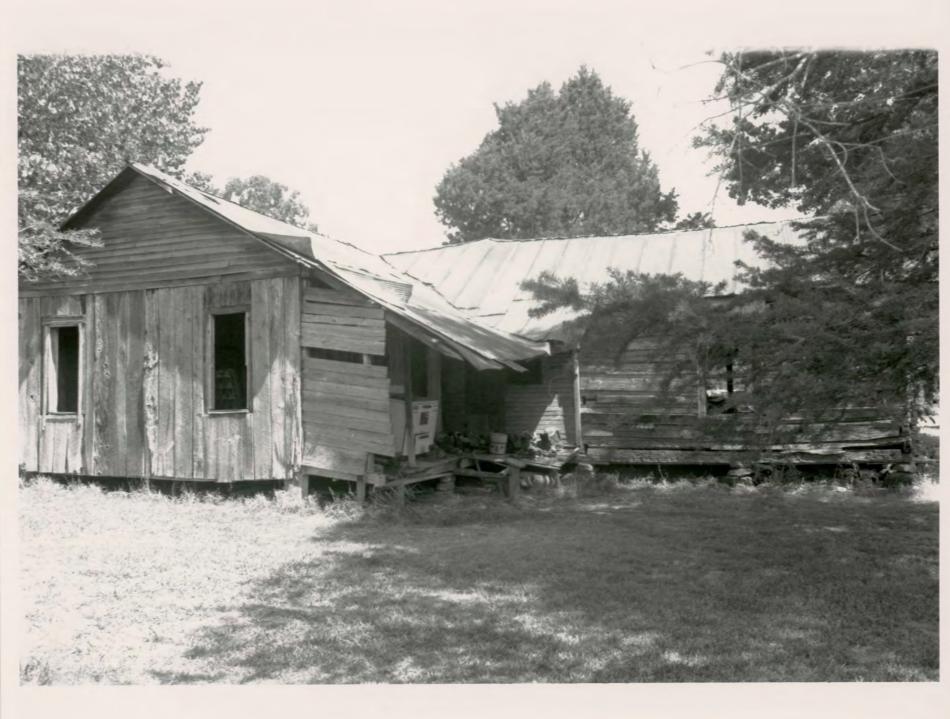
The William Walker, Sr. House was the first building to be built by the Walker family at this site. It was initially constructed c. 1850. Before a second pen and open hallway were added to form a dog-trot, the original building was one-story tall, square in shape, gable roofed, and constructed of hand-hewn logs. All of the original logs are 18' 1.5" in length, are square notched, and chinked with hand-rived horizontal battens. Even though this house was built c. 1850 and is presently unoccupied, it is still in fair condition. The building's original entrance faces north toward County Road 56.

WILLIAM WALKER, SR. HOUSE, WALKER HOMESTEAD HISTORIC DISTRICT
GARNER VIC., ARKANSAS WHITCH
PHOTOGRAPH BY S. MITCHELL
VUNE, 1988
NEGATIVE ON FILE AT AHPP
VIEW FROM SOUTHEAST
#1

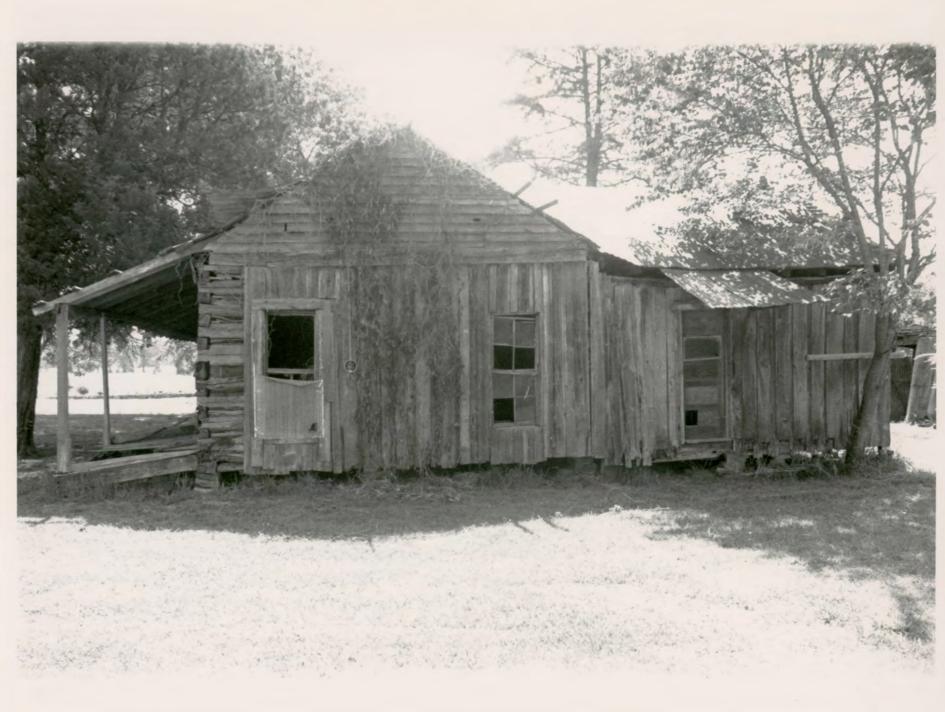
Two four-over-four double-hung sash windows are located on the west elevation of the original pen. The lower portion of this side has been clad with board and batten while the upper portion is covered with weatherboard. A 9' 2.75" hall (originally open, but now enclosed) is located on the east elevation of the original pen. The exterior of the enclosed hall is clad with novelty siding and is relieved by a double door which is situated east of center. This hall is attached to another square log pen which was added at a later time. This pen is constructed of logs which are 18' long, chinked with hand-rived horizontal boards and joined with half-dovetail notching. The north elevation of this pen is relieved by a paired window from which all sash has been destroyed.

VIEW FROM WEST

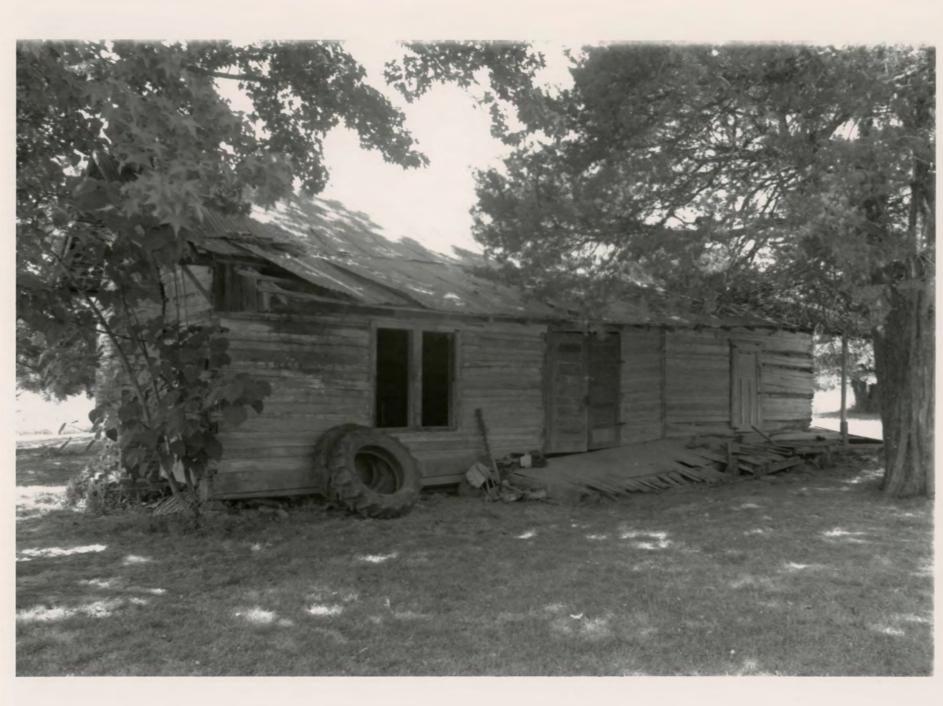
WILLIAM WALKER, SR. HOUSE; WALKER HOMESTERD HISTORIC DISTRICT GARNER VIC., ARKANSAS ensite Co PHOTOGRAPH BY S. MITCHELL JUNE, 1988 NEGATIVE ON FILE AT AHPP VIEW FROM NORTHEAST

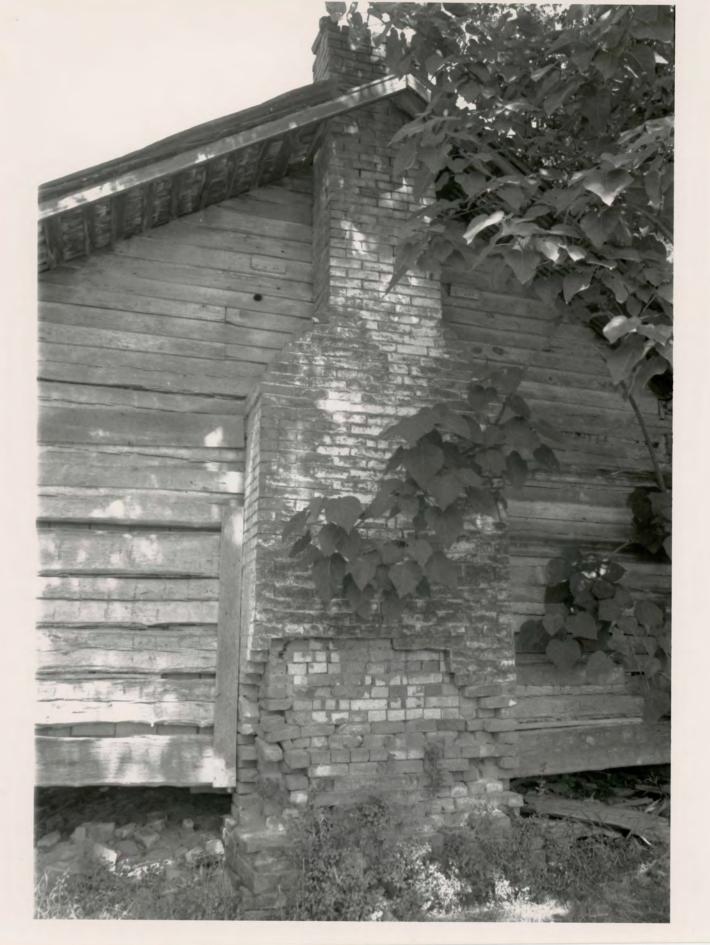
A brick chimney is located at the gable end of the east elevation, with weatherboarding covering the upper portion. Both gable roofs of this building are now covered with corrugated steel. The remnants of a double-hung sash window are the pen's only openings on its south elevation. A single square, board and batten, pen is attached to the south elevation of the original pen. The only windows in this pen are located on the south elevation and in both cases all sash has been removed. An interior end metal flue is located at the apex of the gable. The east and west elevations of this room are each relieved by a single door. The door on the east elevation opens onto a deteriorated shed roof porch which extends the length

WIZZIAM WALKER, SR. HOUSE; WAZKER HOMESTEAD HISTORIC DISTRICT GARNER VIE. ARKANSAS whiteco PHOTOGRAPHED BY D. MITCHELL VUNZ, 1988 NEGATIVE ON FILE AT AHPP CHIMNEY DETAIL

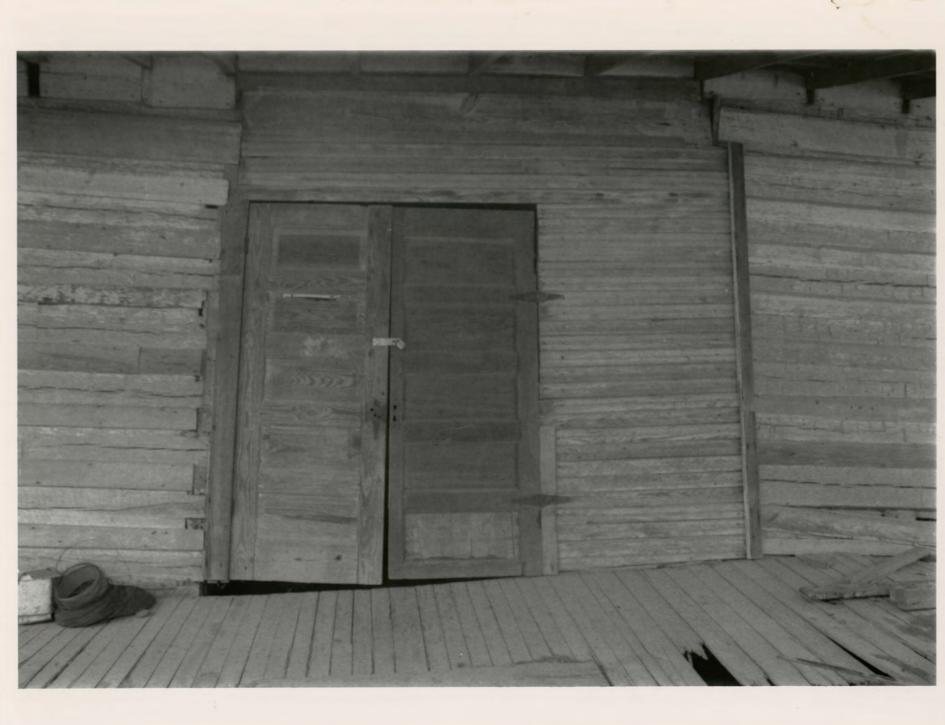
WILLIAM WALKER, SR. HOUSE; WALKER HOMESTERD HISTORICE DISTRICT CHARNER VIC., ARKANSAS WHITCHELL PHOTOGRAPH BY S. MITCHELL VUNE, 1988 NEGATIVE ON FILE AT AHPP FRONT ENTRANCE DETAIL

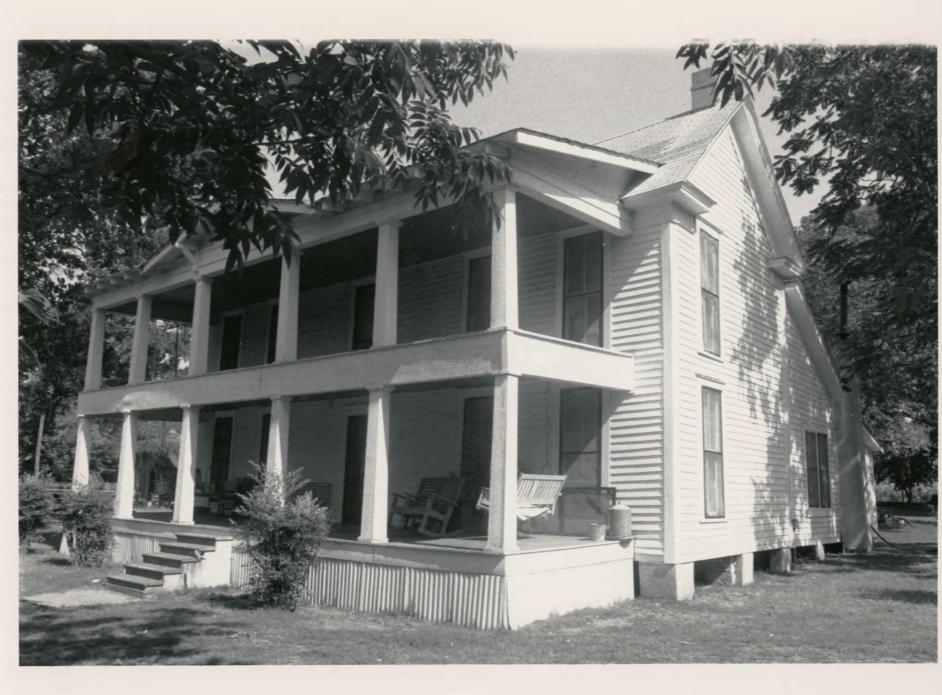
The Billy Walker House is approximately one hundred and fifty feet northeast of the William Walker, Sr. House. Constructed c. 1900, the Billy Walker House is an example of a vernacular house with Greek Revival details. It is still in good condition. The original portion of the building is two-stories tall, single-pile with central hall, and has a one-story rear ell wing. The building is built of balloon frame construction clad with weatherboard. Its main facade, which faces south, is dominated by a two-story porch which stretches across three-quarters of the building. It has a shed roof from which a central, bracket-supported, triangular pediment rises. Six box columns with simple capitals support each of the porch floors. A centrally placed side-gable door leads provides access to each of the porches.

Facade fenestration consists of symmetrically placed two-over-two double-hung sash windows. The west elevation of the two-story portion of the building is relieved only by two-over-two double-hung sash windows and gable returns. Continuing along this elevation towards the north is the western side of the rear ell. A large stucco clad chimney separates the main block of the building from this wing. The side-gable entrance found on this wing is crowned by a shed roofed stoop which was a later addition. This entrance is located slightly north of center and is flanked by paired windows. While the windows north of the door are similar in light arrangement to ones found on the south elevation, the other windows are four-over-four double-hung sash windows. Fenestration on the north elevation of the ell consists of two double-hung sash windows which have different light arrangements. One has four-over-four sash while the other has two-over-two sash. Only one gable return is left on this side of the building; the other was removed when a porch was enclosed. This original porch was located on the east elevation of the rear ell. It has a shed roof, modern aluminum sash windows, and has been clad with novelty siding.

Billy Walker House, Walker Homestead Historic District Garner vicinity, Arkansas Photograph by Steve Mitchell June, 1988 Megative on file at AHPP Southeast elevation

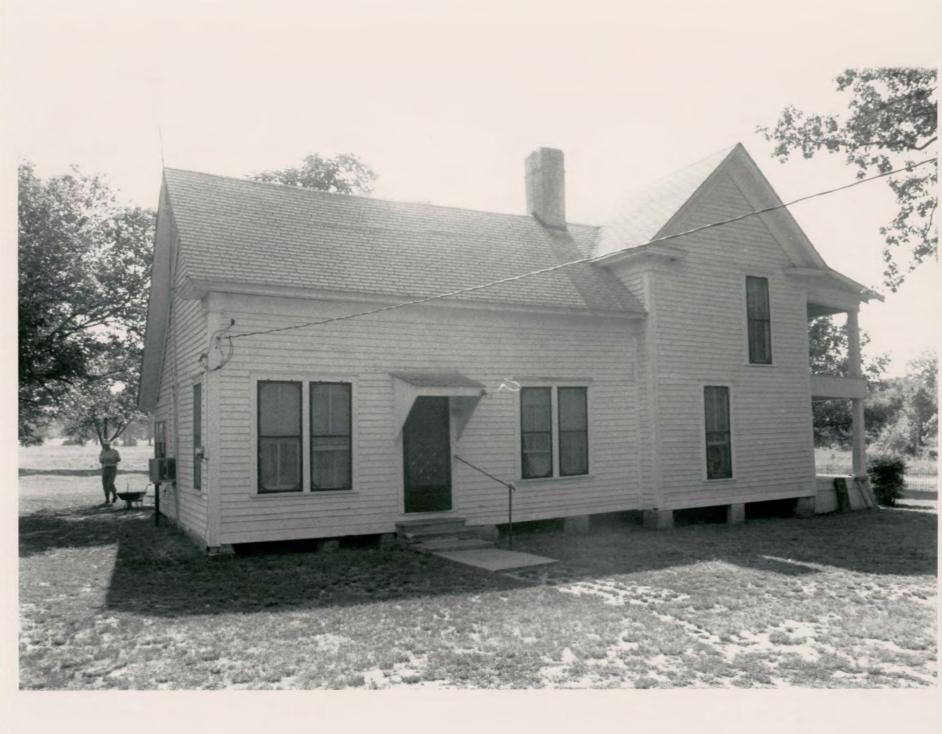
Billy Walker House, Walker Homestead Historic District Garner vicinity, Arkansas Photograph by Steve Mitchell June, 1988 Negative on file at AHPP West elevation #2

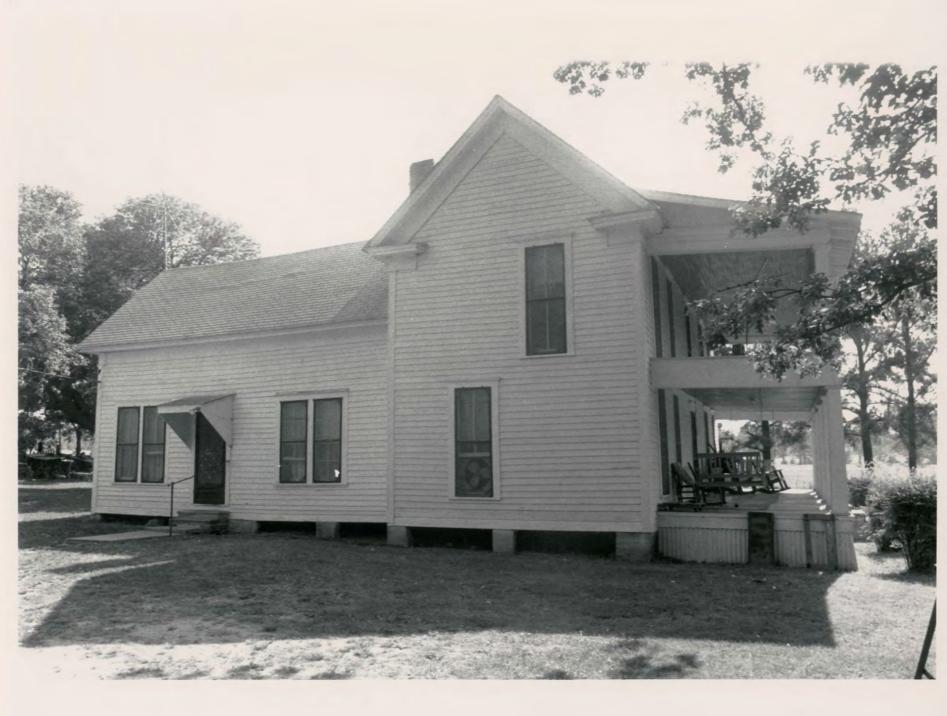
Billy Walker House, Walker Homestead Historic District Garner vicinity, Arkansas Photograph by Steve Mitchell June, 1988 Megative on file at AHPP West elevation

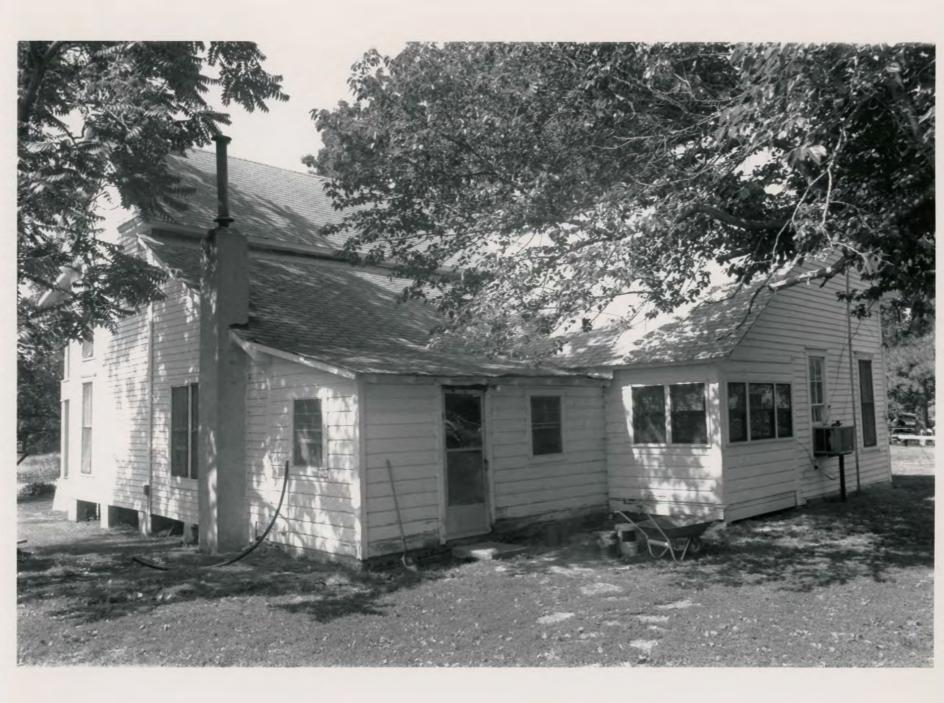
of the building is similar to the west elevation opposite in that it has two-over-two doublehung sash windows and gable returns. There is, however, a stucco clad interior end chimney present. The entire roof of the building is covered with composition shingles and the entire structure rests on a brick pier foundation.

Billy Walker House, Walker Homestead Historic District Garner vicinity, Arkansas culture Photograph by Steve Mitchell June, 1988 Negative on file at AHPP Northeast elevation

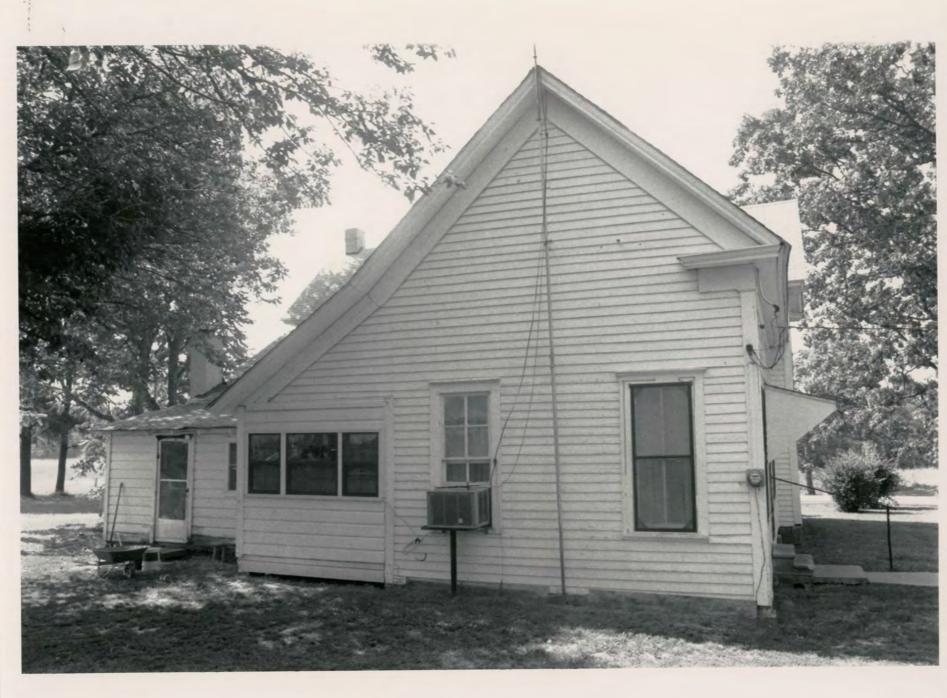
Extending from the north elevation of the two-story portion of the house is a shed roof room which has a paired two-over-two double-hung sash window on its east elevation. Slightly north of these windows is an exterior chimney which has been covered with stucco and the age of which is therefore impossible to determine. Attached to the north elevation of this room is another shed roof room which was probably a porch originally but which has since been enclosed and clad with novelty siding. It is adorned with modern aluminum sash windows and an aluminum screen door which provides access to the north elevation of the room. The roofline has exposed wooden rafters. The east elevation of the two-story portion

Billy Walker House, Walker Homestead Historic District Garner vicinity, Arkansas whitee Photograph by Steve Mitchell June, 1988 Negative on file at AHPP North elevation

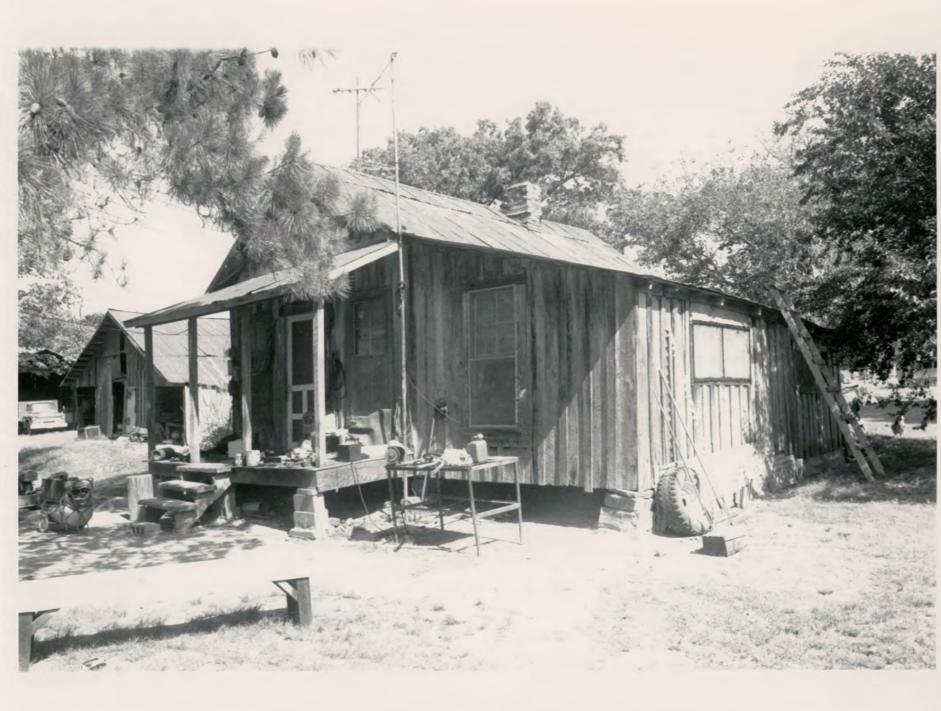
Approximately thirty feet northwest of the Billy Walker House is the Commissary Building which was probably constructed at the same time. It is a one-story, shotgun style building, two room deep and of box construction. It is clad with board and batten siding. It is currently unoccupied and is in fair condition. This gable roofed building has been covered with corrugated metal. A brick chimney rises out of the building's interior on the gable's eastern slope.

The entire building sits on a stone pier foundation. The door on the building's south elevation is flanked by four-over-four double-hung sash windows. A shed roofed porch extends the length of this original section of the structure and is supported by simple wooden posts. The windows on the west elevation of the building are similar to ones found on the south elevation. A centrally placed door on the structure's north elevation opens onto a shed roof porch which extends across three-quarters of the original portion of the building. Like the porch at the opposite end of the building it too was supported by simple wooden posts. Only one, however, survives on this porch. A shed roof addition extends the length of the structure's east elevation. A single four-over-four double-hung sash window adorns the south elevation of the addition while two four-pane pocket windows are situated on the east elevation.

Commissary, Walker Homestead Historic District Garner Vicinity, Arkansas white a Photograph by Steve Mitchell June, 1988 Negative on file at AHPP Southeast elevation

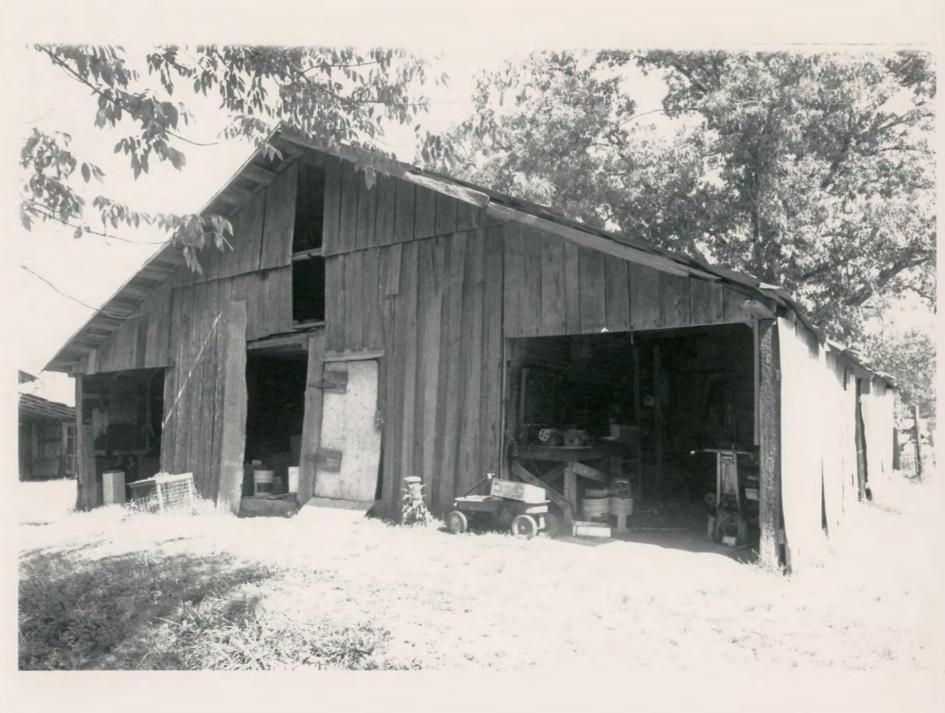
The Cotton Seed Barn is located approximately one hundred and ten feet northwest of the Commissary Building. While its floorplan is irregular in shape, it is covered by a single corrugated metal gable roof. This one-and-a-half-story building is of frame construction covered with board and batten siding. Side drives extend the length of both the east and west elevations. The east drive, however, has been partially enclosed. What was possibly originally a central drive has been partially filled in with the addition of a single door. The building does not have any other openings. It was constructed c. 1915 and is in fair condition.

Cotton Seed Barn, Walker Homesterd Historic District Garner Vicinity, Arkansas Photograph by Steve Mitchell June, 1988 Megative on file at AHPP South elevation

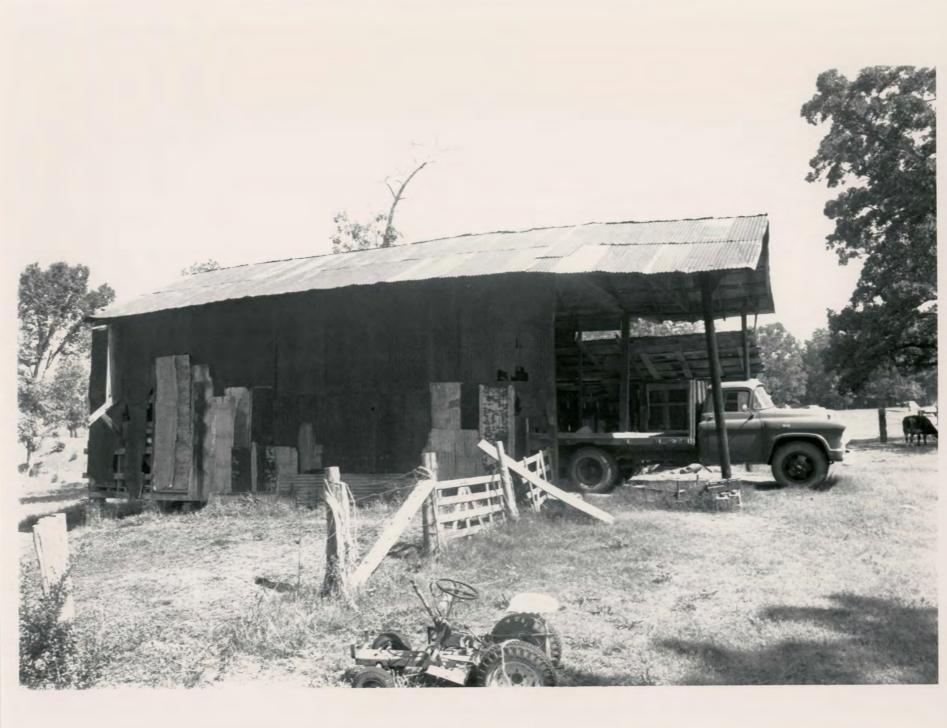
Cotton Gin, Walker Homestead Historic District Garner vicinity, Arkansas

A Cotton Gin is located approximately sixty feet northwest of the Cotton Seed Barn. It was built c. 1930, and has experienced the ravages of time; it is greatly deteriorated. The western third of the structure has been demolished and the interior has been gutted. The exterior of the structure is clad with corrugated metal and is supported by wood frame construction which rests on a brick pier foundation. A shed roofed addition is attached to the north elevation of the building. The entire east elevation of the main portion of the structure is open although this was probably not original.

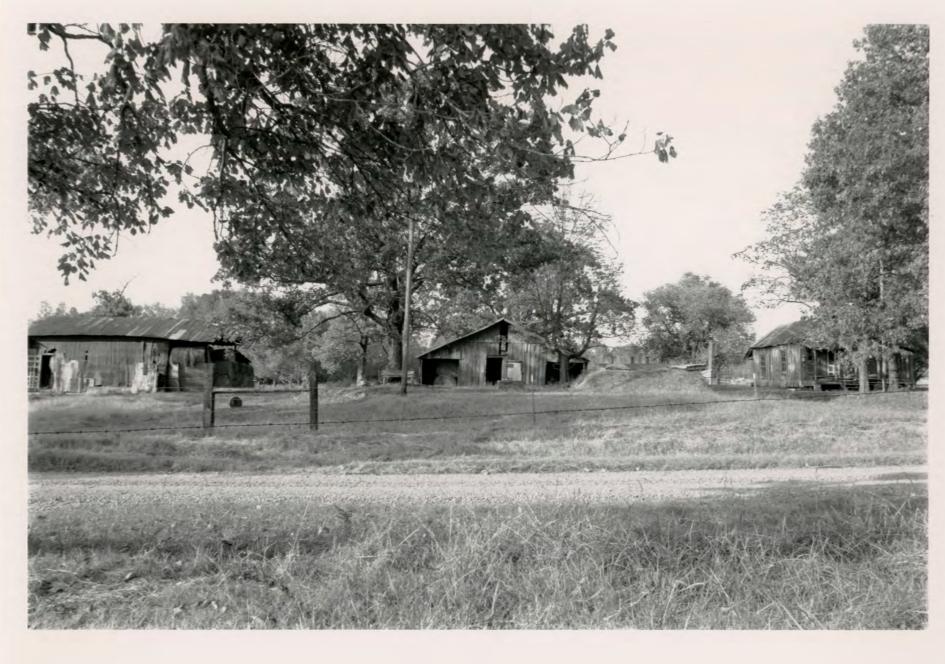
COTTON SEED BARN (#4) AND COMMISSARY

BUILDING (#3)

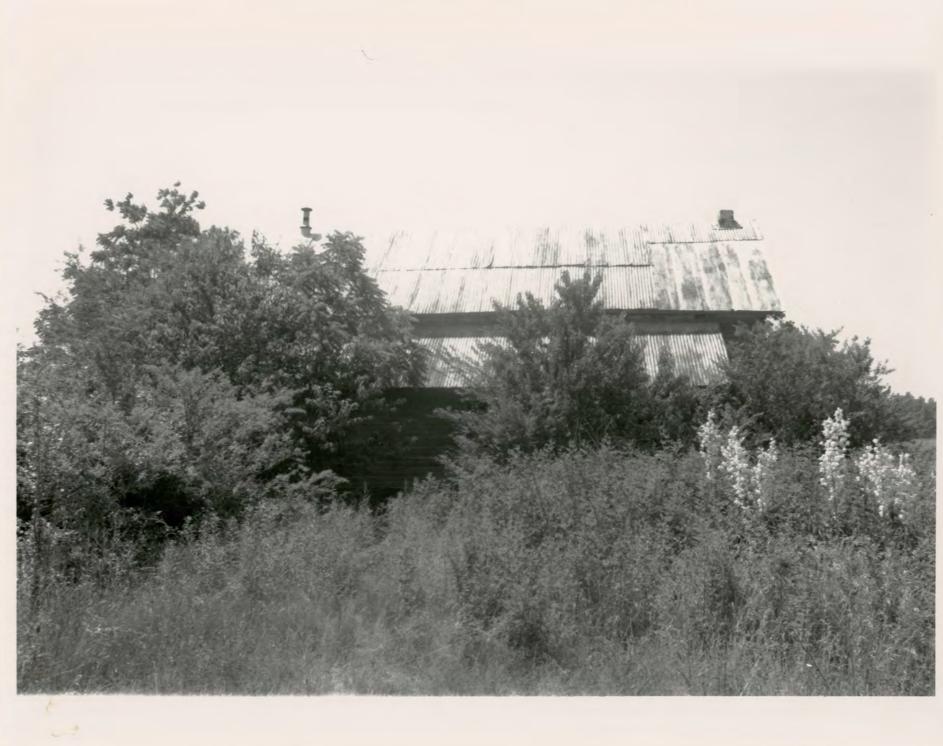
The surviving Tenant House is located approximately eight hundred feet west of the William Walker, Sr. House. It is heavily overgrown and in fair condition. This one-story, side-gable with corrugated metal roof building was originally clad with weatherboarding and constructed c. 1910. Some of this has been replaced with novelty siding. Originally, two brick interior end chimneys rose from the gable peak. The eastern chimney, however, has been replaced by a metal flue.

This single pile with central hall building rests on stone piers. A shed roof porch, supported by a single remaining wooden post, stretches three-quarters of the length of the building's north elevation. The door leading into the central hall is flanked by single four-over-four double-hung sash windows. One of the east elevation windows on the original portion of the structure has been covered over but the other is fenestrated like those on the building's north elevation. A shed roof, box construction addition extends the length of the structure's south elevation. The window on the east elevation of the addition is similar to the ones on the east side of the building's main block. A shed roof, rear half-porch extends from the center of the building westward. Its roof is supported by three simple posts. A paired pocket window is located on the west elevation of the box addition. North of this and located on the main portion of the building is a single four-over-four double-hung sash window. Approximately thirty feet south of the main building is a square shaped non-contributing structure which was built c. 1950. It probably housed the well.

TENANT HOUSE; WALKER HOMESTERS HISTORIC DISTRICT
CARNER VR., ARKANSAS WHITCH
PHOTOGRAPH BY S. MITCHELL
VUNE, 1988
NEGATIVE ON FILE AT AHPP
VIEW FROM NORTH
#6

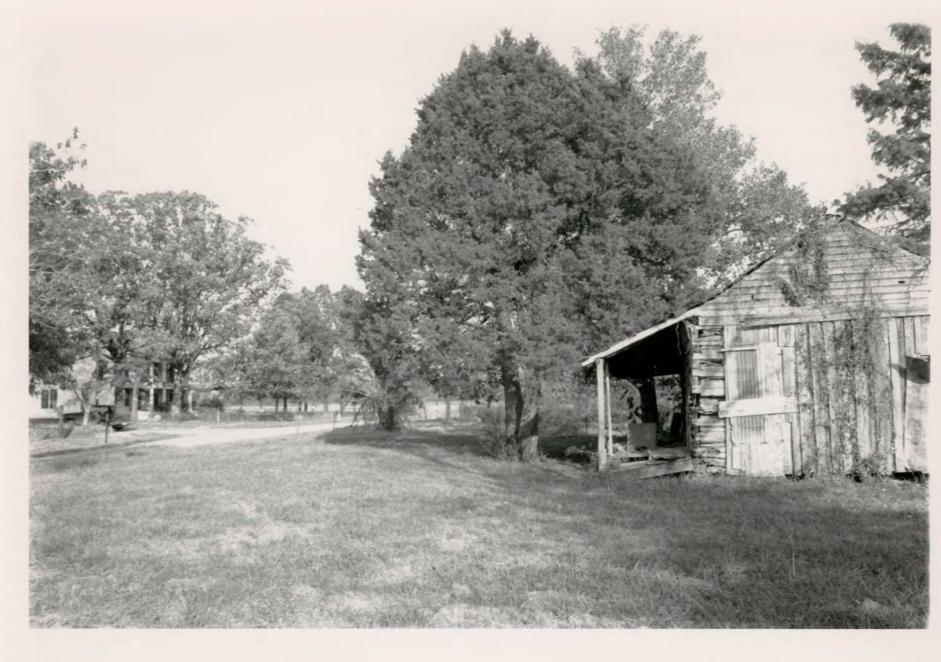
WALKER HOMESTEAD HISTORIC DISTRICT; OVERVIEW
GARNER VIC., ARKANSAS
WILLIAM
PHOTOGRAPHED BY V. MITCHELL
VUNE, 1988
NEGATIVE ON FILE AT AHPP
VIEW FROM WEST

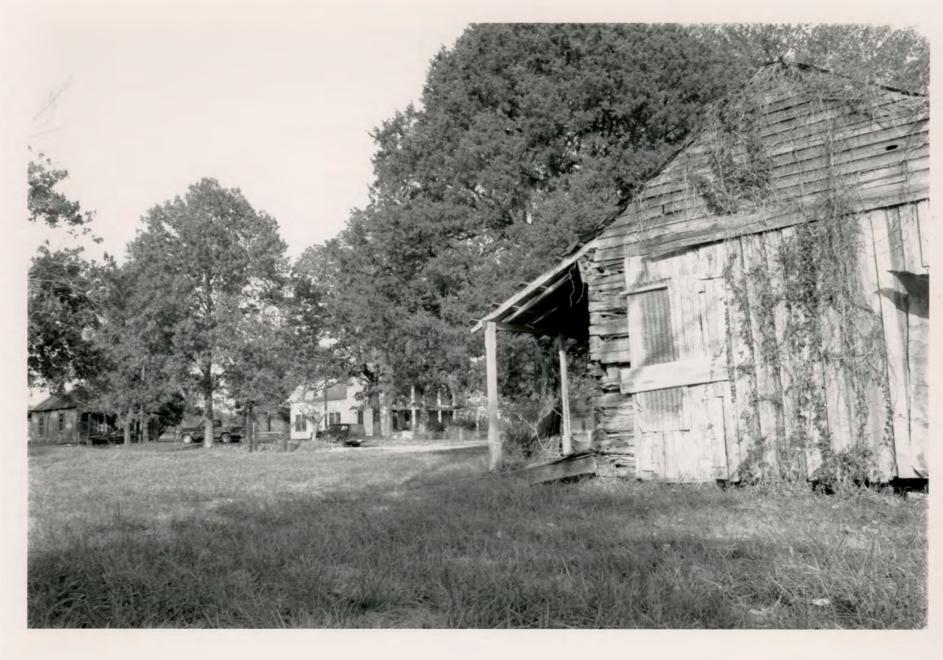
WALKER HOMESTEAD HISTORIC DISTRICT; OVERVIEW
GARNER VIC., ARKANSAS WHITCHELL
PHOTO GRAPHED BY S. MITCHELL
VUNE, 1988
NEG, ATIVE ON FILE AT AHPP
VIEW FROM SOUTHWEST

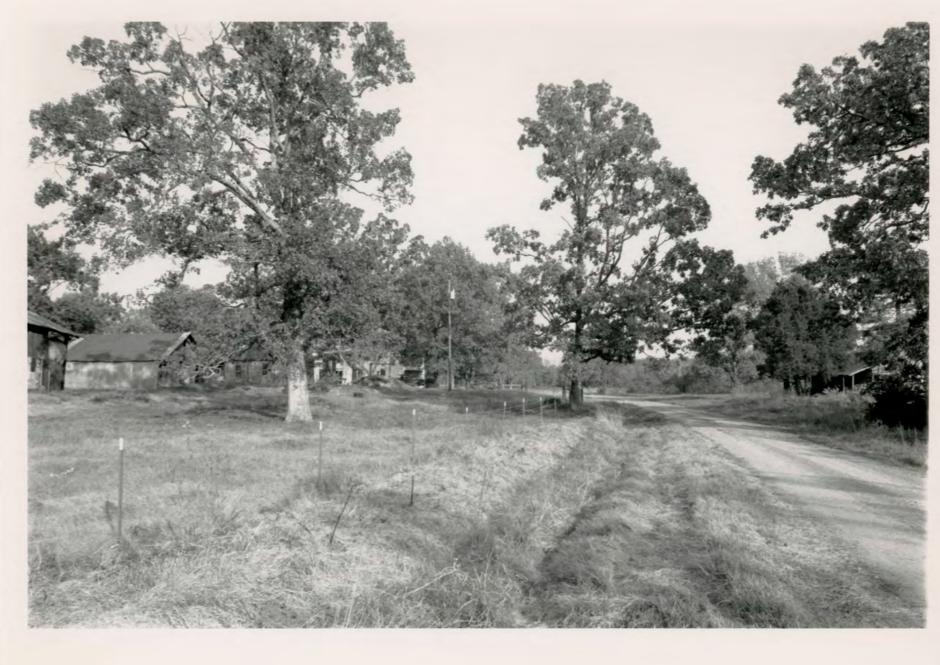
WALKER HOMESTEAD HISTORIC DISTRICT; OVERVIEW
GARNER UN., ARKANSAS White GO
PHOTOGRAPHED BY S. MITCHELL

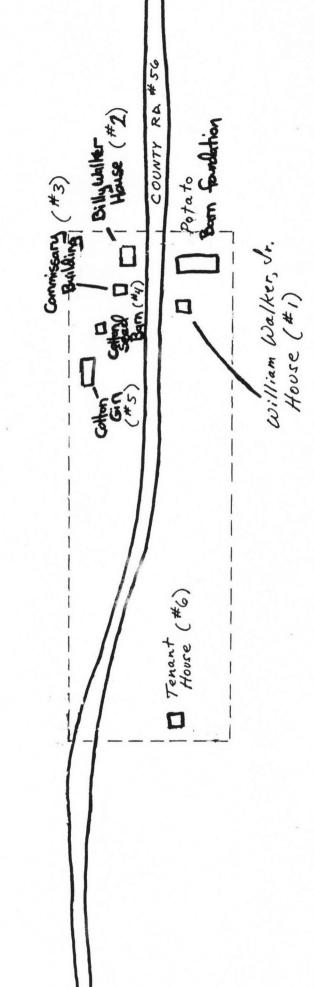
Walker Homestead Historic District Garner vic., Arkansas --- District Boundary Scale: 1" = 200'

Beginning at the point formed by the intersection of the southern edge of County Road #56 with a perpendicular line running parallel to the western elevation of the associated tenant house (#6) and located 25 feet to the west thereof, proceed southerly along said line for a distance of 275 feet to a point formed by its intersection with a perpendicular line running parallel with the southern elevation of the associated potato barn foundation; thence proceed easterly along said line for a distance of 1,050 feet to a point formed by its intersection with a perpendicular line running parallel with the eastern elevation of the Billy Walker House (#2); thence proceed northerly along said line for a distance of 350 feet to a point formed by its intersection with a perpendicular line running parallel to the northern elevation of the associated cotton gin (#5); thence proceed westerly along said line for a distance of 1,050 feet to its intersection with a perpendicular line running parallel to the western elevation of the associated tenant house; thence proceed southerly along said line for a distance of 45 feet to the point of beginning.
