United States Department of the Interior National Park Service National Register of Historic Places Registration Form

historic name Mount Zion Baptist Church

street & number 419 North Elgin East Avenue [N/A] not for publication

Late 19th and 20th Century Revivals:
Late Gothic Revival

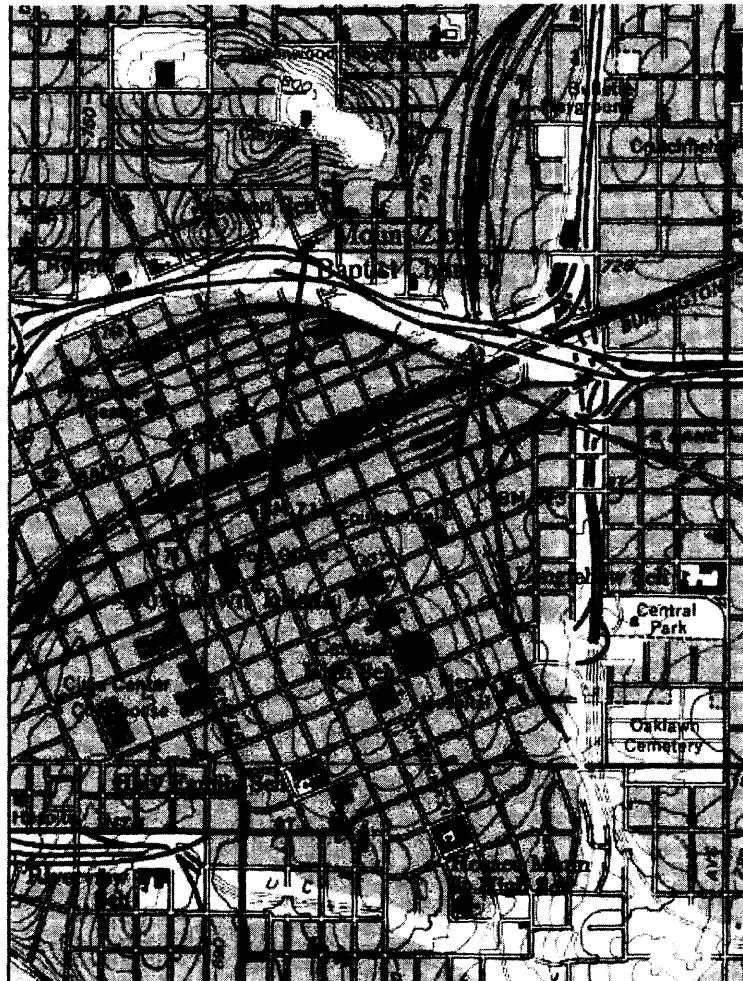
Figure 1. Mount Zion Baptist Church in
Relation to Downtown Tulsa

Mount Zion Baptist Church is located six-tenths of a mile north, northwest of downtown Tulsa. It is situated facing the southwest on the city grid, oriented to railroad tracks instead of the cardinal directions. The church sits just north of and next to Interstate Highway 244, which is part of a highway loop around Tulsa's central business district. The church is within an area in Tulsa historically known as the Greenwood neighborhood, a once-segregated neighborhood where black community members resided and transacted business (see Figure 1, which shows its position on the skewed grid and proximity to I-244).

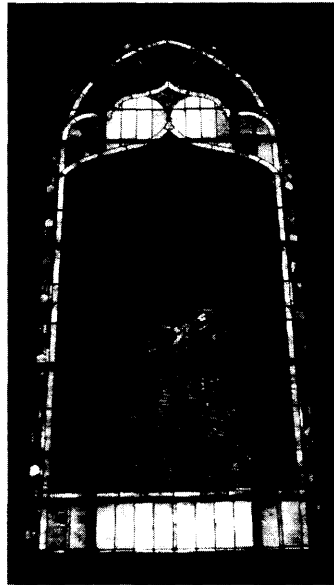
Photo 0005. Stained Glass Window over Baptismal Font, Looking North, Northeast

The stained glass windows were made in Germany.¹ The window over the baptismal font represents the Jordan River. The window in the front façade is of Jesus praying in the Garden of Gethsemane (See Photo 0005). The ground level of the church is used for small assemblies and there are Sunday school rooms on each side. The annex has the children's department, a food bank, Project Help, and a prayer room. The sanctuary faces northeast and there is a "U" shaped balcony at the rear and sides overlooking the sanctuary seating. The balcony is supported by metal poles attached to the ceiling above (See Photos 0006 and 0007).

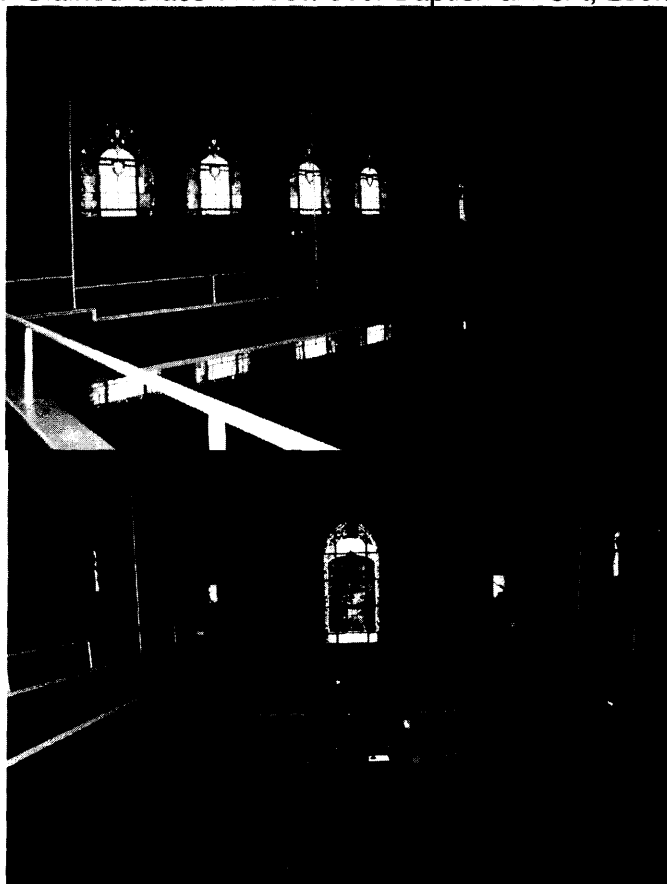
Photos 0006 and 0007. Side Balcony, and Pulpit from the Rear Balcony, Looking North, North East and North East

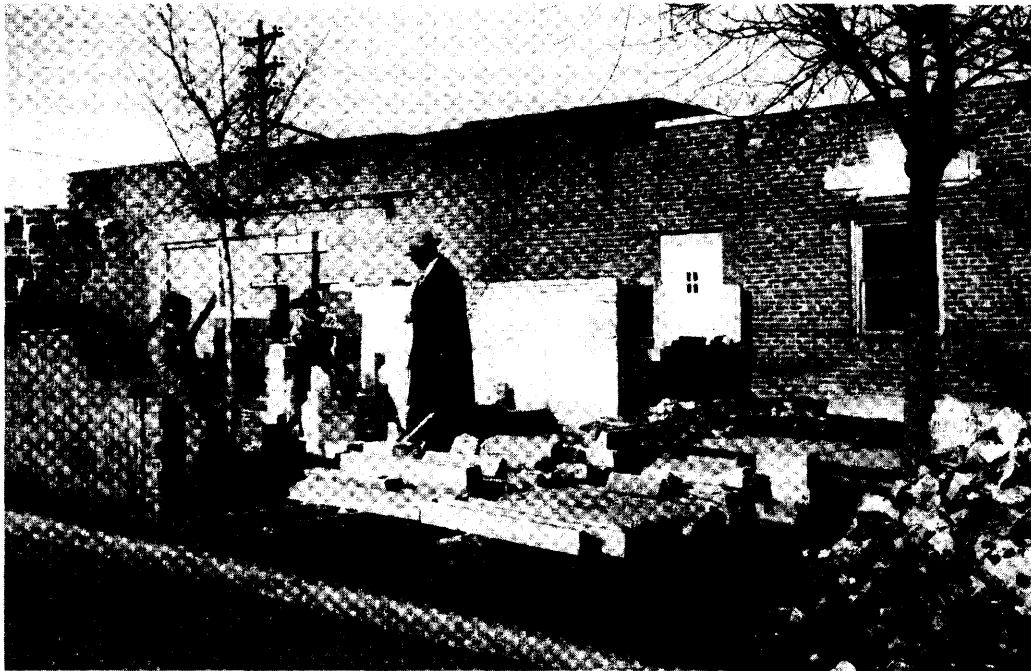
Photo 12. Mount Zion Rebuilding and Integrating Old Church, 1945.⁴⁴

⁴⁴ Shown on the side of this structure above the window is the stonework reinstalled in the new church annex, recognizing Rev. Whittaker.

minister, Reverend Dotson. With the same determination mustered to pay off the old debt, the congregation began to build their new church over the first floor of the old one (Photo 12). Figure 3 is a Sanborn Map from 1939, which shows the parsonage completed, and the church under construction. A Time magazine article in February 1945,³³ noted the church's efforts of patience and perseverance – and as a quiet Christian rebuke to racial intolerance. The story was eventually picked up in Facts, a magazine which reached international readers, and donations continued to be sent to the church from people all over the world.³⁴ Both articles brought in much needed contributions as the first bricks of the church were laid.
