# National Register of Historic Places Registration Form

historic name Siskiyou Smokejumper Base

other names/site number Siskiyou Aerial Project, "Gobi Desert," Cave Junction, CJ

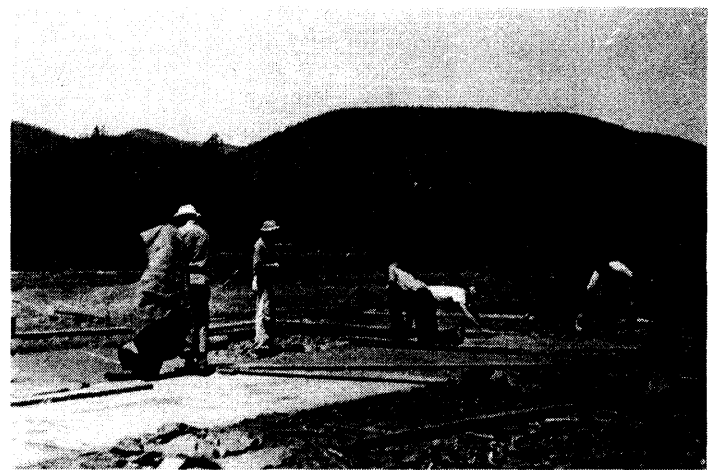
A-02: Construction of north warmup pad  
Photographer: Nick Pauls, 1945; Looking northwest.  
The pad was poured by the smokejumpers in the Civilian Public Service (CPS). Woodcock Mountain is in the distance.

*Warm up pads:* Some of the oldest features at the base are the concrete pads used for anchoring airplanes when not in use and to prevent damage to the fabric coverings of the airplanes kicked up by the wind from the propeller as the engine warmed up for takeoff. The oldest two pads, the **north** and **south warmup pads**, were installed in 1945 and 1946 respectively. These concrete structures feature a distinctive substrate of rounded river rocks ranging from the size of a fist to the size of a ping pong ball. These are contrasted with two later pads, the **center warmup pad** and **ready pad** installed around 1950 and 1954 respectively that have a substrate of pea gravel. Two of the pads also had small pits next to them for housing the fueling equipment, each of which was protected by a metal door cover. The fueling doors have been removed and fueling wells have been filled with dirt. Rings imbedded in the cement for tying down aircraft can be found on some of the pads. The oldest cement pads, subterranean fuel tank and pit-reel pumps were installed prior to or by 1946, the same year power was brought out to the airport, a requirement for the electric pumps used to pump gas.

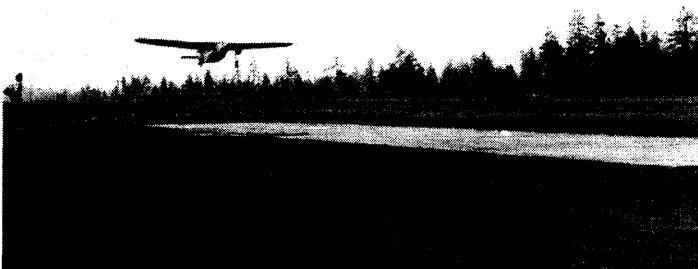
A-03: North warmup pad, shadow of hanger  
Photographer: Robert Moffitt, 1948; Looking southwest  
A shadow from the hanger shows the position of the building to the north warmup pad. Ford Trimotor takes off.

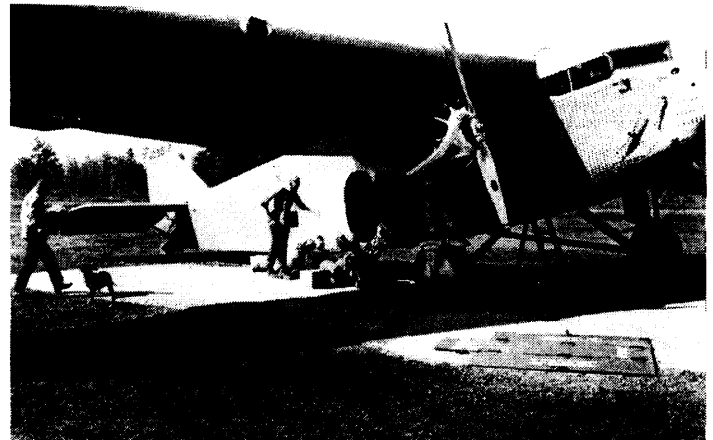
A-04: North warmup pad with metal fuel door  
Photographer: Bob Moffitt, 1948; Looking southwest.  
A metal fuel door is angled into the cement warmup pad. A smaller hinge door is seen along the left.

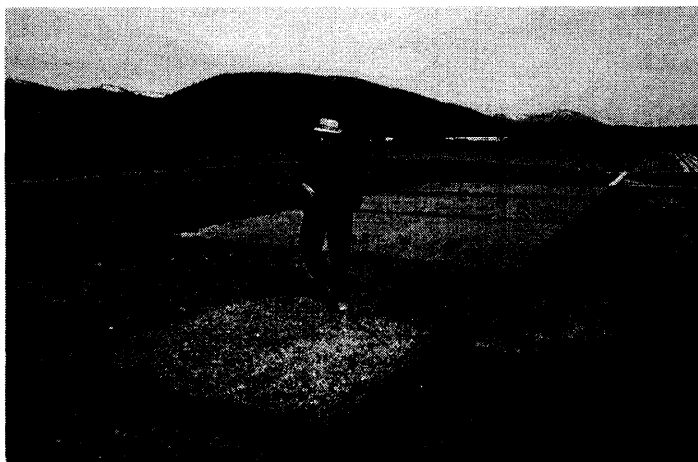
A-05: North warmup pad and outline of fuel door  
Photographer: Roger Brandt, 2005; Looking northwest.  
The trace of the metal fuel door on the north pad is seen to right of Paul Block. Note outline of hinge door.

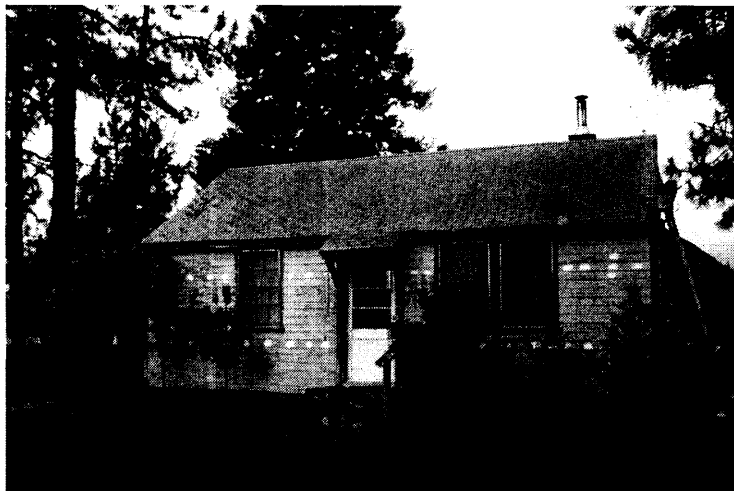
F-01: 1948 foreman residence  
Photographer: Roger Brandt, 2005; Looking west  
The 1948 residence is located near to the entrance to the base.  
This side faces Highway 199 about 100 yards away.

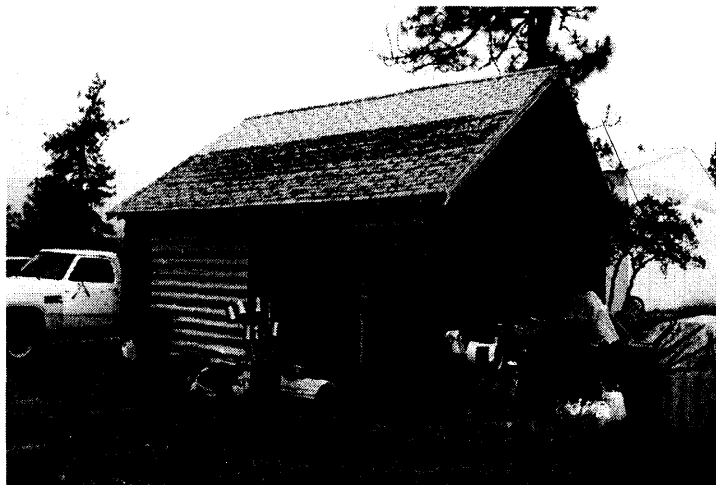
F-04: 1948 foreman residence garage  
Photographer: Roger Brandt, 2005; Looking northwest  
The door to the garage appears to be the only exterior  
modification to this building since its construction.

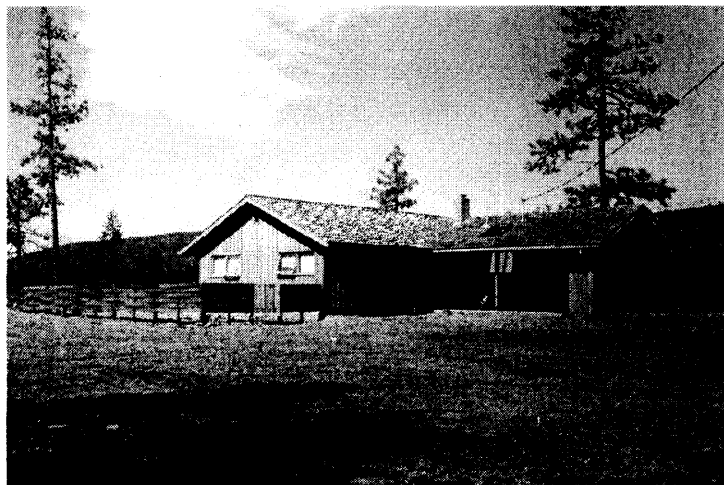
F-05: 1957 foreman residence  
Photographer: Unknown, USFS, circa 1958; Looks southwest  
This building has an external siding of 1x8 and a car port on  
the north side. No rockwork along driveway is yet installed. .

*1957 residence:* The 1957 residence sits on the south side of Smokejumper Way and was built in 1957 with an exterior finish of 1x8 boards standing perpendicular to the ground with 1x2 strips covering the cracks between each board. The yard is presently fenced in, and rock work lines the driveways into and out of the front yard.

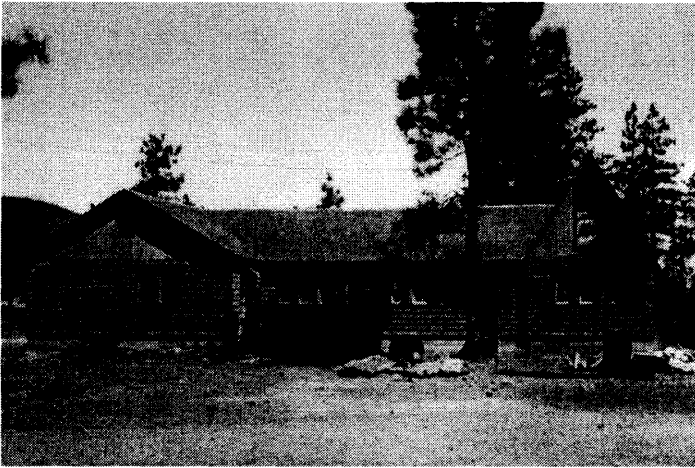
P-01: Parachute loft  
Photographer: Bob Nolan, 1950; Looking north  
View of south wall of the parachute loft. Parachute inspection tower on right, office on left, rigging room center.

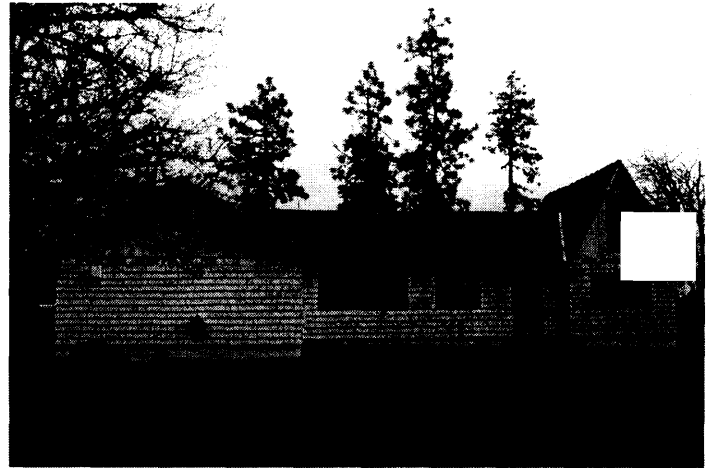
P-02: South wall of parachute loft  
Photographer: Roger Brandt, 2005; Looking north  
South wall of the parachute loft. Note window on office (left) has been removed.

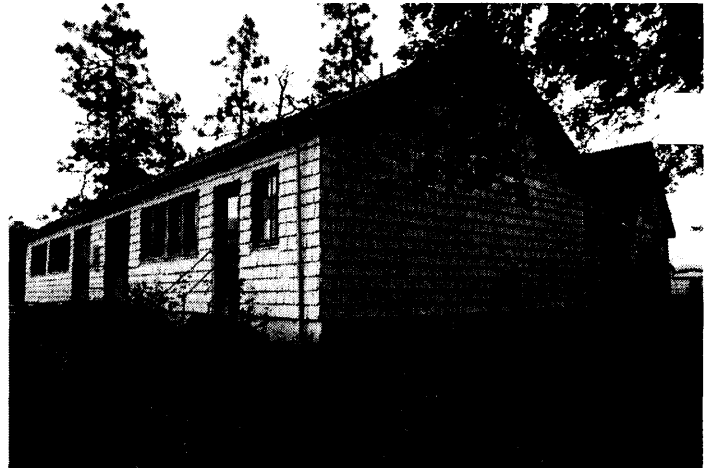
P-04: Parachute loft south and west walls  
Photographer: Roger Brandt, 2005; Looking northeast  
Dock and entrance to loft on left. Window of office has been removed and door added on west wall.

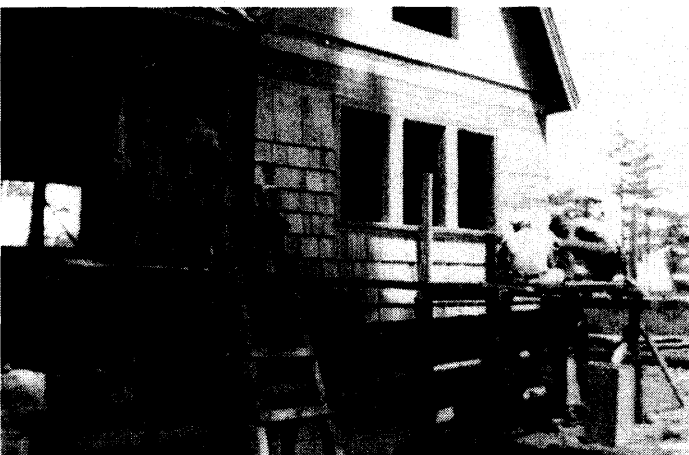
P-05: Working on loft  
Photographer: Bob Nolan, 1950; Looking northeast  
Smokejumpers working on south wall of parachute inspection tower.

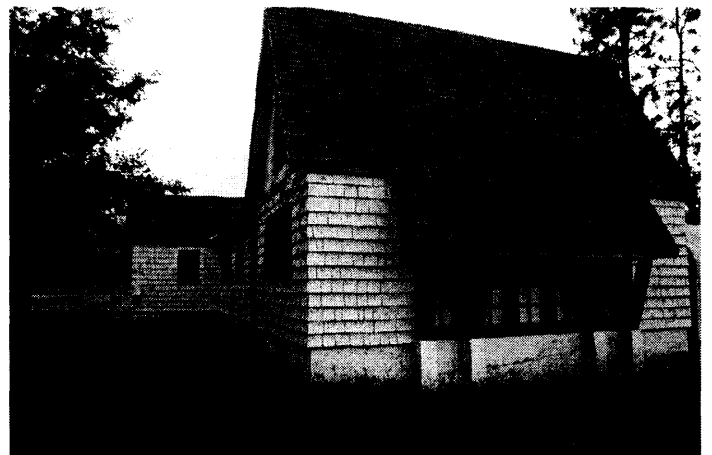
P-06: Parachute loft west and south exterior  
Photographer: Roger Brandt, 2005; Looking northwest  
The roof of the parachute inspection tower has heavy bracing. Office protrudes on far end.

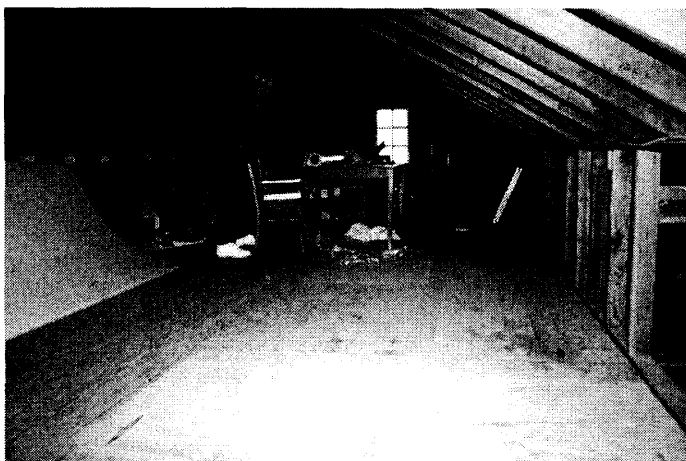
P-07: Parachute loft attic  
Photographer: Roger Brandt, 2005; Looking north  
A section of the attic above the repair room looking toward stair well. Storage bins can be seen along right.

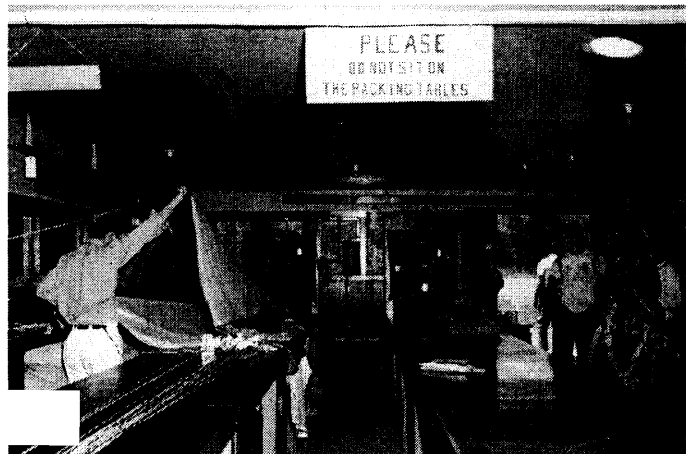
P-09: Parachute rigging tables  
Photographer: Jack Rittier, circa 1954; Looking out west doors  
Office on left, tarmac outside door in background, repair room right. Note tool pouches hanging at end of tables.

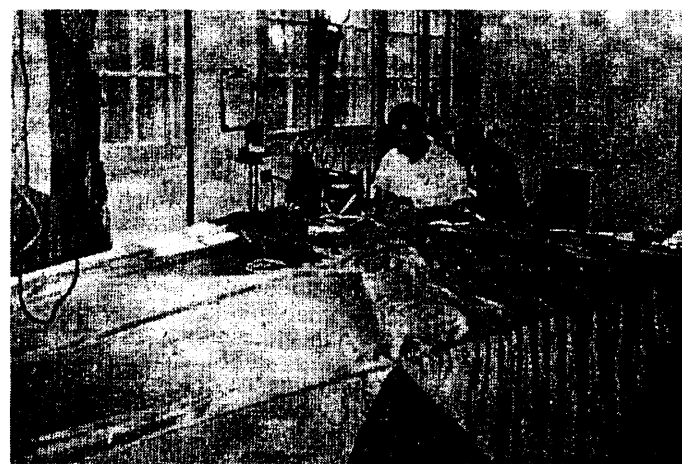
P-12: Parachute loft  
Photographer: unknown newspaper; Looking southeast  
A repair table for fixing individual sections of a parachute was located in the southeast corner of the repair room.

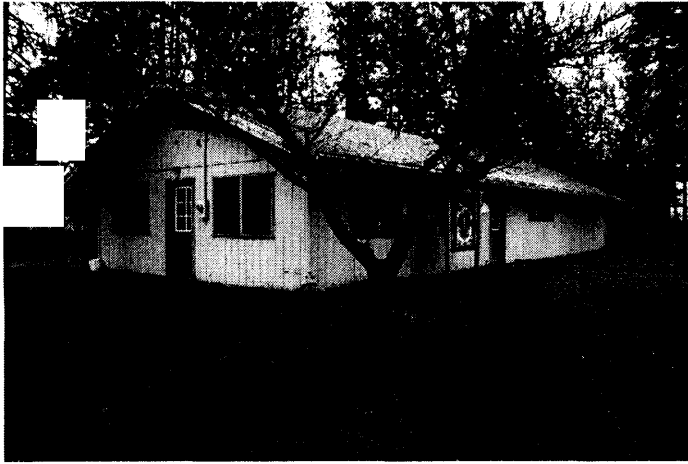
R-01: 1954 Barracks  
Photographer: Roger Brandt, 2005; Looking southeast  
Barracks constructed in 1954.

*1954 cook house, bath house, and barracks:* In 1954 a new cook house, bath house, and second barracks were constructed, all of which were built on concrete slabs and finished on the outside with shingle siding. The exteriors of these buildings were later modified to plywood siding which is the visible exterior seen today. The cook house used propane from a tank located several feet behind the building on the east side. In 1964, the cook house was severely damaged by fire and was reconstructed the following year on the original cement pad with basically the same interior floor plan as the original building. Doors on the reconstructed building were installed so existing walkways and entry pads from the original building could be used.

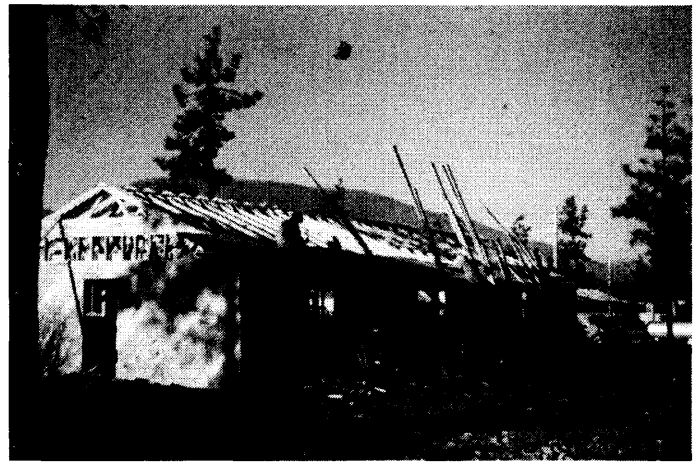
R-02: Barracks under construction  
Photographer: Jim Allen, 1954; Looking northwest  
Barracks under construction showing one-by-six subsiding that was later covered with shingles.

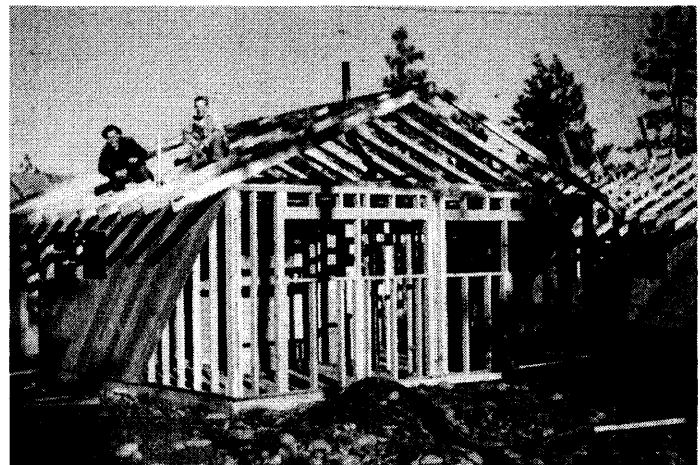
R-04: Bath house under construction  
Photographer: Jim Allen, 1954; Looking northeast  
Bath house shows position of windows and one-by-six subsiding. Barracks is under construction in background.

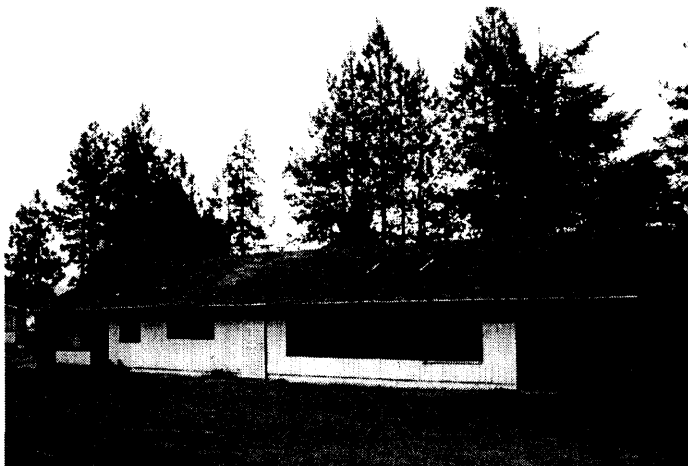
R-05: Cook house  
Photographer: Roger Brandt, 2005; Looking northeast  
This structure was reconstructed after fire damage in the early 60's. It sits on the same foundation and uses same entry walks.

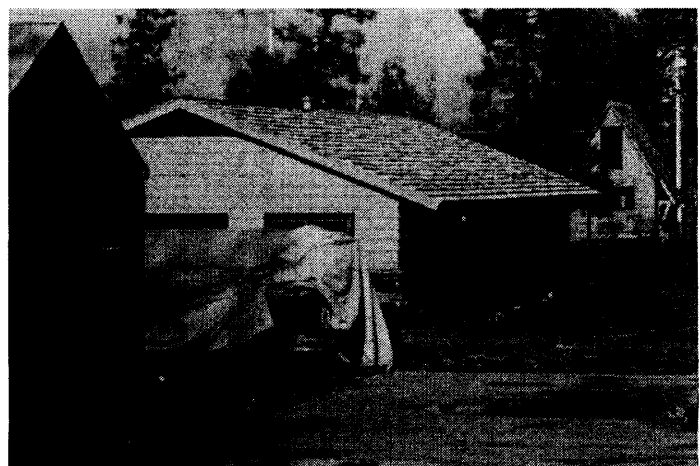
R-06: 1954 Cook house shingle siding  
Photographer: unknown, circa 1954. Looking north  
The original siding of the buildings constructed in 1954 were shingles. These were later replaced by plywood.

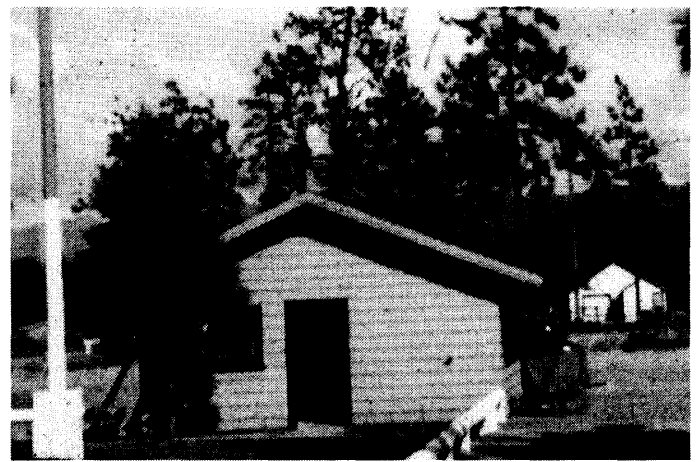
S-02: Storage shed  
Photographer: Jim Allen, circa 1952; Looking northeast  
Storage shed with the original shingle siding installed when the building was erected..

*Storage shed:* A small **storage shed** is located next to the parachute loft and was used to repair fire-fighting equipment but also for the storage of packaged food used in the field. This shed retains its original shingle siding and has one door on the west side of the building and a small nine-light window protected by metal bars. The building's low pitch roof features rafter tails that have been left exposed. The original interior had one large room where staff sharpened and repaired fire fighting tools and a smaller room on the south side where packaged food, candy bars and other treats were stored. Crews could pick up to ten pounds of food from this store which would be dropped to them while out on a fire call along with the less palatable C-1 rations. The wall to the food storage room has recently been removed by the present owner to make a single room workspace. The shed is included as part of the parachute loft operations in this nomination because of its direct, but subordinate role in support of the loft.

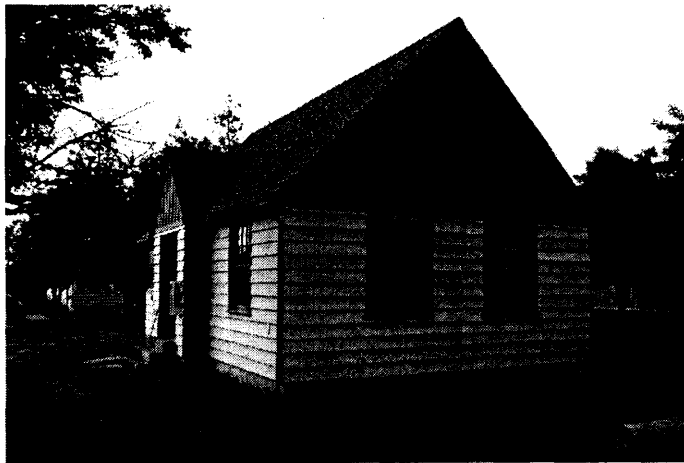
S-03: Administration office  
Photographer: Roger Brandt, 2005; Looking northeast  
The administration building was formerly the Redwood Ranger Station constructed in 1936.

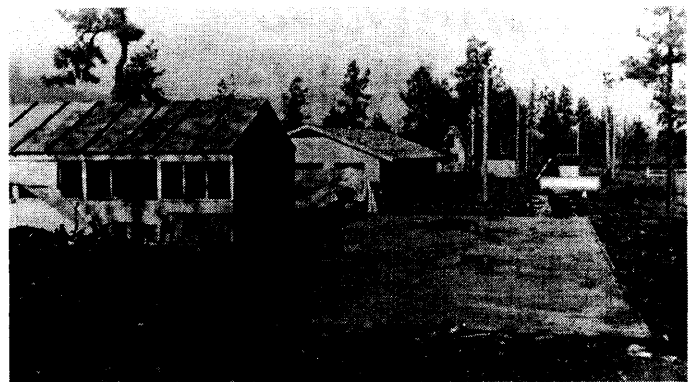
S-06: Fire pump house in background  
Photographer: Jim Allen, 1954; Looking north  
Fire pump house is seen in the background behind the cement pad for the new barracks.

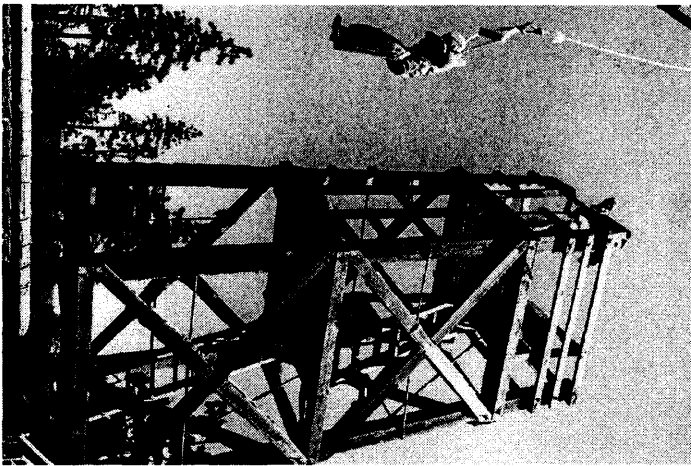
T-01: Jump tower  
Photographer: \_\_\_\_\_, circa 1949; Looking east  
The first jump tower at the base was a wood structure. This was removed when a metal tower was constructed in 1954.

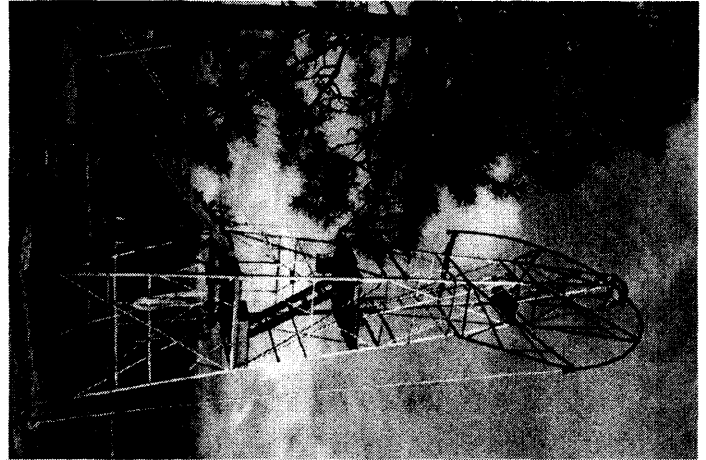
T-02: 1954 Jump tower  
Photographer: Jack Rittier, 1954; Looking northeast  
This tower is a modified radio tower with an arched top to keep trainees away from the structure as they practiced.

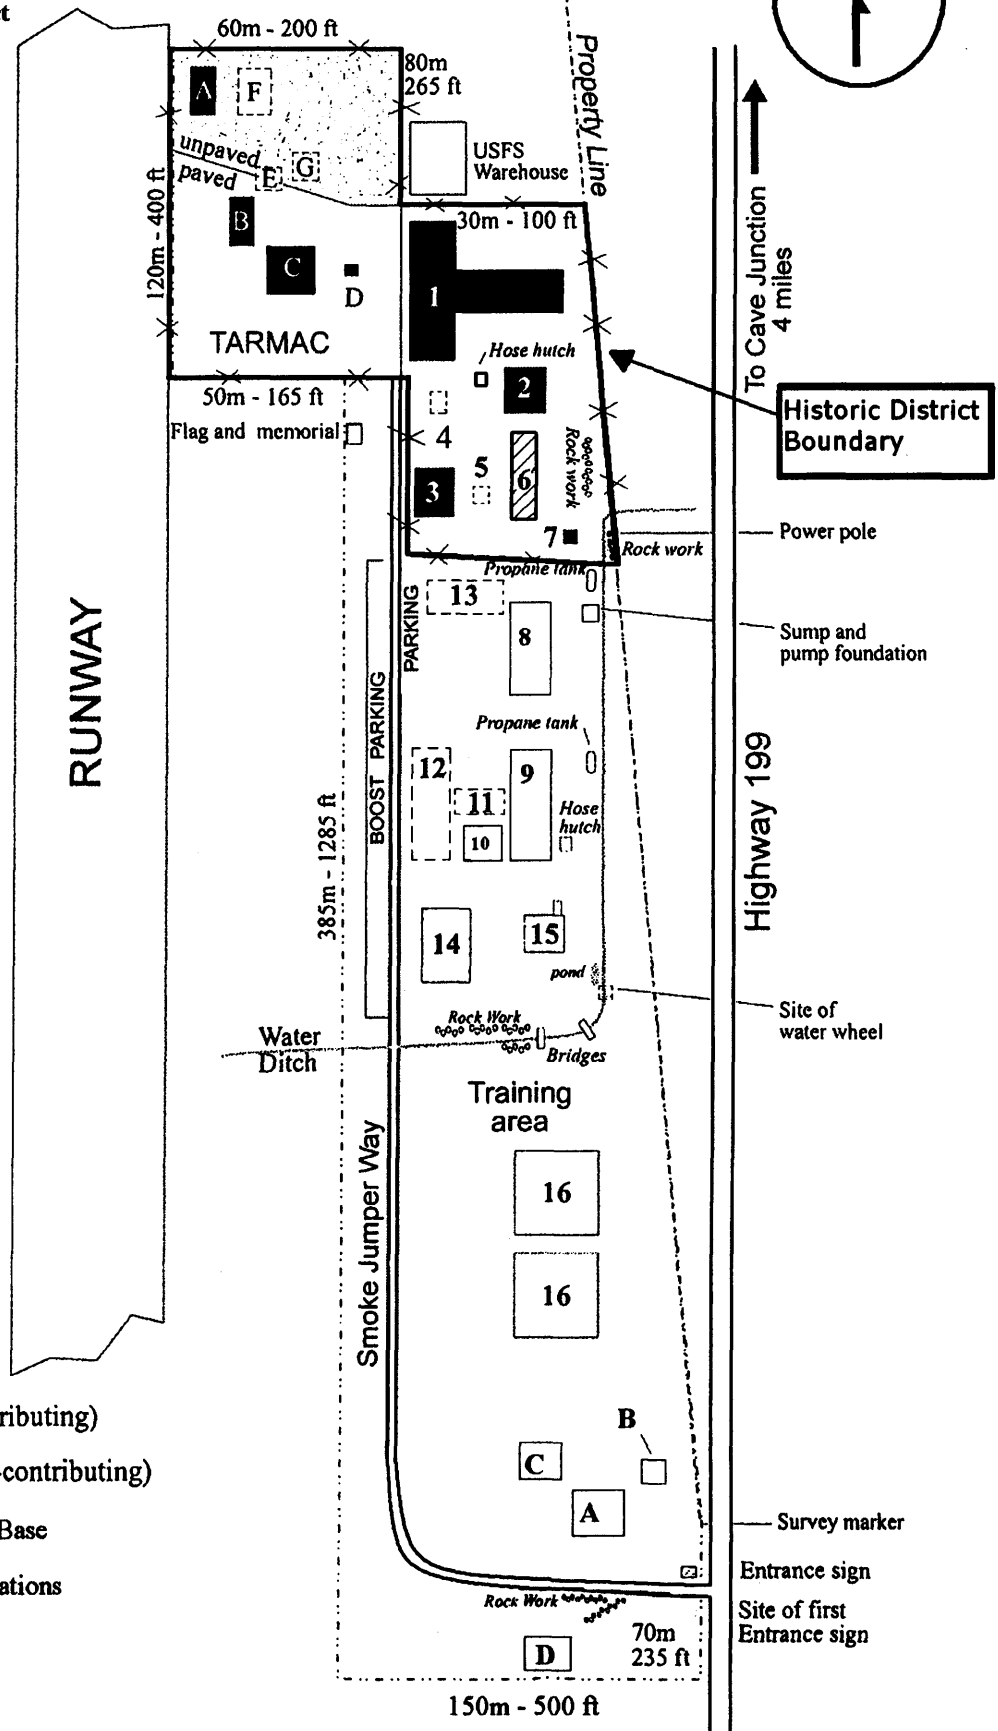
# Siskiyou Smokejumper Base Historic District

- TRAINING AREA**
- 14) Volley ball court (1960's?)
  - 15) Exercise pad (1960's?)
  - 16) Hangers (1990's?)
- Note: main training area was torn down and replaced with hangers.

- SUPERVISOR RESIDENCE**
- A) Residence (1948)
  - B) Well house (1948)
  - C) Garage (1948)
  - D) Residence (1957)

- Buildings and structures (contributing)
- Buildings and structures (non-contributing)
- Other Buildings Related to the Base
- Former Building/Structure Locations
- Rock work
