National Register of Historic Places Registration Form

Historic name: Poinsett State Park Historic District

Historic Resources of South Carolina State Parks

Poinsett State Park

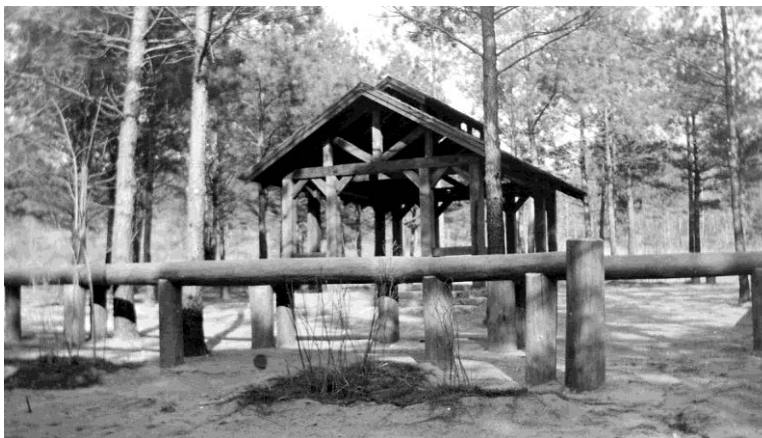
The Picnic Shelter #2 (PO-S2) sits on a small hill overlooking the Park's main parking area, office and lake. It was completed in late 1936 or early 1937.²⁷ It is a wood, rectangular, one room, open air shelter with a vented gable roof (See Figure 1) and composite shingles. The roof is supported by rafters with exposed rafter tails, two tri-bearing trusses, two horizontal braces,

Figure 1: Picnic Shelter #2 [“Poinsett State Park (SP-3)—No.242 Guardrail at serving table, barbecue pit, and shelter: 5/1937,” May 1937, CCC files (photographs), State Commission of Forestry Records, SCDAH, Columbia, S.C.]

top plates and twelve posts, three at each corner, with braces and railings. There are four entryways, each centered on one of the shelter's four elevations. There are three full length coquina rubblework stairs leading to the west entrance. The floor is concrete. Originally, the floor was coquina and had a centered barbecue pit made of coquina rubblework and firebrick. This floor and pit were removed between 1948²⁸ and the 1949²⁹ and replaced with a concrete floor. Wood shingles were replaced with composite shingles and electricity was added after 1949.³⁰ Originally, the wood was stained. Painting began in the 1940s

Figure 1: Poinsett State Park (SP-3)—No.242 Guardrail at serving table, barbecue pit, and shelter: 5/1937,” May 1937, CCC files (photographs), State Commission of Forestry Records, SCDAH, Columbia, S.C.—**page 9**

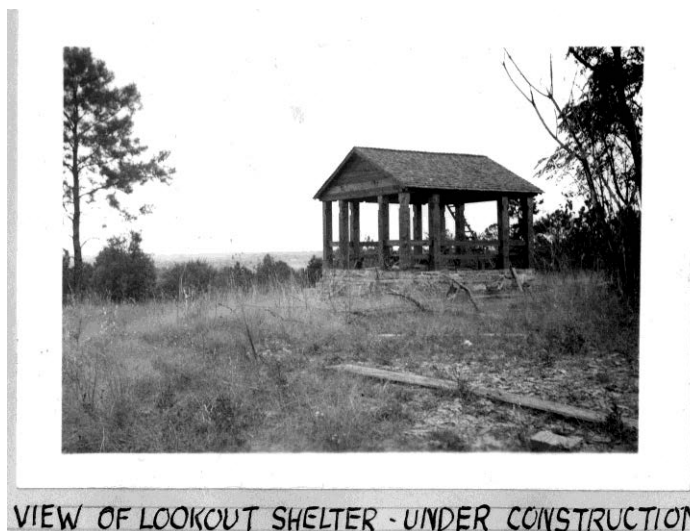
Figure 2: Shelter #5 under construction [Photo album of State Parks, 1934-1940, CCC files (photographs), State Commission of Forestry Records, SCDAH, Columbia, S.C.]

The Picnic Shelter #5, completed in November 1935,³¹ sits on a bluff overlooking the Wateree River floodplain (See Figure 2). It is a front gable, one room, open air, wood shelter with a rectangular coquina foundation and a basket weave patterned brick floor. The roof has composite shingles and rafters with exposed rafter tails. The gables are clad with flush wood siding. Originally, the roof was shingled with cypress. Four flared coquina rubblework stairs lead to a centered entryway on the north and

south elevations. Twelve square, notched wood posts are grouped in three at each corner with notched braces and top plates. There are three wood braces connecting the east and west elevation top plates. A wood railing runs from the north entryway along the west elevation to the south entryway. An identical railing is located on the east elevation. Wood benches were installed below these railings but were removed sometime between the mid-1970s and 1996³² and added back in 2012. Many of the other original hewn posts were replaced with rough sawn posts sometime before 2012. The vista of the Wateree River floodplain is an important associated feature of the surrounding landscape.

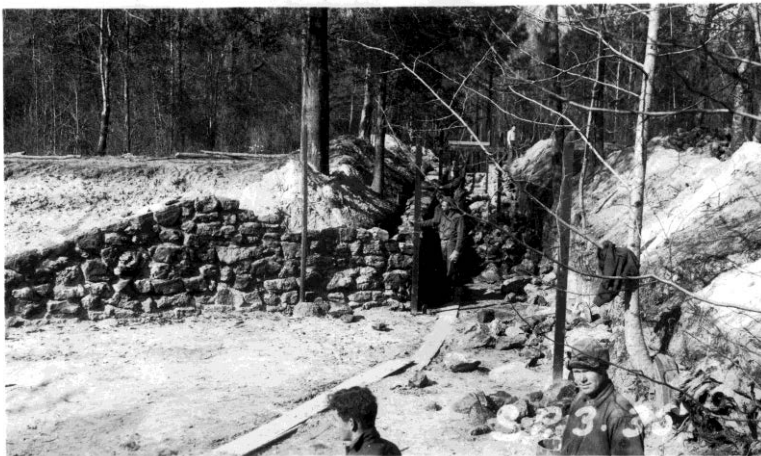
ROCK RETAINING WALL-----EAST END OF THE DAM
NO. 35 SP-3
70

Figure 3: Small spillway under construction by Company 421. [Poinsett State Park Photograph Collection, SCDAH]

The small spillway is north of the dam. The first run and drop with accompanying walls were built by Company 421 in 1935 (See Figure 3).⁴⁵ The second run and drop with accompanying walls was built by Company 2413 sometime during 1936-1937.⁴⁶ It is a stepped spillway made mostly of coquina block. Water is funneled into the spillway's flared entrance which is created by two staggered coquina walls. The first run is approximately 110 feet long and six feet wide.

Figure 3 - Small spillway under construction by Company 421.⁴⁷

Figure 3: Small spillway under construction by Company 421. [Poinsett State Park Photograph Collection, SCDAH]—**page 13**

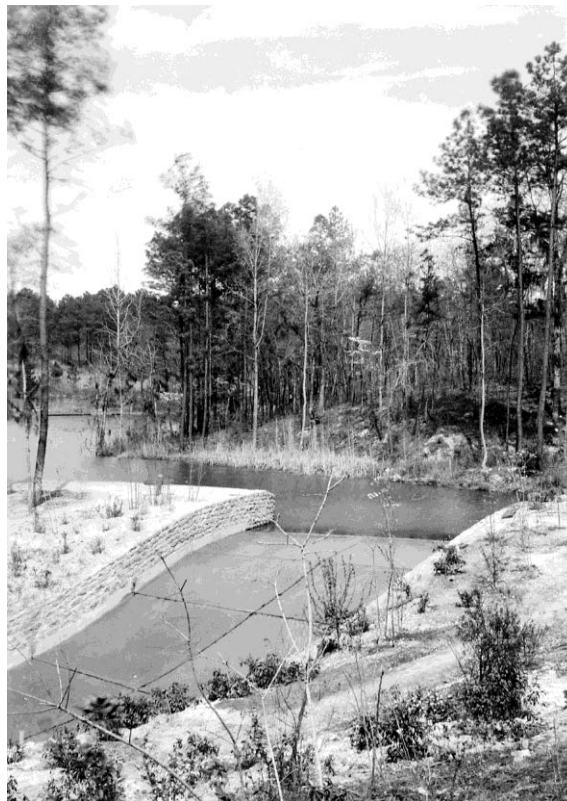
Figure 4: Large spillway showing concrete floor added by Company 2413. [Poinsett State Park Photograph Collection, SCDAH]

spillway and earthen dam. It was built in 1935 by Company 421.⁴⁸ It's sloped and curved

funnel shape consists of two four feet high coquina and concrete walls, a concrete floor and coquina rip rap at the terminus. Originally, the floor was coquina rubblework and it was replaced with concrete (See Figure 4) by Company 2413 during 1937-8.⁴⁹ The north wall is 131 feet long and the south wall is 134 feet long. The concrete floor is seventy-six feet long and fifty feet wide at the spillway mouth and narrows slightly at the terminus.

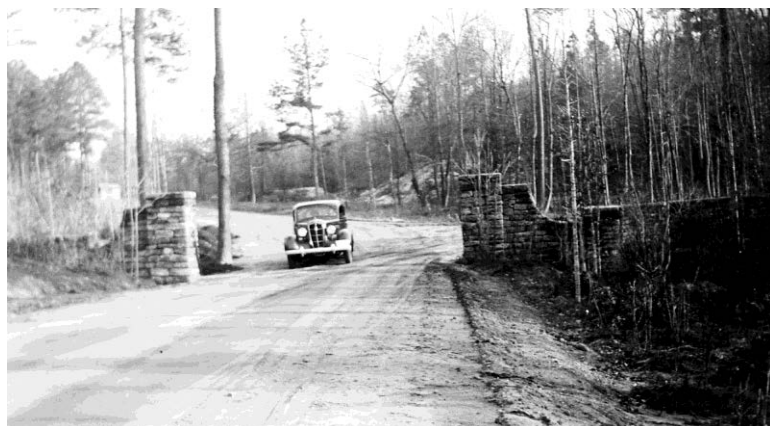
Figure 5: Entrance portal after completion [“Poinsett State Park (SP-3)—No.236 Stone wall and gate at main park entrance, approaching from east : 3/1937,” March 1937, CCC files (photographs), State Commission of Forestry Records, SCDAH, Columbia, S.C.]

23. Entrance Portal—Structure

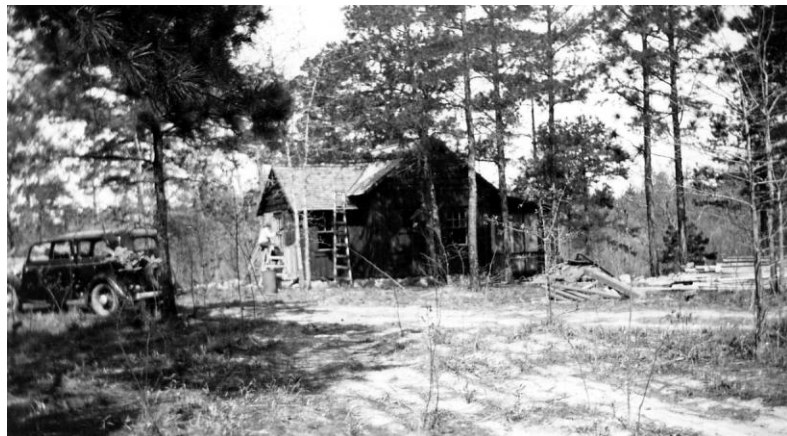
Figure 6: Cabin being stained [“Poinsett State Park (SP-3)--No.110 Overnight cabin, being stained, Project 107-B”, n.d. [ca. 1934-1942], Civilian Conservation Corps (CCC) files (photographs), State Commission of Forestry Records, South Carolina Department of Archives and History (SCDAH), Columbia, S.C.]

Another native material that was used in the park's design was wood, South Carolina pine and cypress, which helps to create a rustic feeling.¹⁴⁴ Many buildings are clad in weatherboard siding whose horizontal lines help them subordinate to their surroundings while others are clad with board and batten, which was seen as an economical choice and harmonious with a wooded setting.¹⁴⁵ Both support the rustic design aesthetic of the Parkitecture style. The oldest buildings designed while the Junior Company 421 was present, the Ranger's Residence, Cabin #1, and Cabin #2, are clad in weatherboard. Buildings like Cabin #3 and #4 and the Shop that were designed later and built by Veteran Company 2413 were clad in board and batten. In yet another effort to subordinate buildings and structures to the surrounding environment, the exterior wood was stained (See Figure 6). In later decades, the South Carolina State Park Service began painting buildings and structures to protect the wood better. They continued the tradition of using certain earth tone colors like browns and grays to help them blend in with the surrounding environment.
