National Register of Historic Places Registration Form

Historic name Gottsch Farmstead

Other names/site number WN00-121

Street & Number 17201 Dutch Hall Rd

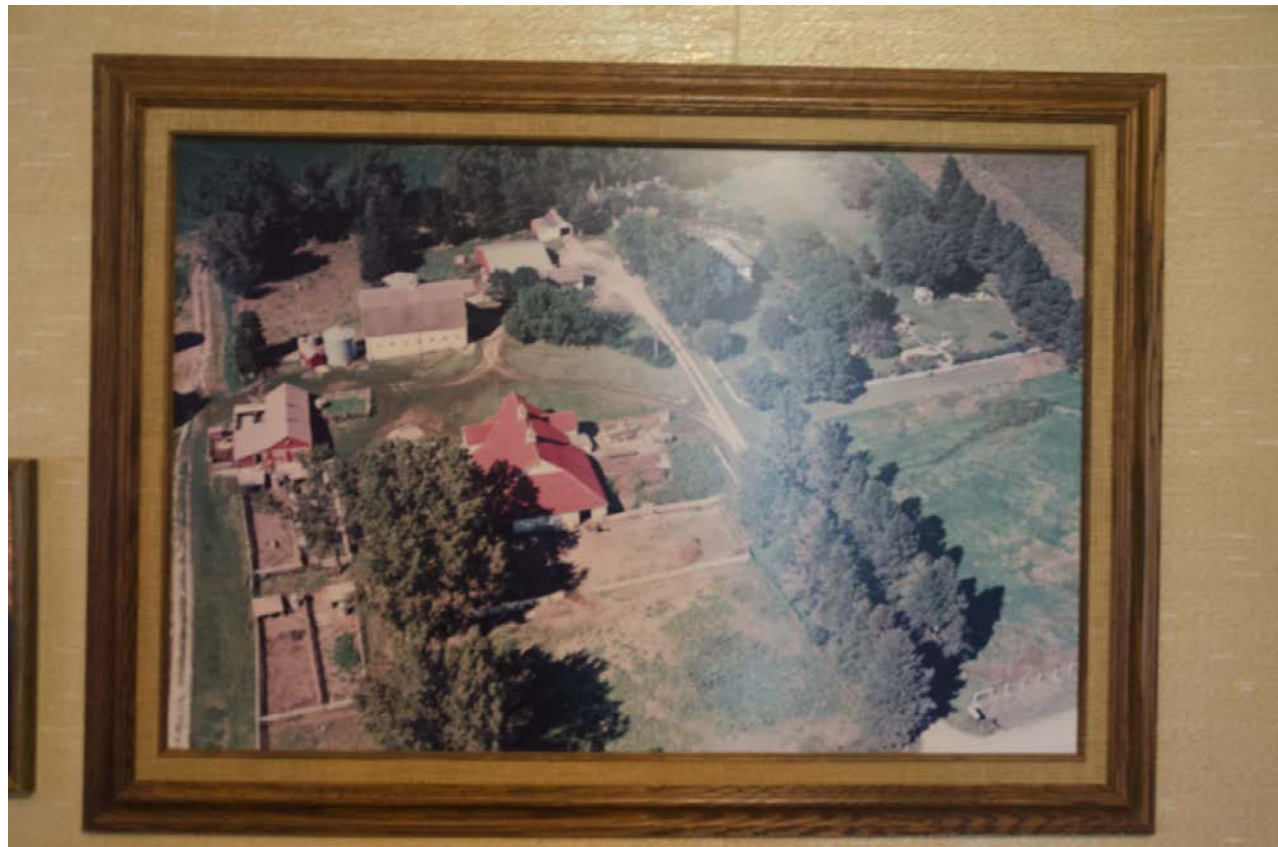
Figure 3: Aerial Photo of Gottsch Farmstead located in the farmhouse showing original barn. North is to the top. Date is unknown.

The farm is entered through a gravel drive that the sheltered by rows of tall pine trees. The drive divides the farmstead into two distinctive functional zones. To the east, the domestic farming area composed of the single family home, an extensive yard to the south of the house and a brooder house to the north. The windbreak encloses the domestic side of the property to the east and north. The other side of the property is the livestock producing area. In the center is the large non-contributing barn (original burned down in the early 1990's) with cattle yard. The other structures in the farming area are hog barns, horse and milk barn, corn crib, chicken coop and windmill (figure 1, 3).

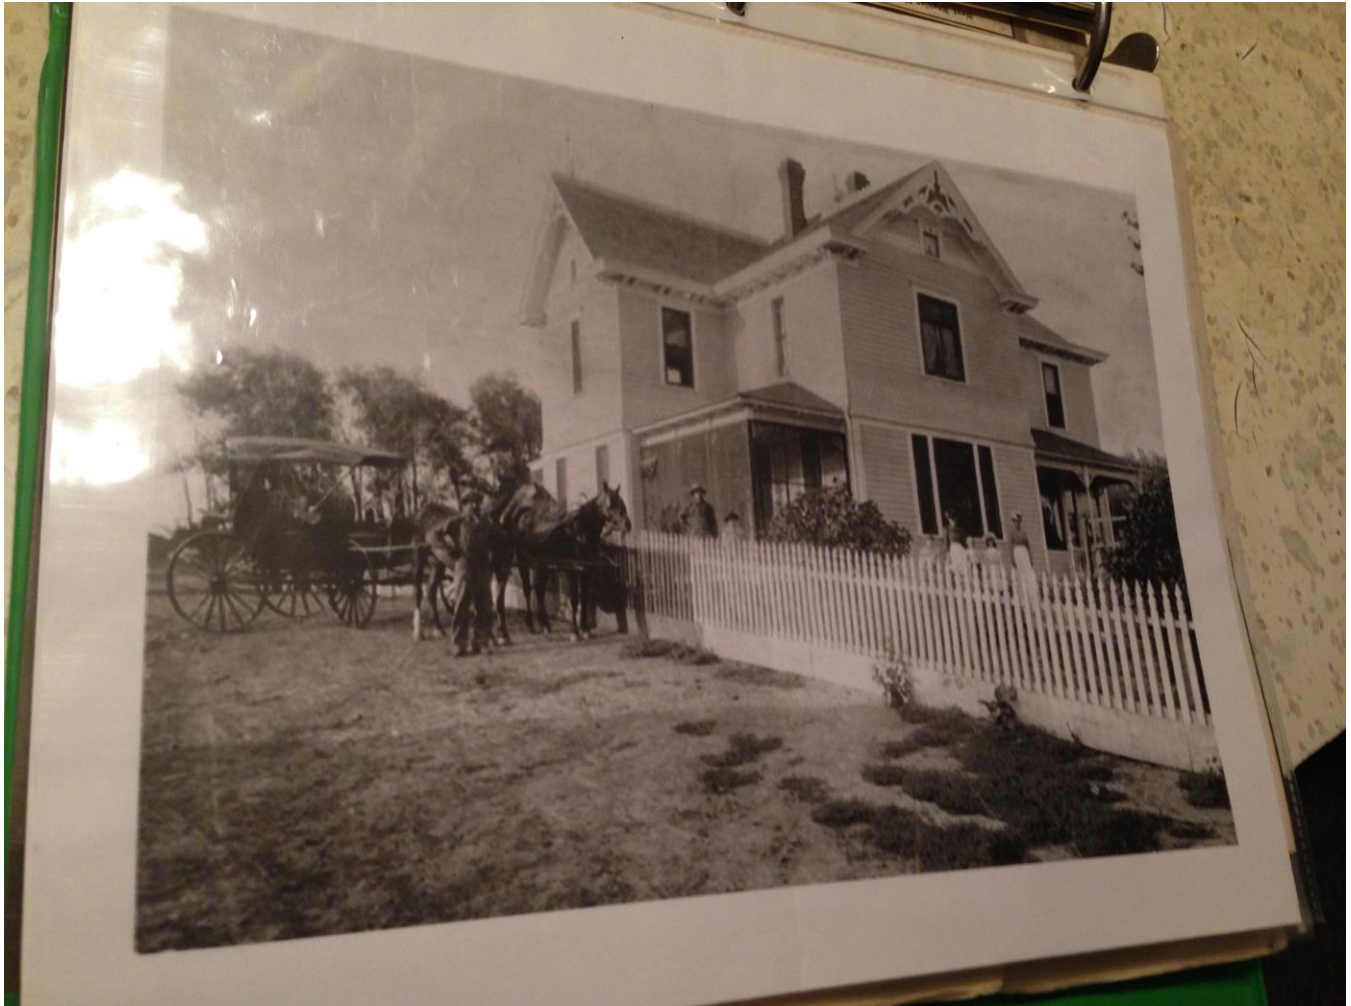
Figure 4: Historic photo of the farmhouse, date unknown. Many of the architectural details present in this photo, including the barge boards, bracketing, siding, and spindlework porches survive on the present house mostly unchanged.
