National Register of Historic Places
Inventory—Nomination Form

historic Hi Bug Historic District

Hi Bug Historic District
Continuation sheet

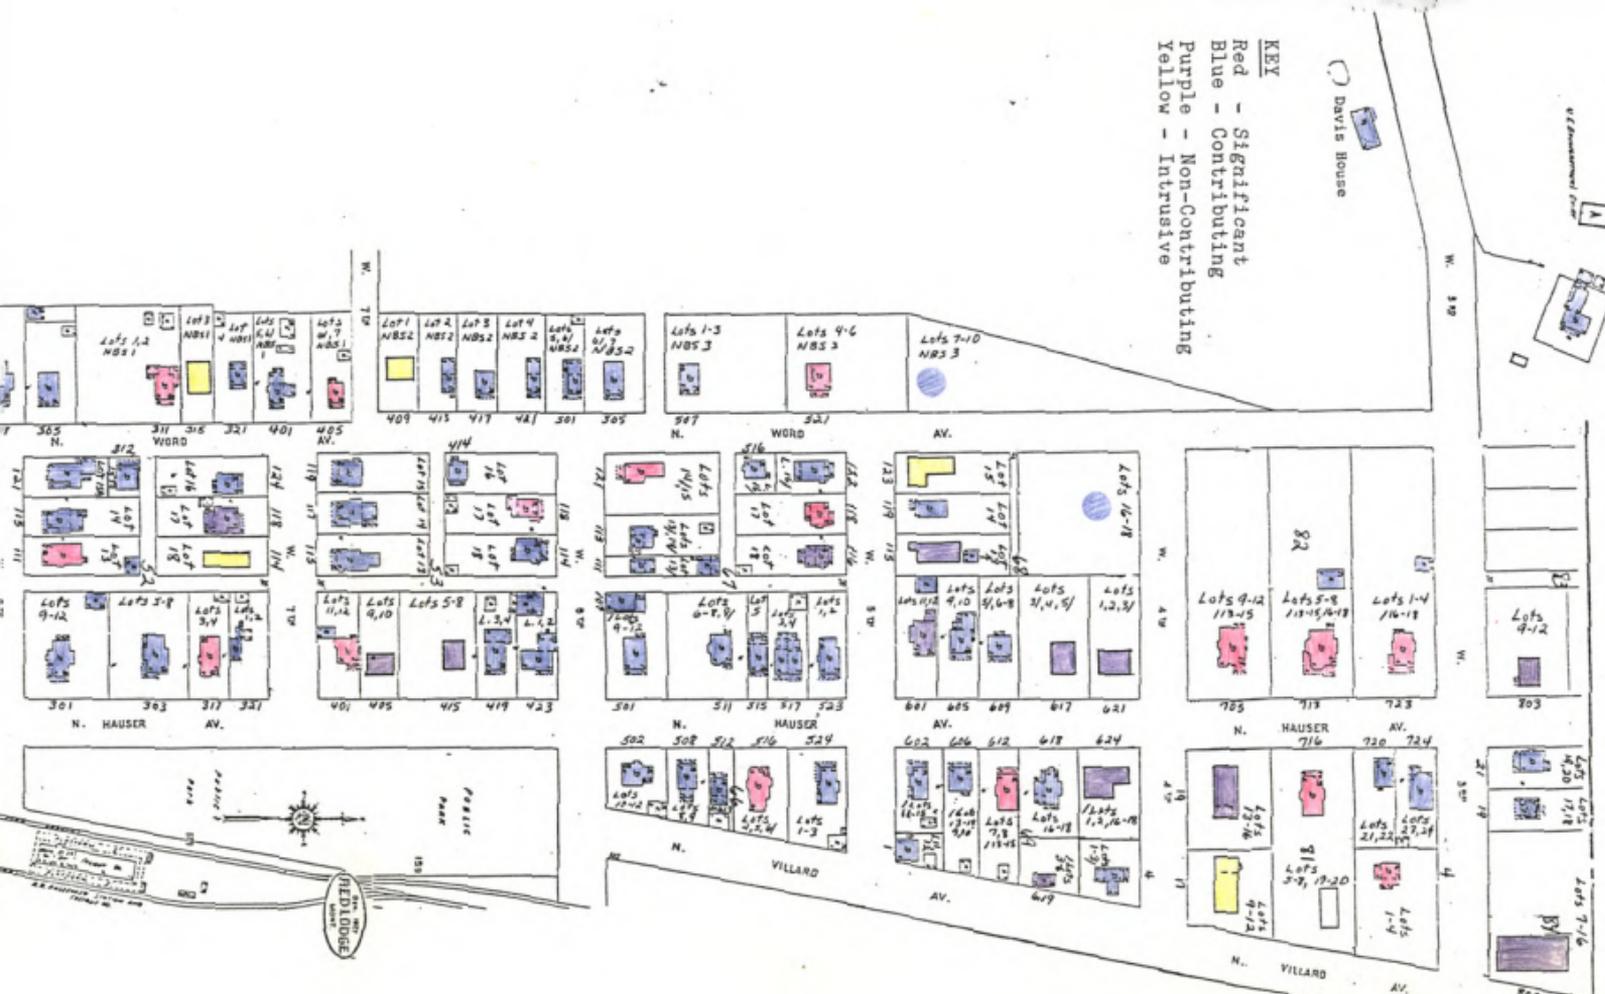
Hi Bug Historic District Red Lodge, Montana

- KEY**
- Red - Significant
 - Blue - Contributing
 - Purple - Non-Contributing
 - Yellow - Intrusive
