**National Register of Historic Places  
Continuation Sheet**

Property Name: Staats House County: Somerset State: NJ

historic name STAATS HOUSE

**Historic Structure Report**  
**Abraham Staats House**  
 17 Von Steuben Lane  
 South Bound Brook, New Jersey

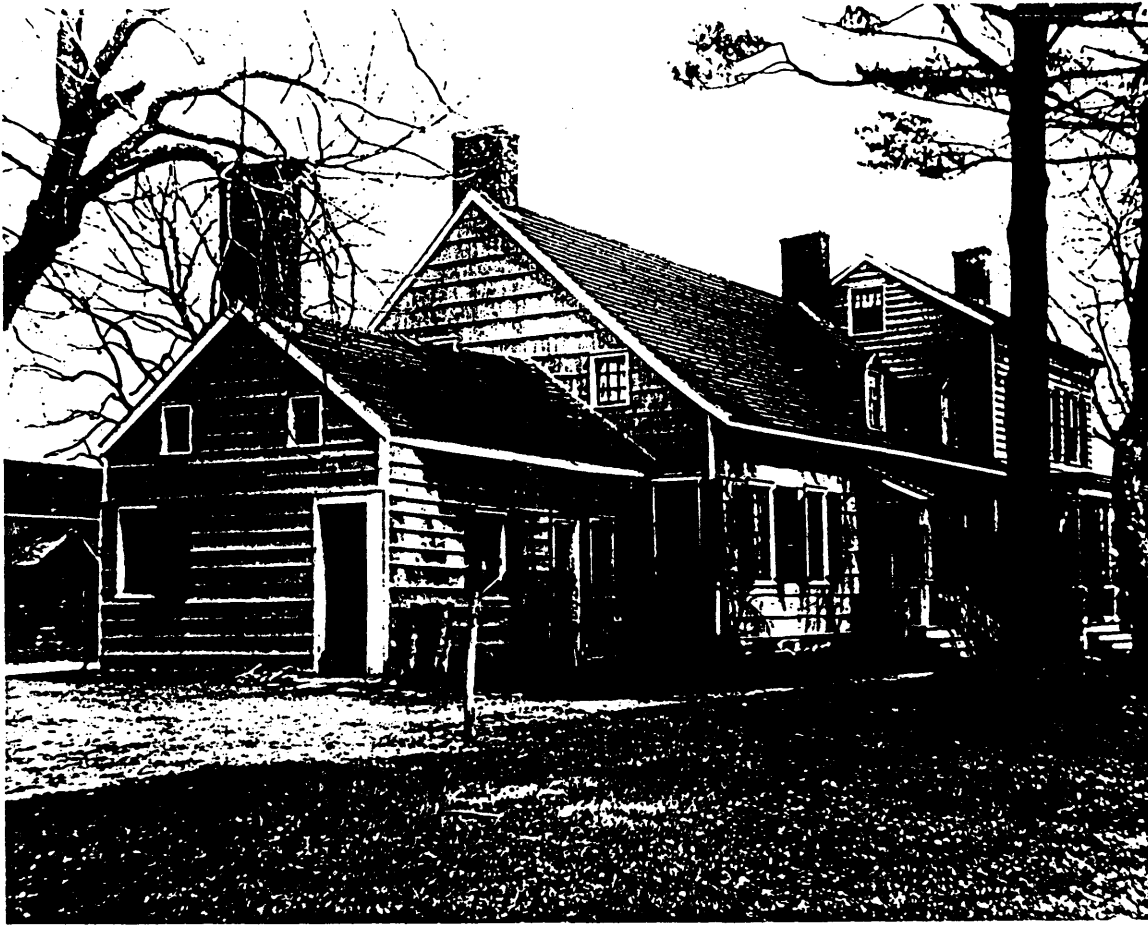
Figure 2. Taken at the close of the nineteenth century by F. N. Voorhees, this view from the southwest shows several surviving early features, including the small, gable-roofed dormers in the central section and the door centered on the southern façade of the kitchen. The photograph also shows the wooden steps leading up to the front entrances of both the central section and the east wing. The bake oven in the west wall of the kitchen wing has already been removed and replaced by a window. The outbuildings depicted behind the house no longer exist. *Special Collections, Rutgers University Library.*

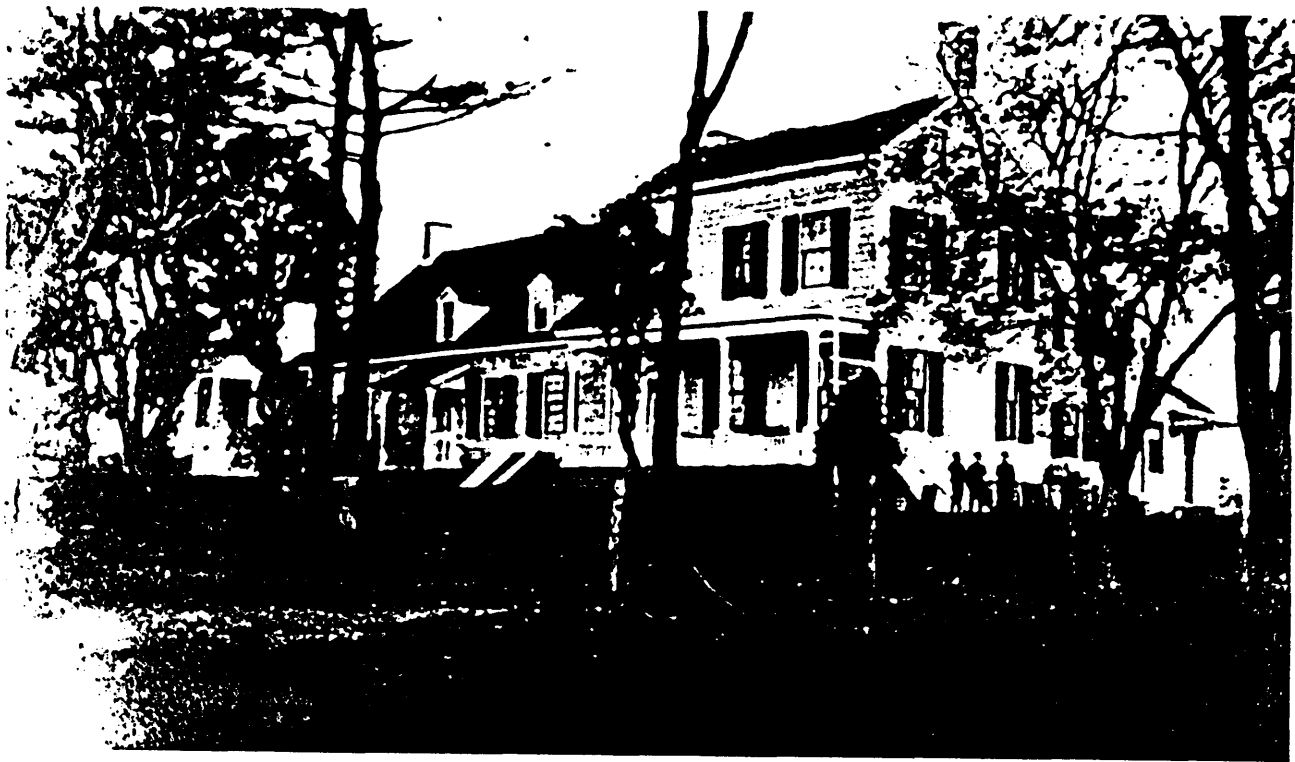
Figure 3. An early twentieth century postcard depicts the house from the southeast and confirms many of the features shown in the Voorhees photograph. Note the 12/12 sash in the central section and the bulkhead between its two eastern windows. Although early postcards often were hand tinted and thus not always reliable, this one correctly depicted the building's color scheme of yellow body with white trim and green shutters. *Somerset County Historical Society.*

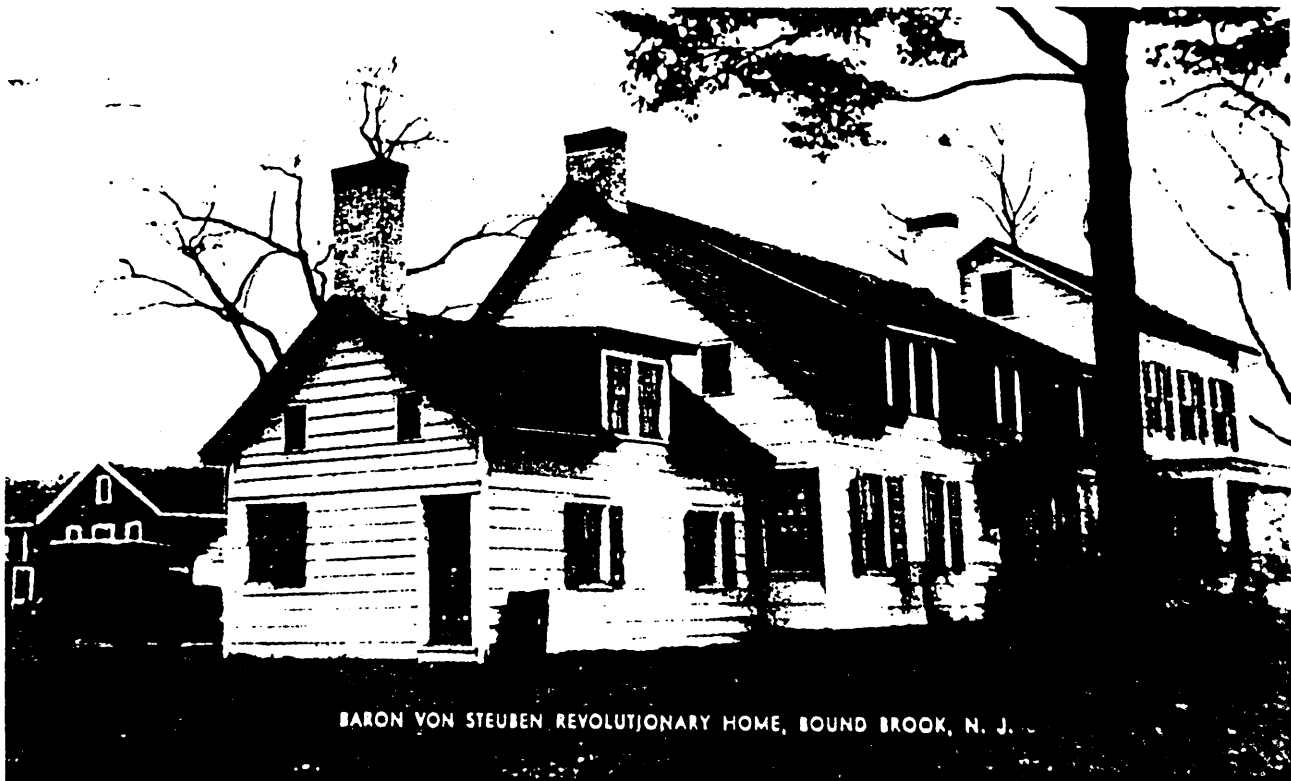
Figure 4. By the time this photograph was taken in the late 1920s or early 1930s, the LaTourettes had installed large shed-roofed dormers on the central block and the east wing and removed the southern door to the west wing. *Somerset County Historical Society.*

They made other alterations to the front of the house, removing the door to the kitchen wing and replacing the east wing's porch, or at least its columns, with square posts with a low parapet between them. (Figure 4) The LaTourettes also replaced the small portico at the entrance to the central section of the house with a pergola that featured benches.<sup>3</sup> (Figure 8) At the rear they extended the east wing by about eight feet. This required a slight change in the pitch of the shed roof. The Latourettes added a one-story shed behind it and a shed-roofed porch to shelter the rear door. (Figure 5) This certainly provided more convenient kitchen facilities. Cooking must have been done on a coal or wood-burning stove. A tall chimney to carry off the smoke rose at the rear. They also added the large bay window at the rear of Room 103. It probably was during this construction that the partition was removed between this room and what had been a small room at the rear of the stairs.

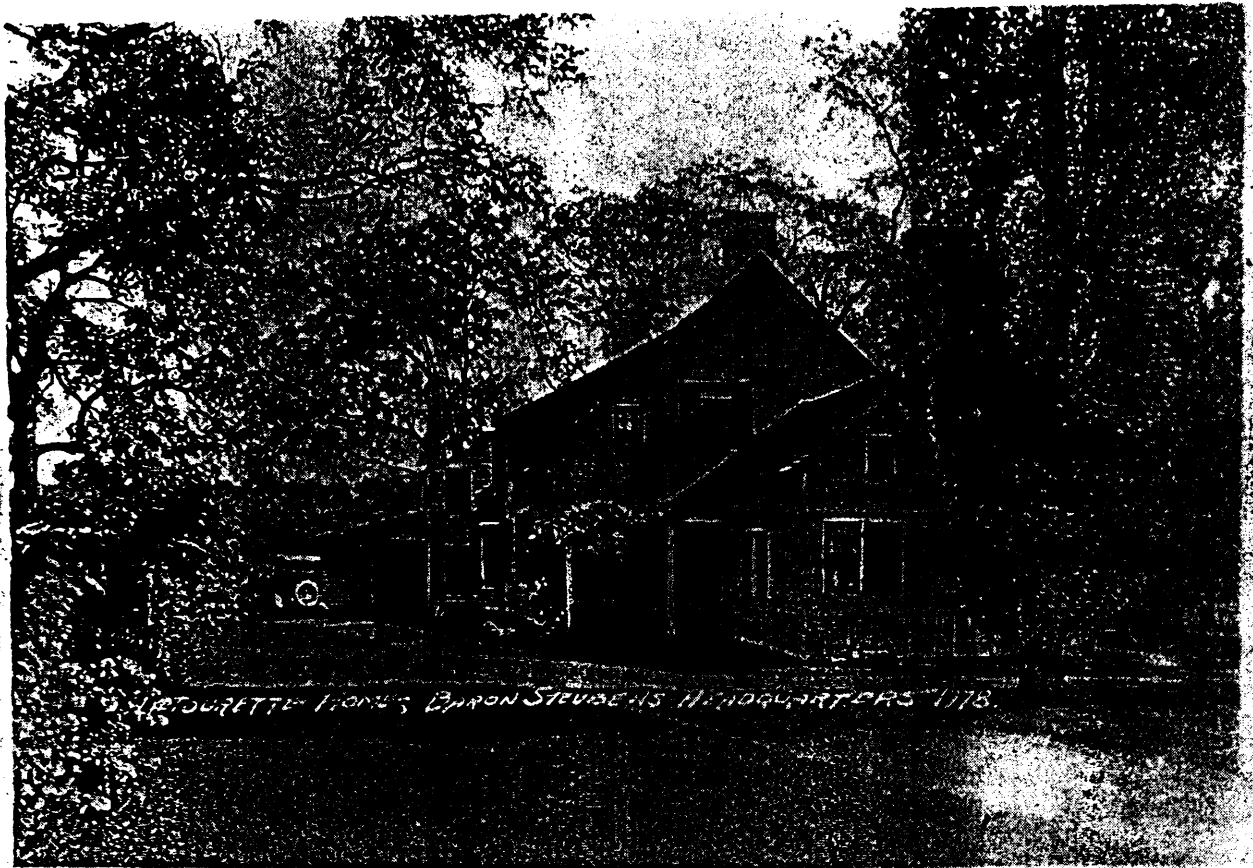
Figure 5. By the early twentieth century, there also were shed-roofed dormers at the rear of the central section and the bay window had been installed. The extensions to the rear of the east wing also were in place. *Somerset County Historical Society.*

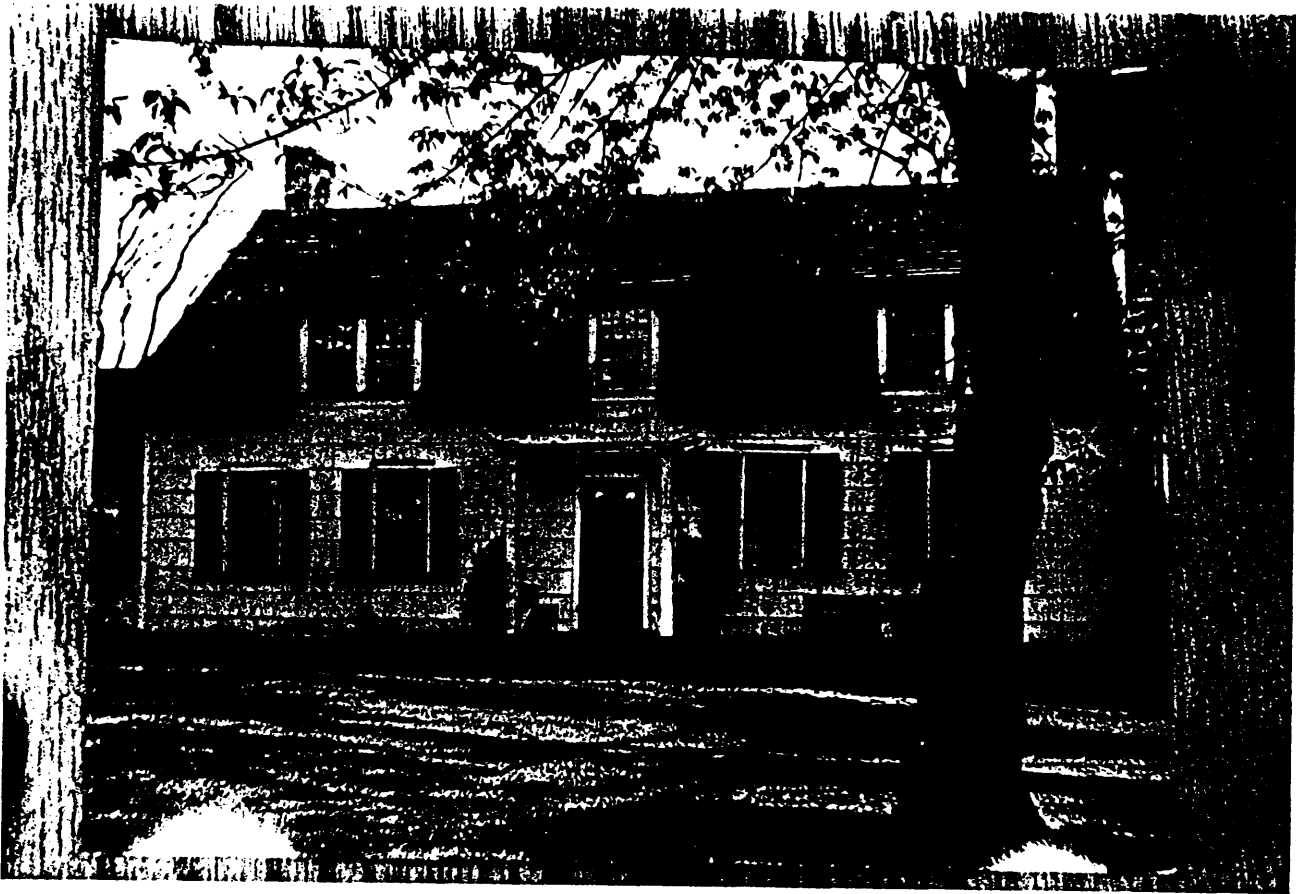
Figure 8. Rosemary Fellows Bailey preparing her book, *Pre-Revolutionary Dutch Houses and Families in Northern New Jersey and Southern New York*, made field trips in 1932 and 1933. The photograph of the Staats House shows that the bulkhead still remained under the windows of the east end of the central section. The wooden steps had not yet been replaced by stone. The stoop at the front door, however, had been replaced by the pergola that still appears in the Historic American Buildings Survey drawings. An original print of this and several other photographs made for the book are at *Special Collections, Alexander Library, Rutgers University*.

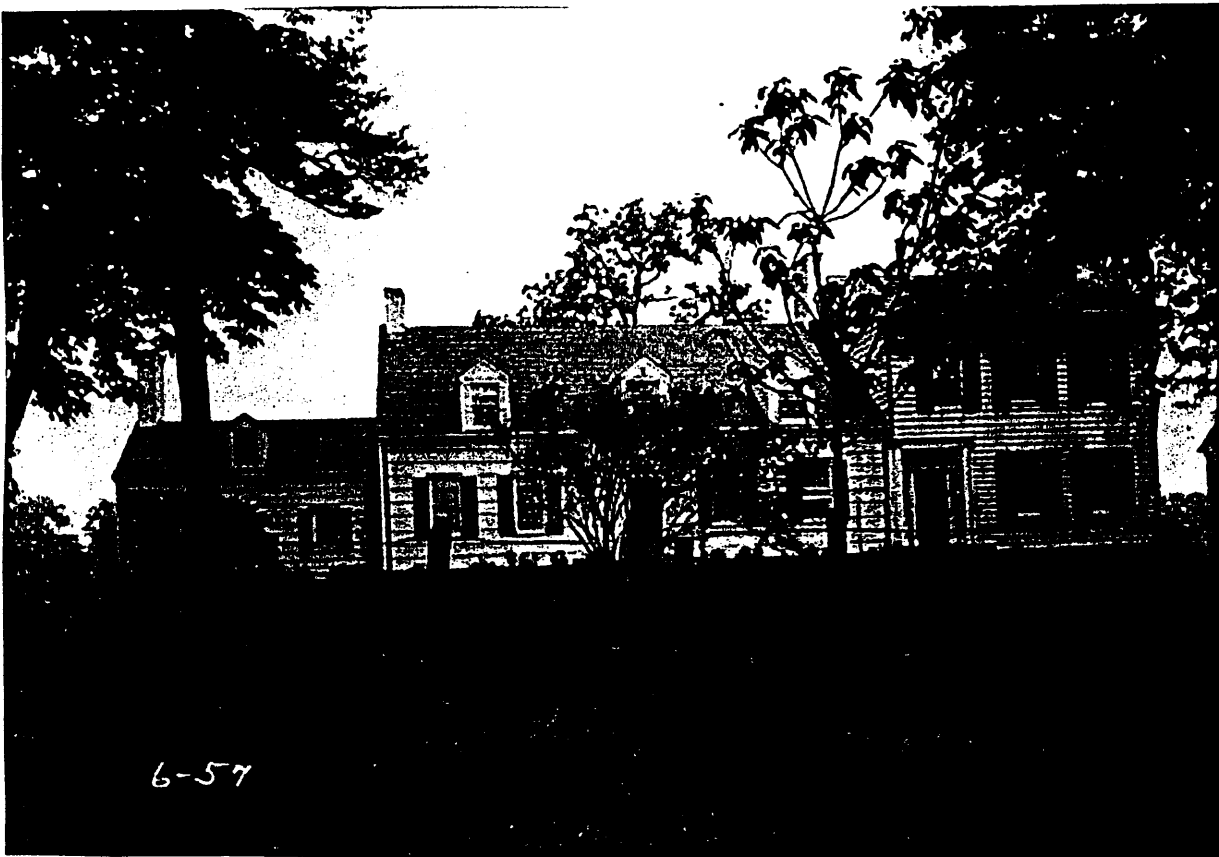
Figure 9. By the time the Historic American Buildings Survey photographed the Staats House in 1936, the Riddells had removed the shed-roofed dormers, replacing them with the gable-roofed dormers that still survive.

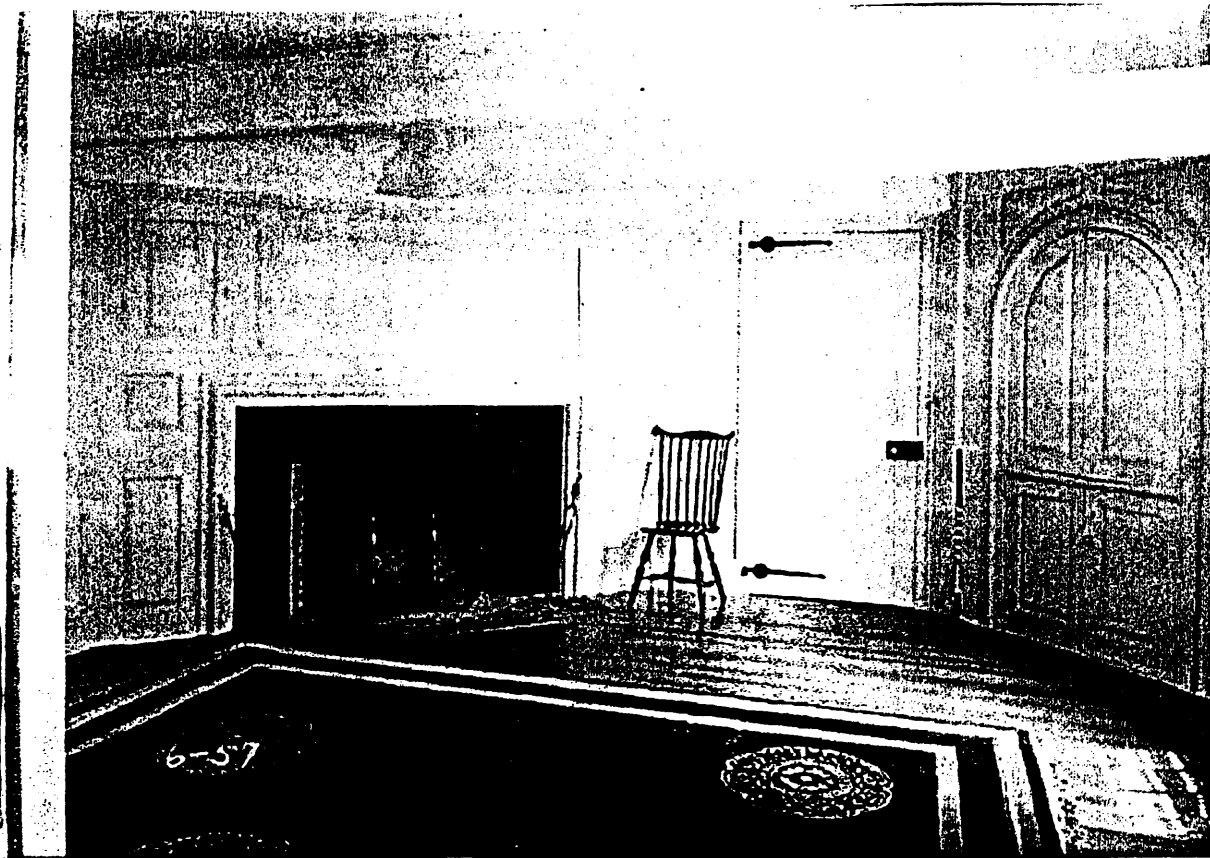
Figure 10. Without the distraction of furnishings, Abraham Staat's paneled fireplace and corner cupboard show to advantage in this Historic American Buildings Survey photograph.

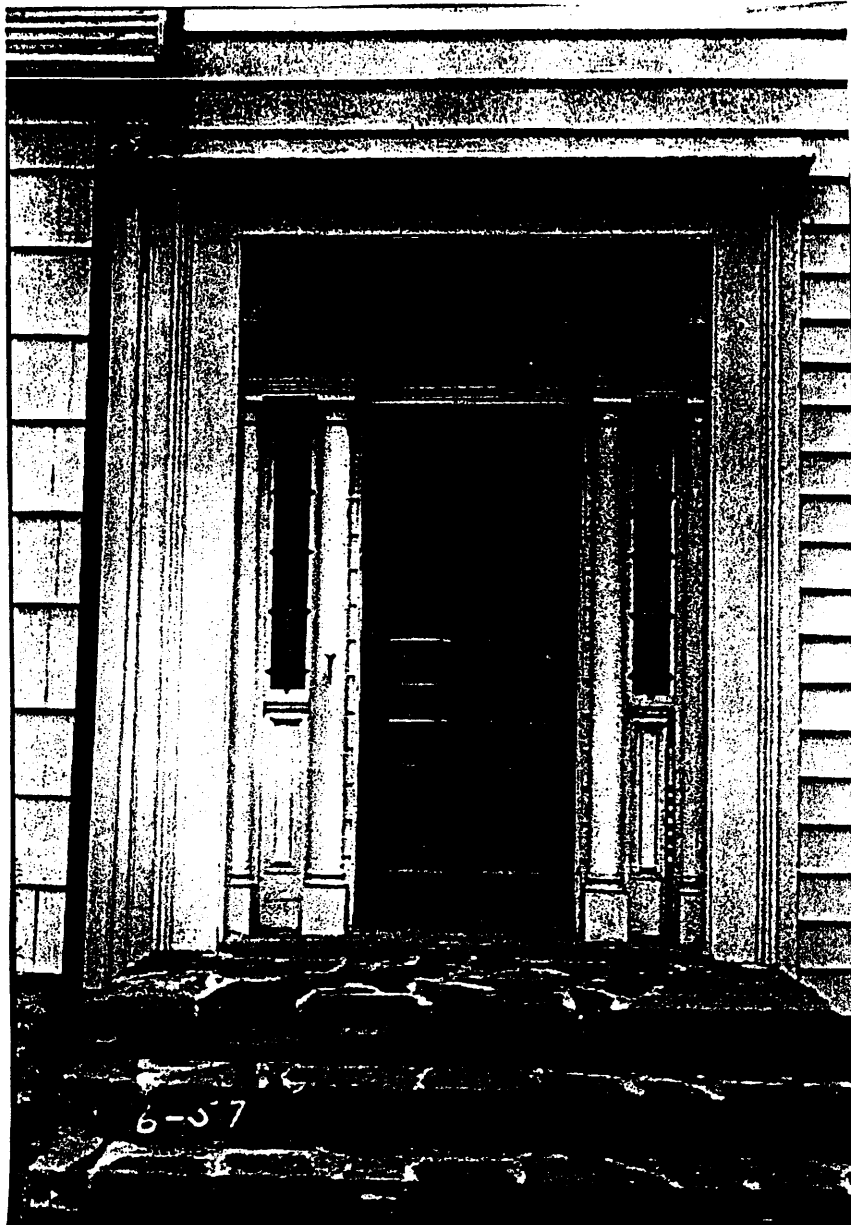
Figure 11. By the time the HABS team visited in 1936, the porch had been removed and stone steps built in front of the east wing. The ornamental lead in the sidelights and transom still was in excellent condition.

This date would accord well with the Federal-style front doorway with its leaded sidelights and transom. (See Figure 11 and HABS, sheet 7, "Entrance to 1820 Wing") Typical of fine early nineteenth-century work, the doorway features attenuated Tuscan columns, backed by blocks beveled to simulate rusticated stone. The repetition of the columns on the interior, in the form of pilasters, is especially notable. The staircase, with its slender balusters, also dates from this period. (Photo 12)

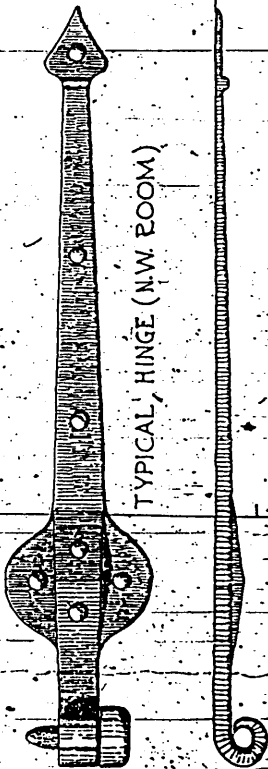
TYPICAL HINGE (N.W. ROOM)

BRASS KNOCKER  
ORIGINAL DOOR

W.I. HINGE  
IN  
NORTH PARLOUR

FRONT DOOR (UPPER SECTION)

Hillsborough Township, believed to date to the late 1760s. Nevertheless, the Dutch retained a preference for some features not found in houses built by other ethnic groups. They continued to construct unusually large fireplaces, perhaps a reminder of the old jambless fireplaces. Often these incorporated small cupboards, as does the fireplace in Room 102. For hanging large doors, they also favored cross-garnet or strap hinges, hammered into a round nailing plate near the hinge and with bean pod or pointed finials. At the Staats House, such hinges can be seen on the front door of the older section and and throughout the interiors of the central section. (See HABS drawing, sheet 17, "Hardware Details")
