**NATIONAL REGISTER OF HISTORIC PLACES
CONTINUATION SHEET**

Senior Officers' Quarters Historic
District, Yerba Buena Island
Property Name

historic name Senior Officers' Quarters Historic District, Yerba Buena Island

Senior Officers' Quarters Historic District, Yerba Buena Island
San Francisco, CA

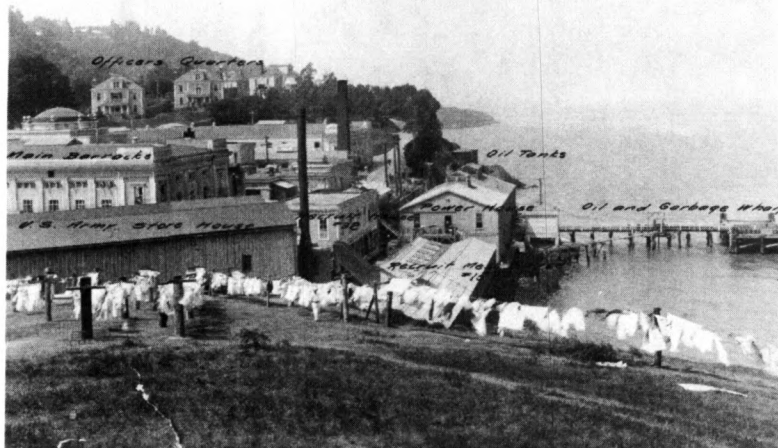
Figure 1. View of Naval Training Station, 1901, with Officers' Quarters labeled in left background. [Treasure Island Museum Collection, unnumbered, Treasure Island, San Francisco, CA]

The main facility on the station was the large training barracks building constructed in 1900 that also contained a large drill hall, offices, kitchen, pantry, storehouse, and petty officers' quarters. Designed in a Neo-Classical style, it was the largest building on the island, measuring three hundred by two hundred and sixty feet. The building had a clear floor span of three hundred feet and was capable of housing up to 500 men. As the construction on this enlisted barracks hall progressed, the Navy began to build a series of officers' quarters just up hill from the barracks. The Commander's Quarters, Building 1, was completed in 1900 (Figure 1), the seven other Officers' Quarters (Buildings 2-8), were completed between 1901 and 1905 (see Figures 2 and 3).

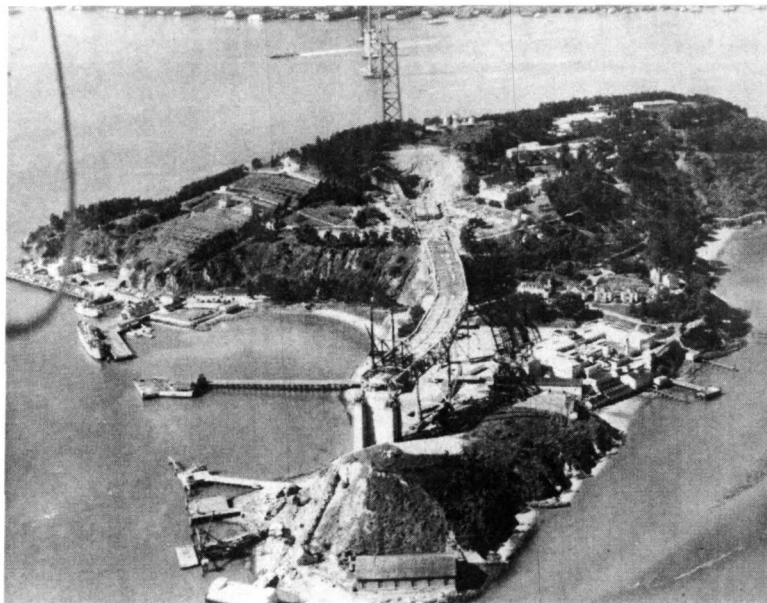
Figure 4. Yerba Buena Island during construction of the Oakland Bay Bridge. The Training Barracks and Officers' Housing are shown center right. [Treasure Island Museum Collection, Yerba Buena Island folder, Treasure Island, San Francisco, CA]

Three events of substantial importance forever changed the topography and history of Yerba Buena Island: the construction of the two spans of the San Francisco-Oakland Bay Bridge, the decision by the City of San Francisco to host the Golden Gate International Exposition, and the onset of World War II. The first event, the building of the San Francisco-Oakland Bay Bridge, or Bay Bridge, caused massive disruption to the topography of the island. Construction began in 1933 and included the largest diameter tunnel bore in the world and installation of an anchorage, piers, and abutments on Yerba Buena Island (see Figure 4). The construction occurred at a time in which the Navy had all but abandoned operations on the island, and very few buildings were in the alignment of the bridge. As a result, relatively few Navy buildings were demolished to make way for the bridge. Some demolition did occur; the State of California financed construction of several buildings on the east end of the island, to compensate the Navy for its losses.
