National Register of Historic Places
Registration Form

historic name Roxbury Fish Hatchery

other names/site number Roxbury Fish Culture Station

This document amends the 1994 National Register nomination for the Roxbury Fish Hatchery with an updated resource inventory. Between August 27 and September 2, 2011, Tropical Storm Irene caused extensive damage to the property. The site is located on an alluvial plain between the Flint Brook and the Third Branch of the White River. During Tropical Storm Irene, Flint

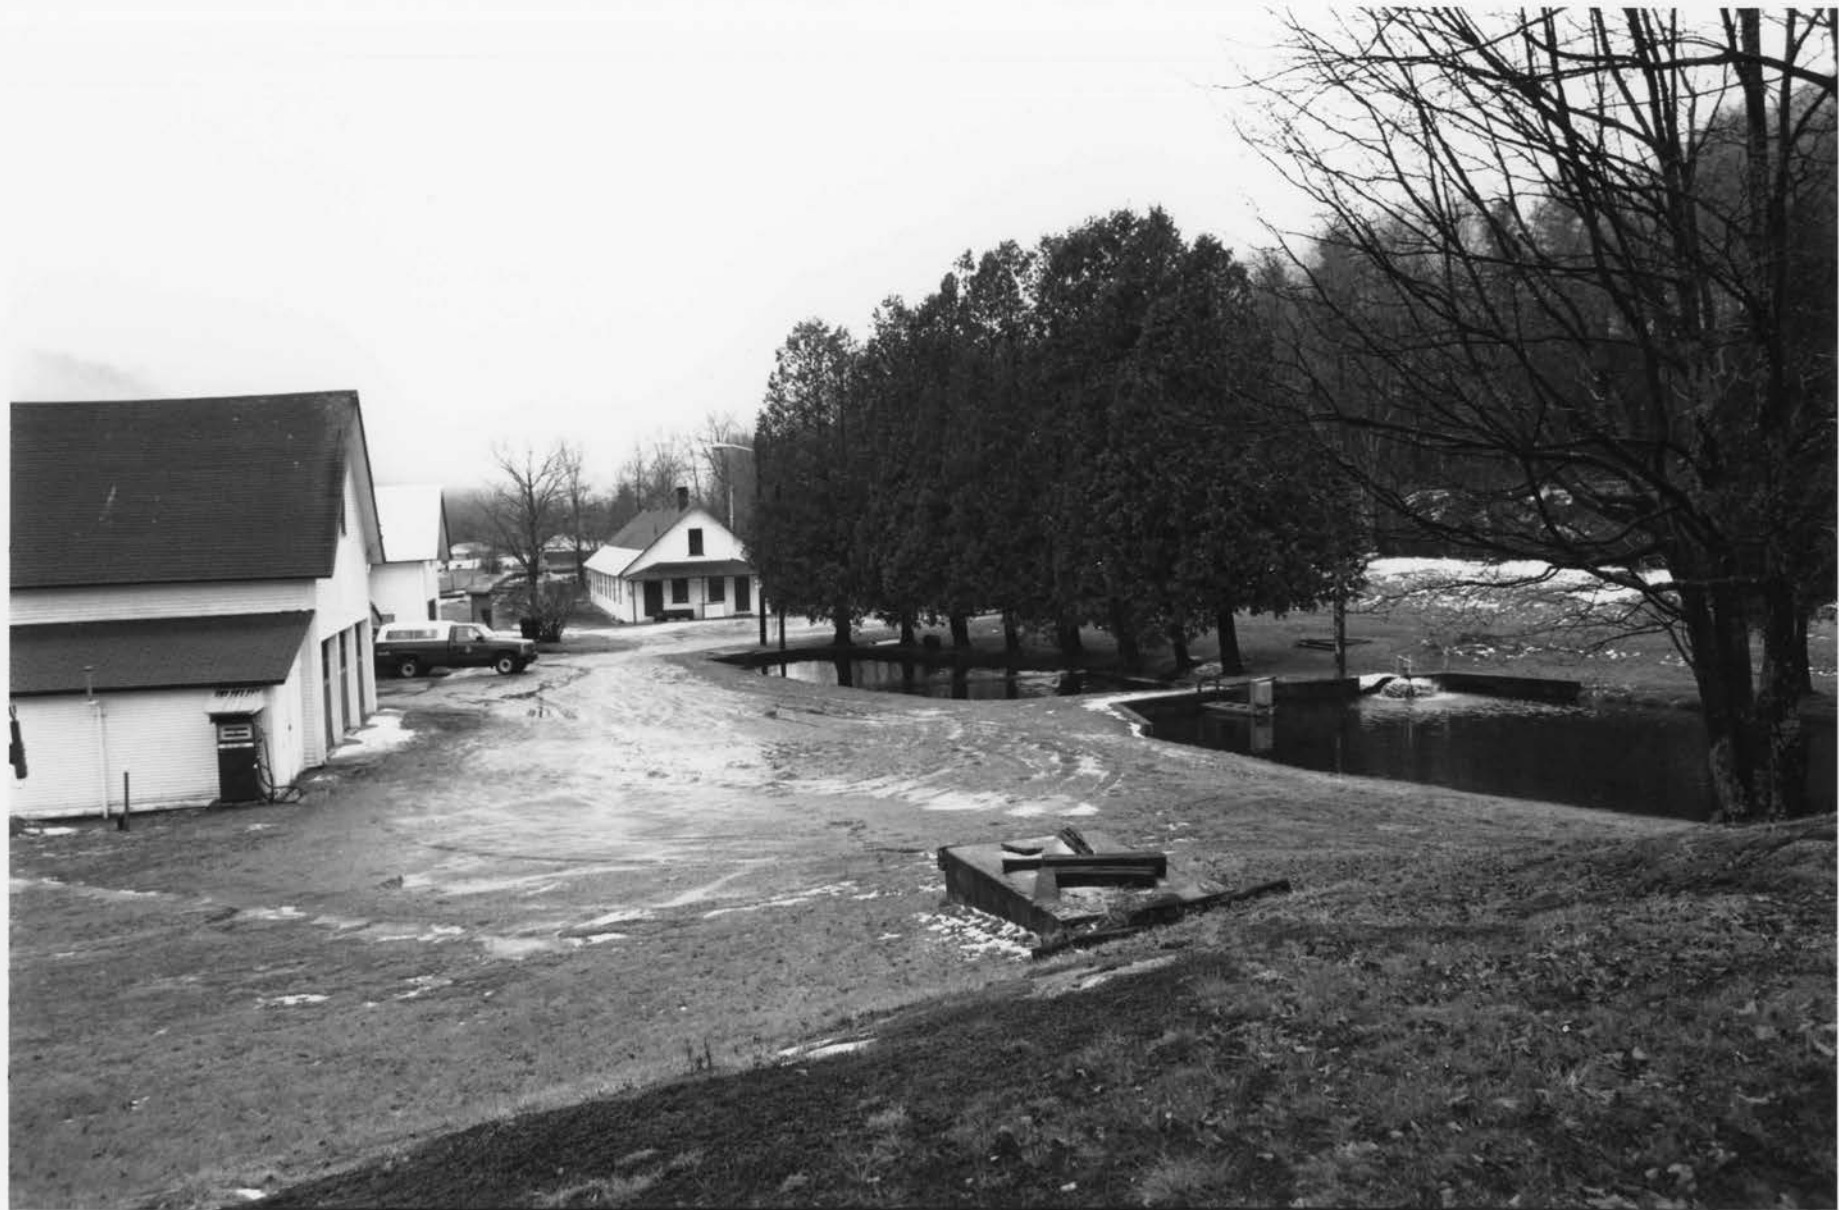
Photograph #1

1. #1, #2, #3, #4, Roxbury Fish Hatchery
2. Washington, Vermont
3. Ann Cousins
4. January, 1993
5. Vt. Division for Historic Preservation
6. View looking South. (l. to r.) #3 Carriage Barn
#2 Ice Meat and Cook House, #1 Hatchery Building
#4 Ponds.

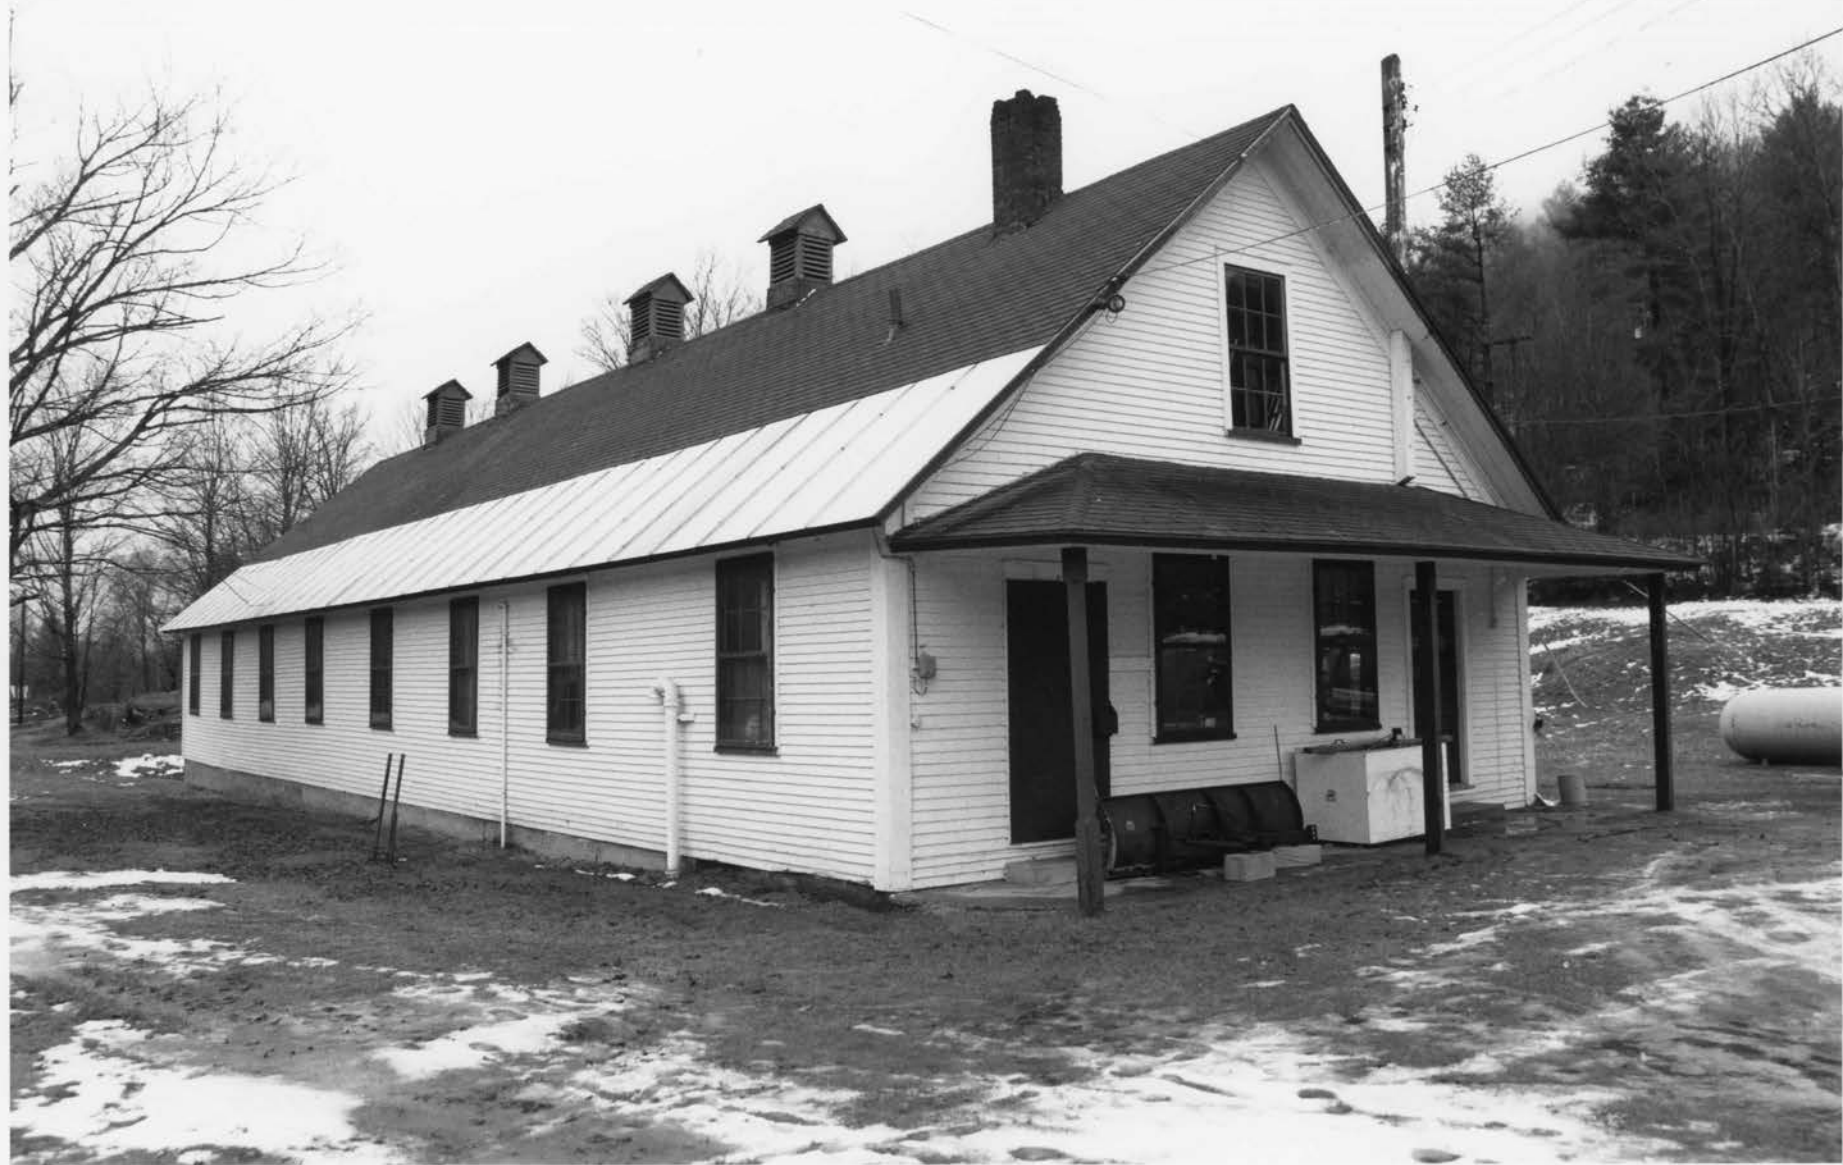
Photograph #2

- 1) #1 Hatchery Building, Roxbury Fish Culture Station Hatchery
- 2) Washington, Vermont
- 3) Ann Cousins
- 4) January 1993
- 5) Vermont Division for Historic Preservation
- 6) View looking southwest, #1 Hatchery Building

door at the left bay. The present doors replace original four-paneled doors, and the left bay entrance was widened, probably in 1938 when the interior was renovated. The facade is protected by a hipped roof, full width, concrete deck porch. When built, the front of the porch formed the wall of an approximately 25' square rearing pool that was part of a series of pools extending approximately 75' north of the building. The elongated hatchery sits on a concrete foundation, has clapboard siding and a gable roof covered with asphalt shingles with standing seam ice flashing at the lower third of the slope. There are four wood ventilators at the ridge above the trough room and a brick chimney at the west slope near the ridge above the office section. Architectural detail includes wide cornerboards rising to a narrow frieze, and plain surrounds with a drip cap framing the regular 6/6, double-hung sash. The exterior of the building is remarkably unchanged.

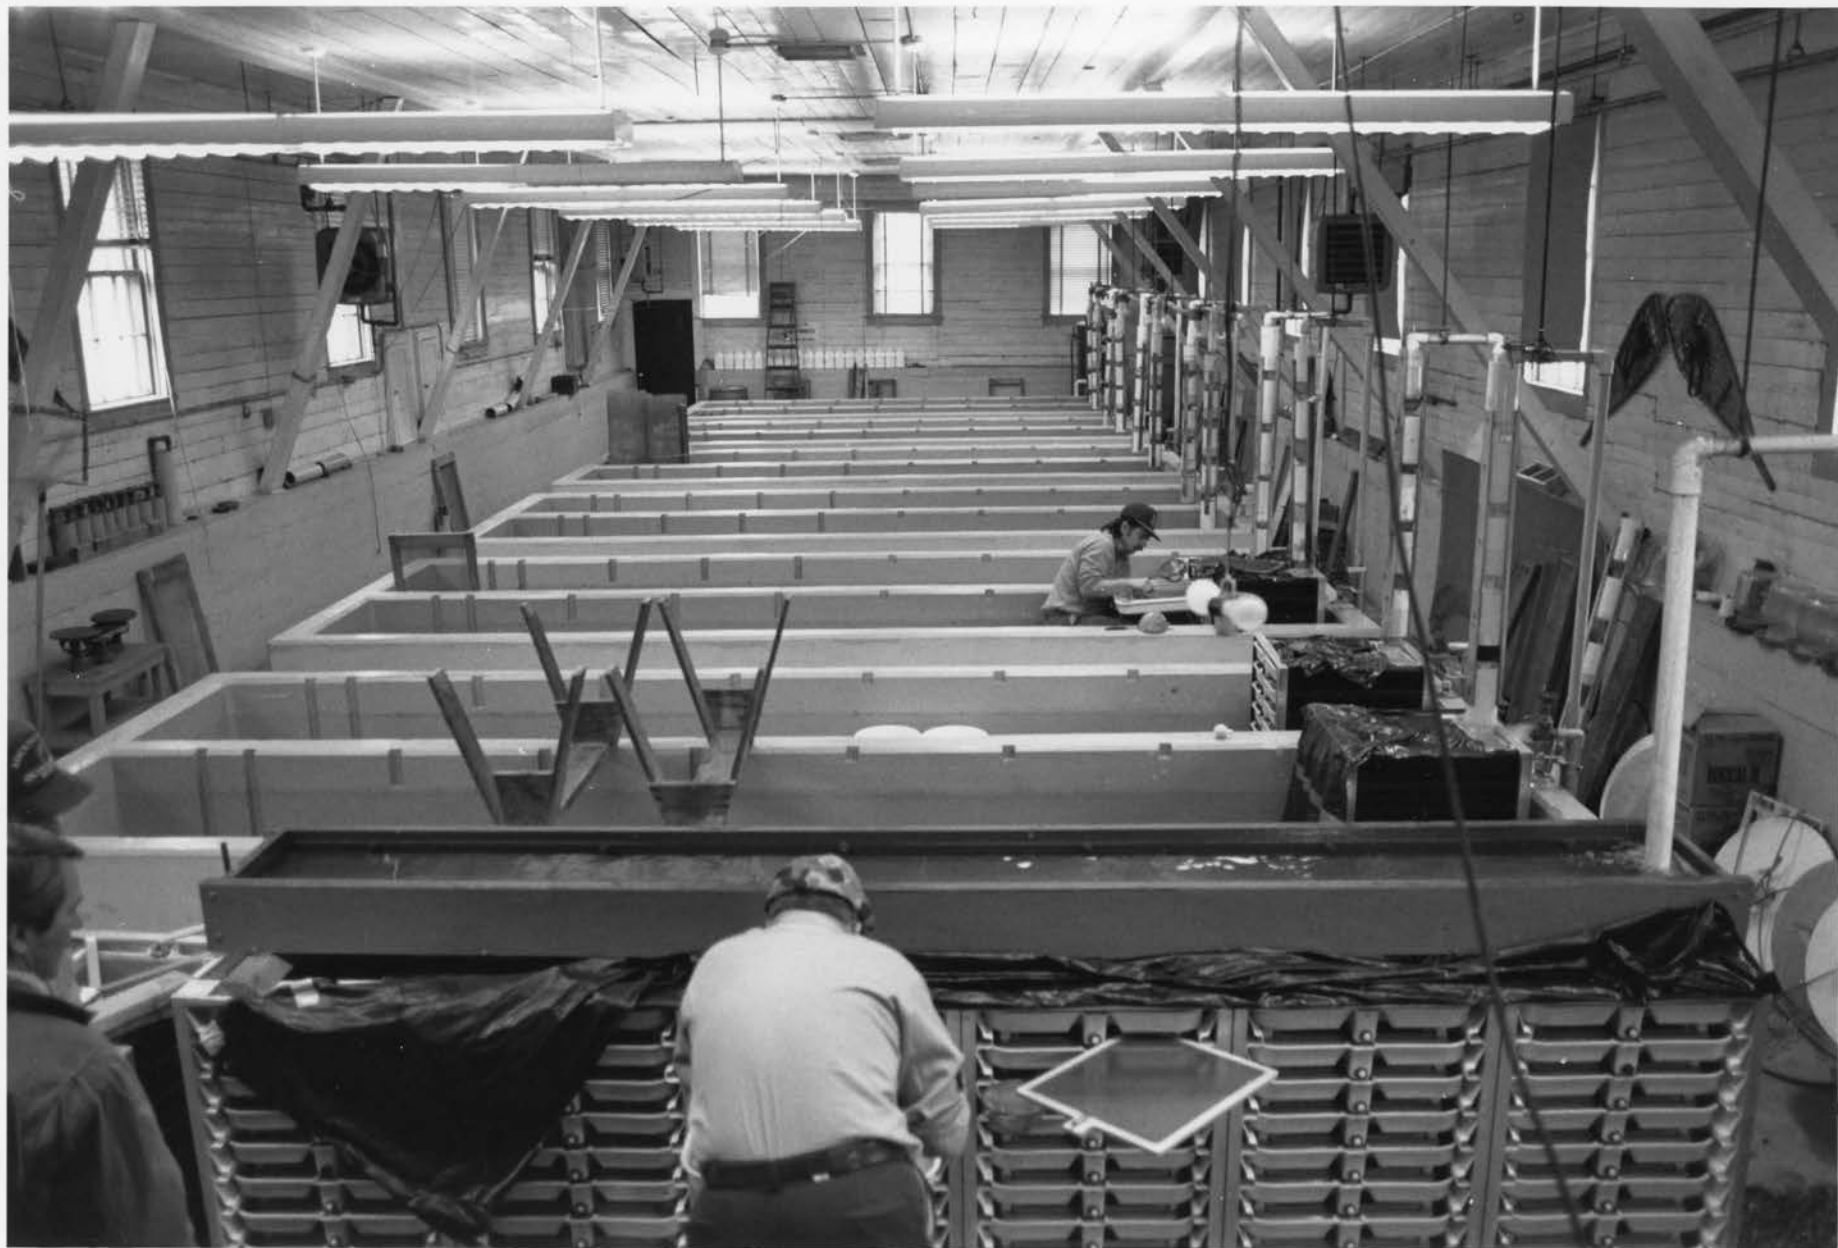
Photograph #3

- 1) #1 Hatchery Building, Roxbury Fish Hatchery
- 2) Washington, Vermont
- 3) Ann Cousins
- 4) January, 1973
- 5) Vermont Division for Historic Preservation
- 6) Interior of Hatchery Building

The interior of the hatchery building has two offices, a storage closet and a bathroom in the front section, and an elongated trough room, or hatch room, below grade (down four steps), stretching behind. The interior represents a series of renovations made to the building in response to changing fish culture technology. When built, the hatchery was equipped with wooden rearing troughs set on a wood floor. In the wet environment, the floors and sills quickly deteriorated, and in 1912, the building was raised out of the ground, placed on new sills, and the decaying floor was replaced by a concrete floor set two feet lower than the original floor to better take advantage of gravity for the water delivery system. This necessitated pouring concrete walls five feet high from the floor to raise the woodwork out of the ground. The concrete half-wall now supports diagonal bracing that was added to reinforce the ceiling. Because the floor was dropped and the walls raised, the base of the windows now begin approximately six feet above the floor, a feature not found in subsequent state hatcheries. The second renovation took place in 1938 when the C.C.C. installed toilets and a new heating system in the hatchery building. By this time the hatchery had probably been electrified. Finally, in 1977, as prevailing fish culture practice suggested that wood troughs can harbor harmful microorganisms, the cypress troughs were replaced with six, paired, concrete troughs, each approximately 3' tall by 7' wide by 20' long. There is a walkway at the ends and on either side of

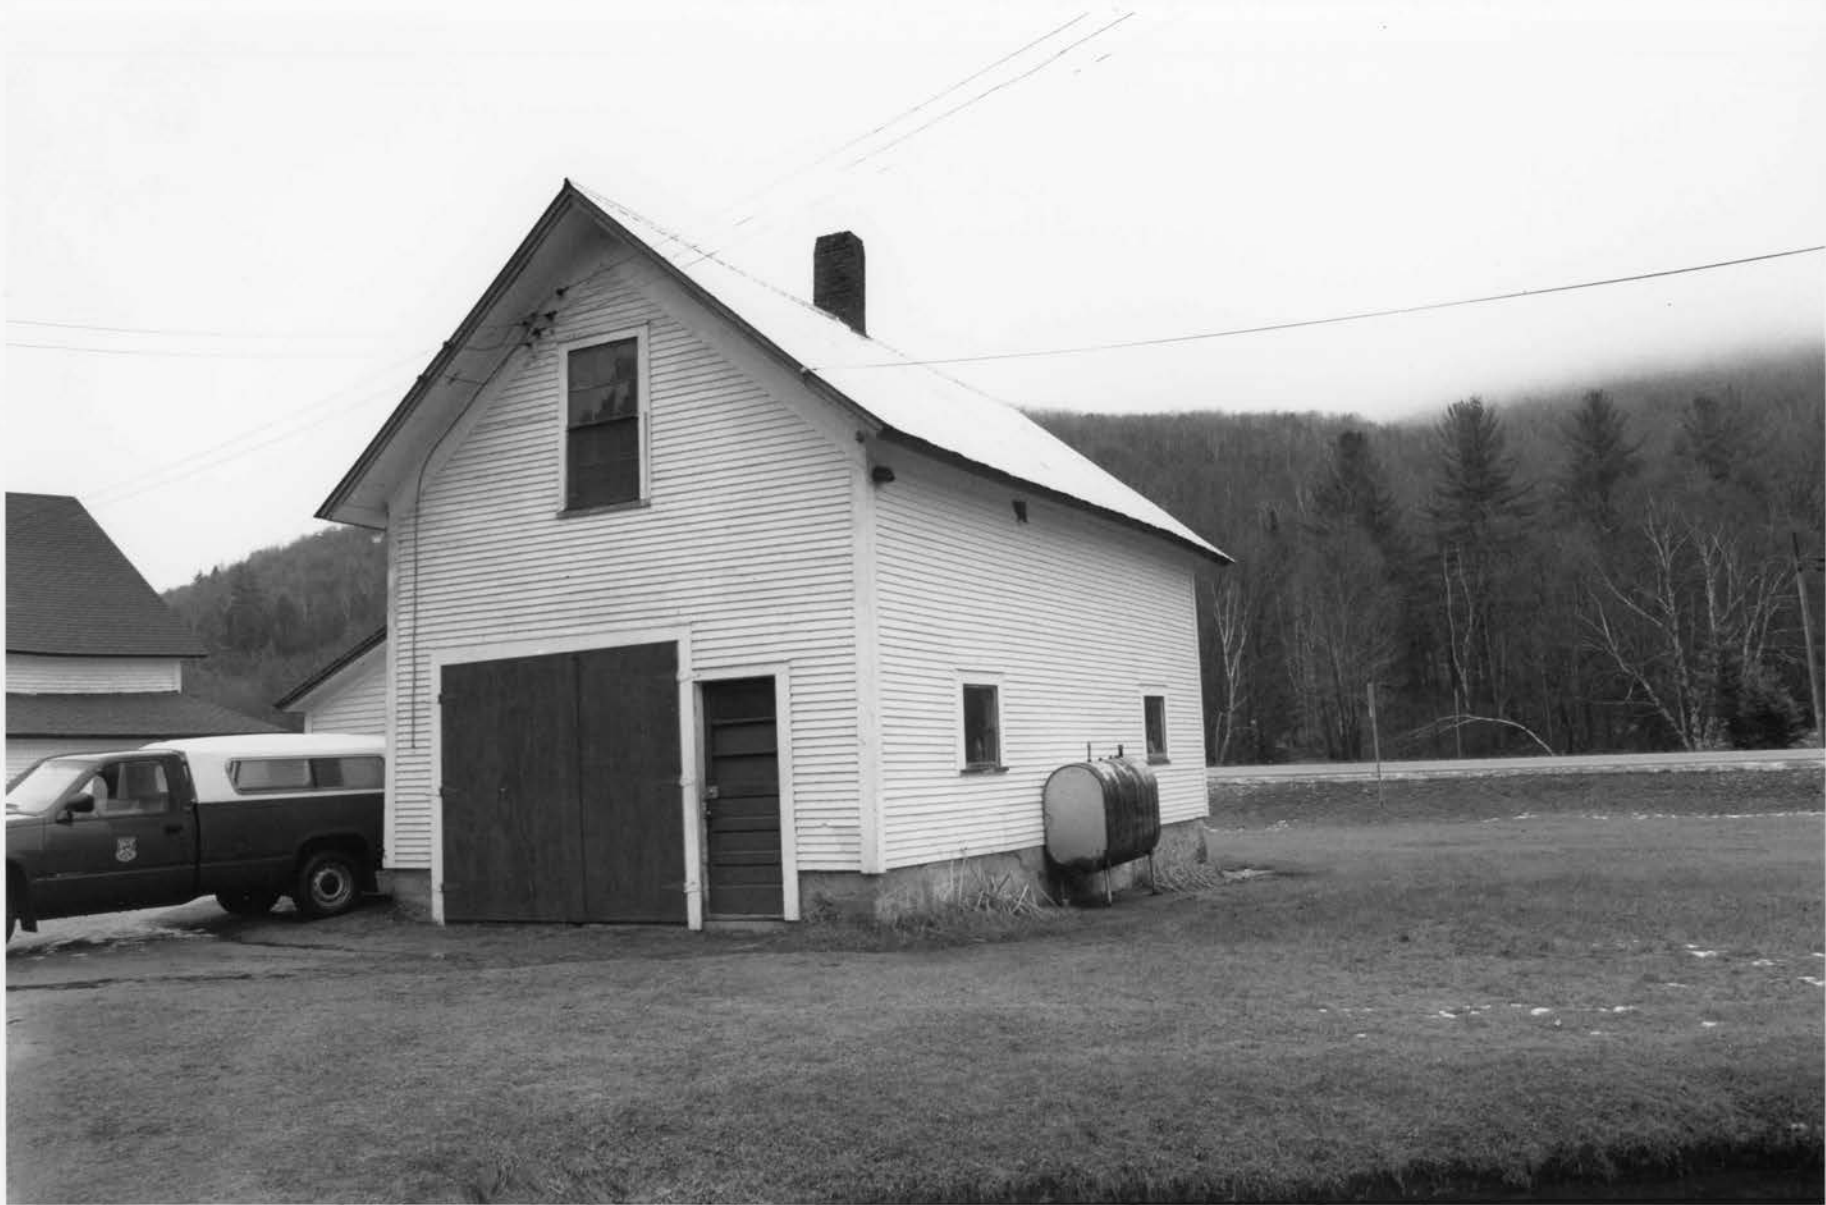
- 1) #2. Ice, Meat and Cook House, Roxbury Fish Hatchery
 - 2) Washington, Vermont
 - 3) Ann Cousins
 - 4) January 1993
 - 5) Vermont Division for Historic Preservation
 - 6) View looking Northeast, #2 Ice Meat and Cook House, #3 Carriage Barn in background
- Photograph #4

The ice, meat and cook house is a 1-1/2-story, 2 x 2 bay, gable-front, vernacular building facing west (the yard). A three-quarter-length lean-to, housing a walk-in freezer, is attached to the north eaves-side. This c. 1950 appendage replaces an original, full-length lean-to with parapet front that served as the main entrance to the building. The ice, meat and cook house is slightly elevated on a concrete foundation that appears to be a c. 1930 renovation. It has clapboard siding and a gable roof with a wide overhang and corrugated metal roofing with a brick ridge

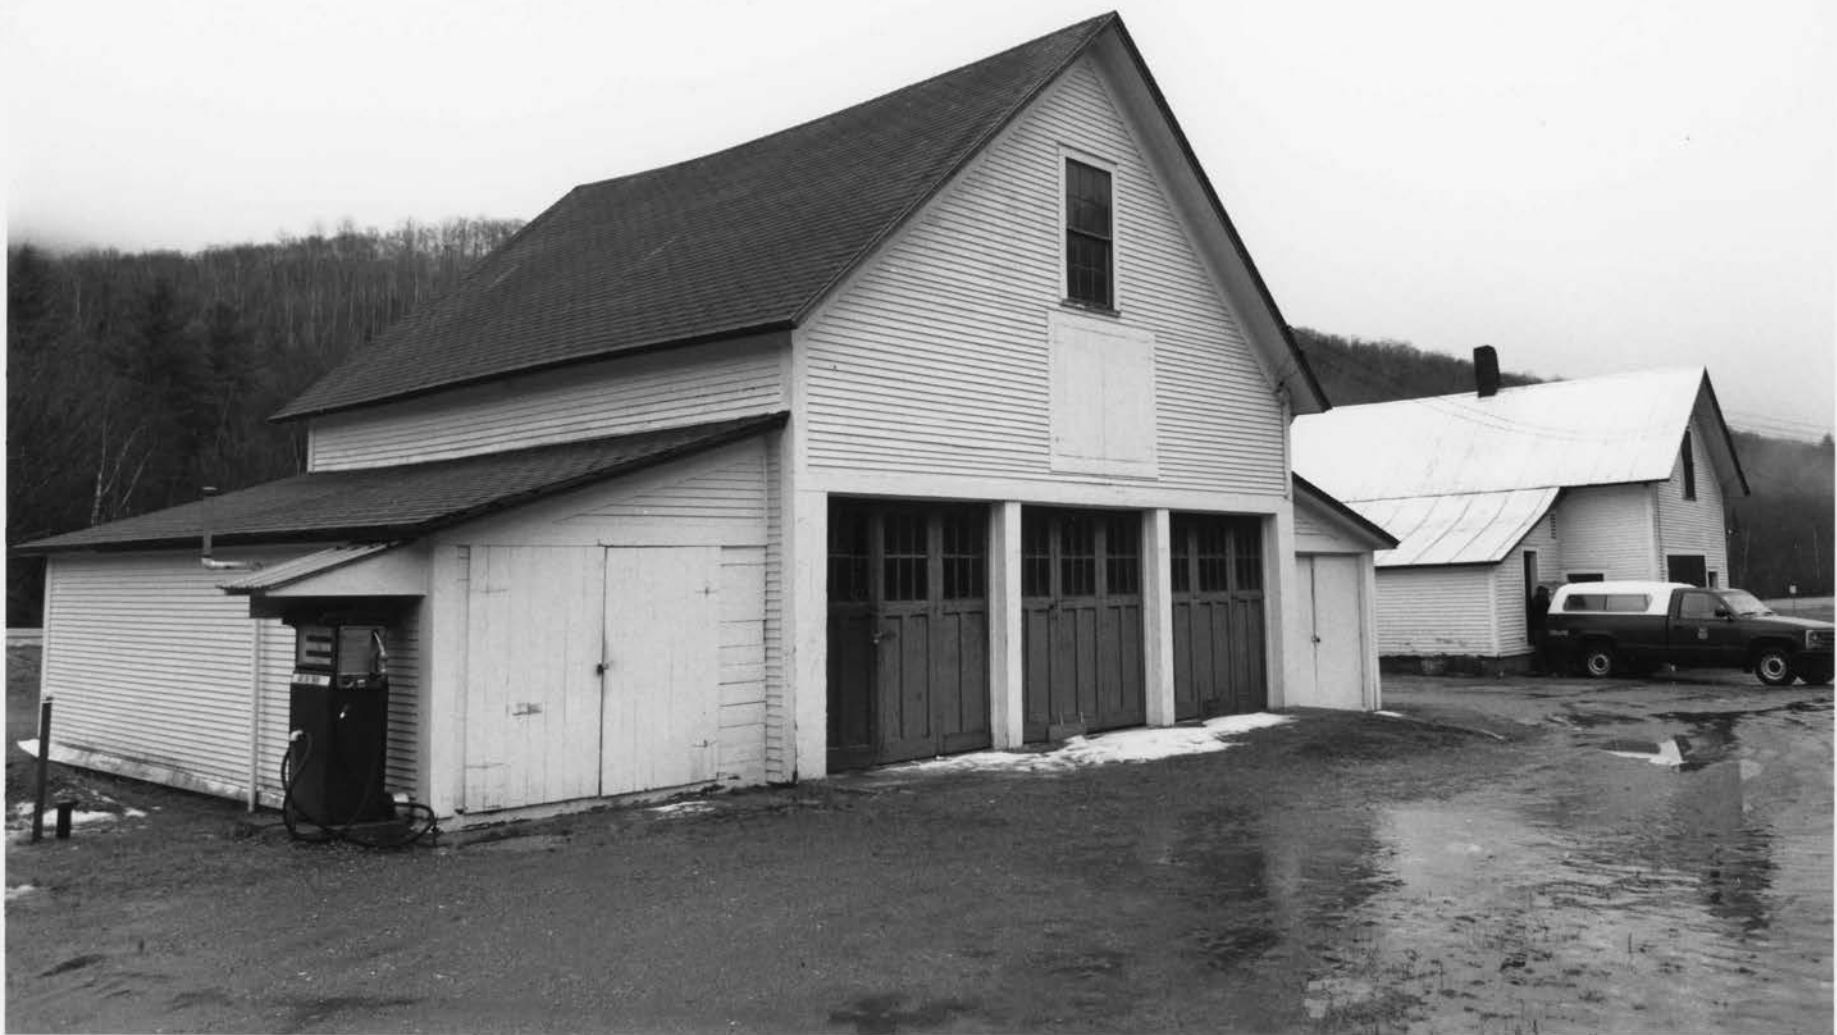
- 1) #3 Carriage Barn, Roxbury Fish Hatchery Station
 - 2) Washington Co, Vermont
 - 3) Ann Cousins
 - 4) January, 1993
 - 5) Vt. Division for Historic Preservation
 - 6) View looking Southeast, #3 Carriage Barn
- Photograph #5

The vernacular, 1-1/2 story, 3 bay wide, gable-front carriage barn sits just to the north of the ice, meat and cook house (#2) on a concrete foundation facing west. Full-length lean-tos are attached to the north and south eaves-sides. The barn has clapboard siding and asphalt shingle roofing. Details include plain cornerboards and frieze. The 3 bay west facade has historic 3-part folding garage doors, dating from c. 1935, that replace an original sliding door in the left bay and two small square stanchion windows in the right bay. A hay loft door remains at the second

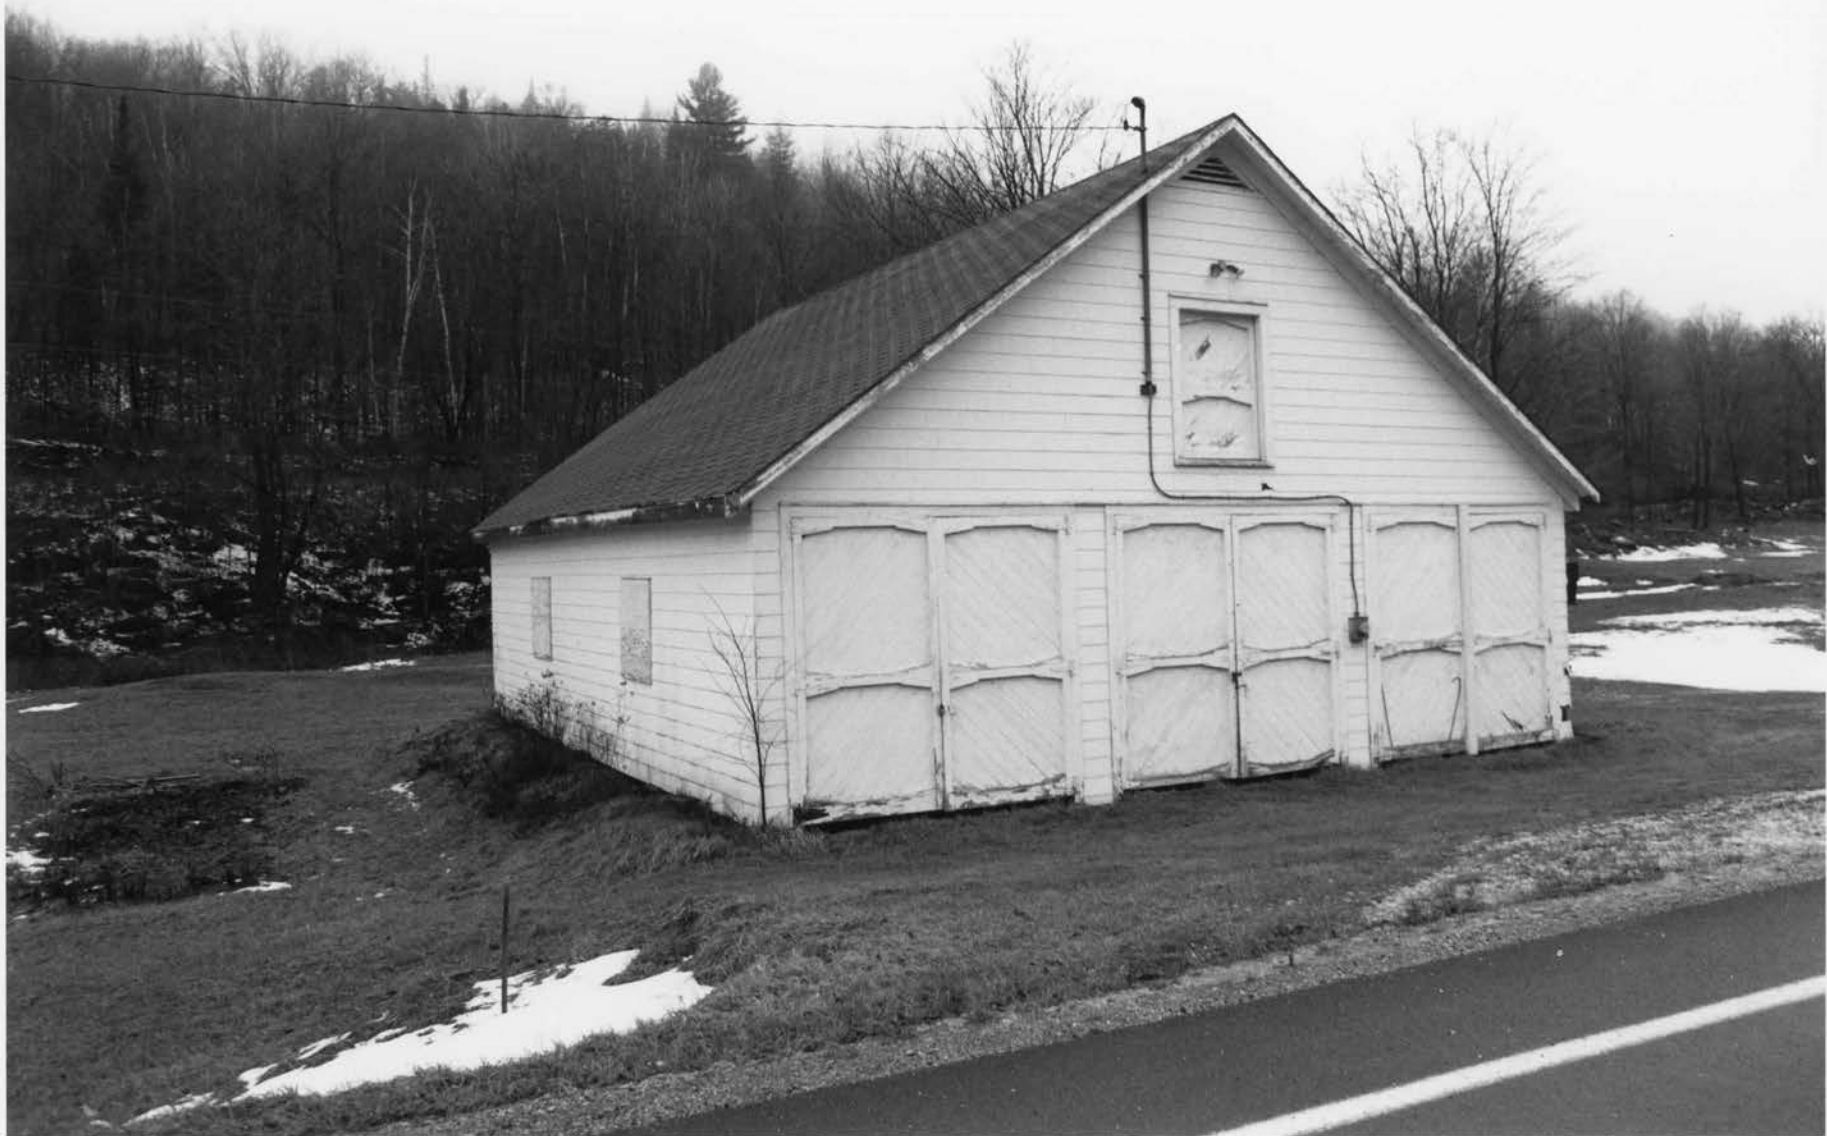
Photograph #6

- 1) #8 CCC Barn, Roxbury Fish Hatchery
- 2) Washington Co. Vermont
- 3) Ann Cousins
- 4) January 1993
- 5) Vermont Division for Historic Preservation
- 6) View looking Northwest, #8 CCC Barn

The vernacular, C.C.C. barn is a 1-1/2-story, approximately 35' by 45' gable-front barn set close to Vermont Route 12A, south of the hatchery building. Now used for storage, the structure sits on a concrete pier foundation, has vinyl siding covering the originals clapboards, and asphalt shingle roofing laid in a basket-weave pattern. The facade has three pairs of diagonal board, double leaf doors with canted framing. The trim is duplicated at the gable window. Windows at the sides and rear are now boarded.

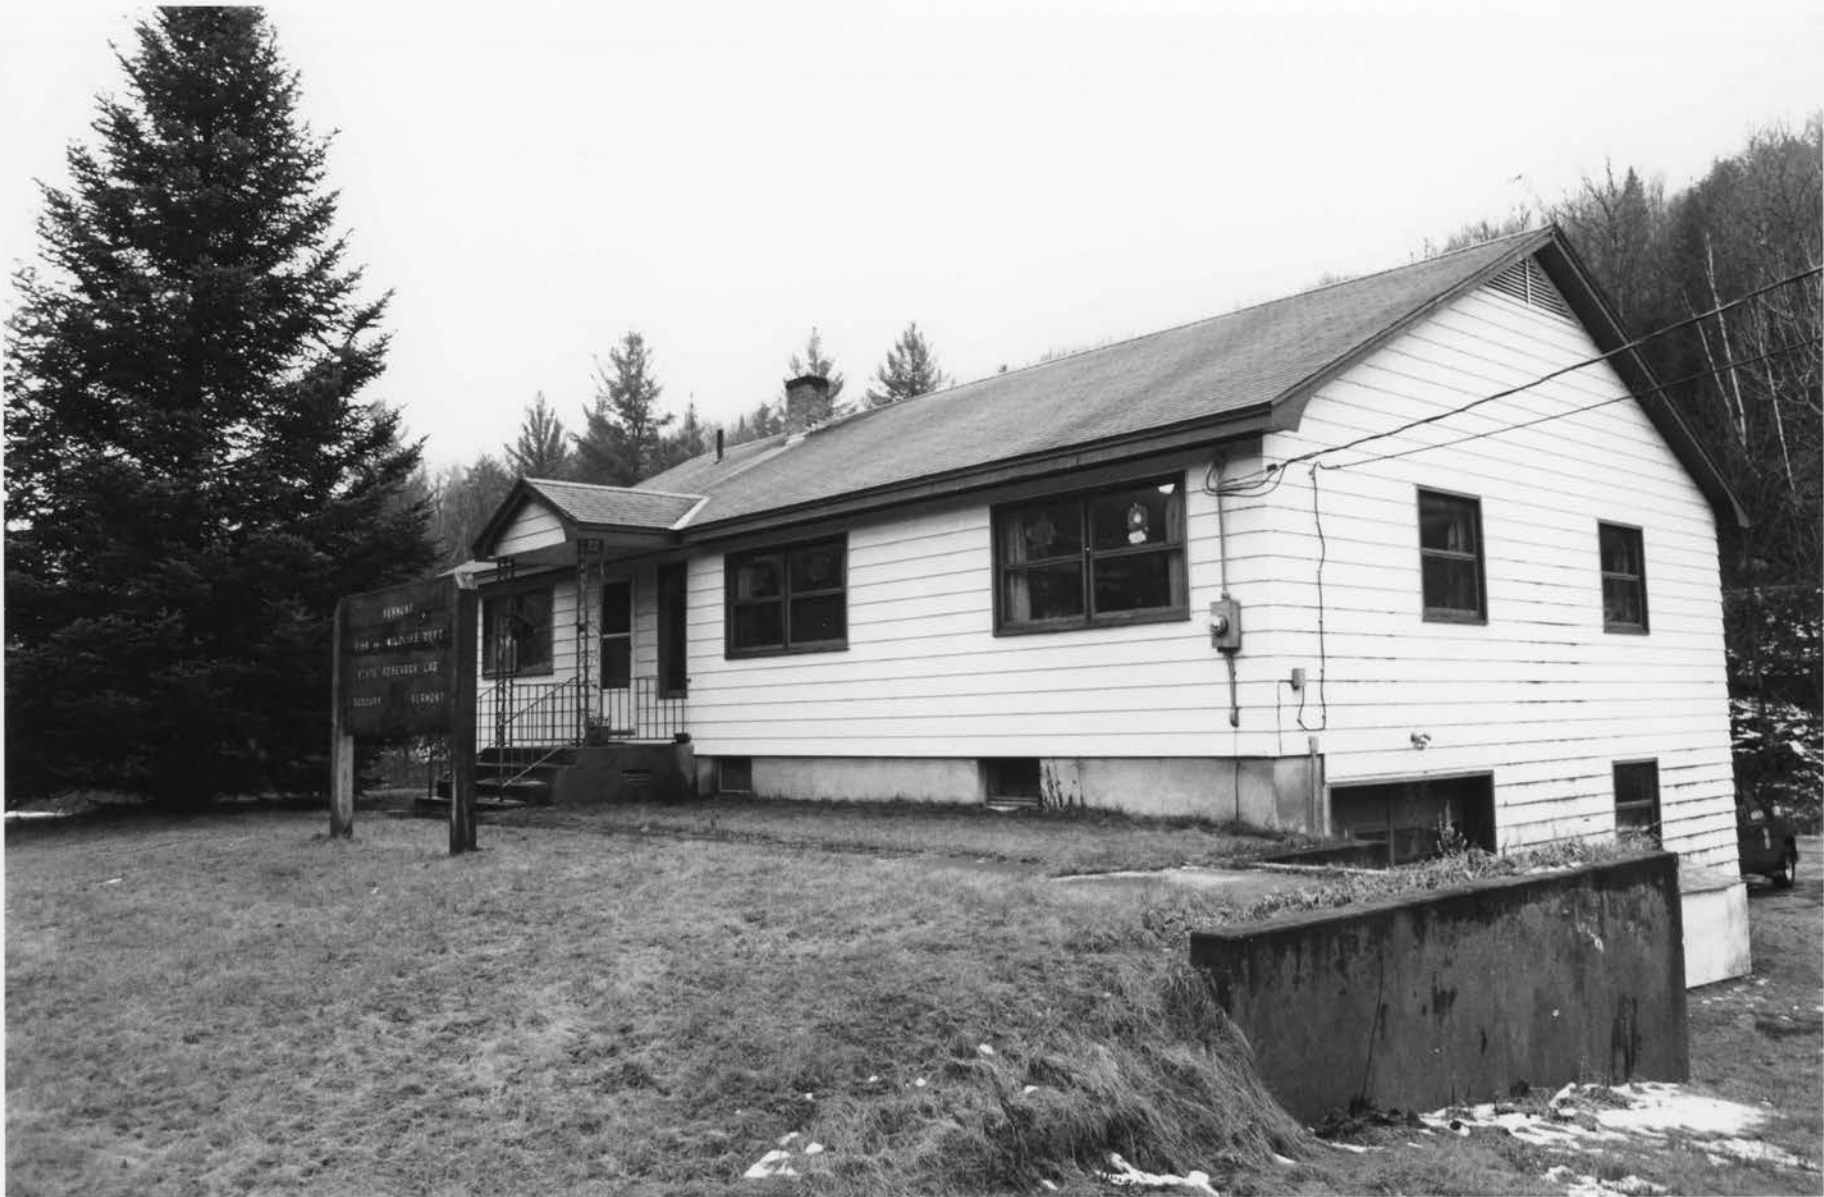
Photograph #7

- 1) #10 State Biology Research Lab, Roxbury
Fish Hatchery
- 2) Washington Co., Vermont
- 3) Ann Cousins
- 4) January 1993
- 5) Vt. Division for Historic Preservation
- 6) View looking Southwest, #10 State Biology
Research Lab

The State Biology Research Lab is a 4 by 2 bay, eaves-front, Ranch style building facing Route 12A (east), with the main entrance left of center protected by a gable-roofed, concrete deck entry porch. Slightly elevated on a concrete foundation the lab is built into a bank so that the front and south sides are 1 story, and the rear and north sides are 2 stories. There is a garage opening into the basement level on the south end. A secondary pedestrian entrance opens into the basement at the rear. The building has synthetic siding and asphalt shingle roofing. Windows are mostly 1/1 sash, some paired.

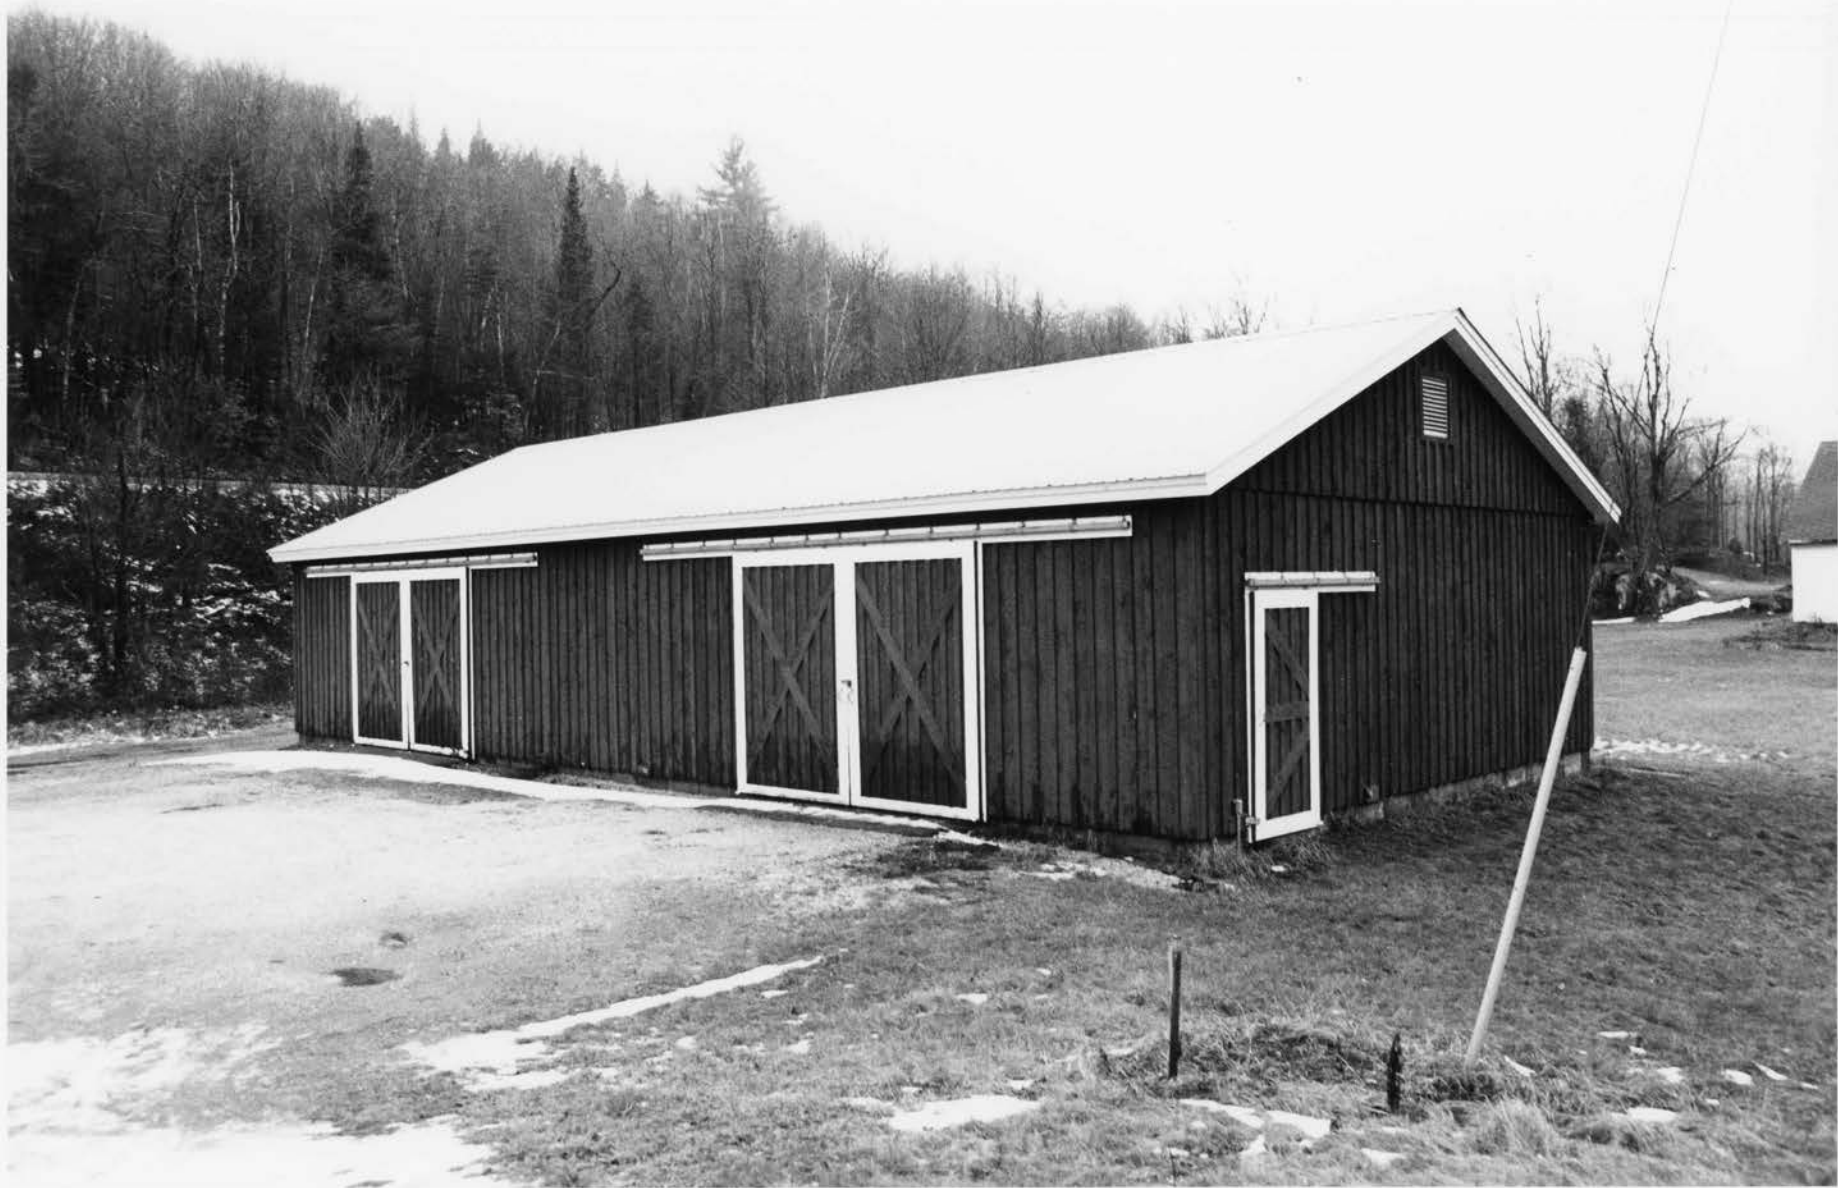
Photograph #8

#11 Shed Roxbury Fish Hatchery

View looking Northwest, #11 Shed, Central
Vermont Railroad tracks in background

This utility shed is approximately 60' x 30', and is set well back and perpendicular to Route 12A, so that its eaves-front faces the biology lab (#10) (south). Set on a concrete foundation the shed has board and batten siding and corrugated metal roofing. The south elevation has two pairs of cross-braced, batten, exterior sliding doors. There is a pedestrian door on the east elevation.
