Edna St. Vincent Millay House,  
"Steepletop",  
Austerlitz, New York

Steepletop

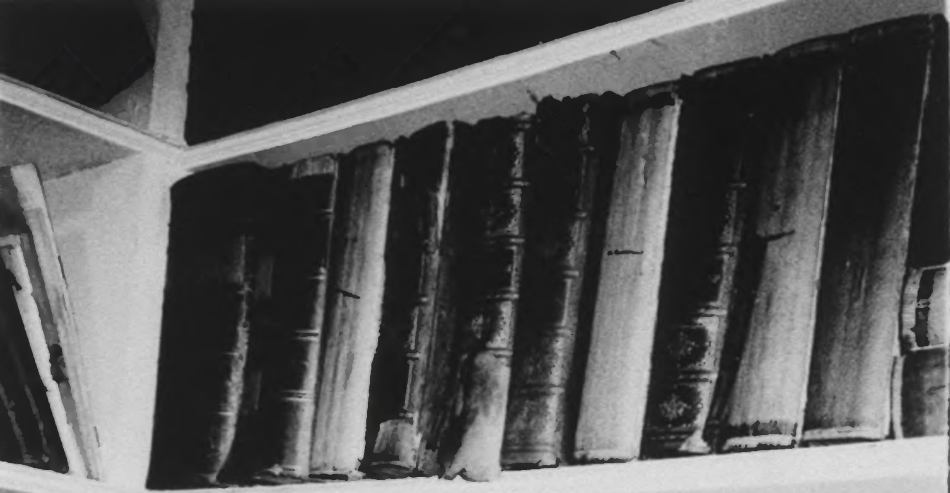
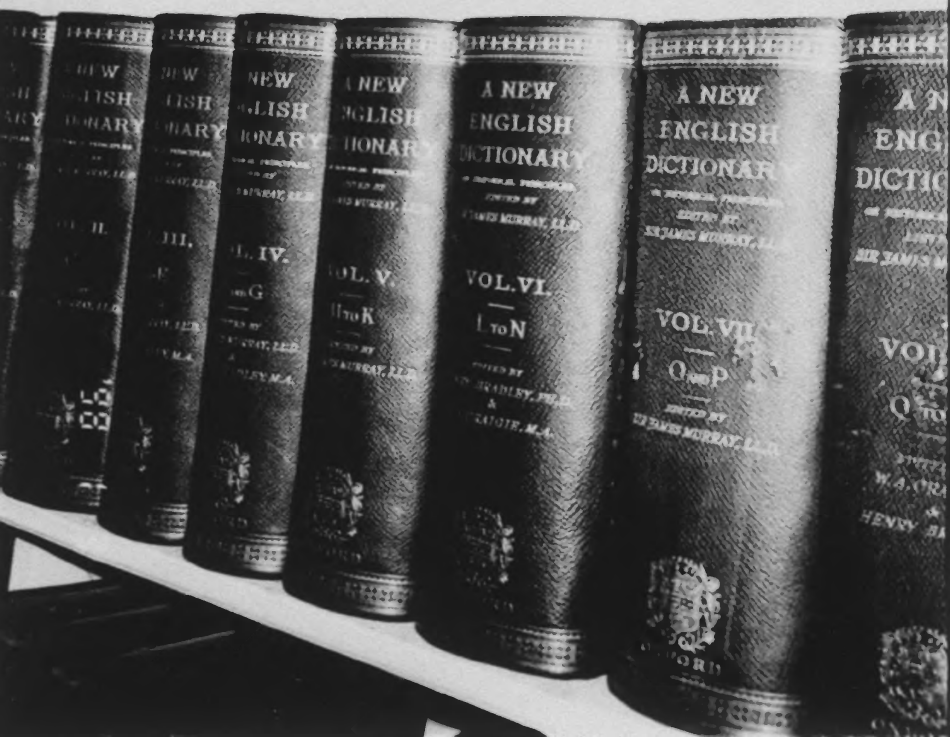
Detail: Milkey's Study, Books

Examples of deteriorated bindings on upper shelf

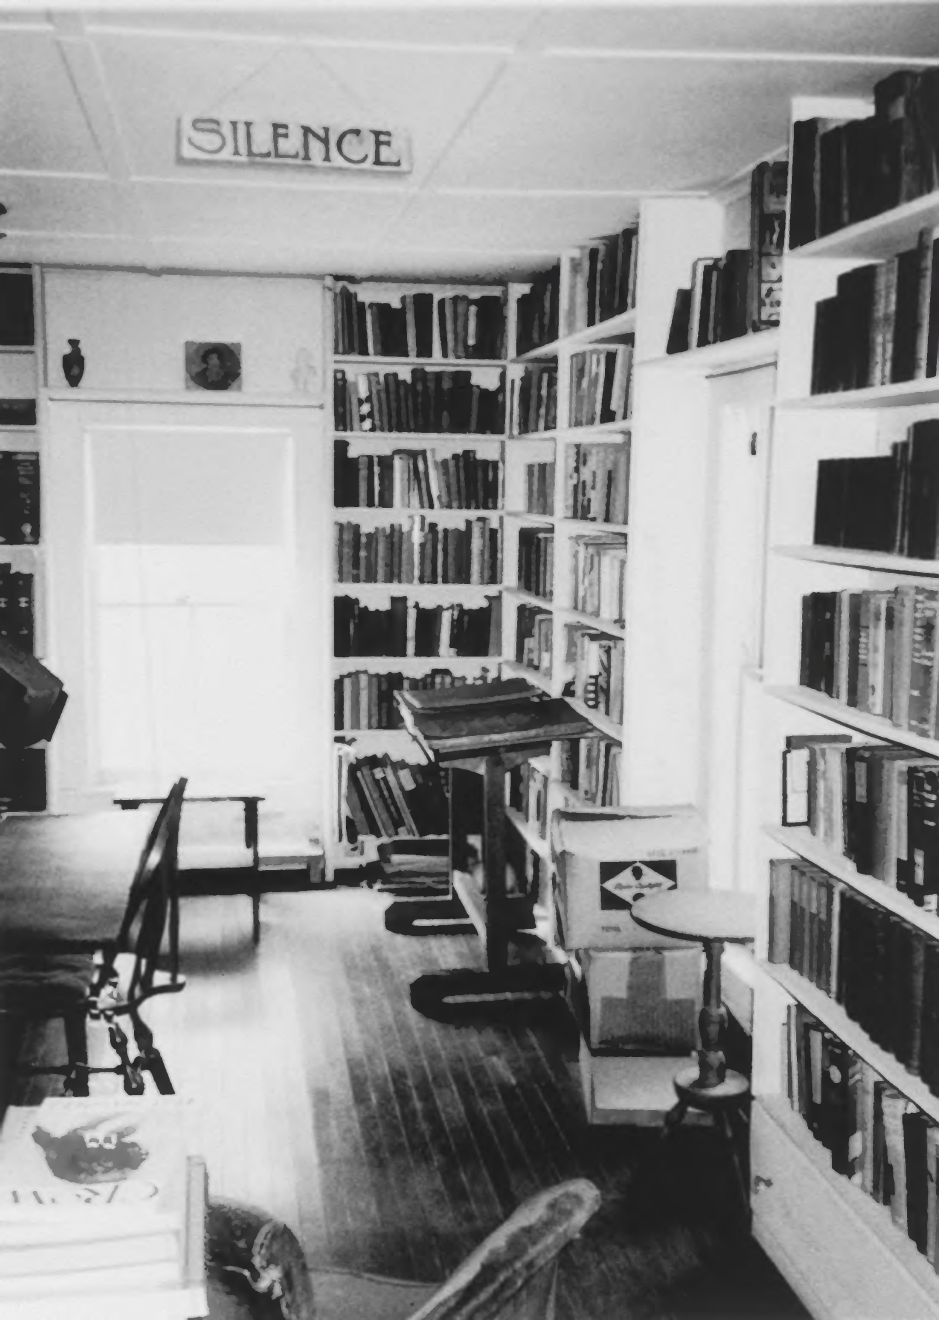
## Milley's Study

Lack of proper climate control has led to  
condensation, mold on books, followed by  
desiccation from forced-air heating in winter.  
Also note damaged epiphytomy in foreground

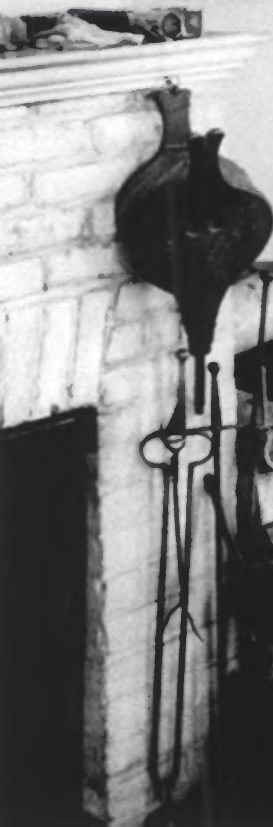
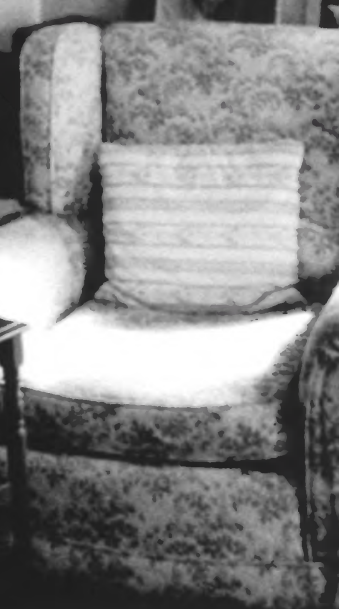
Living Room

Millay's chair, portrait of her husband (l);  
'mermaid' allegory of Millay and husband in pool  
at Steepletop (r). Both paintings require surface  
stabilization to prevent flaking and powdering  
losses

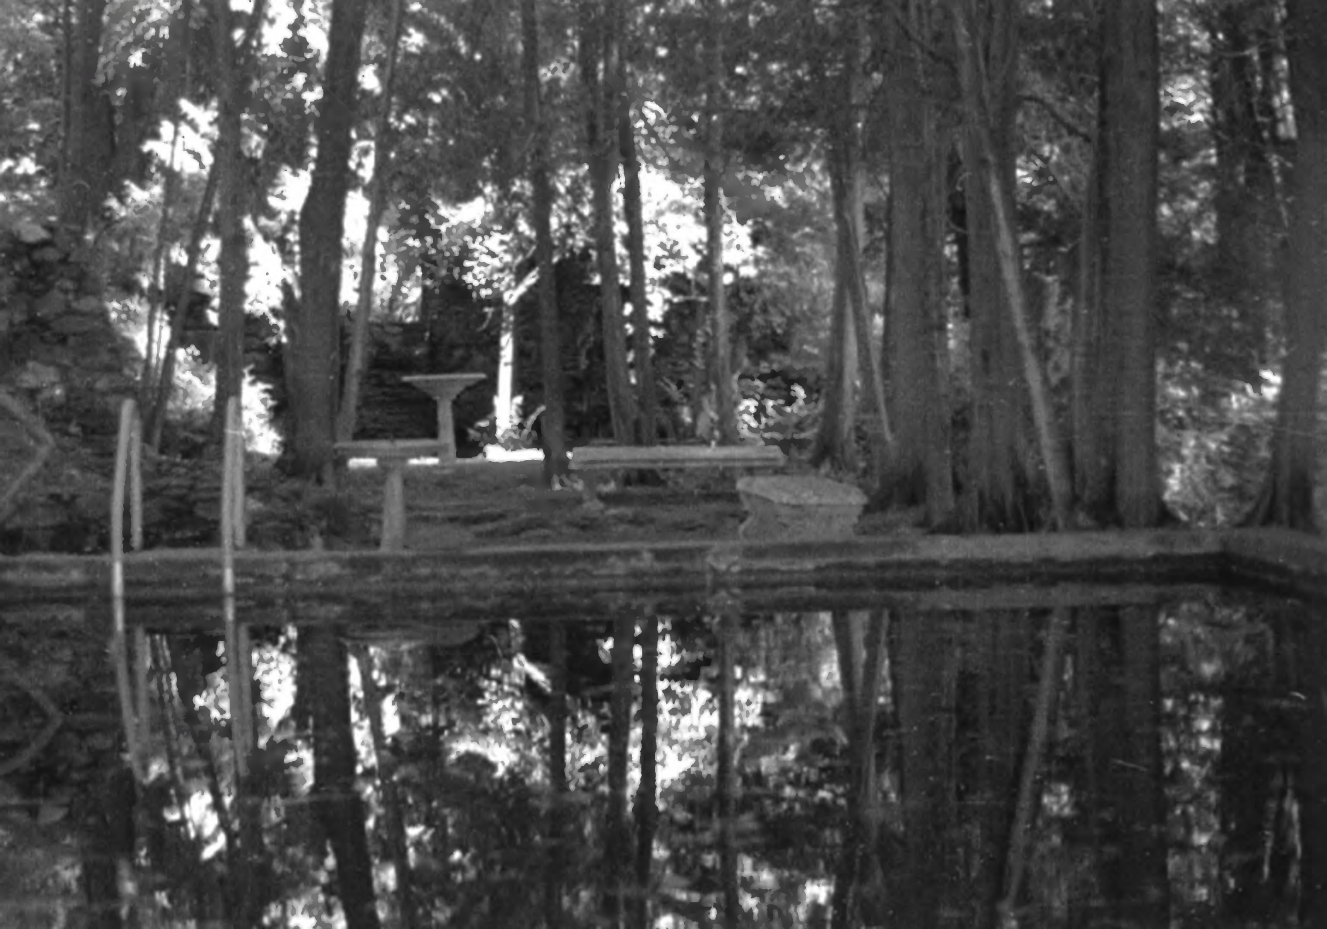
Pool Garden

Designed by Milby, pool requires filtration and  
master's repair to prevent collapse, removal  
of outgrowth, preparation to reinforcement of  
structural details "dressing room."

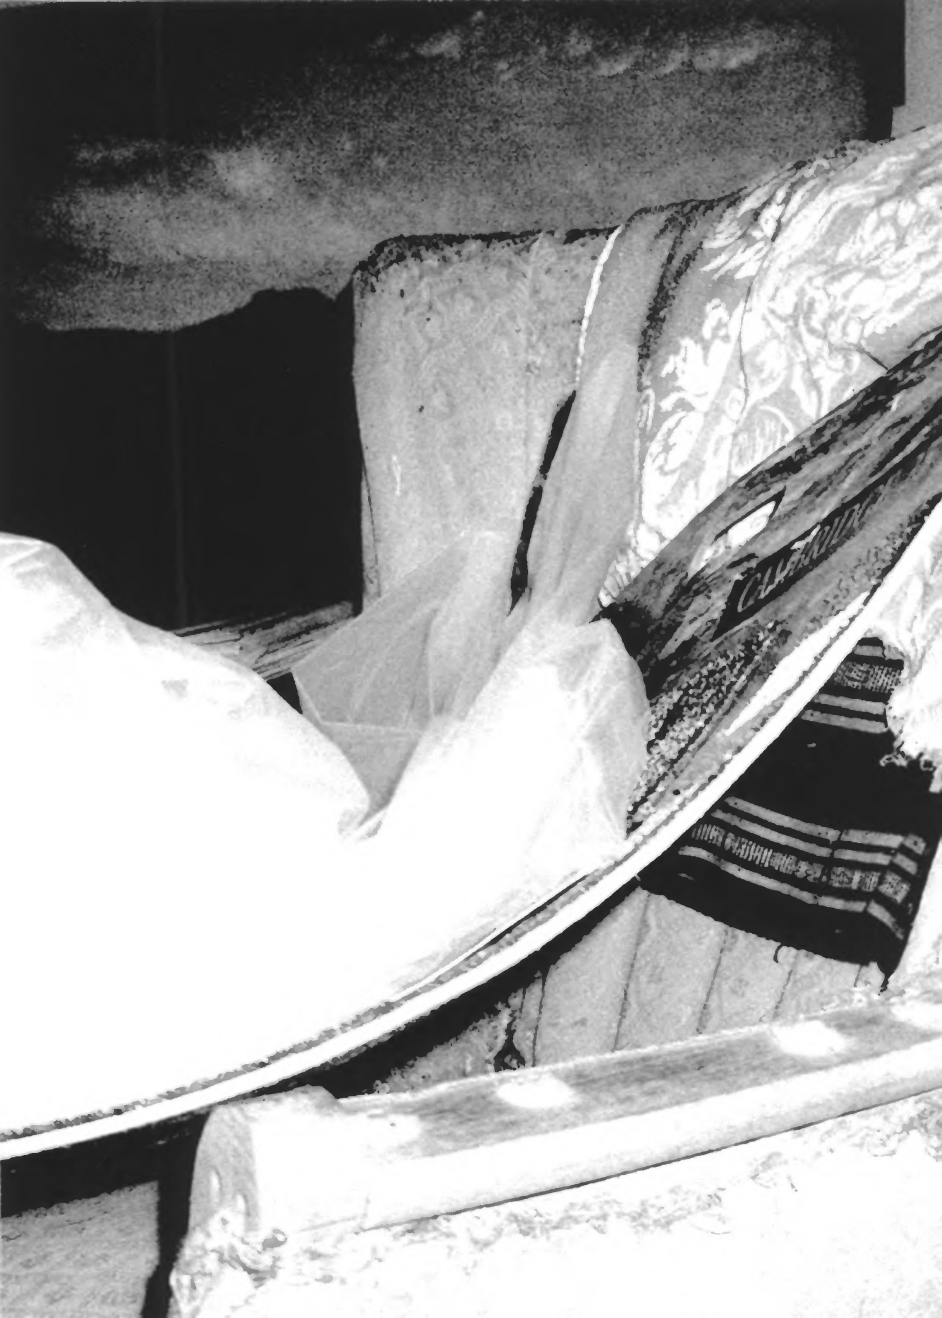
Chair from Millay's Writing Cabin

Note: Chair was removed from cabin after discovery of rodent damage, ca. 1990. Project plan includes on-site storage of cabin collections after treatment

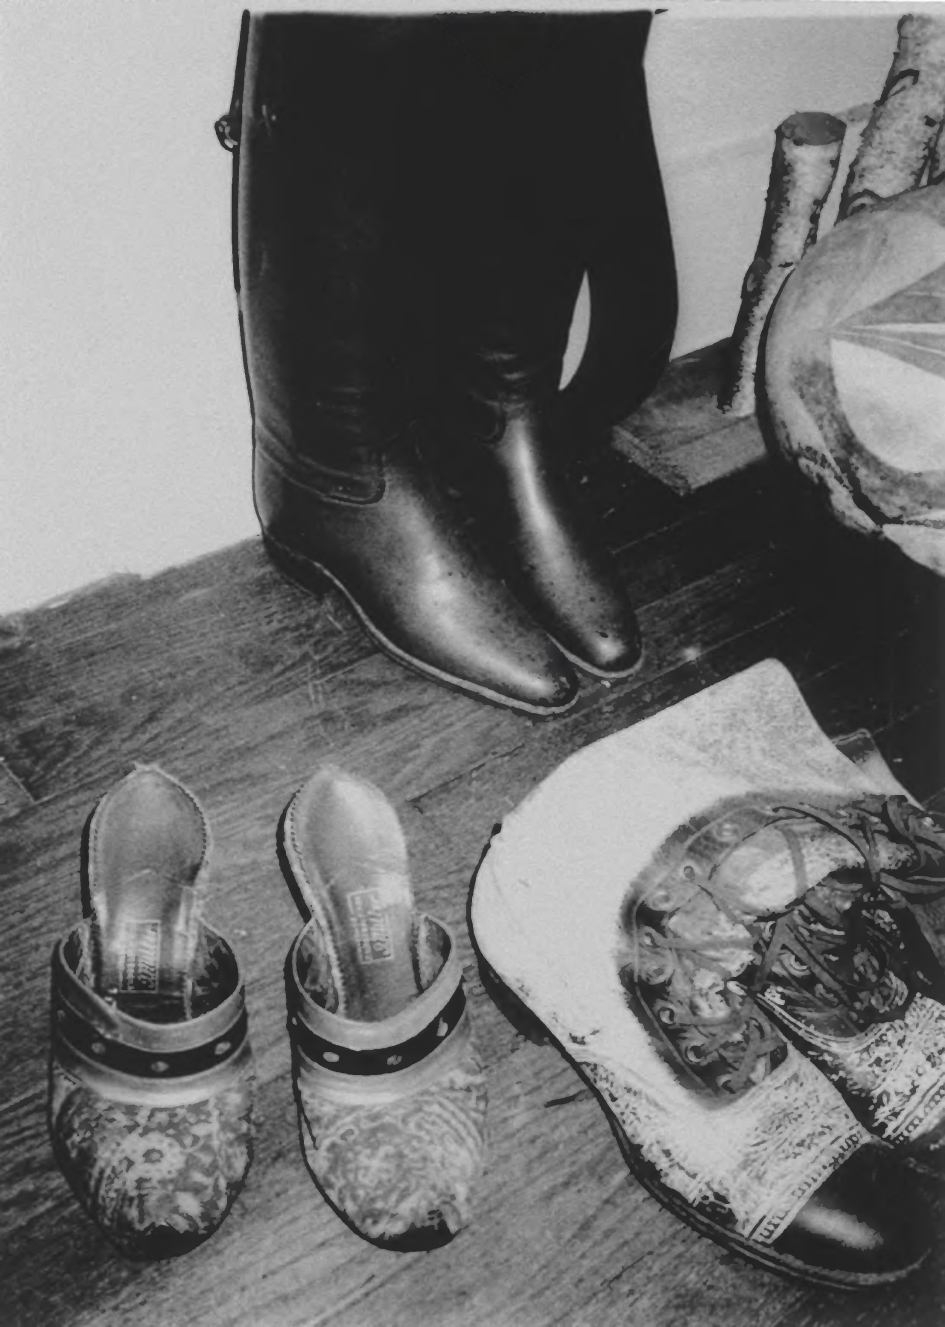
Millay's shoes and boots (3 of

22 pairs). Note heavy construction  
of white lining on work boots (2).

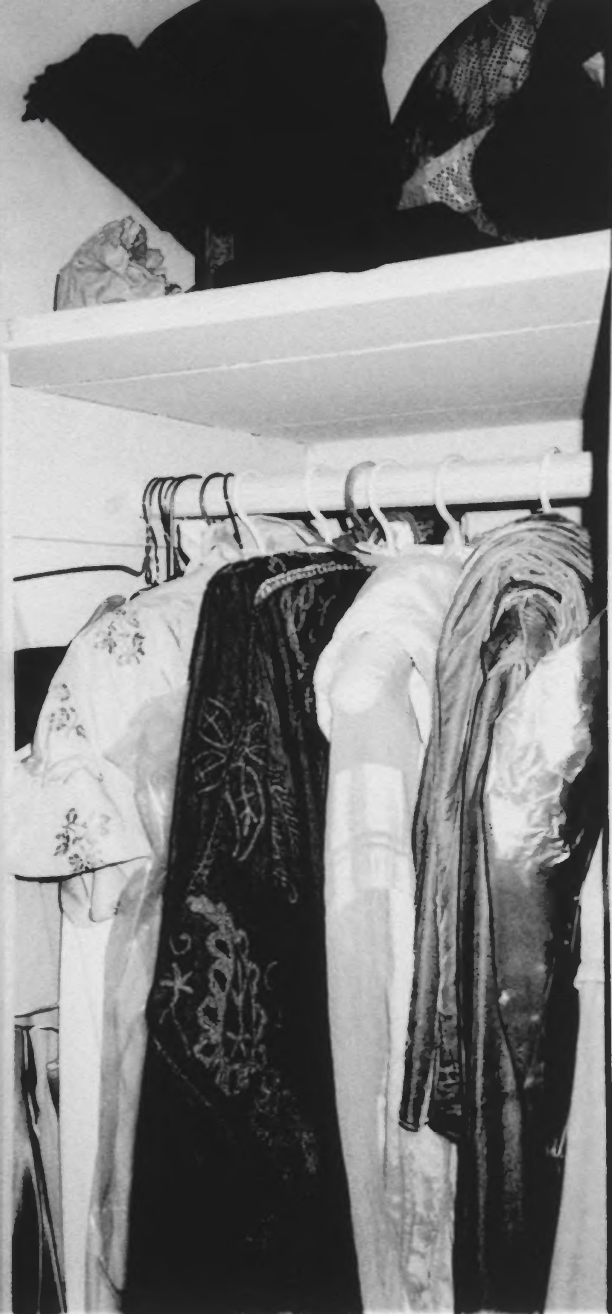
Milley's clothing, bedroom closet. Silk and velvet gowns, lace and feather hats deteriorated from improper support, RH instability. Linen gauze gown (3rd floor) was worn by Milley in portrait by Berenice Abbott.

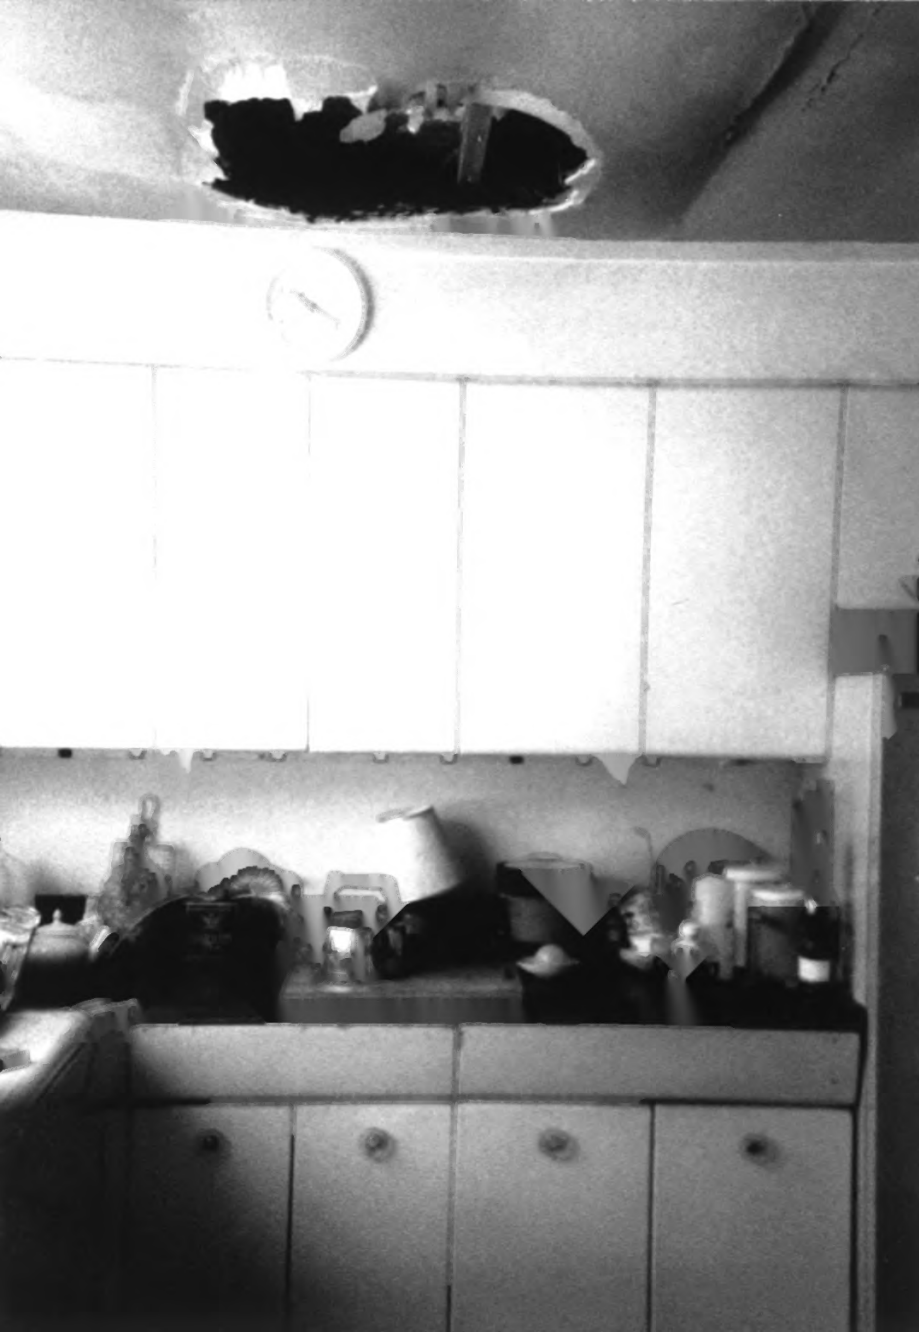
Kitchens

water damage to ceiling. In 1948, Better Homes and Gardens remodeled Millay's kitchen for a feature article on efficient design. Source of water intrusion (roof) has been addressed; damage to ceiling requires treatment to prevent mold.

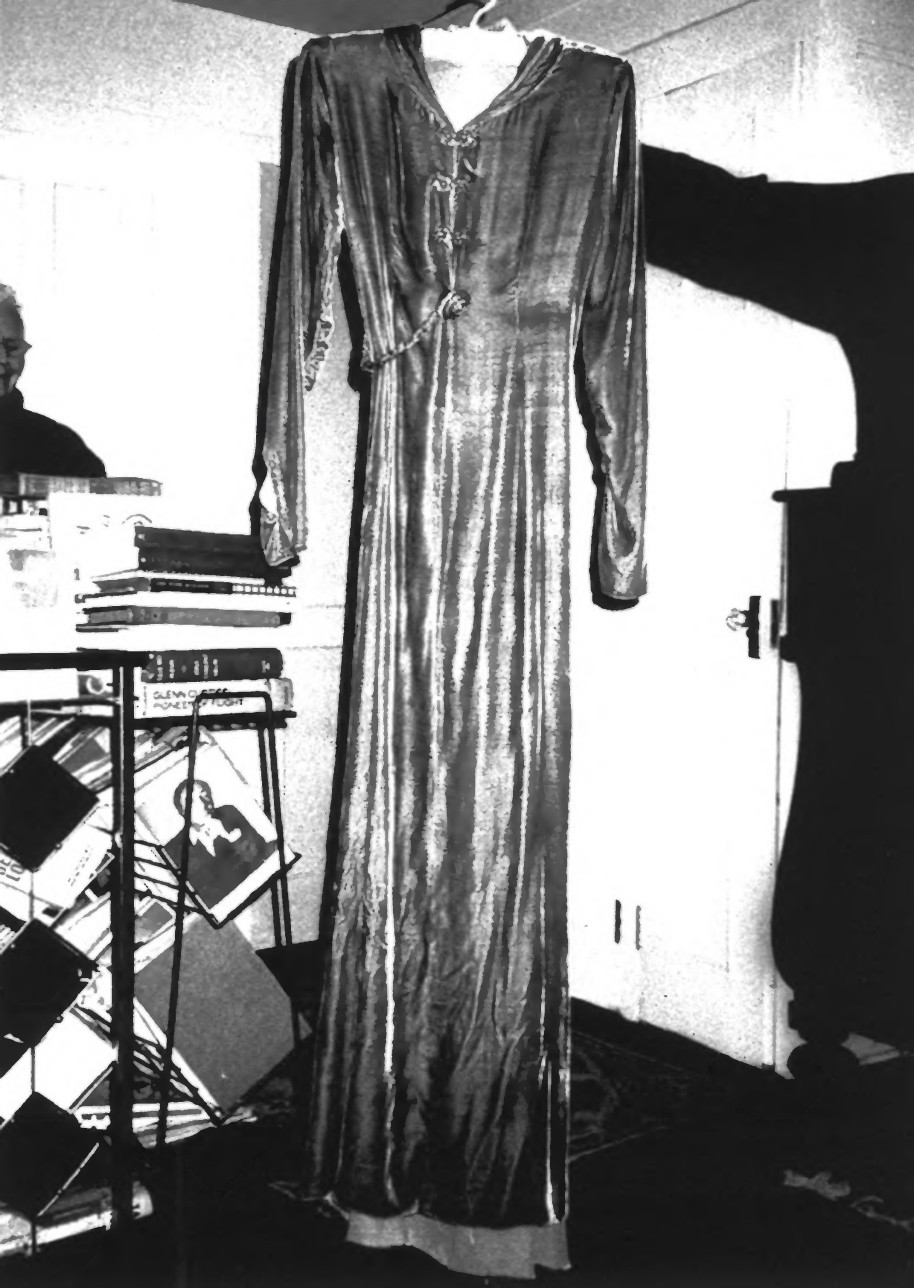
Silk/linen velvet gown with crushed and lost pile, tarnished gold-braid trim. Hand-beading on "flapper" dresses and elaborate trims and embroidery currently leave many spectacular textiles too fragile for display
