FORT BOWIE  
National Historic  
Site

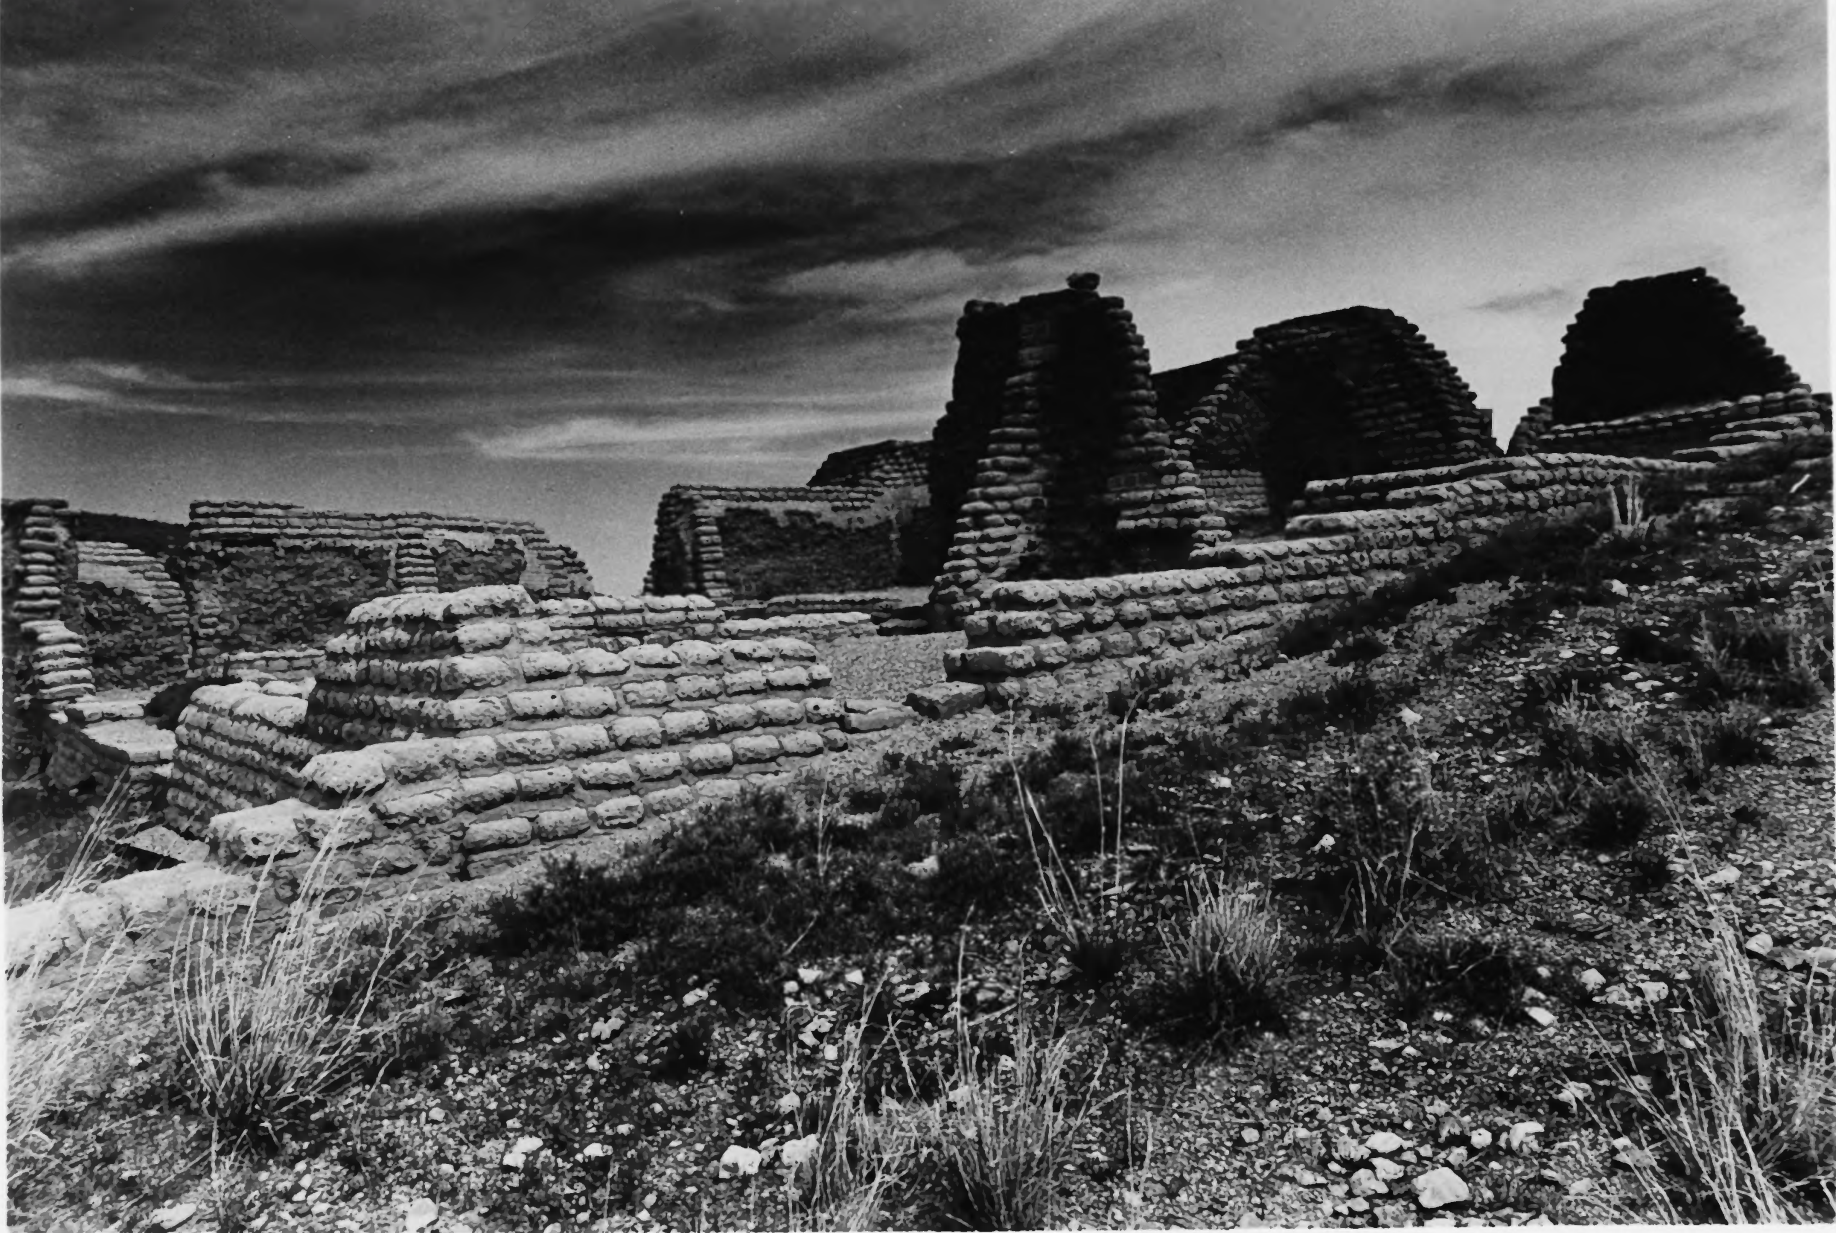
National Park Service  
U.S. Department of the Interior  
NPS Photo by Richard Frear  
195-1855

The remains of a trading post known as "post traders" as seen from the southwest corner of the building. Light colored bricks denote soil cement bricks placed to retain rain-erodable soil in 1967-68. Dark colored adobe is original. Soil-cement bricks were removed in summer of 1978 and replaced with covering of untreated natural adobe to allow even hardness of structure.
