PHOTOGRAPH #1  
 Croton Aqueduct  
 Westchester, Bronx & New York Counties, New York  
 Hydrographic map showing the route of the Aqueduct and  
 an elevation profile of the Manhattan portion.  
 From: Theoph Schramke, Description of the New York  
 Croton Aqueduct, New York, 1843.

GENERAL WORK.

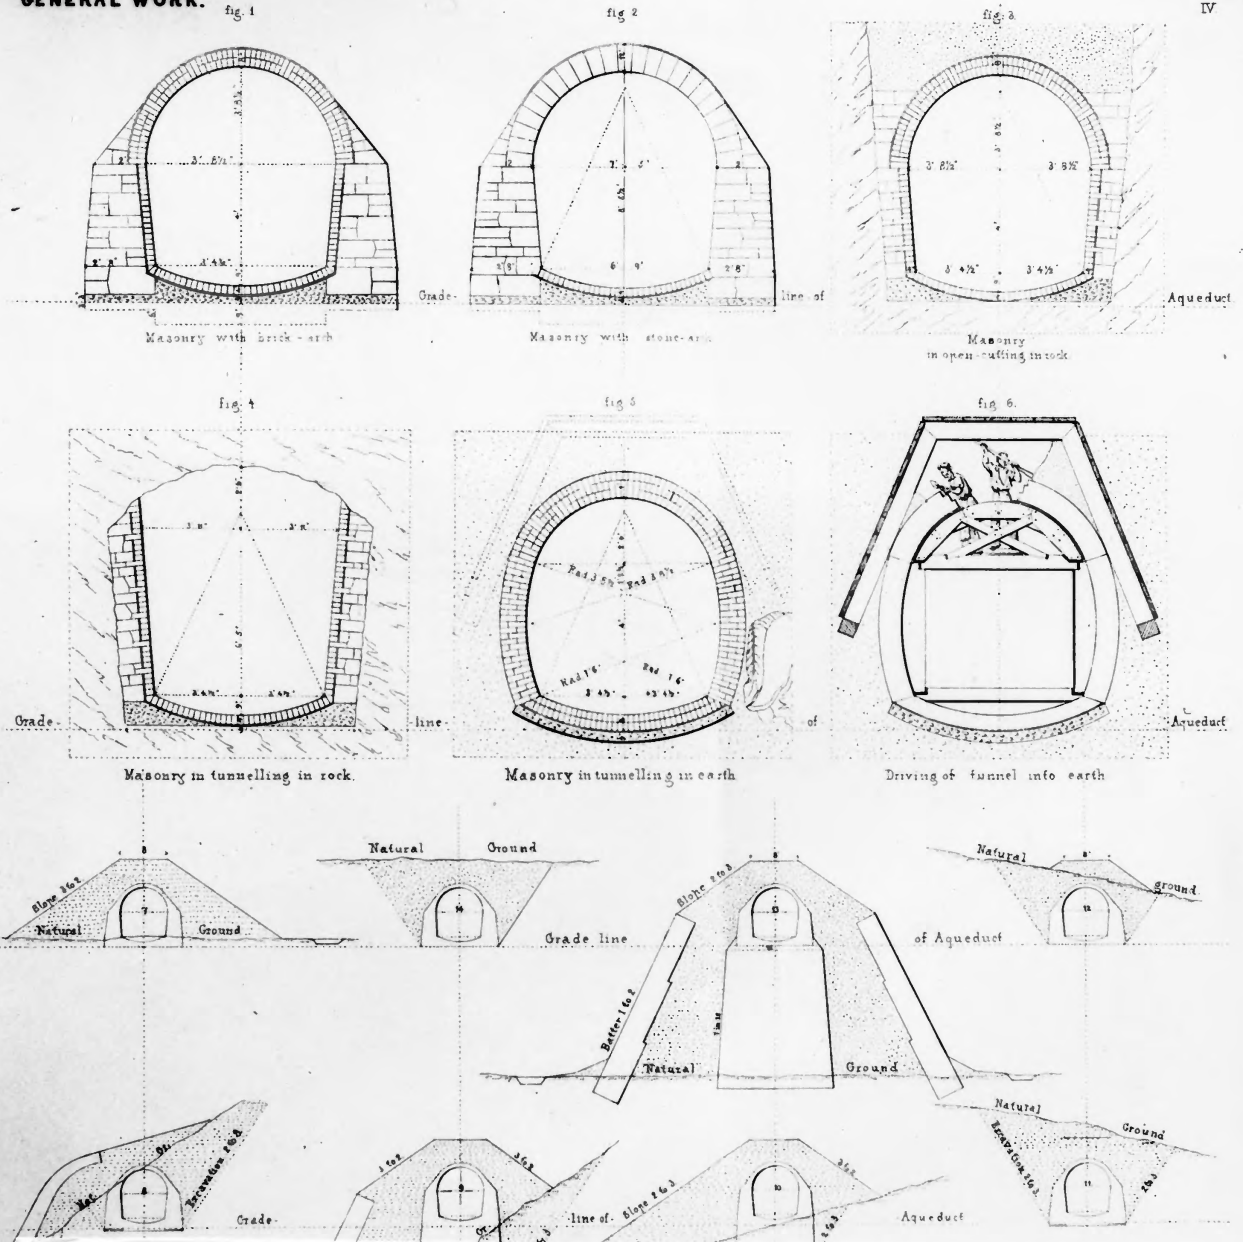
PHOTOGRAPH #2  
 Croton Aqueduct  
 Westchester, Bronx & New York Counties, New York  
 Sections showing construction methods used through  
 different ground materials and grade elevations.  
 From: Theoph Schramke, Description of the New York  
 Croton Aqueduct, New York, 1843.

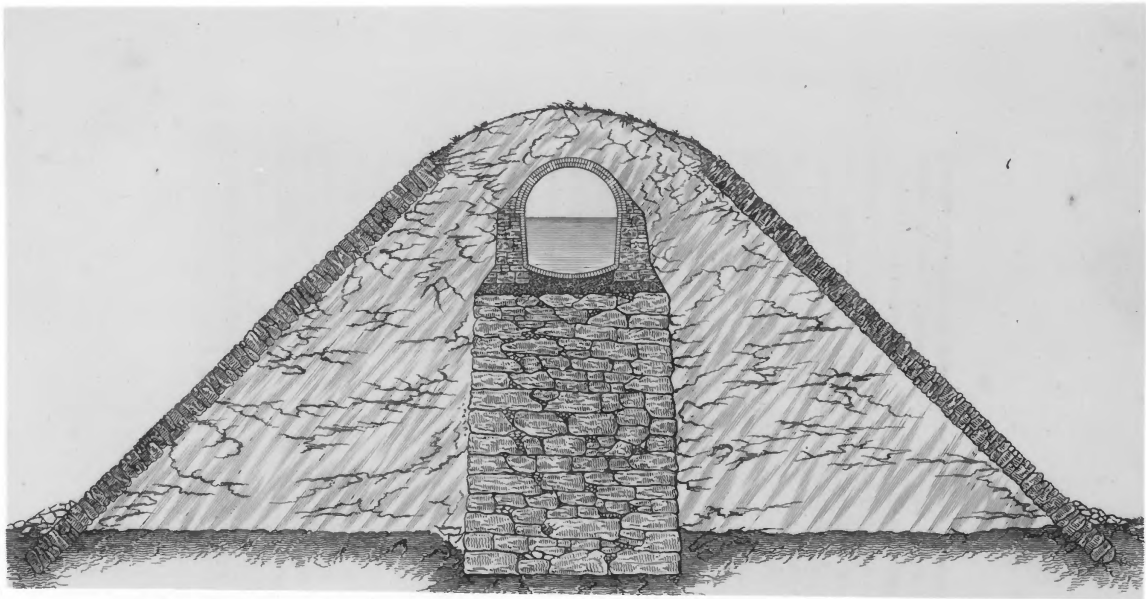
PHOTOGRAPH #3

Westchester, Bronx & New York Counties, New York  
Section showing typical bermed construction of Aqueduct  
foundation and conduit.

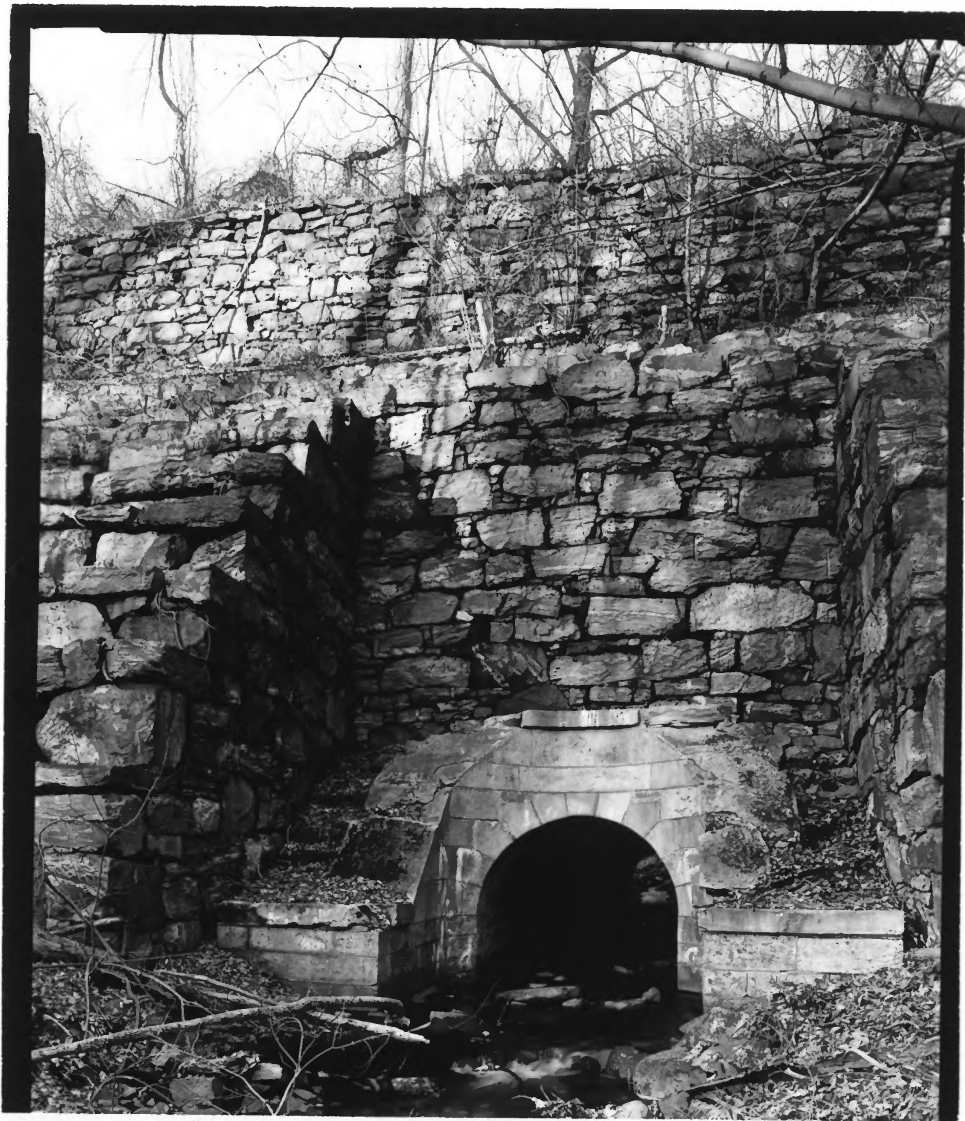
PHOTOGRAPH #4

Indian Creek culvert passing beneath the Aqueduct near  
Reservoir and Quaker Bridge Roads.

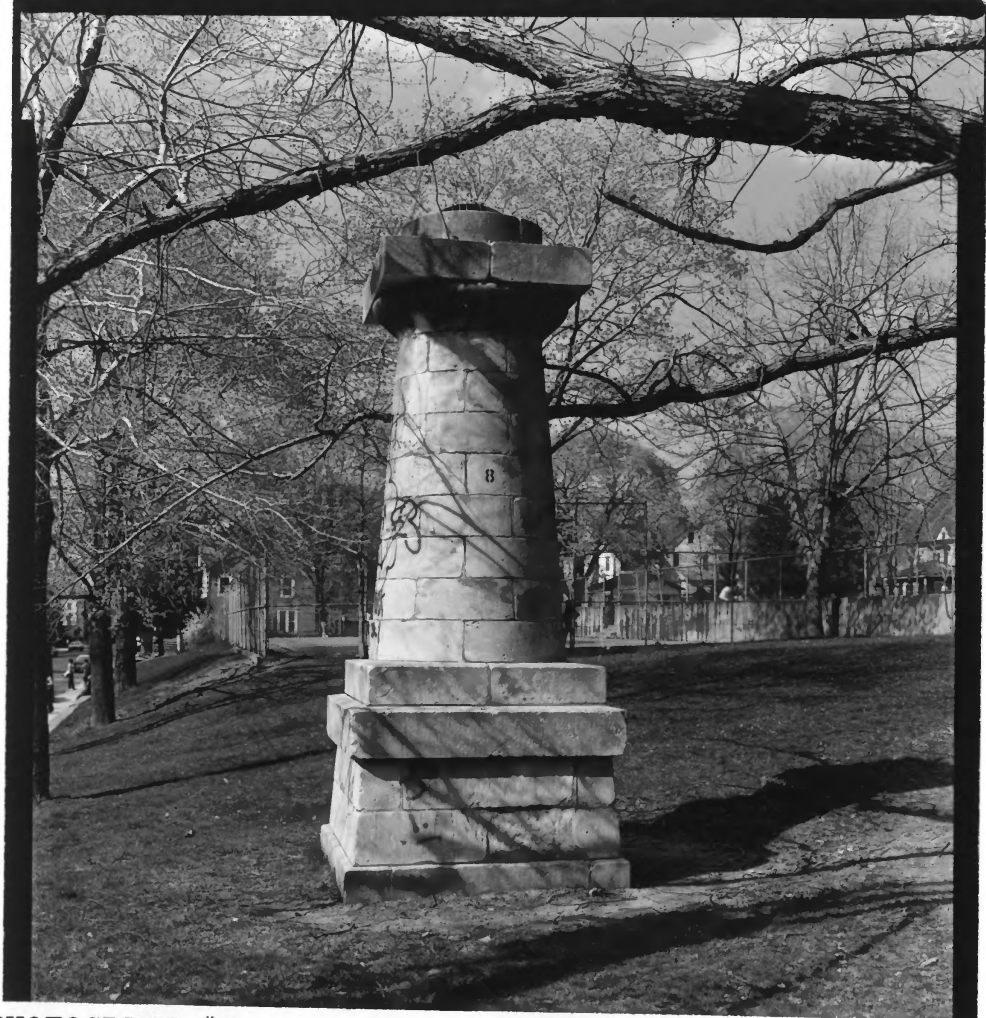
PHOTOGRAPH #5  
Croton Aqueduct  
Ossining, New York  
Ventilator Shaft No. 9 at Spring Street and Everett  
Avenue.  
Jack Boucher, 1978, HAER Photo No. NY-111-1.

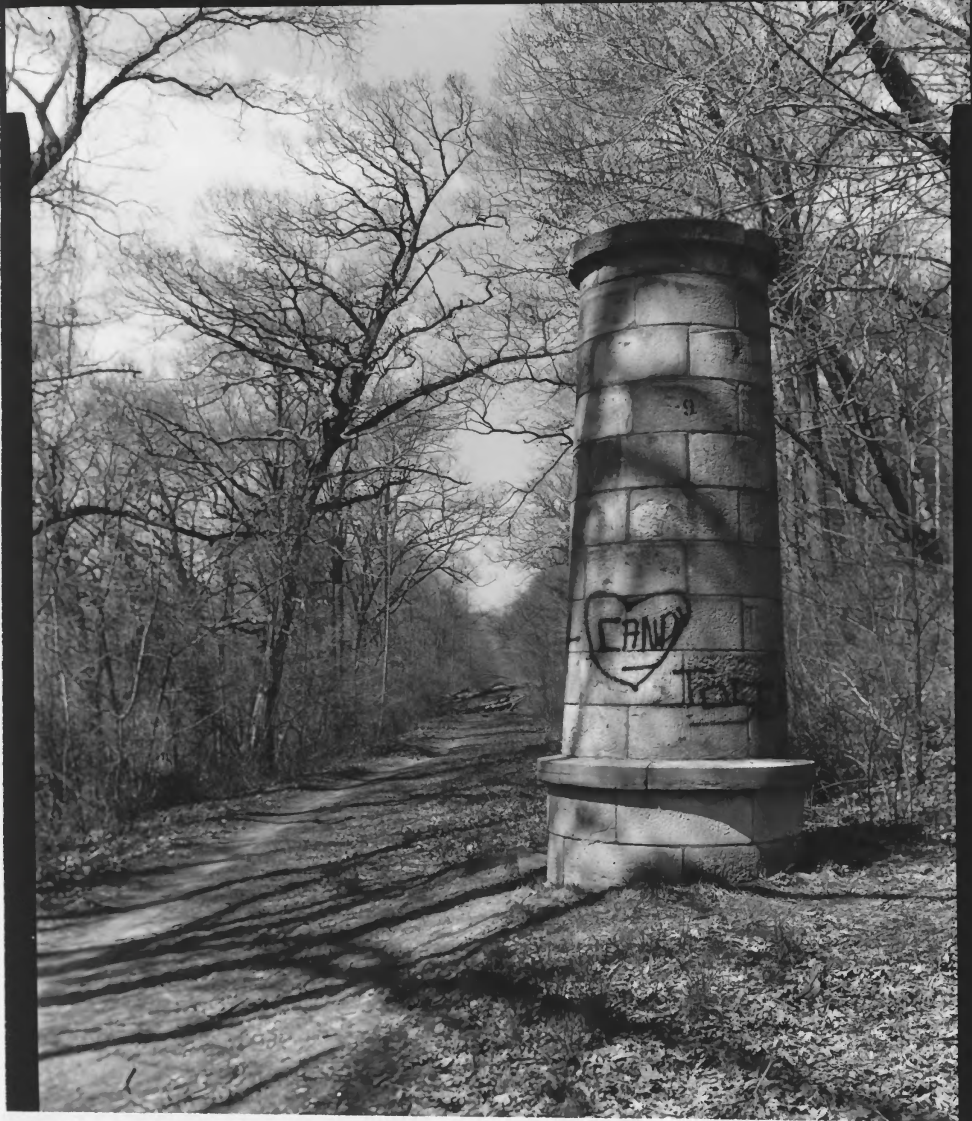
PHOTOGRAPH #6

Ventilator Shaft No. 10, north of Scarborough Road.

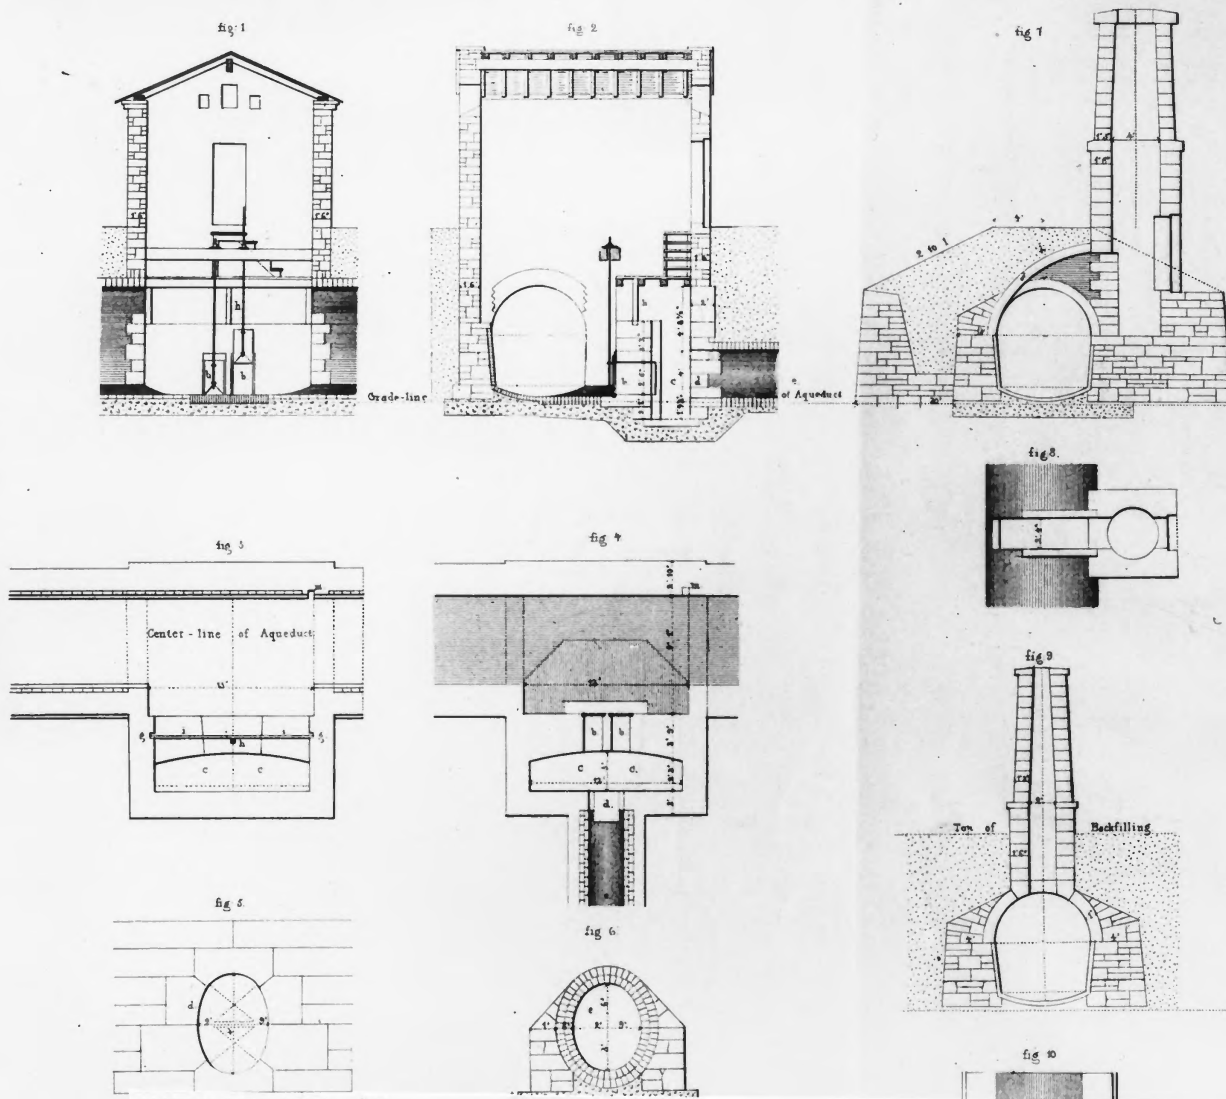
**PHOTOGRAPH #7**  
**Croton Aqueduct**  
 Westchester, Bronx & New York Counties, New York  
 Sections showing typical construction of the Aqueduct's  
 waste weirs and ventilator shafts.  
 From: Theoph Schramke, Description of the New York  
 Croton Aqueduct, New York, 1843.

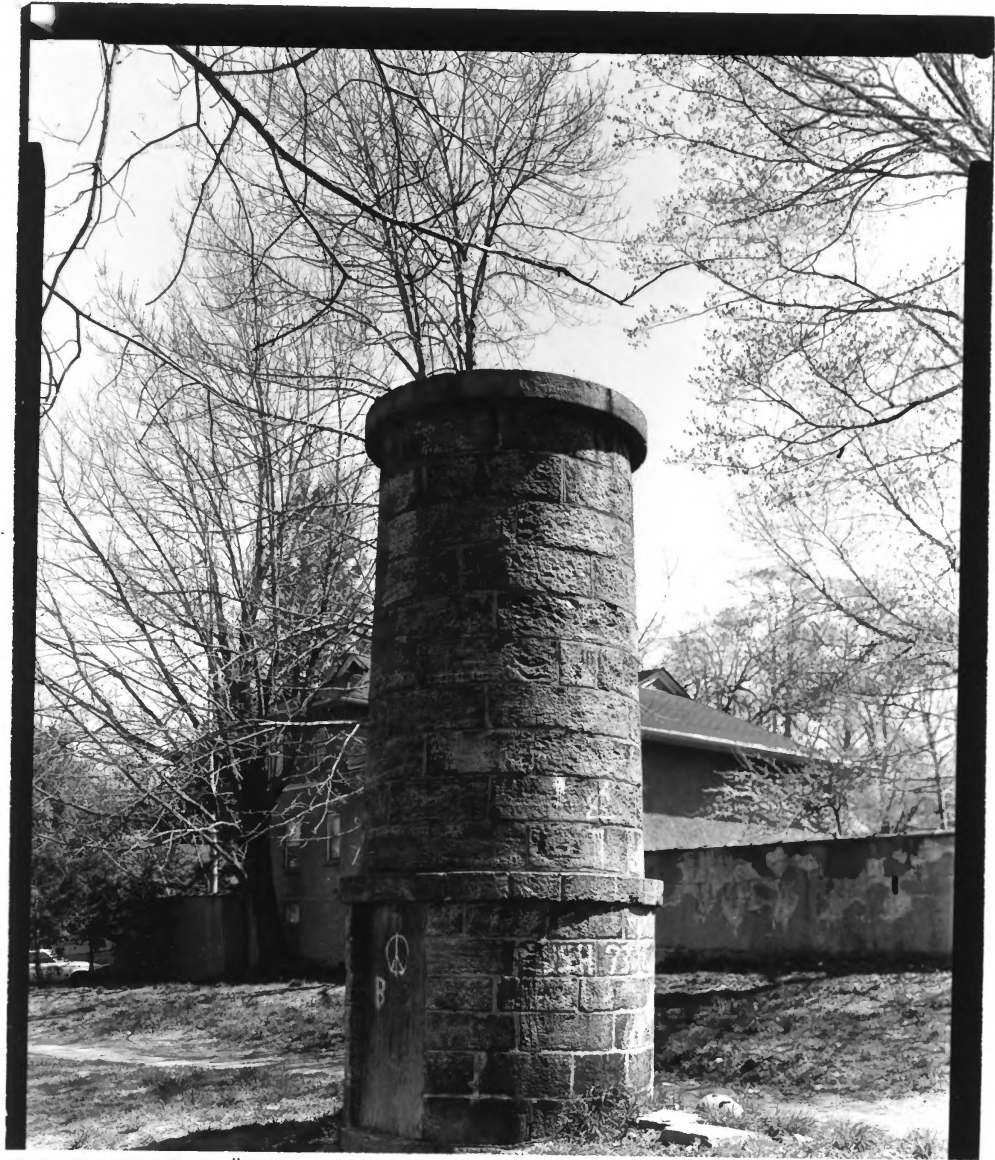
PHOTOGRAPH #8  
Croton Aqueduct  
Irvington, New York  
Ventilator Shaft No. 18 (with access door), south of  
Main Street.  
Jack Boucher, 1978, HAER Photo No. NY-208-1.

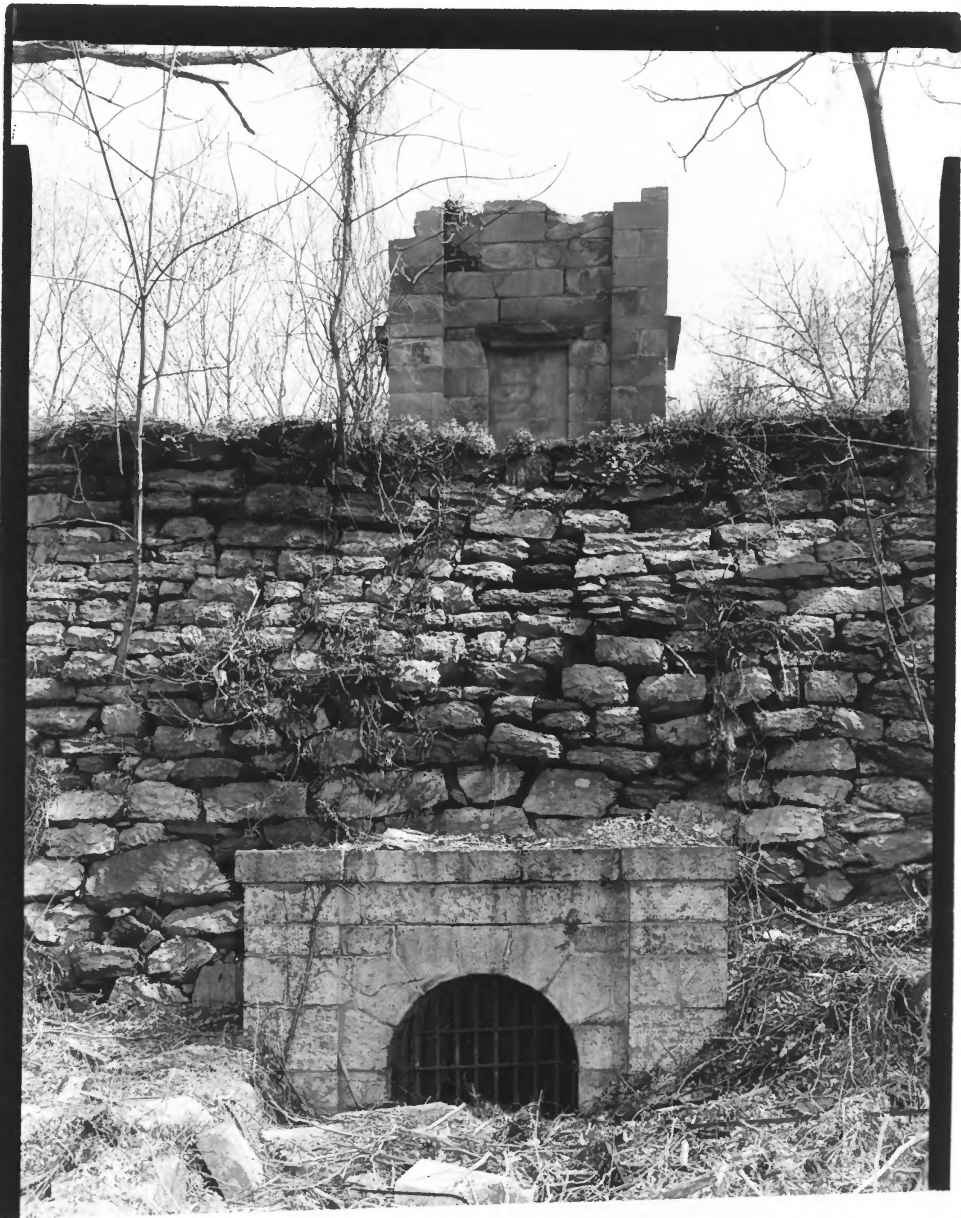
PHOTOGRAPH #9  
Croton Aqueduct  
Ossining, New York  
Western elevation of the waste weir atop the Aqueduct  
and its discharge conduit at Snowden Avenue and Van  
Wyck Street in Ossining.  
Jack Boucher, 1978, HAER Photo No. NY-109-4.

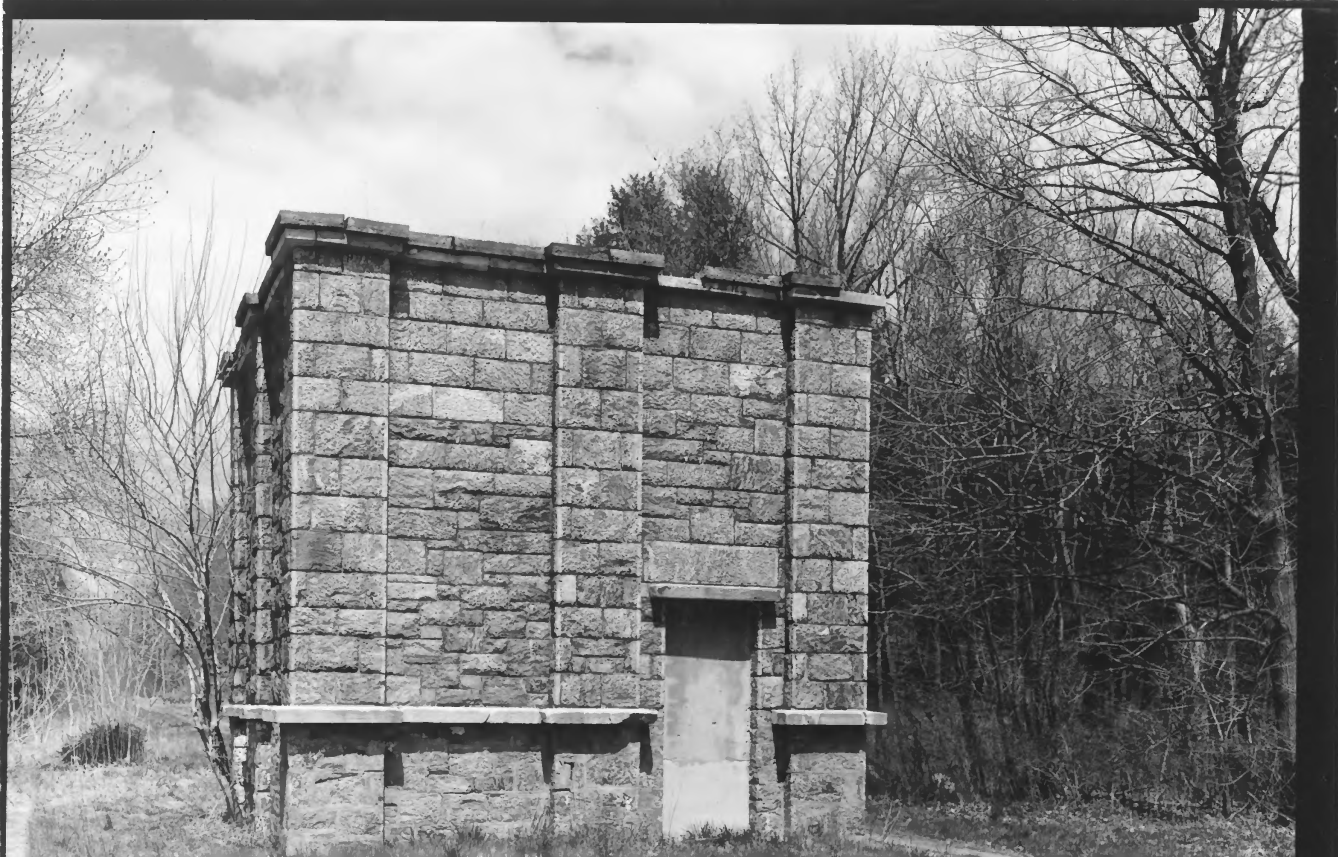
PHOTOGRAPH #10

Mill River waste weir atop Aqueduct near US Route 9 at  
Sleepy Hollow Cemetery.

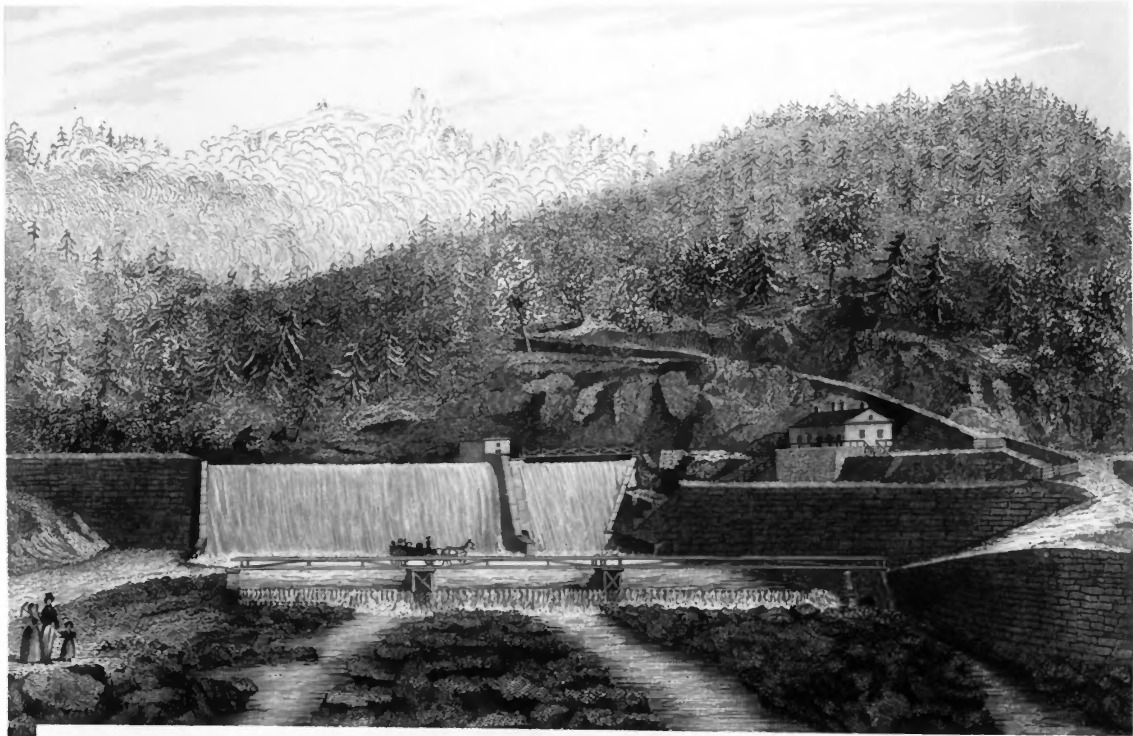
PHOTOGRAPH #11  
Croton Aqueduct  
Croton, New York  
Engraving of the (now submerged) Croton dam and  
gatehouse.

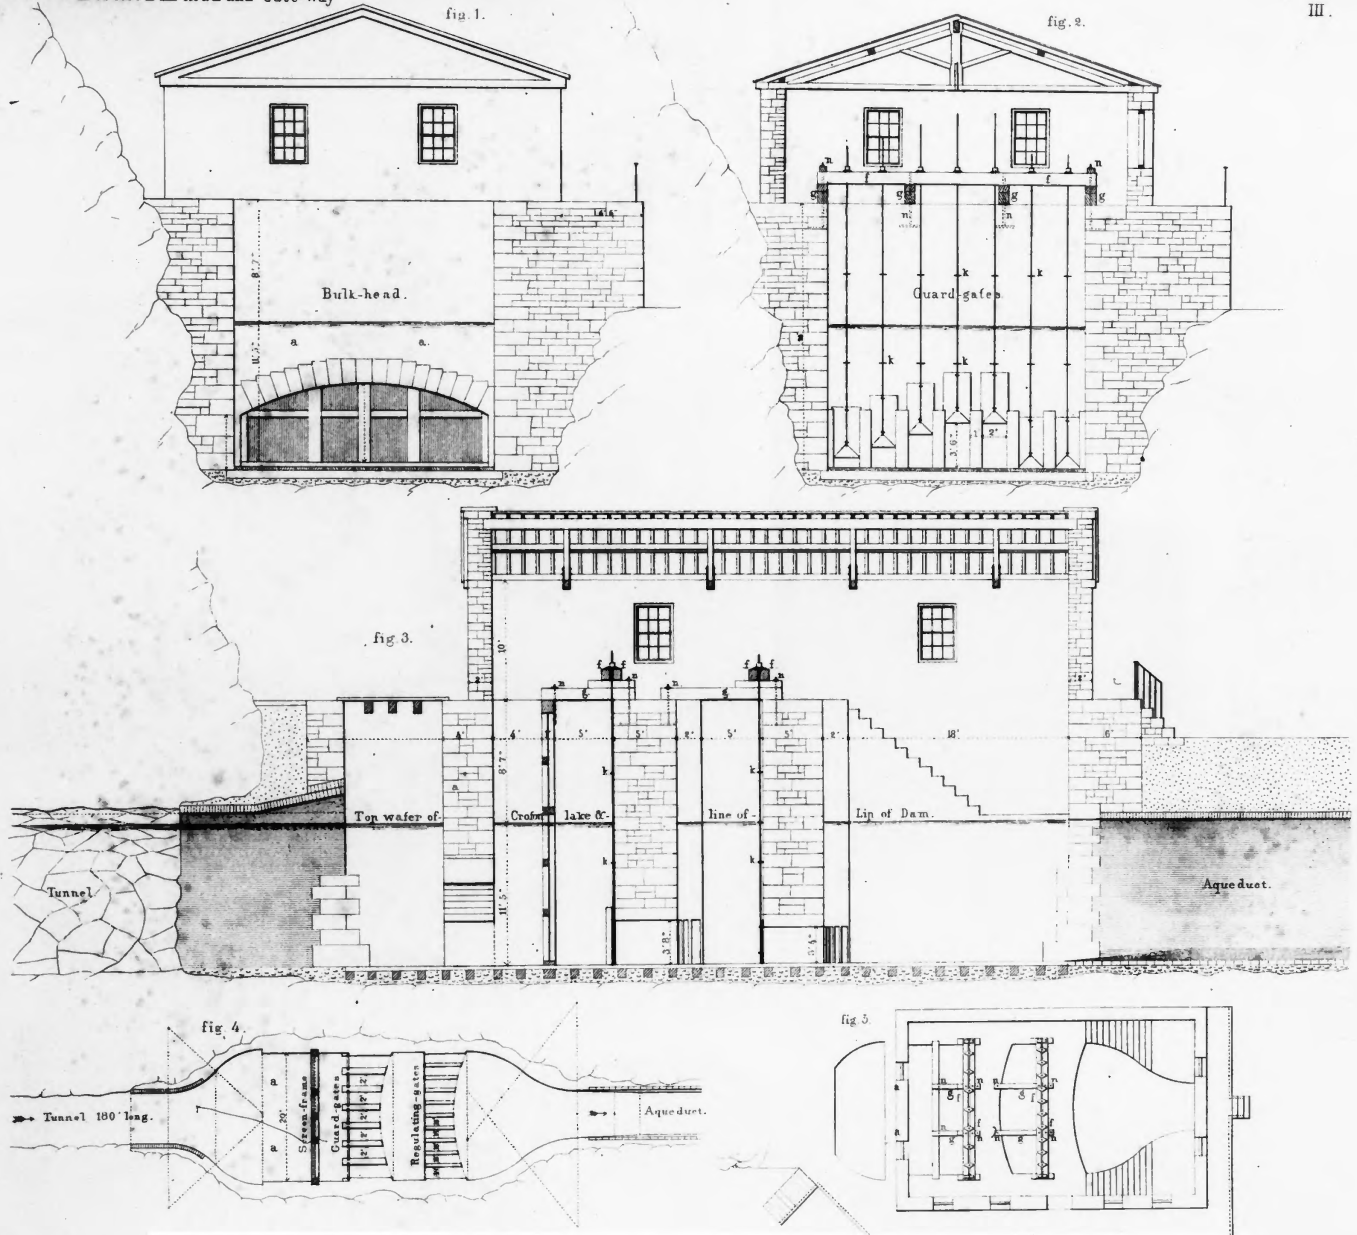
PHOTOGRAPH #12

Sections and plans of the (now submerged) Croton dam gatehouse.

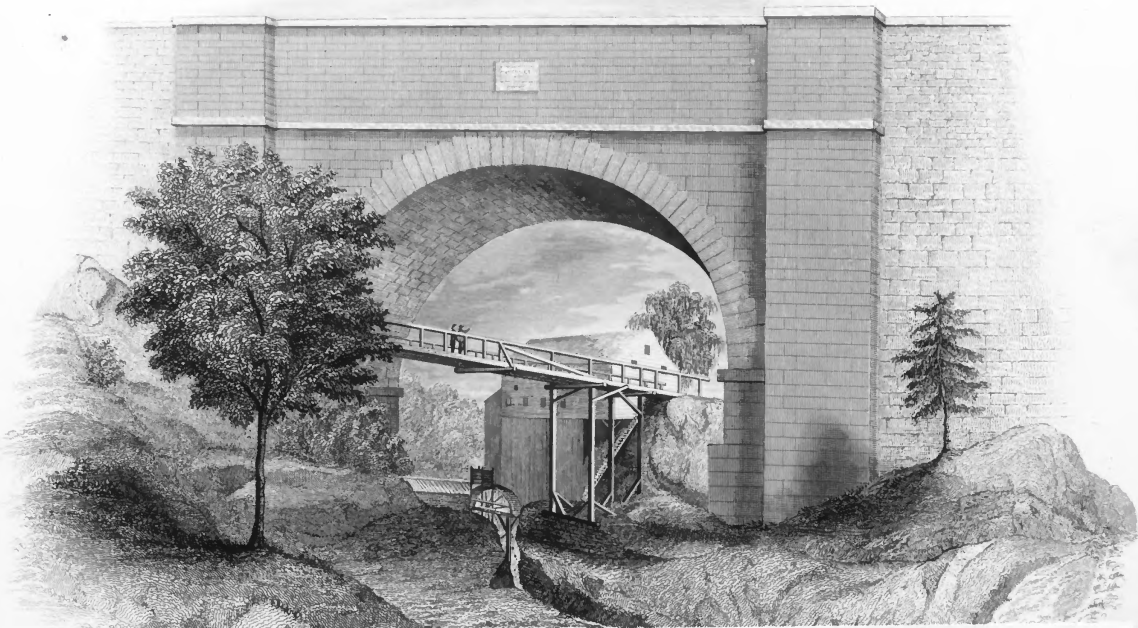
PHOTOGRAPH #14  
Croton Aqueduct  
Ossining, New York  
Engraving of Sing-Sing Kill Bridge, showing the  
existing bridges the Aqueduct was required to cross.  
From: F.B. Tower, Illustrations of the Croton  
Aqueduct, New York, Wiley and Putnam, 1843.

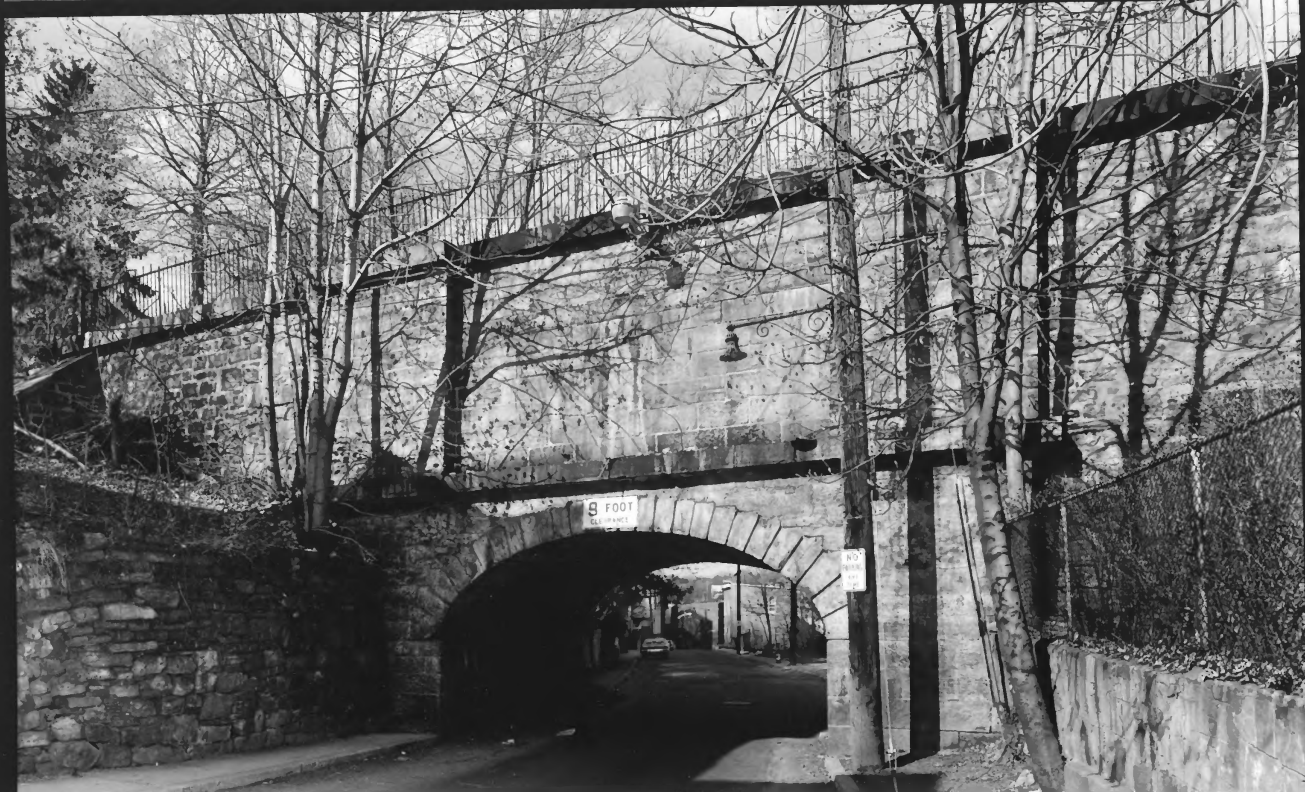
PHOTOGRAPH #15  
Croton Aqueduct

Sing-Sing Kill Bridge, showing the roadway arch located  
at the northeastern end of the structure.

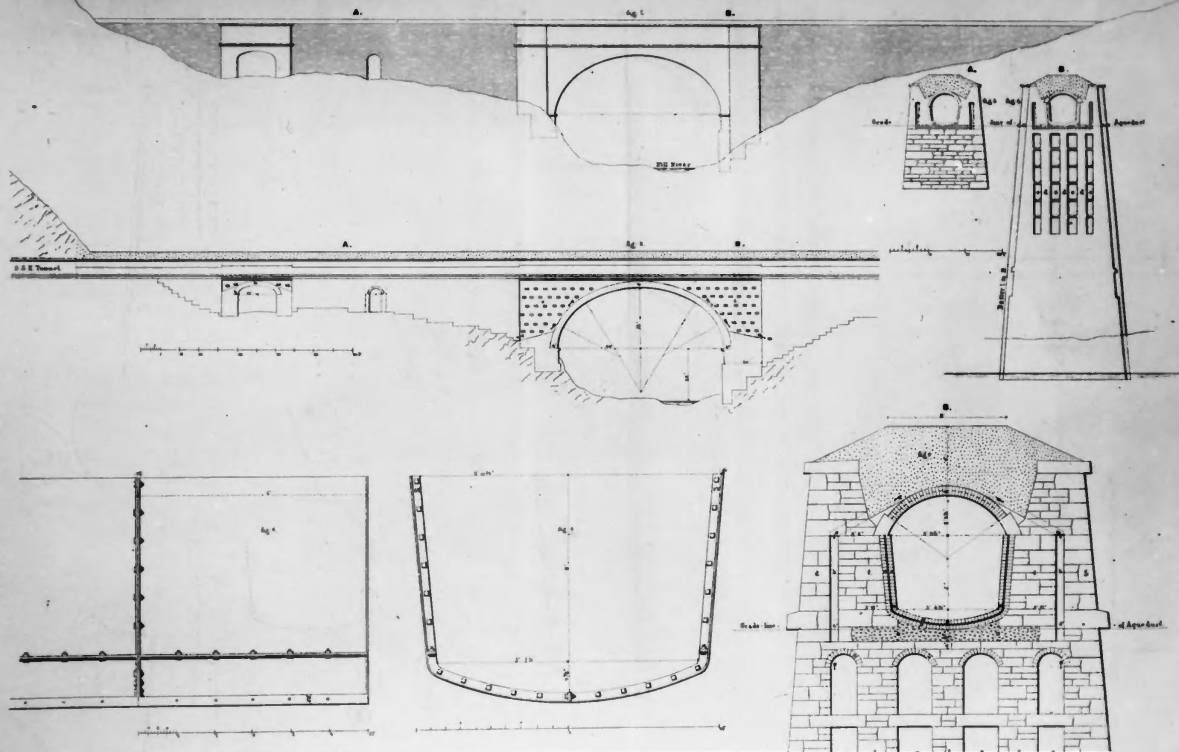
PHOTOGRAPH #16

Sections of Sing-Sing Kill Bridge showing iron lining and hollow space internal construction.

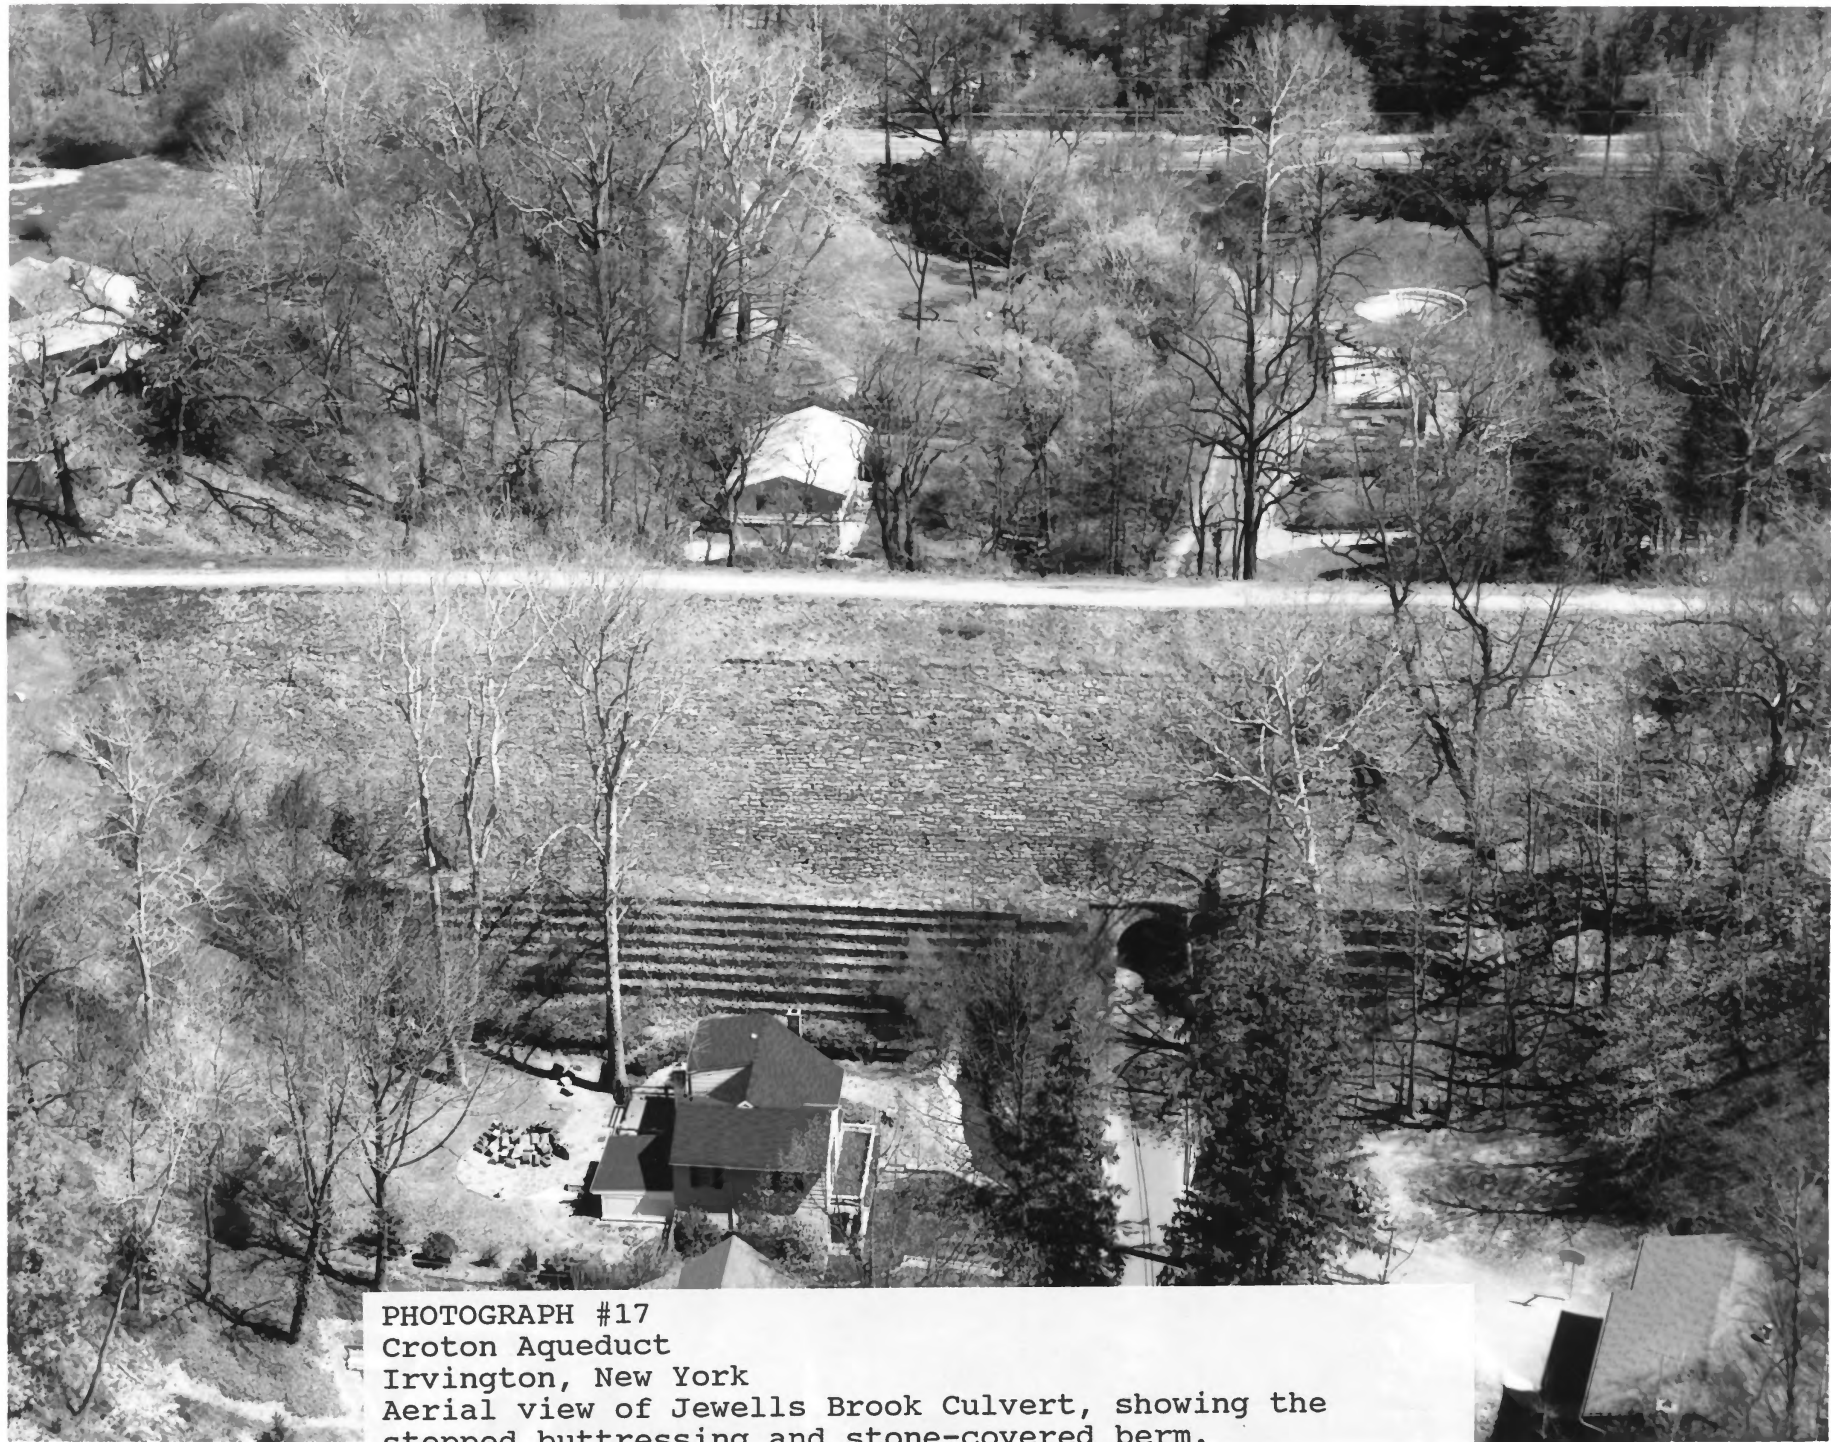
PHOTOGRAPH #17  
Croton Aqueduct  
Irvington, New York  
Aerial view of Jewells Brook Culvert, showing the  
stepped buttressing and stone-covered berm.  
Jack Boucher, 1978.

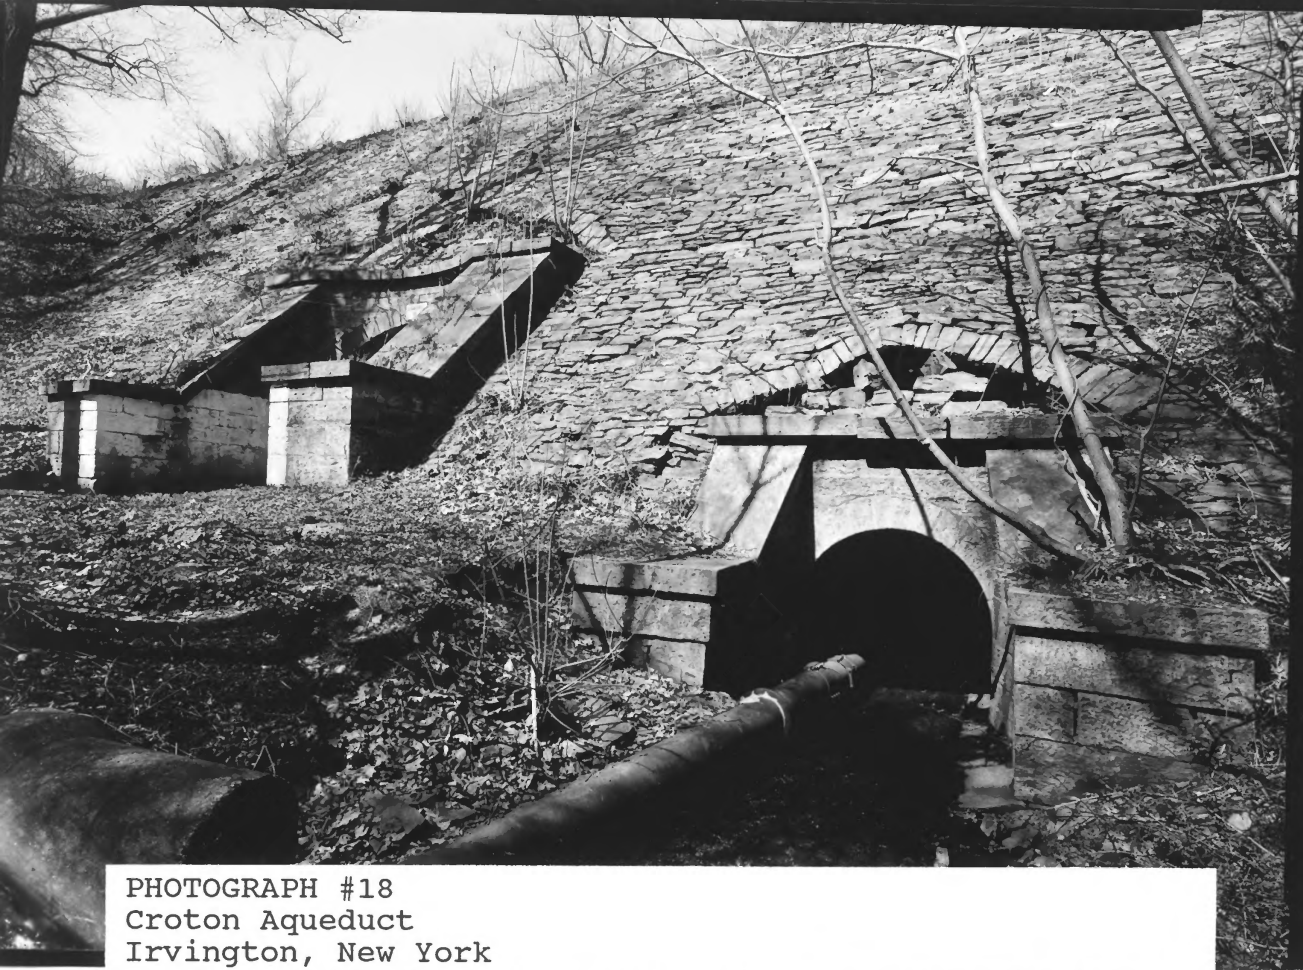
PHOTOGRAPH #18  
Croton Aqueduct

Jewells Brook Culvert, showing the stone-covered berm  
and the Station Road and Jewells Brook culvert arches.  
Jack Boucher, 1978, HAER Photo No. NY-114-6.

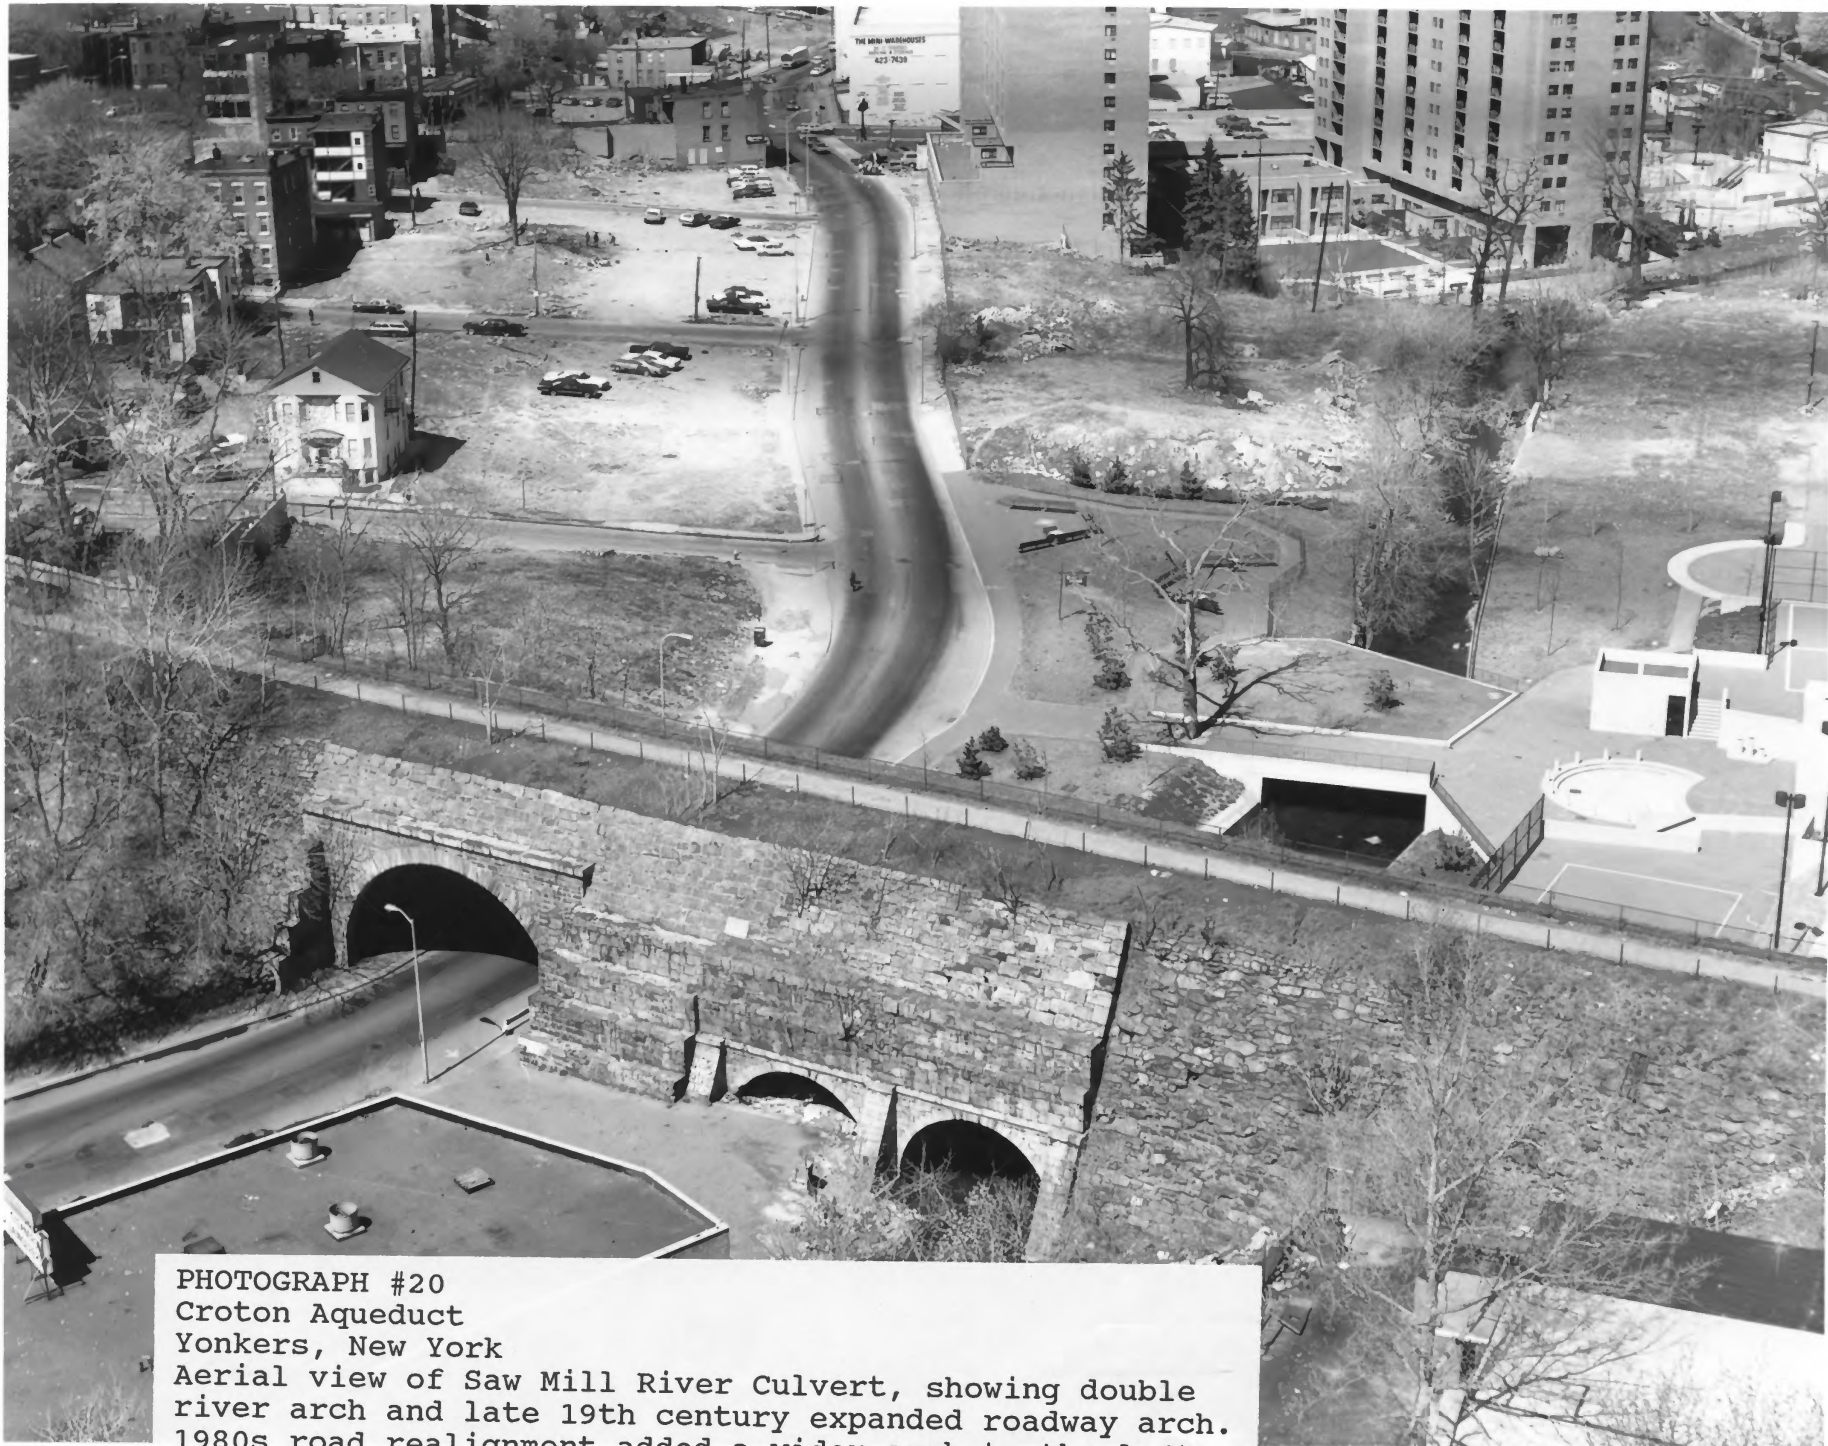
PHOTOGRAPH #20  
Croton Aqueduct  
Yonkers, New York  
Aerial view of Saw Mill River Culvert, showing double  
river arch and late 19th century expanded roadway arch.  
1980s road realignment added a wider arch to the left.  
Jack Boucher, 1978.
