PHOTOGRAPH #1  
 Croton Aqueduct  
 Westchester, Bronx & New York Counties, New York  
 Hydrographic map showing the route of the Aqueduct and  
 an elevation profile of the Manhattan portion.  
 From: Theoph Schramke, Description of the New York  
 Croton Aqueduct, New York, 1843.

GENERAL WORK.

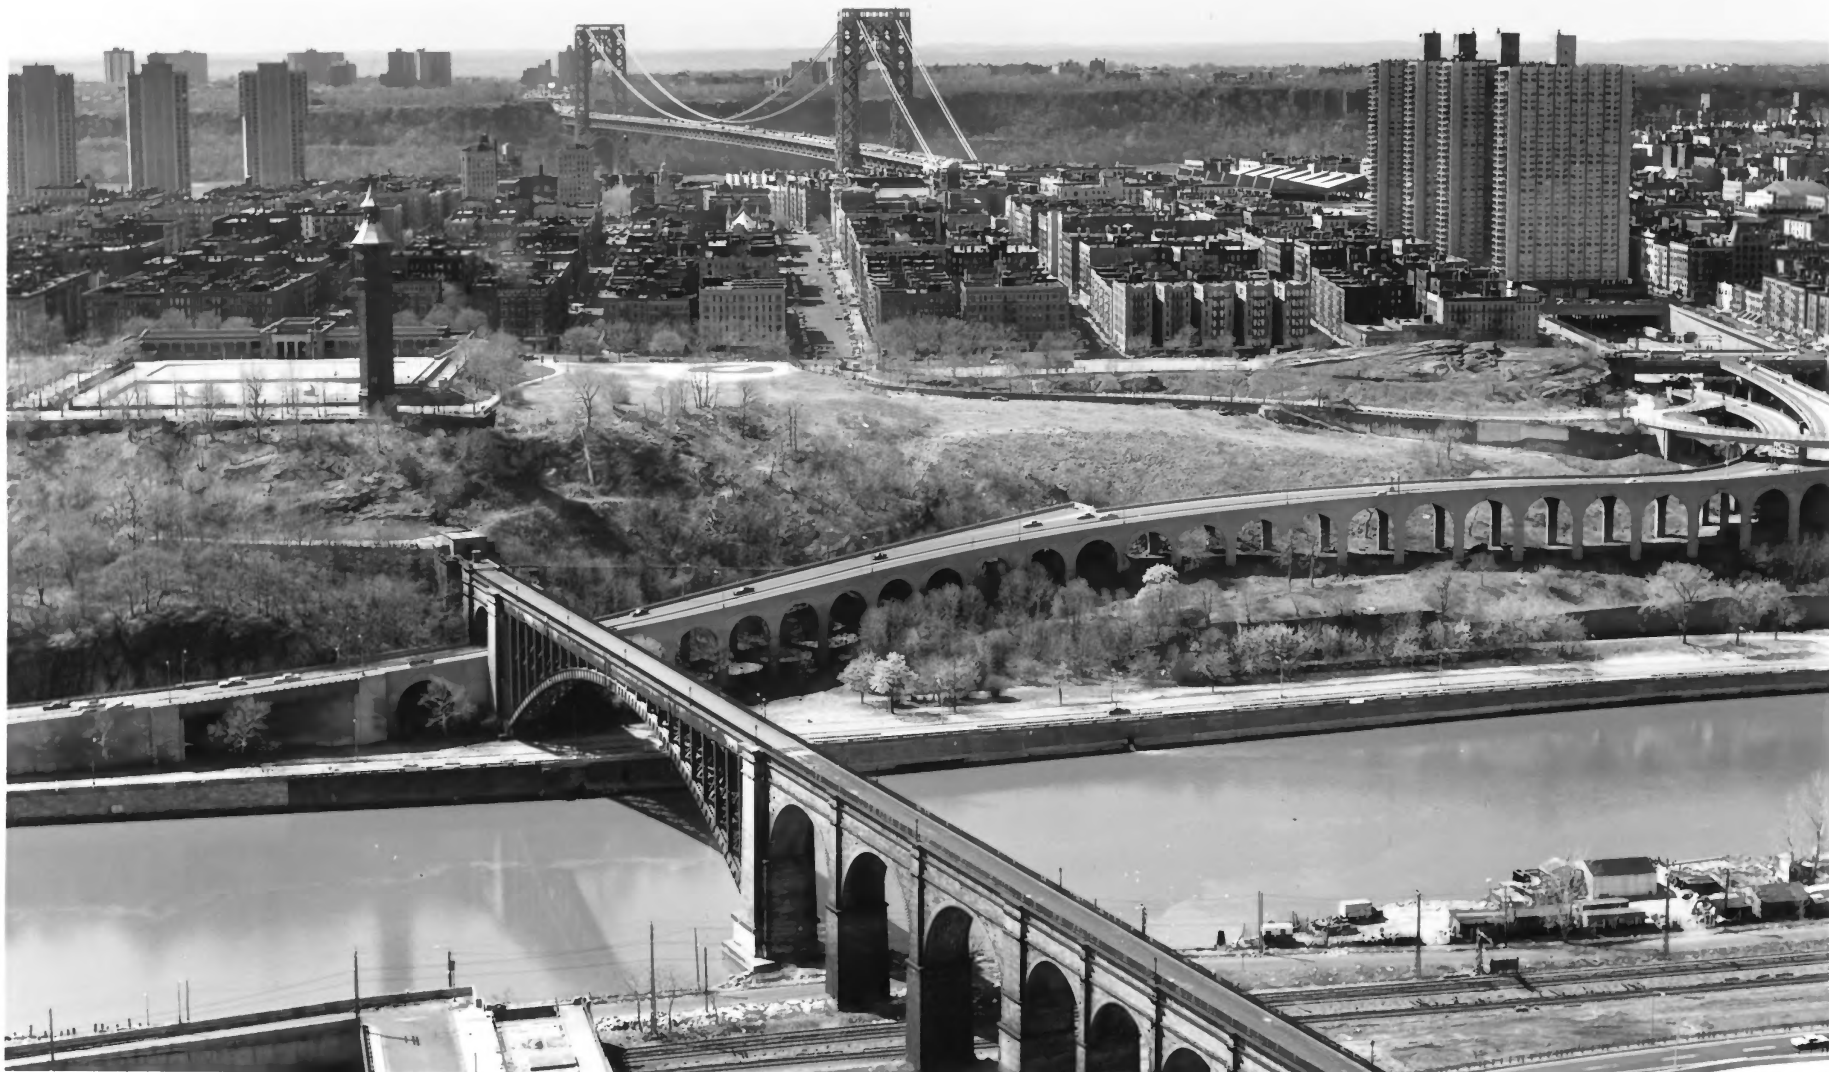
PHOTOGRAPH #21

Aerial view of the Aqueduct's High Bridge crossing the Harlem River from the Bronx (foreground) to Manhattan.

Note High Bridge Water Tower left of center.
