NATIONAL HISTORIC LANDMARK NOMINATION

KENWORTHY HALL

Historic Name: Kenworthy Hall

Other Name/Site Number: Carlisle Hall, Edward Kenworthy Carlisle House

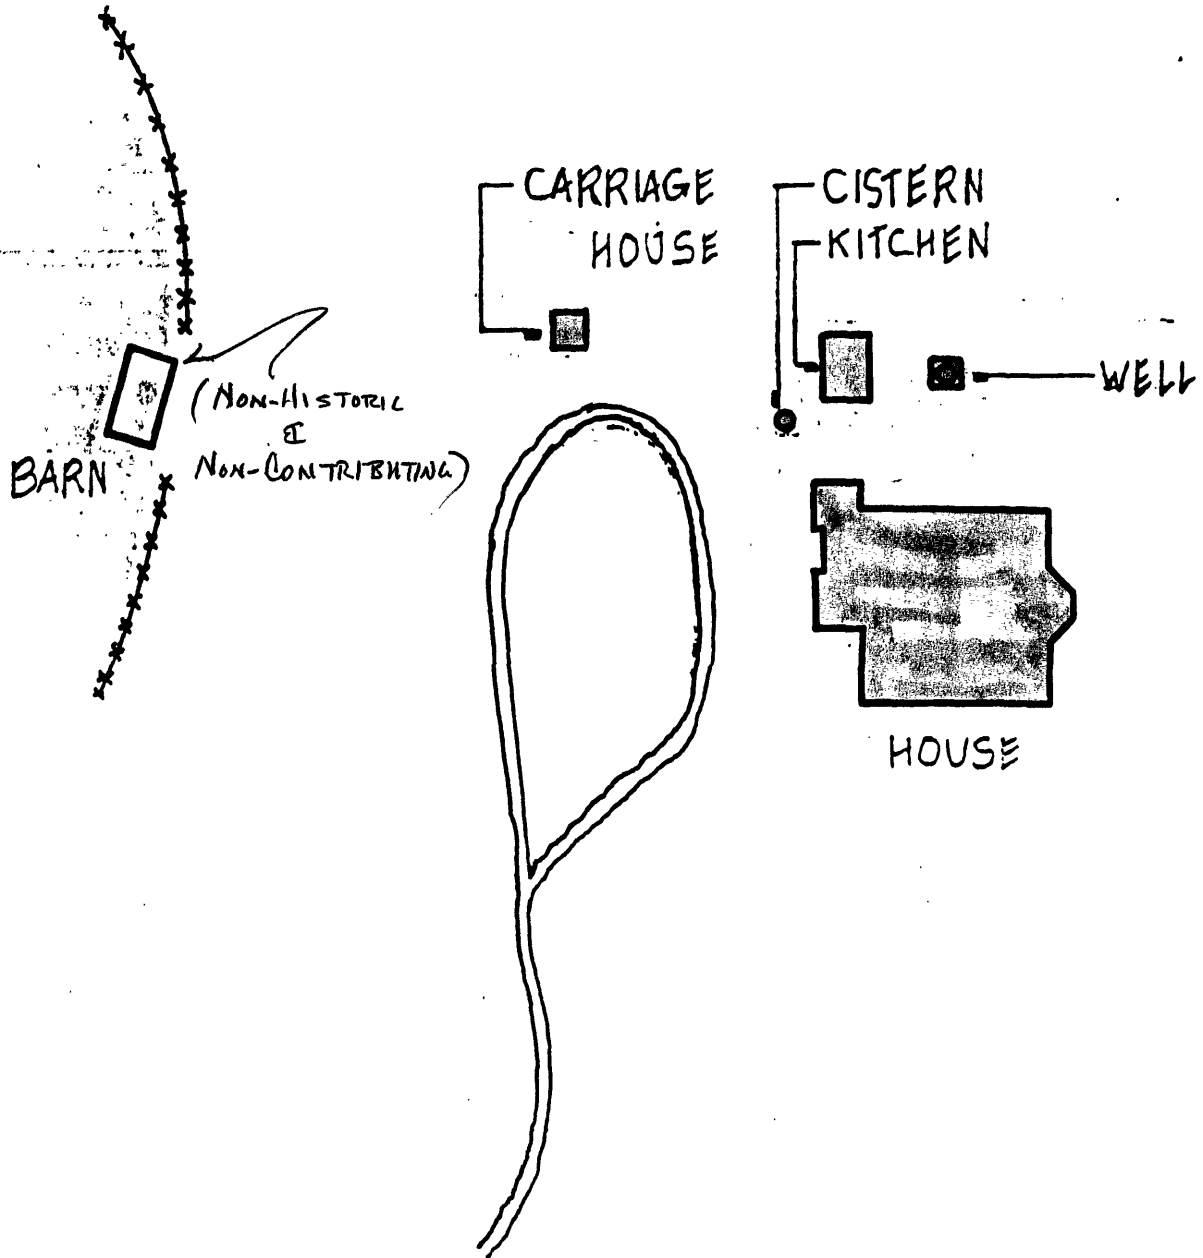
SITE PLAN  
(NOT TO SCALE)

Contributing & Non-Contributing Structures

1. MAIN HOUSE
2. KITCHEN-LAUNDRY
3. CISTERN
4. GAZEBO (NON-CONTRIBUTING)
5. CARRIAGE HOUSE / SMOKE HOUSE
6. WELL HOUSE
7. BARN (NON-CONTRIBUTING)
