National Register of Historic Places
Registration Form

historic name VanDerventer/Brunson House

other names/site number Vermeule Mansion

street & number 614 Greenbrook Road not for publication

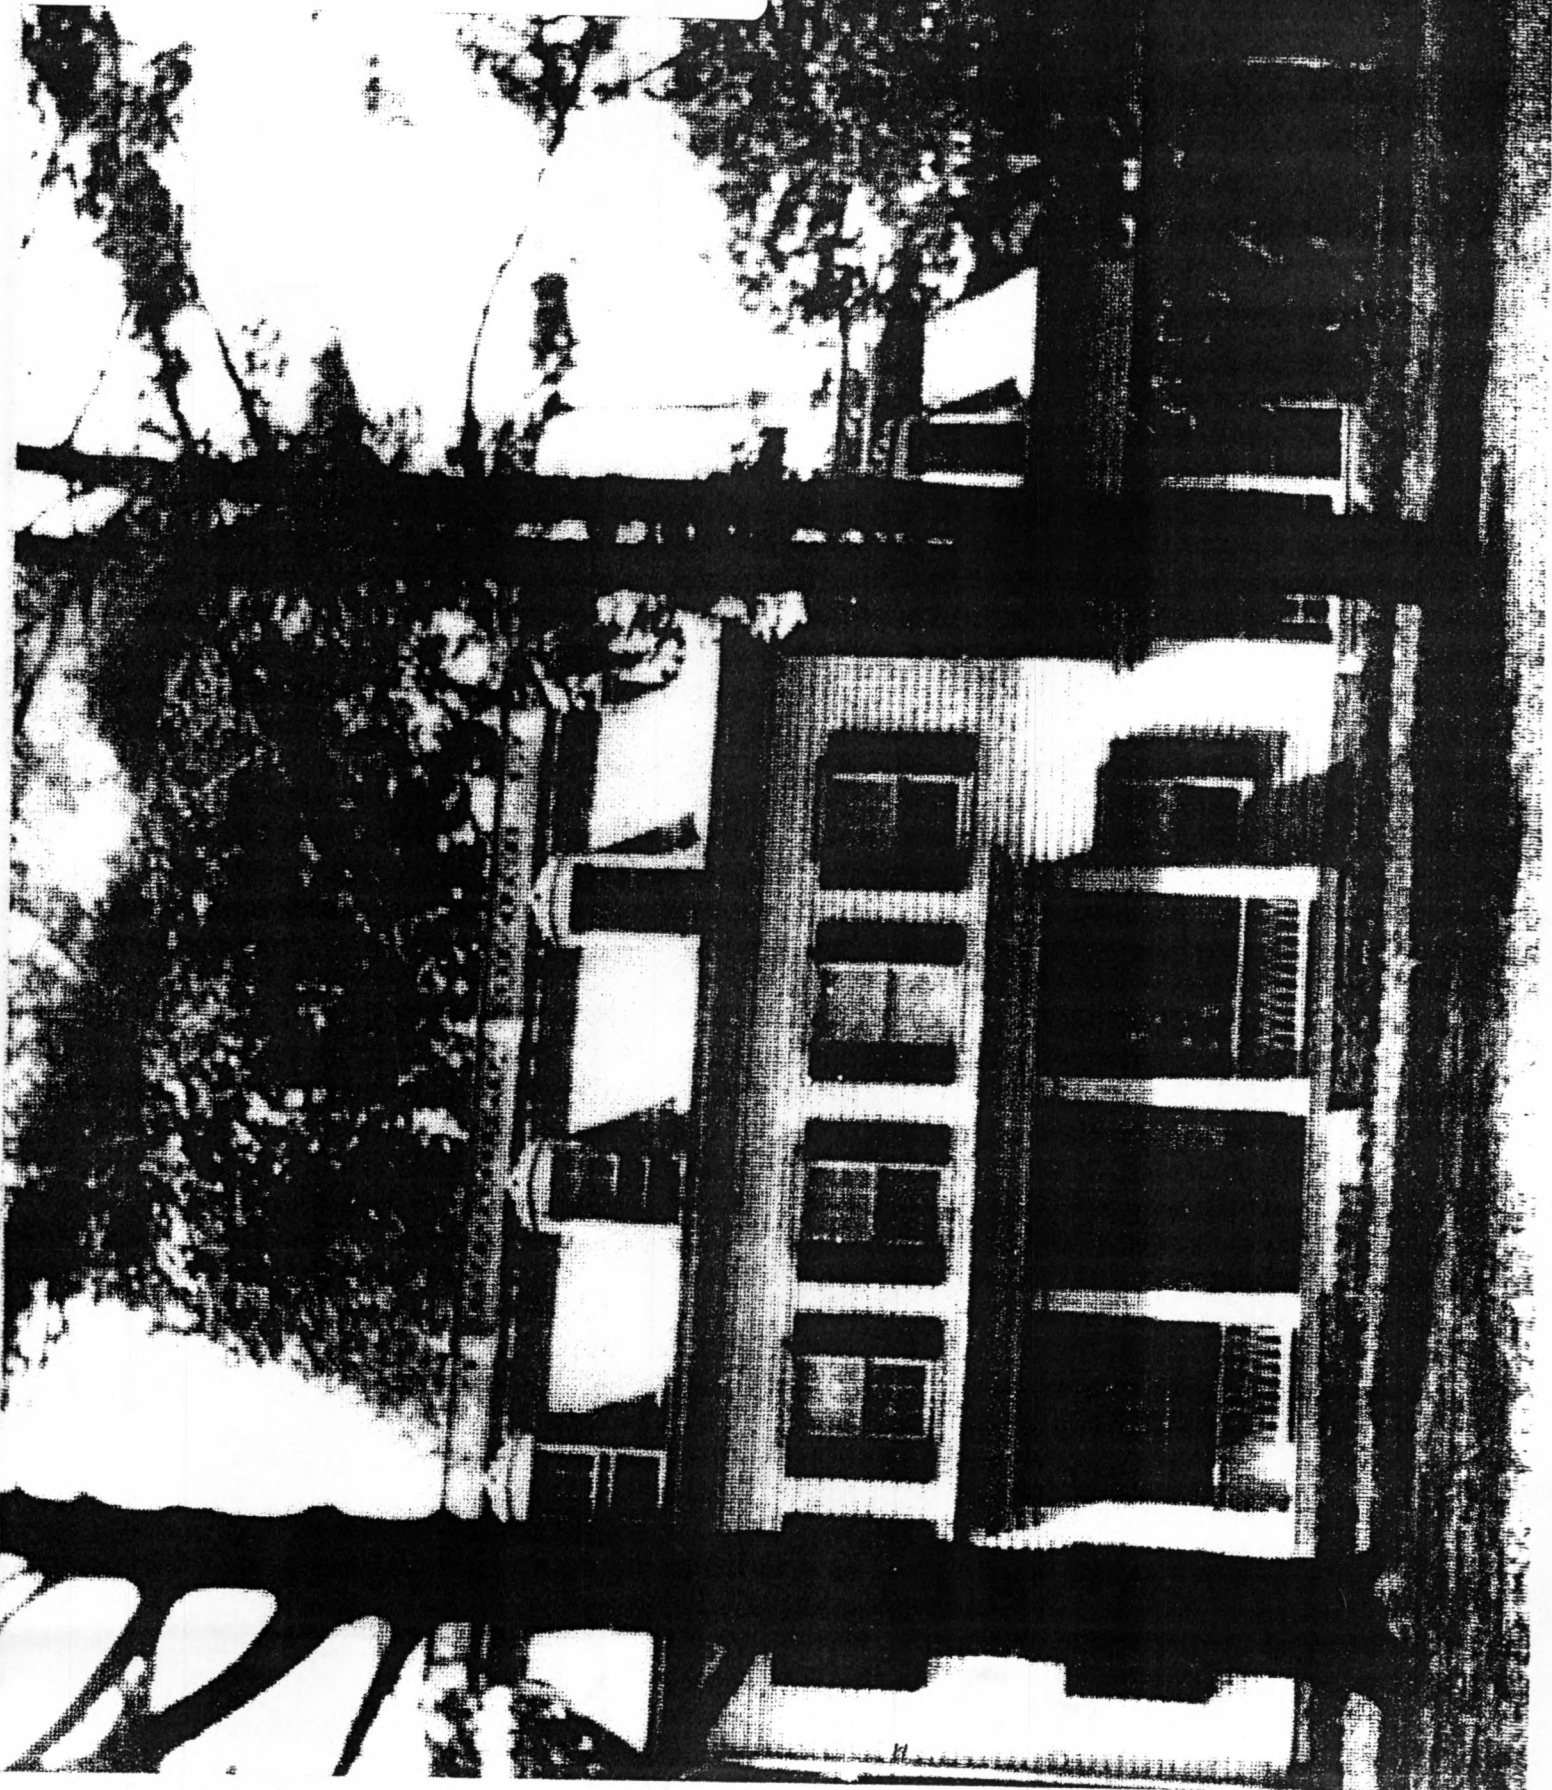
Figure 2, VanDerventer/Brunson House, northeast view, undated photograph documenting its appearance after the addition of the east wing and the mansard roof c. 1860-80.

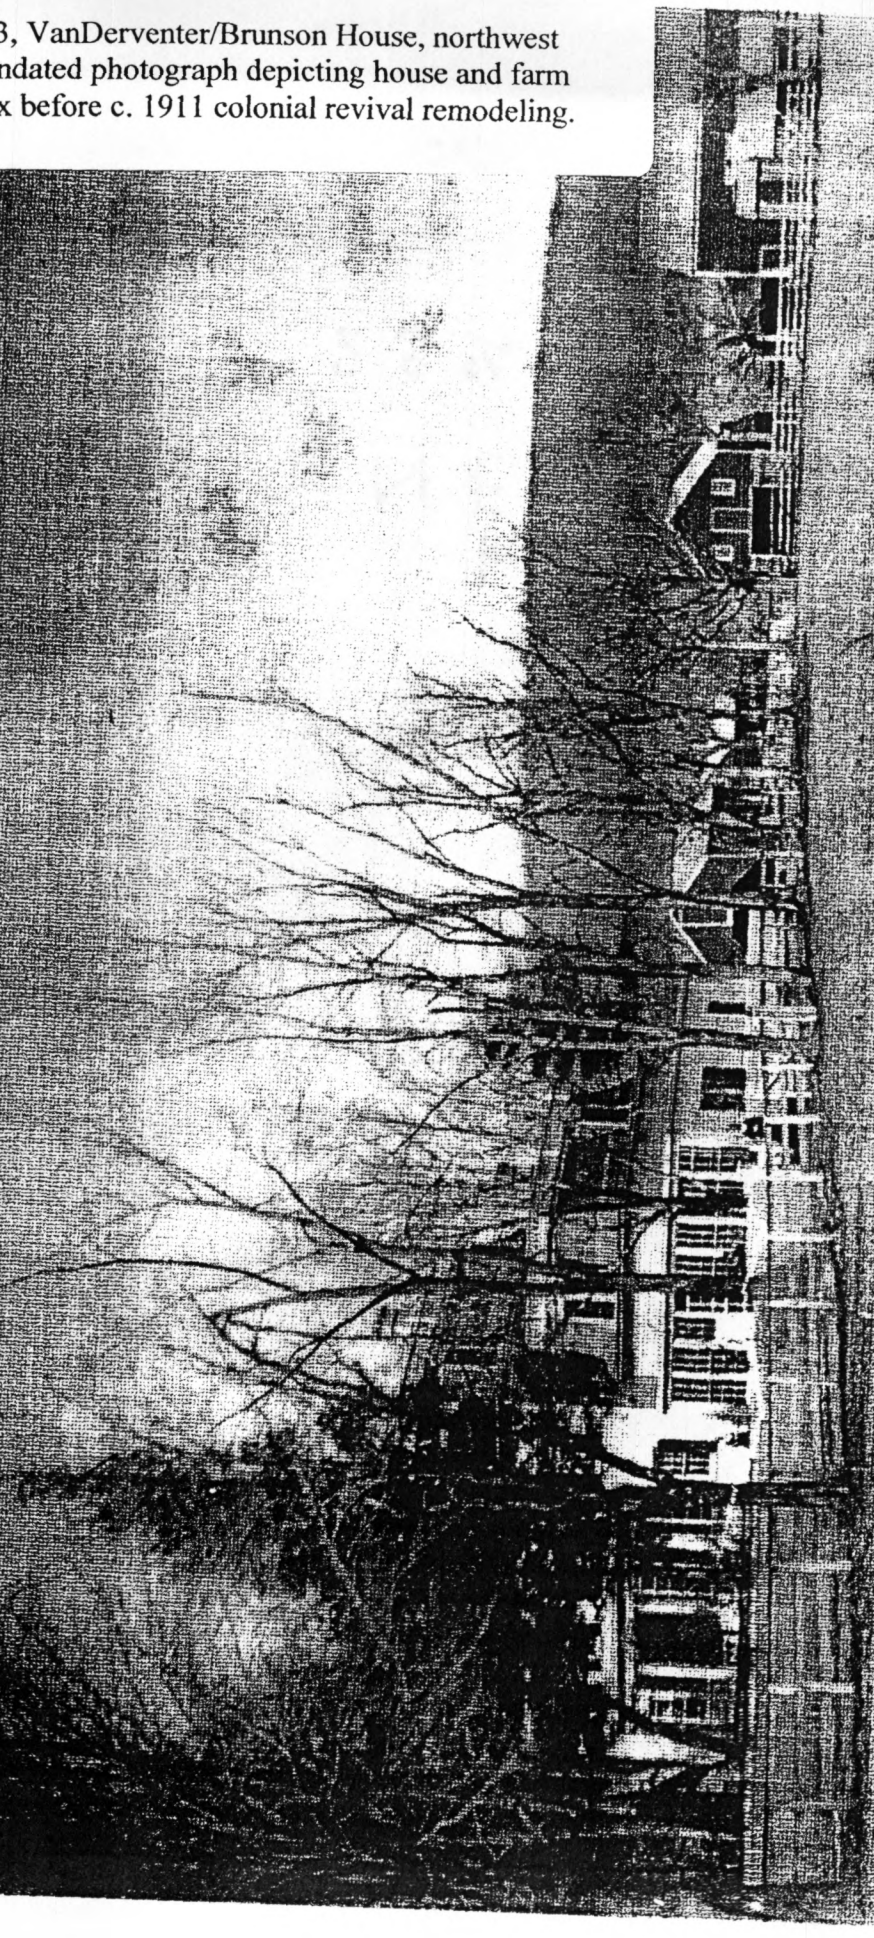
Figure 3, VanDerventer/Brunson House, northwest view, undated photograph depicting house and farm complex before c. 1911 colonial revival remodeling.

along the east side of the house to the back of the property (figures 3 & 4). The present gravel driveway leads from Clinton Avenue near the northeast corner of the lot to a small parking area behind the house.

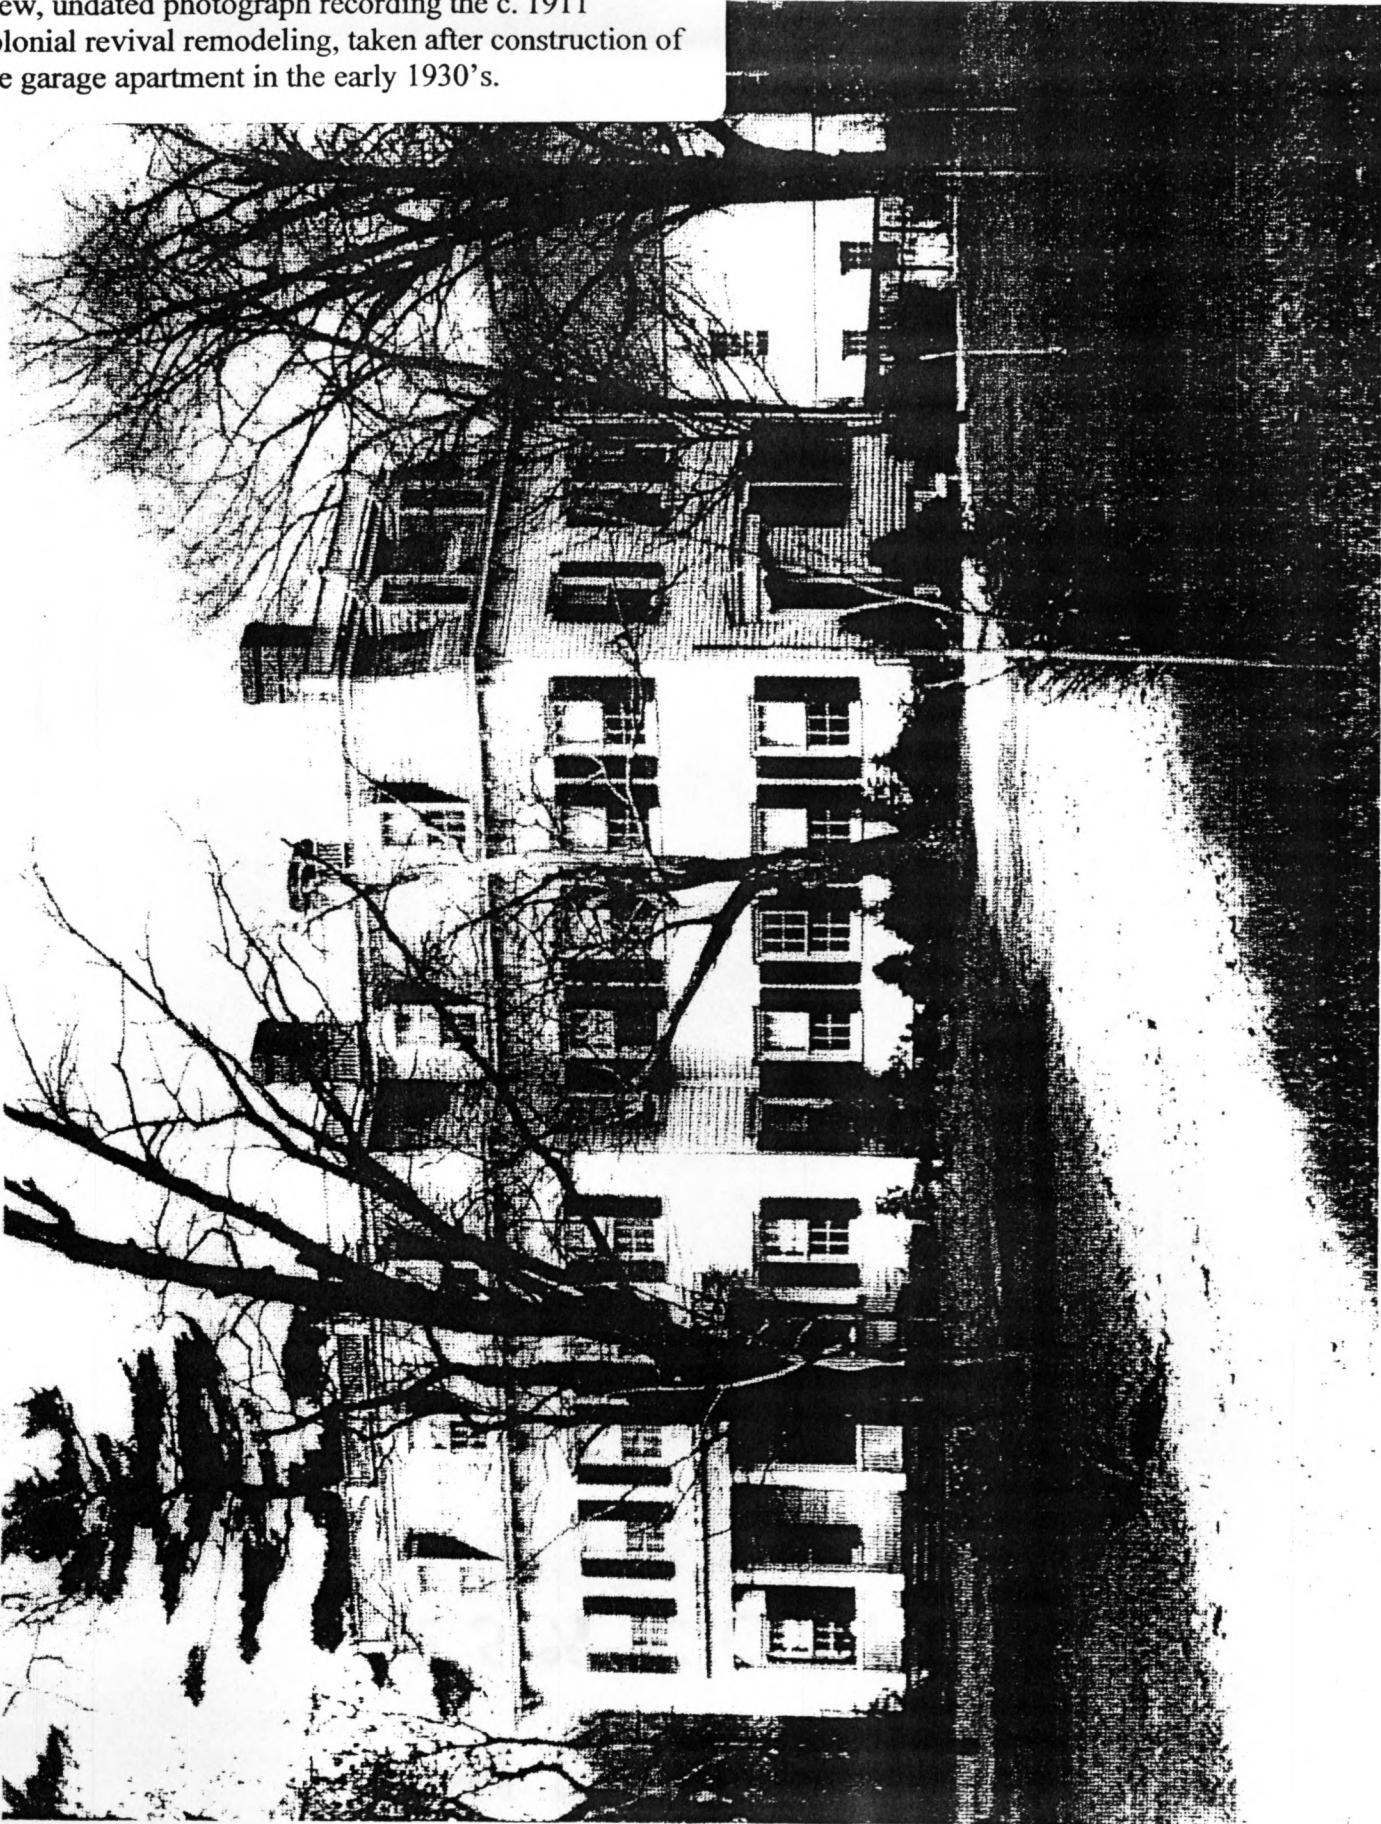
Figure 4, VanDerventer/Brunson House, northwest view, undated photograph recording the c. 1911 colonial revival remodeling, taken after construction of the garage apartment in the early 1930's.

The exterior of the house presents an amalgam of 19th and 20th-century features (photo #s 1–11). The main block's stone foundation is faced with ashlar brownstone, an original feature, on the south or front elevation; the east wing foundation appears to be poured concrete and that of the rear appendages is parged masonry block. The clapboard siding and 6/6-sash windows are a mix of 19th and early 20th-century fabric. Some replacement siding on the west side of the main block is associated with window alterations during the (fourth-period) apartment conversion or more recently, which included the installation of two double 6/1-sash windows, as well as slightly moving the first-story front window to the left of the front entry and a few 6/1- and 1/1-sash replacements on the rear (photo #s 7 & 8). The front entry with its shouldered architrave surround and slightly raked head can be dated to the c. 1870 (second-period) renovations, presumably a replacement for the original single-leaf front door (photo #5; figure #s 1 & 2). Its double-leaf doors probably were replaced, in turn by the present glass-and-panel front door in the c. 1911 (third-period) remodeling. The 3-bay, flat-roofed front porch appears to incorporate elements dating to the first or second construction phases: the quirk-beaded ceiling boards and the two attached posts with paneled shafts in the Greek Revival style (photo #4; figure #s 1 & 2). The simple Colonial Revival entablature, railings, and posts evidently are third-period fabric, although the posts exhibit later reworking at their bases (photo #4; figure #4).
