National Register of Historic Places
Registration Form

historic name South Branch Schoolhouse

South Branch Schoolhouse, Somerset County, NJ

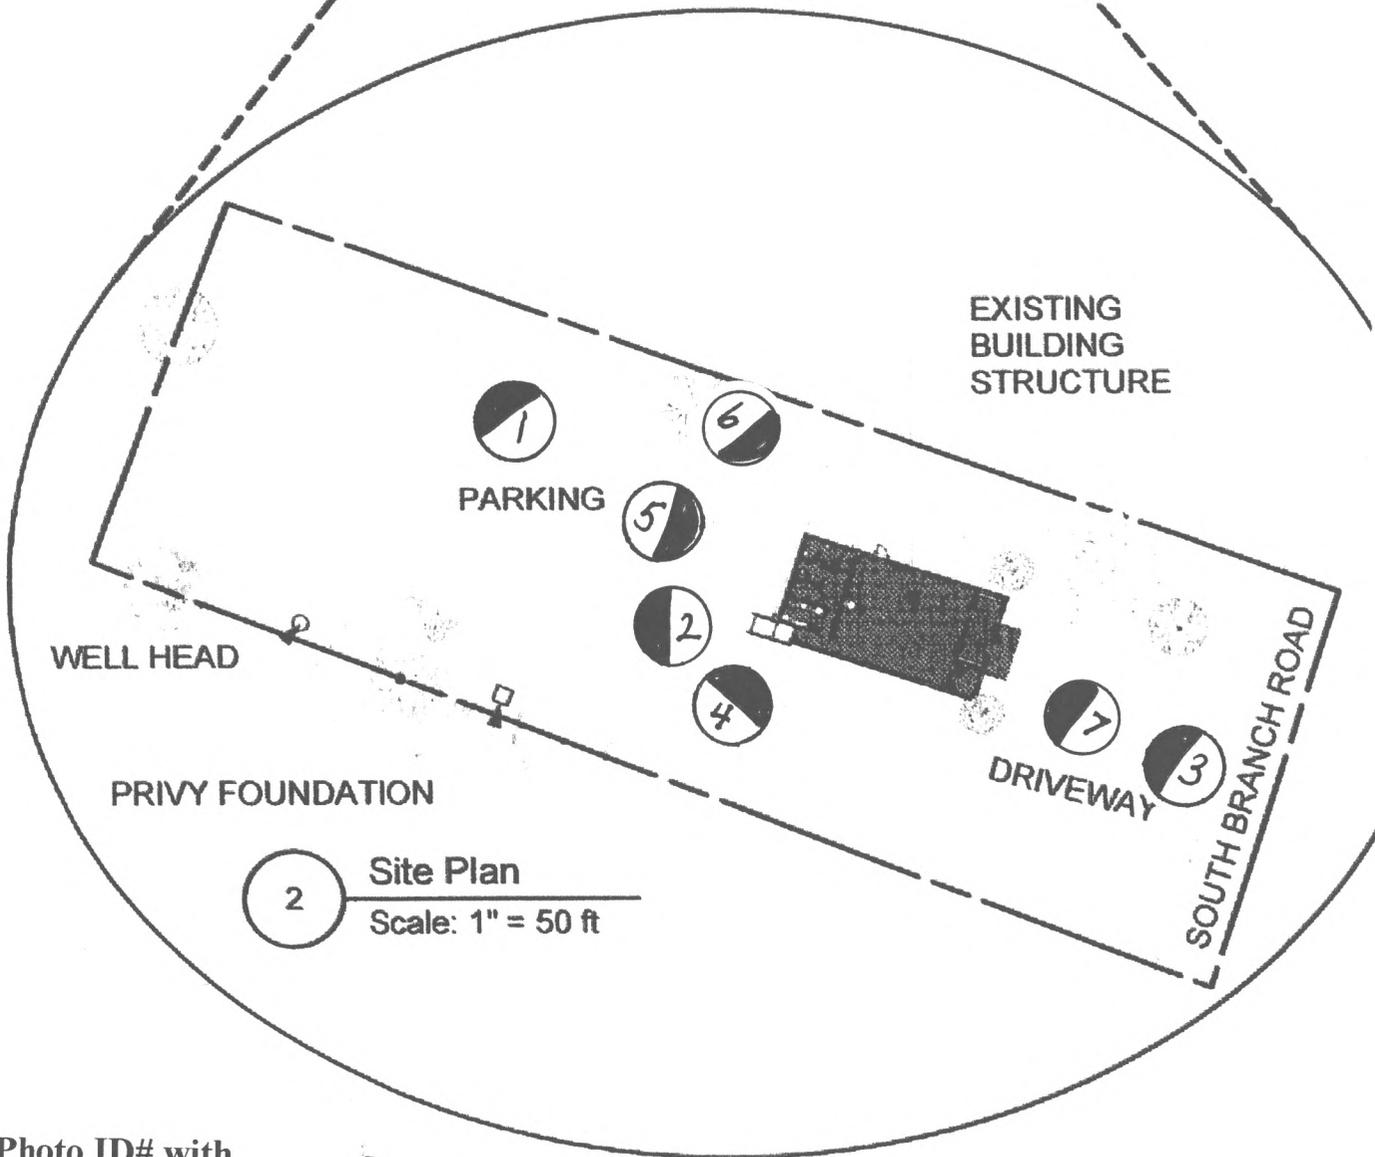
2 Site Plan
Scale: 1" = 50 ft

Photo ID# with
direction of view

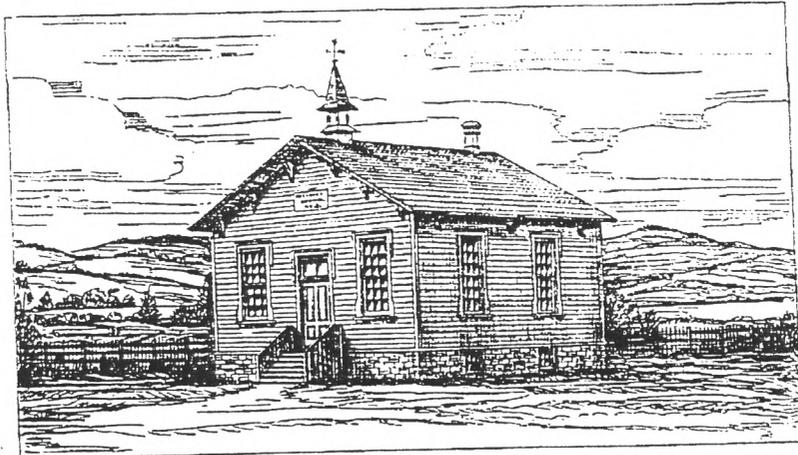
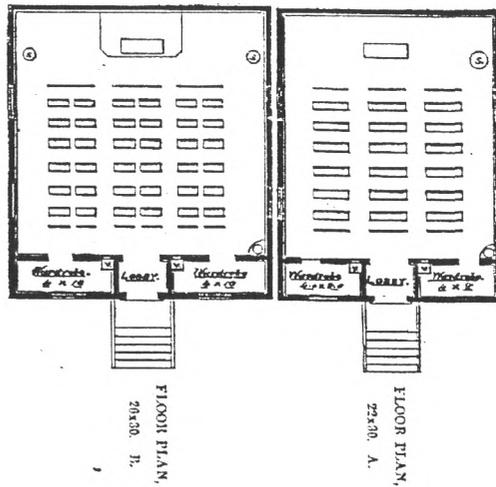
DESCRIPTION OF DESIGN II.

The exterior of this building is inexpensive, plain, and unpretentious; the interior is similar to No. 1, excepting the room is larger, and no provision is made for a teacher's closet. Two floor plans are given to show two methods of seating. Floor plan A is twenty-two feet wide, packed with double desks. Floor plan B is twenty-six feet wide, and is packed with single desks, each pupil having a separate desk and seat; this is a very desirable method, as the scholars are thereby kept separate, but is of course more expensive, as it requires a wider room, and single desks cost nearly as much as double ones. The ventilating arrangements, and the interior fitting up are the same as in No. 1.

The cost of the building, without furniture, will be between \$900 and \$1000.

Figure 1. Model for a small rural school, 1874. Exterior detailing bears a striking resemblance to the South Branch Schoolhouse, as does plan with entry vestibule and platform in the front of the classroom. [Annual Report of the Superintendent of New Jersey Public Schools for the Year 1874, pages 34 and 35.]

Like design #11 in the 1874 school report, the design of South Branch Schoolhouse incorporates decorative motifs derived from the Gothic Revival and Italianate styles fashionable in mid 19th-century America. Italianate cupolas and belfries similar to the one which originally graced South Branch Schoolhouse distinguish a number of the schools, dwellings, churches, and commercial blocks erected in villages and towns around the region during the third quarter of the 19th century, and local factories of the period produced ornamental millwork like that used on South Branch Schoolhouse for the bracketed cornices, raked window hoods and other moldings.⁹

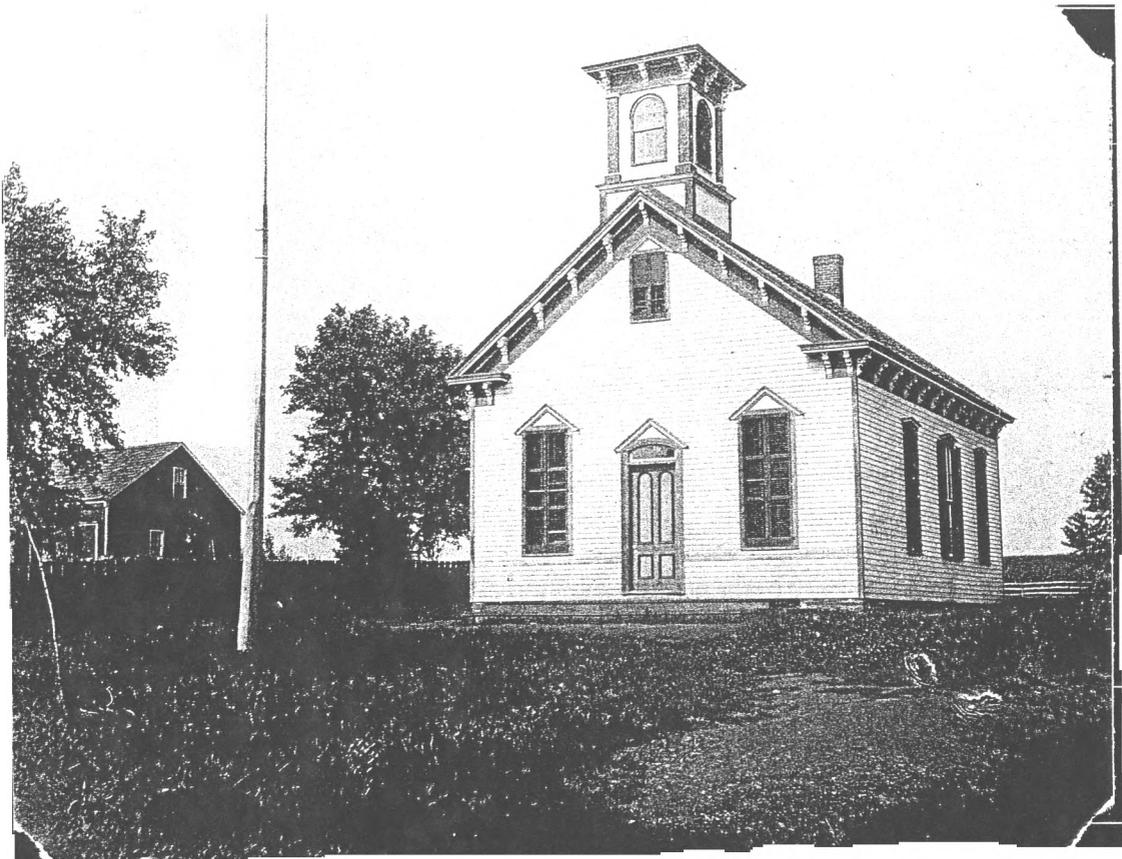
Figure 2. South Branch Schoolhouse, southwest view, circa 1897, collection of Fred Sisser III. Note the building's Italianate belfry, louvered shutters and two-toned paint scheme, as well as the flagpole, carved spar-like from a log.

Historic photographs, mostly notably the one dating circa 1897 (figure #2), document other exterior features that have been lost or altered. The school's most prominent and stylish feature was its Italianate belfry centered on the roof ridge just behind the front gable. Capped by a flat or low-pitched, presumably hip, roof with wide bracketed eaves, the belfry had horizontal flush siding and round-arched windows flanked by pilasters at the corners. The circa 1897 photograph indicates that belfry's cornice brackets, three on each side, matched those at the main roof's eaves, and what appears to be cresting can be seen above belfry's roof eaves on the front elevation. The front belfry window was fitted with 6/6 sashes; the north side window appears to have had closed louvered shutters. The building's front, side and gable windows also had louvered shutters, numbers of which are stored in the cellar and attic, some retaining cast-iron butt hinges. Hinge ghosts can be seen on many on the window frames, and a few hinge leaves remain in place. The front entry stoop evidently consisted of a wooden stoop without railings, about the same size as the existing wooden deck. The four-panel front door had round-arched upper panels, instead of the segmental arched panels of the current replacement, and robust moldings articulated the panel edges. The photographs also indicate that the building had a two-tone exterior paint scheme consisting of a light body color and darker trim

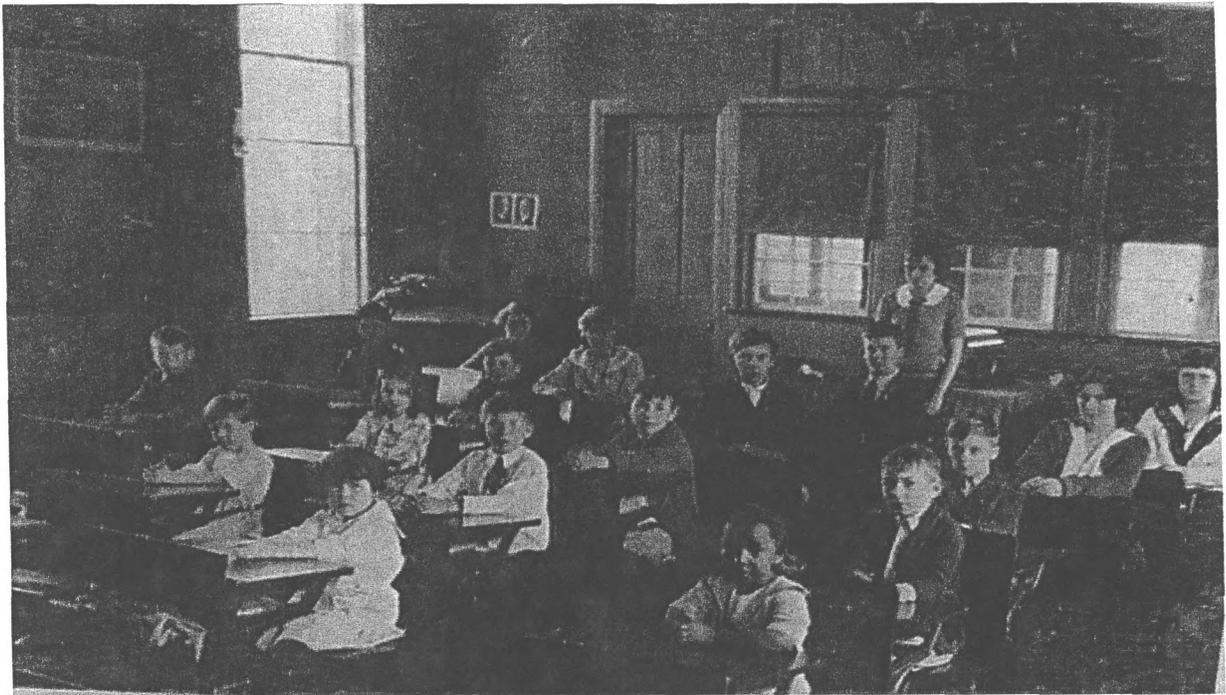
Figure 3. "Little Red Schoolhouse 1924". Room 102, classroom, northeast view. The blackboards on the north wall were lowered sometime after this picture was taken,

While also subject to 20th-century renovations, the interior of the schoolhouse retains much of its original character. The floor plan consists of one large room entered from a vestibule, which served as a cloakroom and included the small office partitioned from its south end in the 20th century. The main room is a high-ceilinged space, about 26-foot square, with three large sash windows on both side walls, two doors to the vestibule on the east wall, and originally a blank west wall (photo #s 8 – 10). In conjunction with the addition of the rear appendage, a door was cut through the south end of the west wall. The two east doors, one of which now leads to office, flank a horizontal band of three 6/6 sash windows (photo #8). Coat racks encircled the vestibule/ cloakroom, and shelves are located on its north wall (photo #s 12 & 15). Benches originally were built in along both side walls of the main schoolroom, as evidenced by the slight cant of the wainscot below the windows and paint ghosts of the removed seats. A one-step-high platform across the west end of the room, documented by patches in the wainscot, also has been removed (photo #11). Blackboards are located between the windows on the side walls, as well as on the windowless rear wall. Iron brackets and a pilaster-like post support the rear-wall chimney, which vents a small cast-iron stove of unknown provenance. The original stove probably was located towards the middle of the room to provide more even heating. The ghosts of what appears to be oil lamp brackets are found on several of the window surrounds, and an oil lamp so mounted, can be seen in a 1924 photograph of the schoolroom (figure #3).

South Branch Schoolhouse had such modern student desks at an early date, if not originally, and several blackboards. While the desks, depicted in a 1924 photograph (figure 3), have been removed, blackboards survive on three walls of the main room. Architectural specifications for model schoolhouses accompanying the superintendent's report called for the lower portion of interior walls to be wainscoted, and the upper portions and ceilings to be plastered. The superintendent recommended cloakroom walls to be wainscoted to a height of six feet and the rooms amply supplied with iron coat hooks, as well as shelves for "dinner baskets and overshoes." Coat racks encircled the South Branch vestibule/cloakroom, and shelves are located on its north wall. As regards painting, Apgar called for interior woodwork "to have three thin coats of paint, grained in imitation of light oak, and varnished."⁵ Interior walls at South Branch are wainscoted and plastered, although the vestibule/cloakroom wainscoting is not six feet high, and paint analysis has
