**National Register of Historic Places
Registration Form**

historic name Baker-DeVotie-Hollingsworth Block [New name and boundary increase]

street & number 516-526 East Grand Avenue [N/A] not for publication

city or town Des Moines [N/A] vicinity

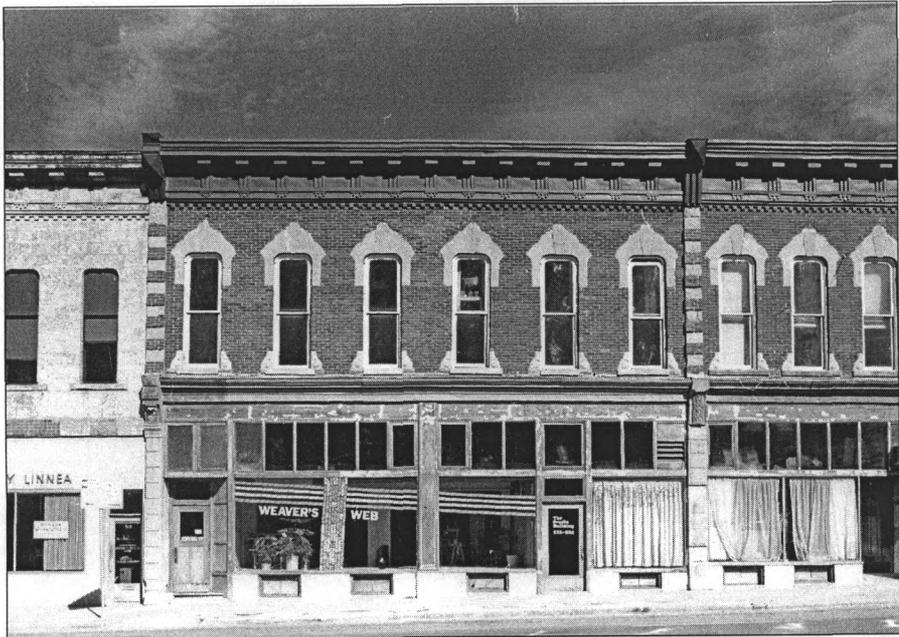
Figure 1: 1976 photo showing 516-518 and 520 East Grand, view north. Note the surviving basement windows, set into the bases of the ground floor display areas and storefront base plates. Note the Society Linnea sign on 518 East Grand, at the far left (courtesy of Tim Rypma)

The use of decorative stone in combination with brick walls descriptive of the earlier Italianate commercial era in Des Moines is of particular interest (Figures 1, 4-5). It is the vertical cadence of these stone quoin pilasters, with the matching stone windows, hoods and cornice lines, that identify this as a single unified design, but one built over time. It reflects an effort to decorate a façade using alternative materials than the cast iron storefronts that were fast became dominant. The use of a quoin pattern, as found in this design example, was also typically used in earlier Italianate examples. In this design, a continuous pile of stone quoins separated the storefronts, and in the case of 524-526 East Grand, used to distinguish a centered upstairs entry hall. The 1883 buildings did not emulate this last feature, the upstairs entrances being relegated to a sidewall location (Figures 1, 30). Upstairs, the quoin treatment continues, with alternating brick and stone segments. A final stone cap on each pilaster supports the cornice line. Massive ornamental stone window and door hoods (restored using fiberglass cast replacements) complete the decorative stonework. These are oversized, wrap around the upper window openings and are paired with lower corner inserts that flank plain stone sills.

A quite remarkable surviving element is the Italianate window form with rounded upper corners on the second floor (Figures 1, 4-5, 10). Usually this type of upper window sash is flattened, reduced or otherwise lost over time. All of these upper appear to be original.

520-522 East Grand has the pier/beam central support system in the basement (Figures 1, 13). The basement floor is currently dirt, an interim concrete block and wood floor system having failed. The ceiling is unfinished. The front basement brick wall features twin centered brick arched doorways, a clear indication that the basement level fenestration was original to construction. Large square window openings flank each door within each of the two storefronts and these have been filled in with an early soft brick, indicating an early closure. On the main floor, six tapered cast iron columns run along the centerline. The rear of the plan is raised slightly as already described. On the back wall at ground level there is a door that is raised above the sill line of flanking side windows. This door had to have an interior stair system when it was in use, given its elevated placement. Two massive safes remain in this part of the building. Invision Architects occupy 522 East Grand on the second floor. Their space contains a central free-standing storage and services module with work cubicles in the front of the plan. The stairway is located in the southeast corner of the plan and it has been transformed into several run of stairs and a landing so as to make room for a ground level opening into 524 East Grand to the east. There are no original or other partition walls. A large sliding metal fire door fills a void into the rear upstairs of 524 East Grand.

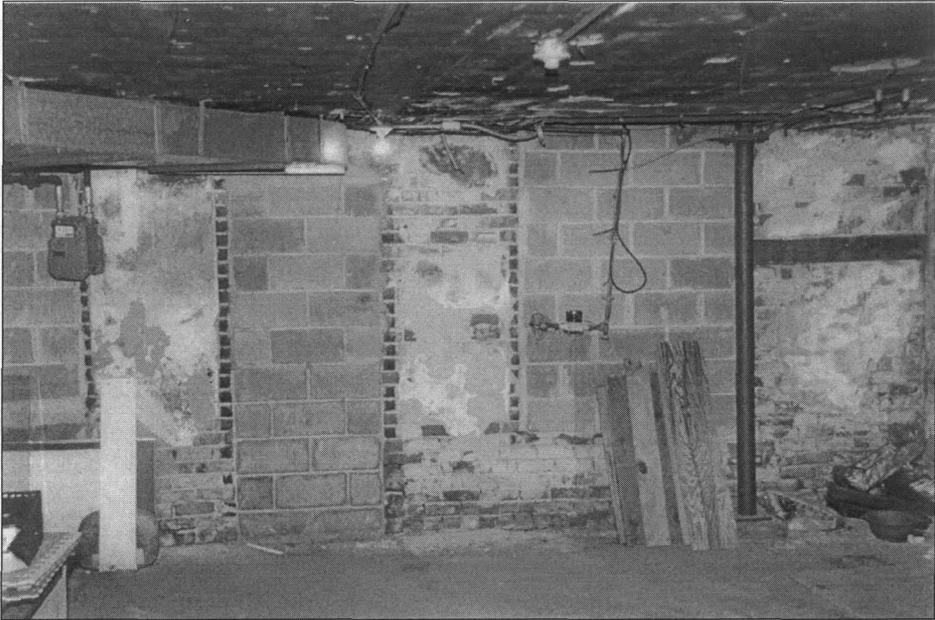
Figure 2: Brick filled windows and doorways in 516 East Grand, south wall, view southeast
(photo by James Jacobsen, February 2007)

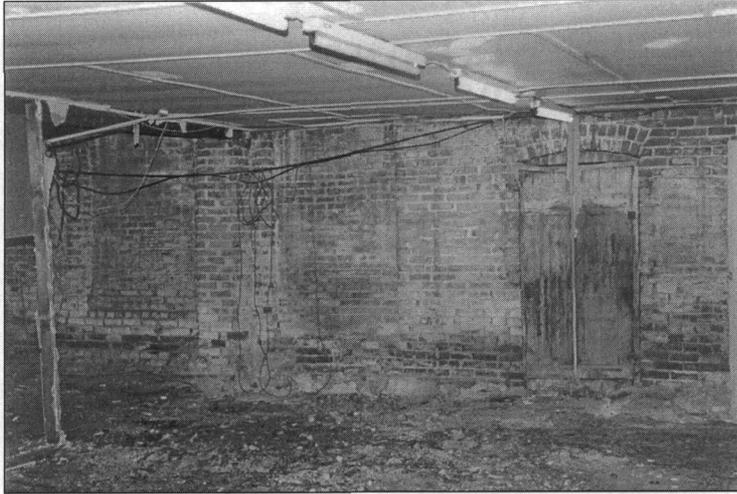
Figure 3: Brick filled windows and doorways in 520-522 East Grand, south wall, view southeast
(photo by James Jacobsen, February 2007)

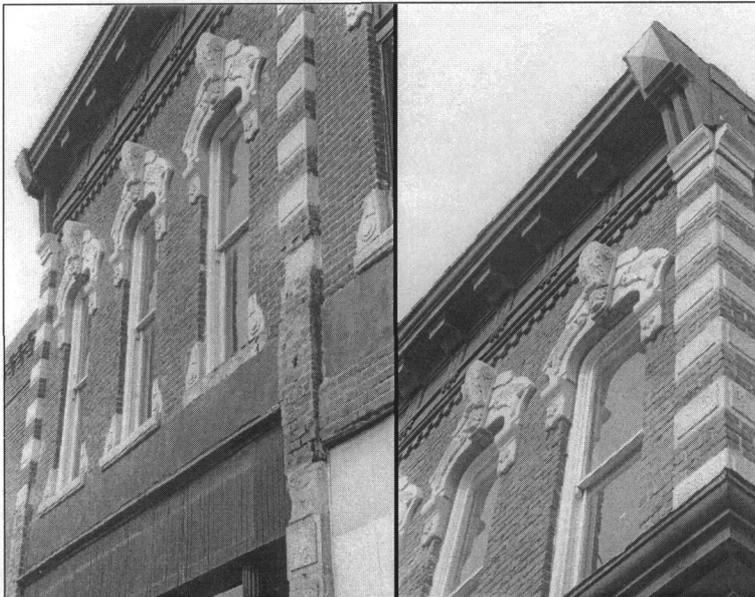
Figures 4-5: Details of upper façade levels, 516 and 526 East Grand Avenue, respectively
(photo by James Jacobsen, February 2007)

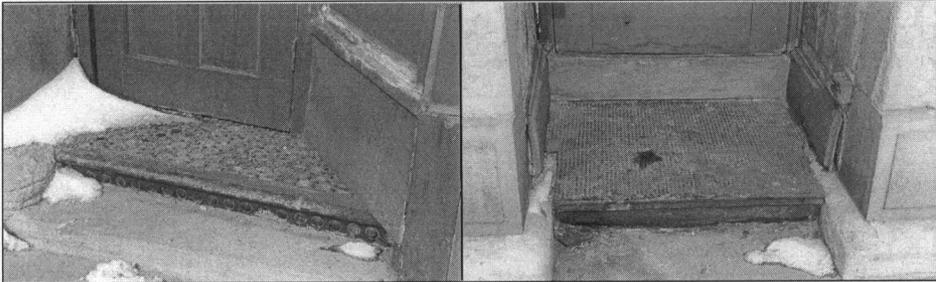
Figures 6-7: Details of original cast iron thresholds, 520 and 524-526 East Grand Avenue, respectively
(photo by James Jacobsen, February 2007)

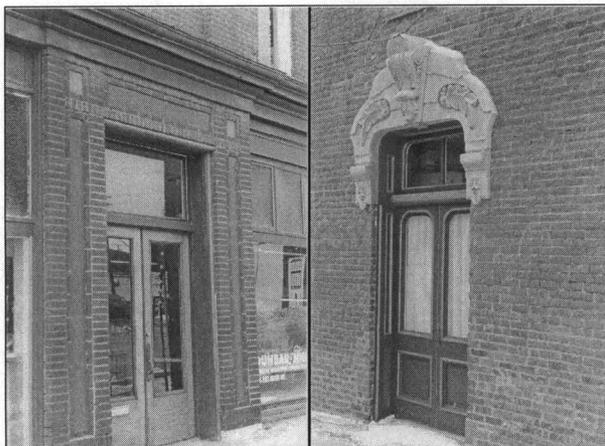
Figures 8-9: Details of East Sixth Street entry and the side entry to the north of same
(photo by James Jacobsen, February 2007)

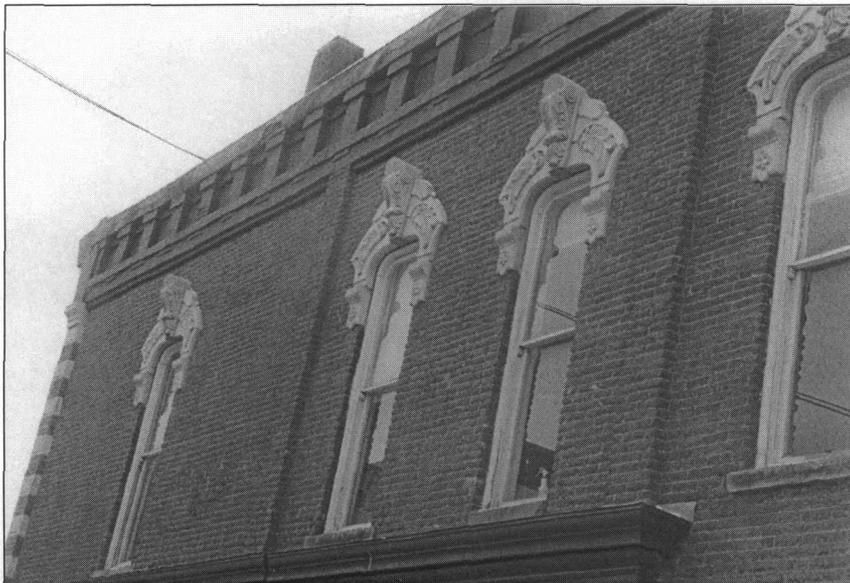
Figure 10: Brick cornice and window details, East Sixth Street sidewall, view southwest
(photo by James Jacobsen, February 2007)

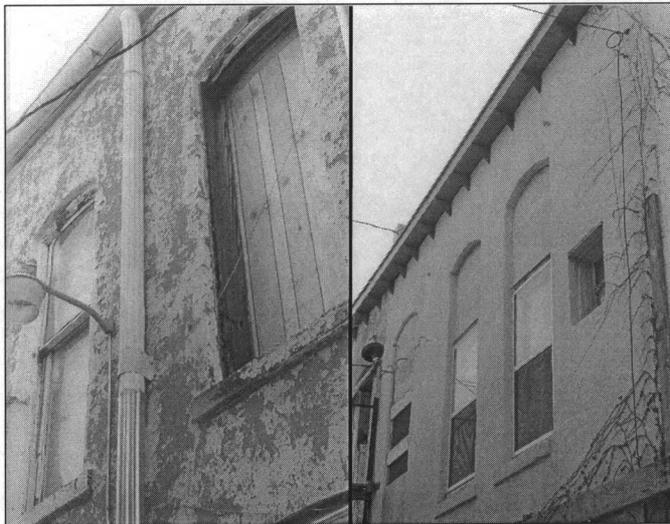
Figures 11-12: Upper level detail views of north/back wall, 526 and 516 East Grand Ave. respectively, view southeast
(photo by James Jacobsen, February 2007)

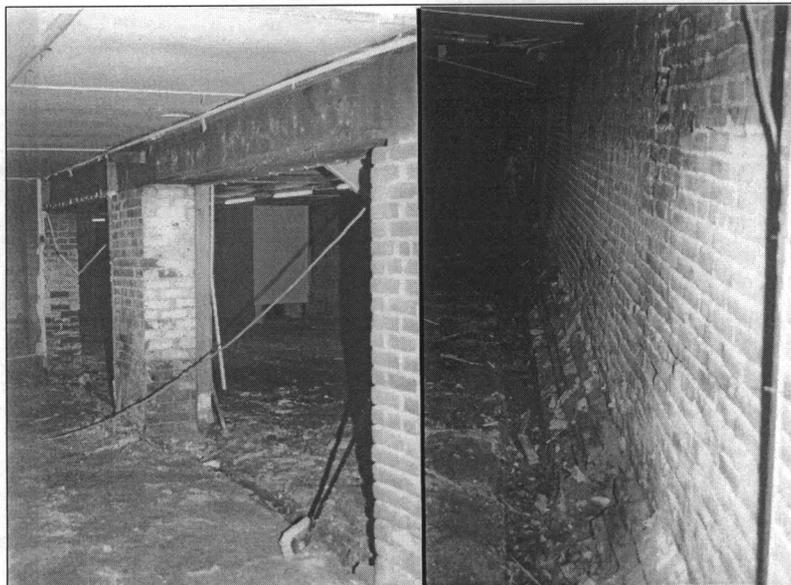
Figures 13 and 14: Left, brick piers and timber beams, right, brick spread footings
(520-522 East Grand, photo by James Jacobsen, February 2007)

The foundation arrangement of the original 1877 building utilizes a spread footing support system (Figure 14). The underpinnings of this broader brickwork are undetermined. Presumably rubble stone or pilings support the perimeter and interior walls. Rubble stone is used in the rear basement wall only which is also a point of interest. The use of stone on all of the basement walls would be the common building technique. Stone footings are exposed beneath the surviving cast iron columns on the façade of 515 East Grand but there is no other evidence of stone foundations apart from the rear (north) basement wall, which is of rubble stone construction.

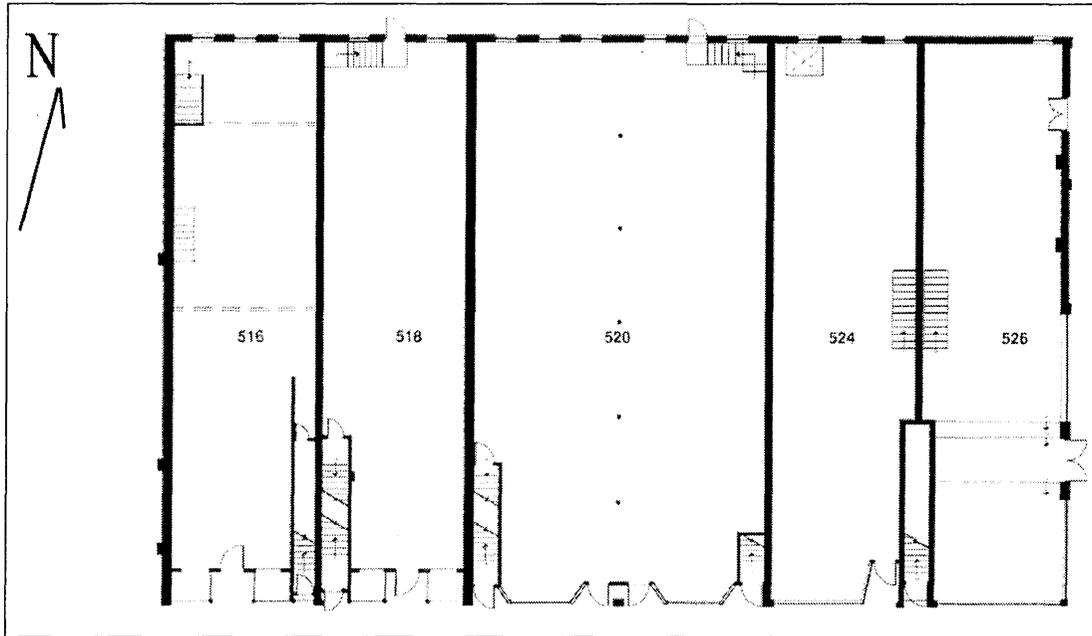
Figure 15: Current First Floor Plan (Herbert Lewis Kruse Blunk Architects, 2007)

Figure 13 depicts the ground level floor plan. The storefronts are separated by brick interior party walls although there is a double-arched opening between 524 and 526 East Grand, just north of the centered stairway.

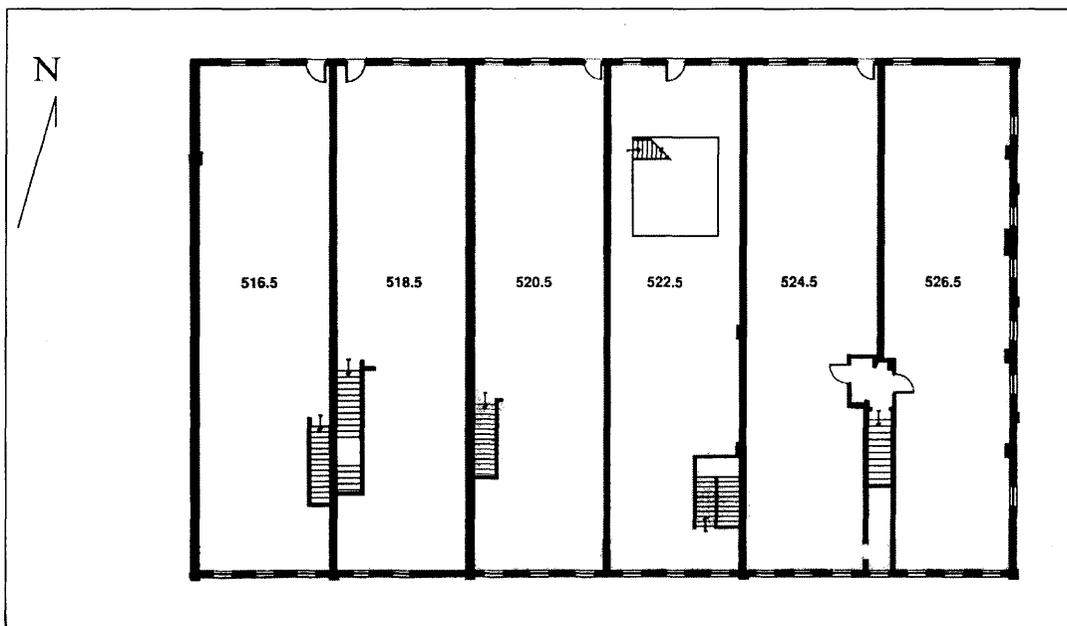
Figure 16: Current Second Floor Plan (Herbert Lewis Kruse Blunk Architects, 2007)

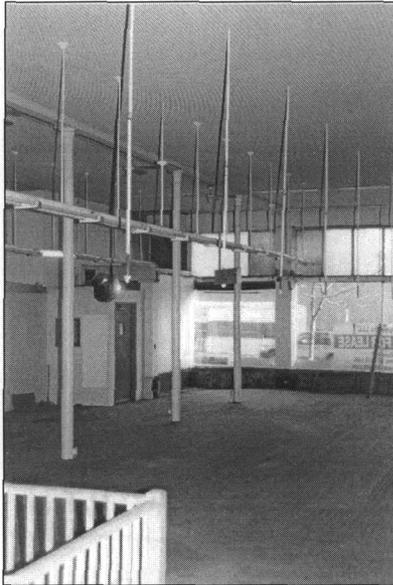
Figure 17: Tapered cast iron columns on centerline of 520-522 East Grand, view southeast
(photo by James Jacobsen, February 2007)

The five hollow cast iron columns that substitute for a solid party wall in 520-522 East Grand are tapered (Figure 17). This is a special point of interest and is recommended as a point of particular architectural interest. The columns have welding lines but no obvious roller marks. In the same storefront, a cast iron threshold with inset prism glass survives in the front entryway. It was part of a system that included front basement windows that provided light into the basements of the building.

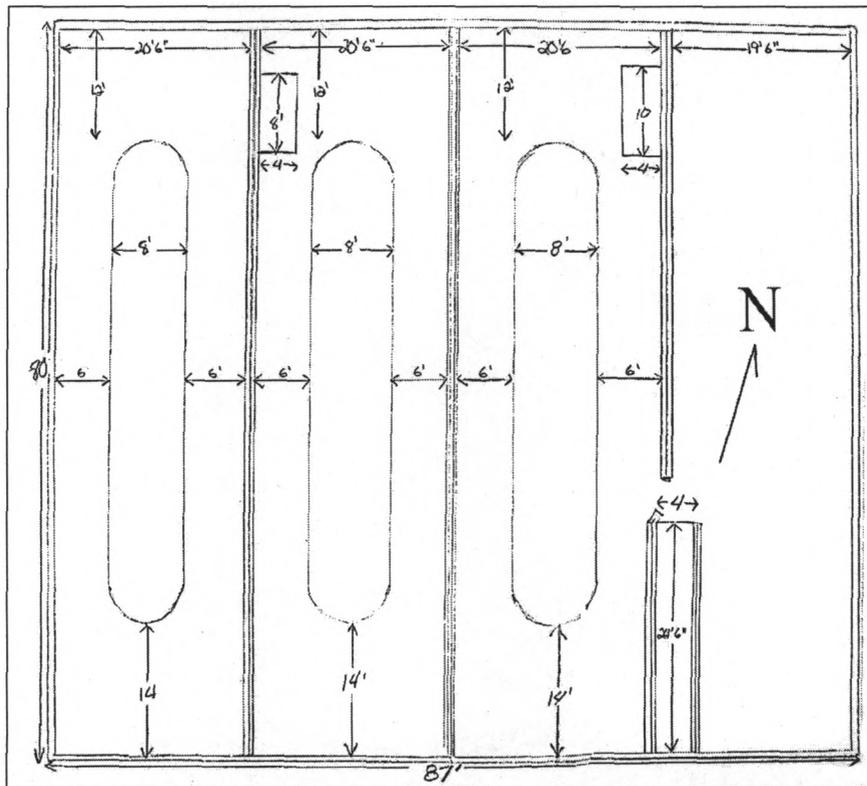
Figure 19: Second floor mezzanine plan, 520-526 East Grand (James Boyt, 1974)

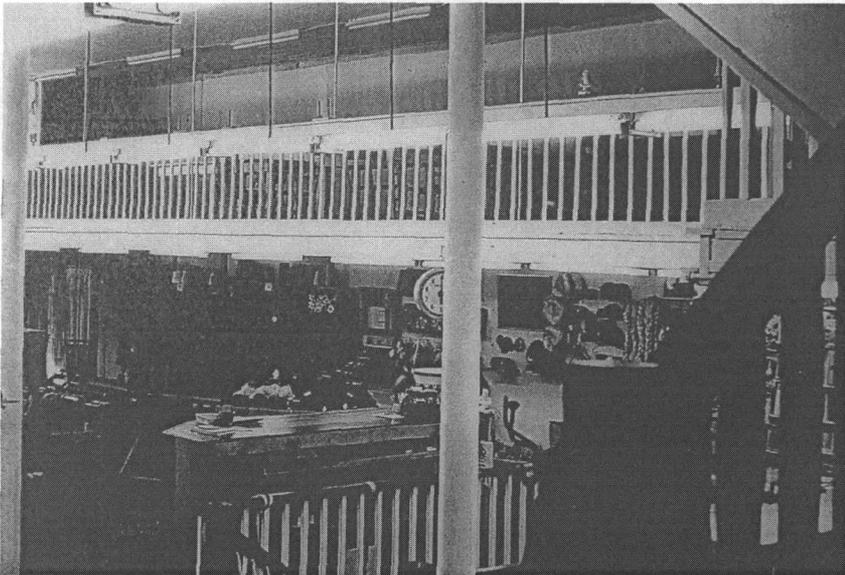
Figure 20: Mezzanine balcony in 520-522 East Grand, viewed southwest from the stair approach (James Boyt, c.1974)

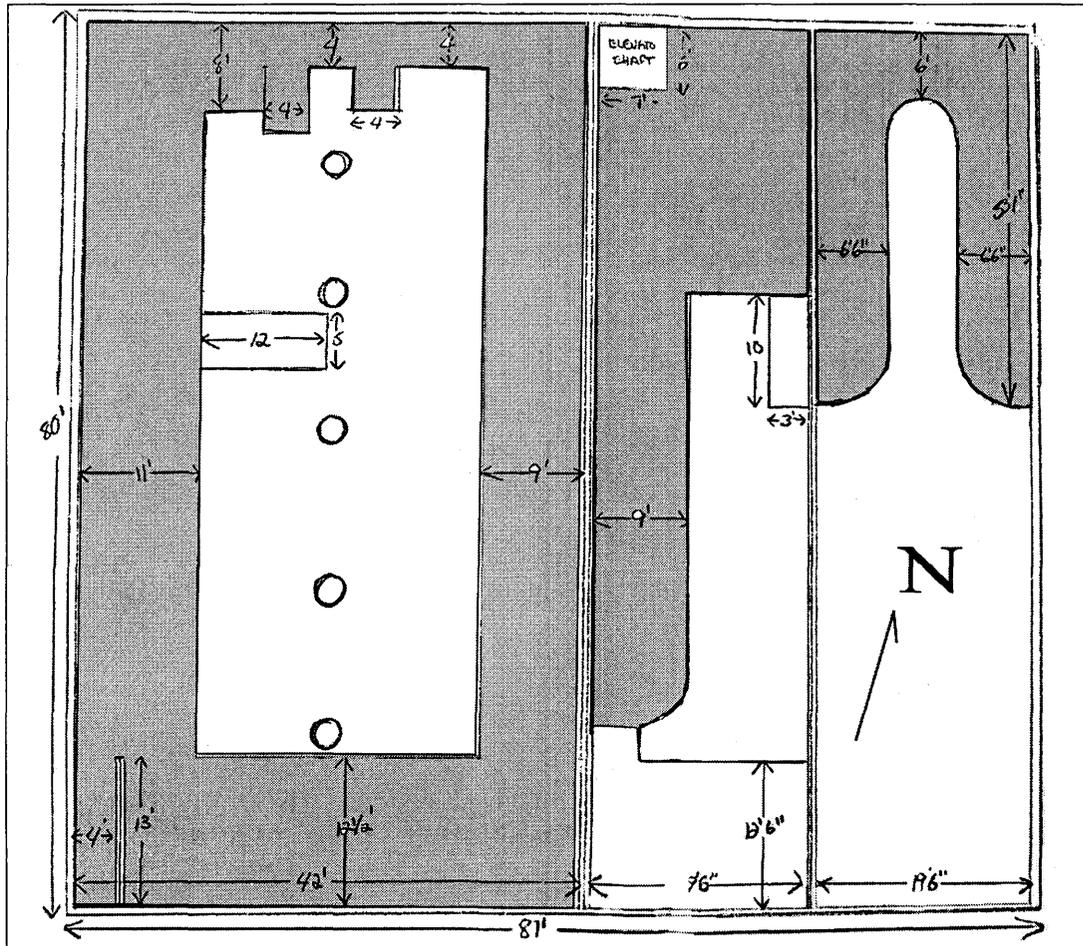
Figure 21: First Floor Mezzanine Plan, 520-522 East Grand (left) and 524-526 East Grand (right) (courtesy of James Boyt) (mezzanine areas shaded gray for clarity)

2006-07: The second floor mezzanine levels were removed as has been described as part of the buildings' current redevelopment. The same feature on the ground floor of 520-522 East Grand is also in the process of being removed (Figure 17). The mezzanine elements in 524-526 East Grand remain in place.

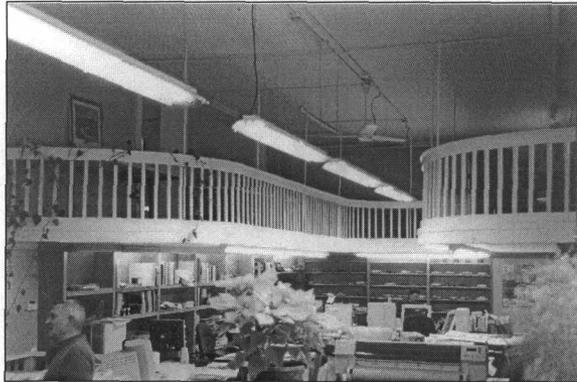
Figure 22: Mezzanine on ground level, 526 East Grand, view northwest
(photo by James Jacobsen, February 2007)

526 East Grand is currently in use as an architect's office (Figure 22). There is a raised floor area in the front of the plan and a double side entrance is on the East Sixth Street side. No historical finishes are visible on the main floor. Upstairs, an apartment has a modern central infill module with kitchen and bathroom but there are no historic or other room partitions.

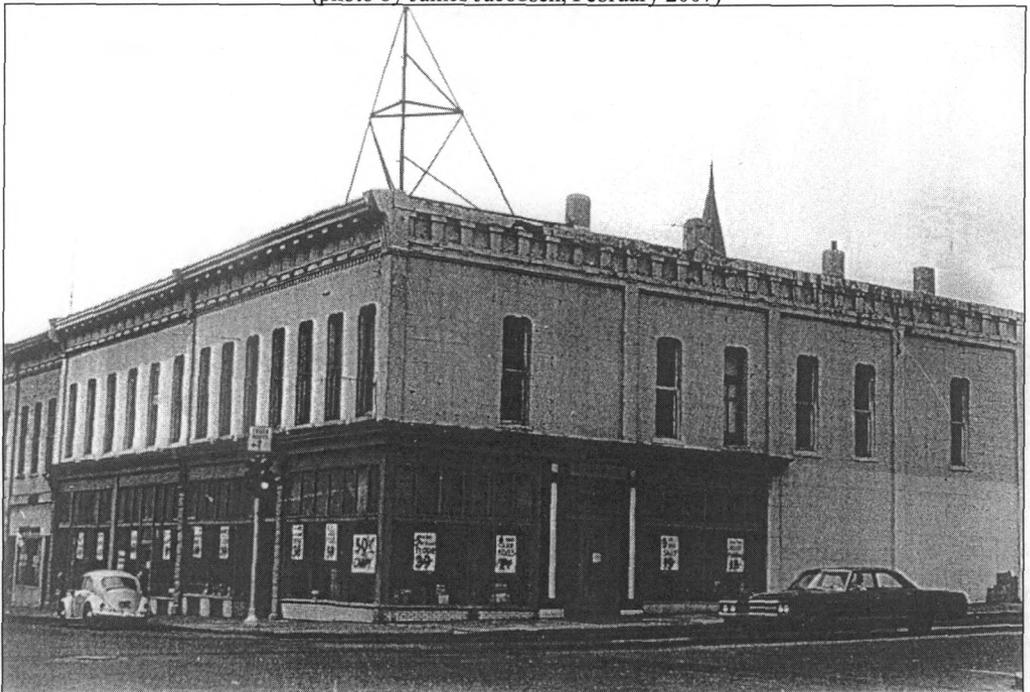
Figure 23: c.1968 photo, view northwest (James Boyt)

Figure 23 illustrates the stuccoed “ashlar stone” appearance of the buildings at the time of its initial restoration. The metal support for the vertical neon “Anderson” sign remains in place. Note also that the restored side door, centered in the fourth bay from the façade on the sidewall, was completely filled in as of this time. Also filled in was a half-sized window in the third bay of the east side wall (now reopened).

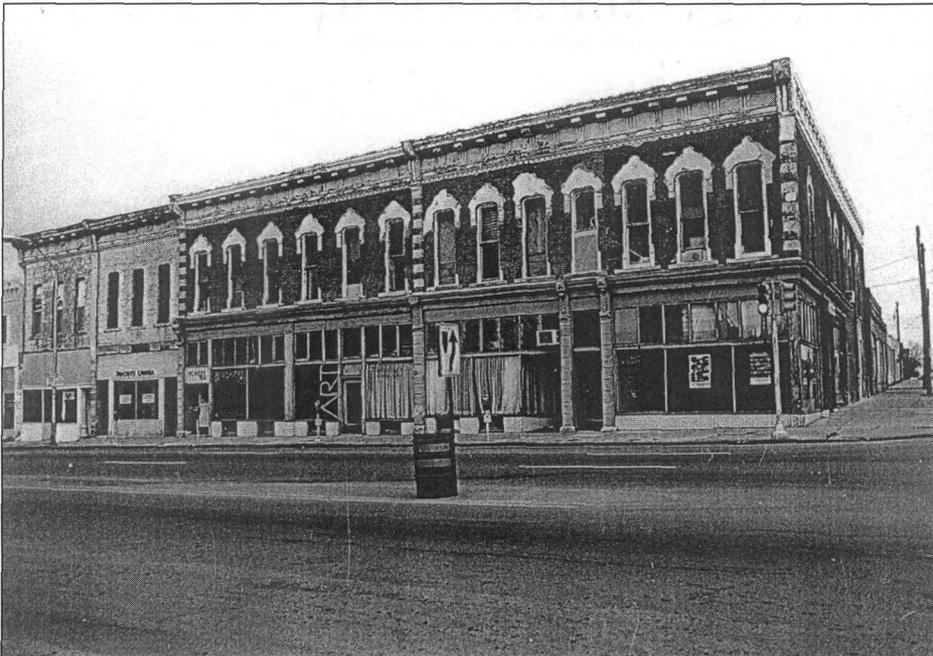
Figure 24: Buildings' appearance following stucco removal, c.1977, view northwest (Courtesy James Boyt)

Beginning in September 1976, the stucco cladding was removed and the damaged stone window hoods were restored. The window hoods were restored by adding pre-cast fiberglass fronts that replicated the original design. Windows were repaired rather than replaced and the brickwork, damaged by the texturing done in 1922 to hold the stucco, was re-pointed and sealed with Hydrozo. This application was then state-of-the art treatment for severely damaged brickwork. The restoration of the exterior has preserved and restored a very early commercial block in an area where most historical buildings have been lost.

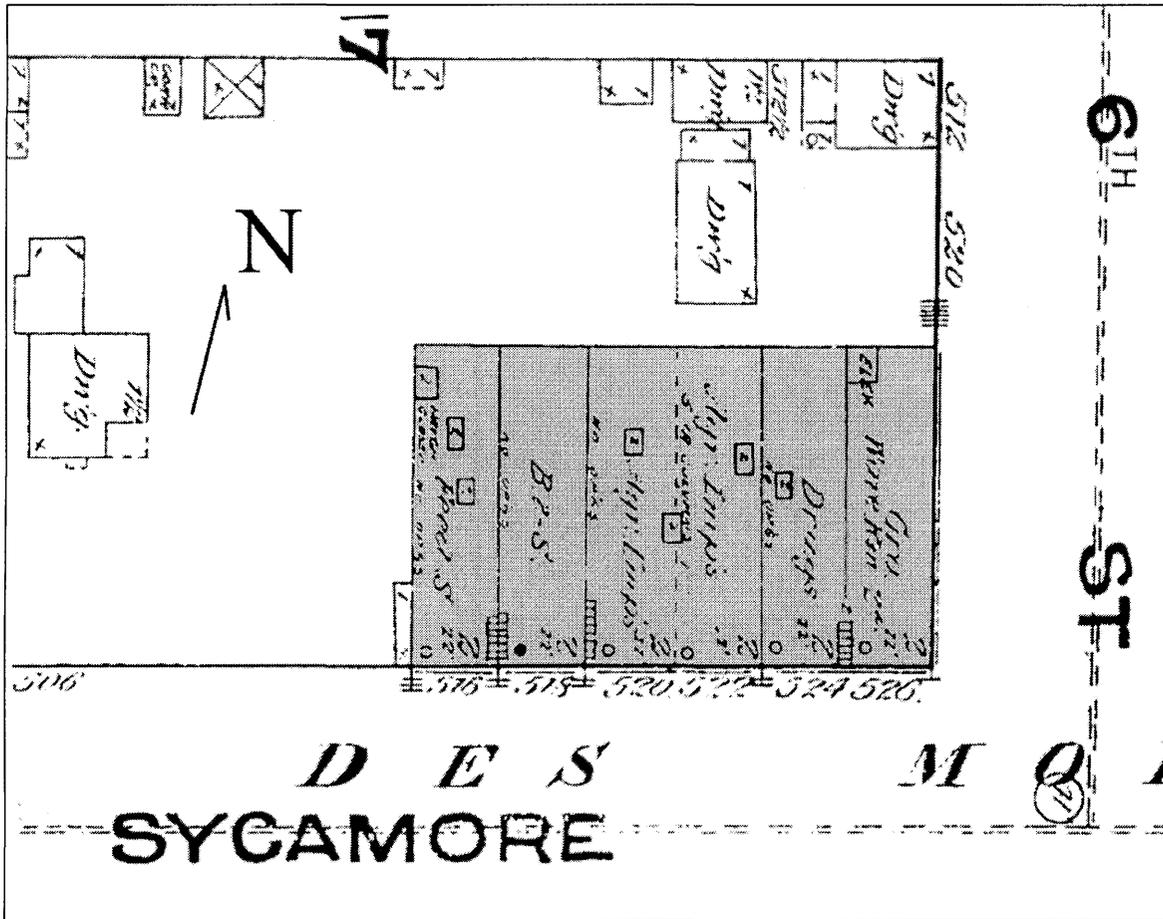
Figure 30: Detail, Sheet 12, March 1884 Sanborn Fire Insurance Map, Des Moines, Iowa
(nominated buildings are shaded gray)

Figure 30 shows the finished buildings just months after their completion. As already noted, additional features were yet to be installed, such as rear porches and exterior stairways. Duane DeVotie's residence is visible at the left center of the map, 506 East Sycamore Street. Seven skylights are depicted along with a freight elevator in the rear of 526 East Sycamore.

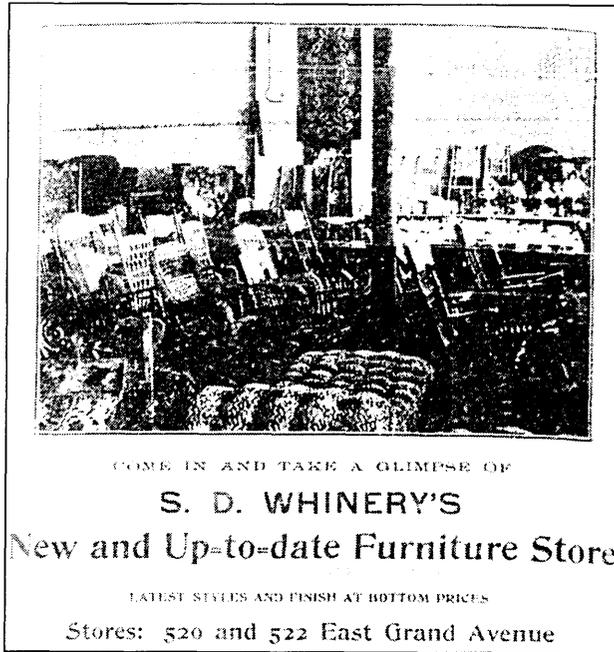
Figure 34: Whinery furniture ad depicts two metal columns (upper center of image)
(*Plain Talk*, February 3, 1900)

Furniture sales made their appearance in 520-522 with the Whinery Furniture Company, in 1899, starting a trend that ended only in 1969 (Figures 33-34). Its founder, Solon D. Whinery (1854-1943), later partnered with A. J. Goar. Solon Whinery and his brother Columbus had partnered earlier with Adolph F. Anderson. With the death of Columbus Whinery, A. B. Elliott bought out their interest and partnered with Anderson. Whinery was successful with his new business. *Plain Talk* reported in early 1900 that "S. D. Whinery's new furniture house, 520 and 522 East Grand avenue, is enjoying a splendid trade. And no wonder. His stock is all new and of the latest designs and the prices are right." The Spring Hub Bicycle Manufacturing Company that had its origins as the Elastic Wheel Company in 1899 (located a block to the west) occupied 518 East Grand beginning in 1912. By 1947 it expanded into 512-516 East Grand to the west and remained in business in the three fronts through 1968. 518 East Grand housed a number of smaller-scale retail operations a grocery, hardware store, jewelry store and even a clothing store, between 1909 and 1922. Martin Johnson's Clothing Store appears to have been associated with the appearance of Linnea Hall, first listed upstairs at 518 East Grand, in 1917. Between that year and 1970, the hall housed the Society Linnea, Society Dania, the Dania Savings and Loan Association and a meat packers' labor union. Jonas A. Bachman's sheet metal shop, established in 1898, occupied 524 East Grand for six years (1901-07). The firm enjoyed considerable success in later years under the management of Bess Bachman (*Plain Talk*, December 9, 1899; February 10, 1900; March 4, 1943; August 11, 1949).

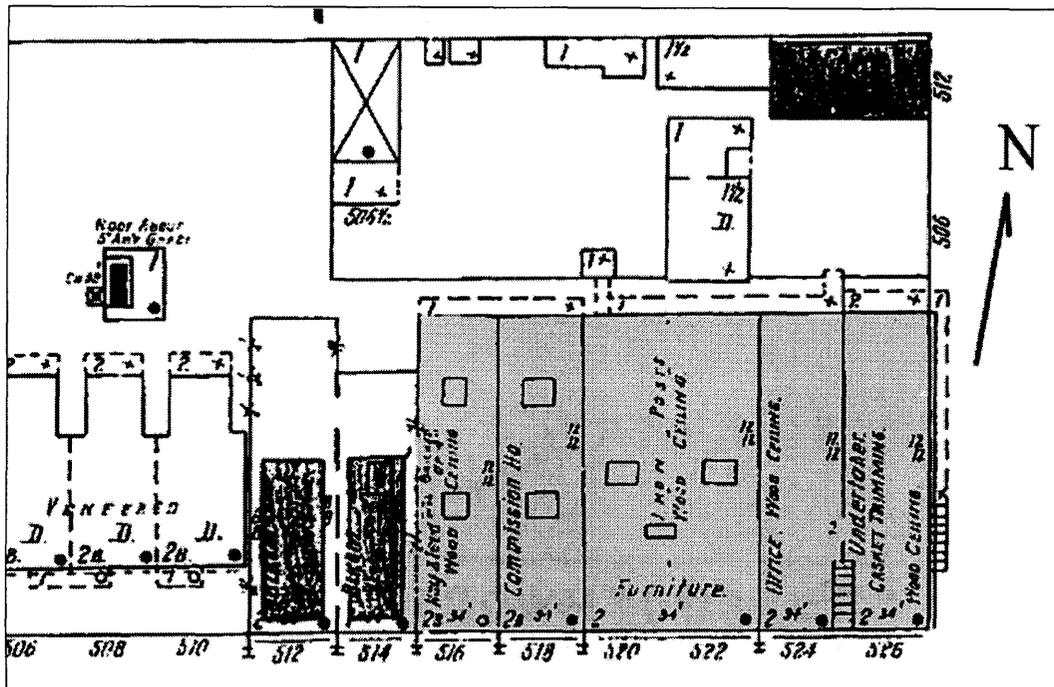
Figure 35: Detail, Sheet 153, Volume II, 1901 Sanborn Fire Insurance Map, Des Moines, Iowa
(nominated buildings are shaded gray)

of the subject buildings. The map continues to exhibit the rear porches, east stair and balcony and the skylights, arrayed more numerous and differently than they were in the previous map. The freight elevator in 526 East Grand is not shown.

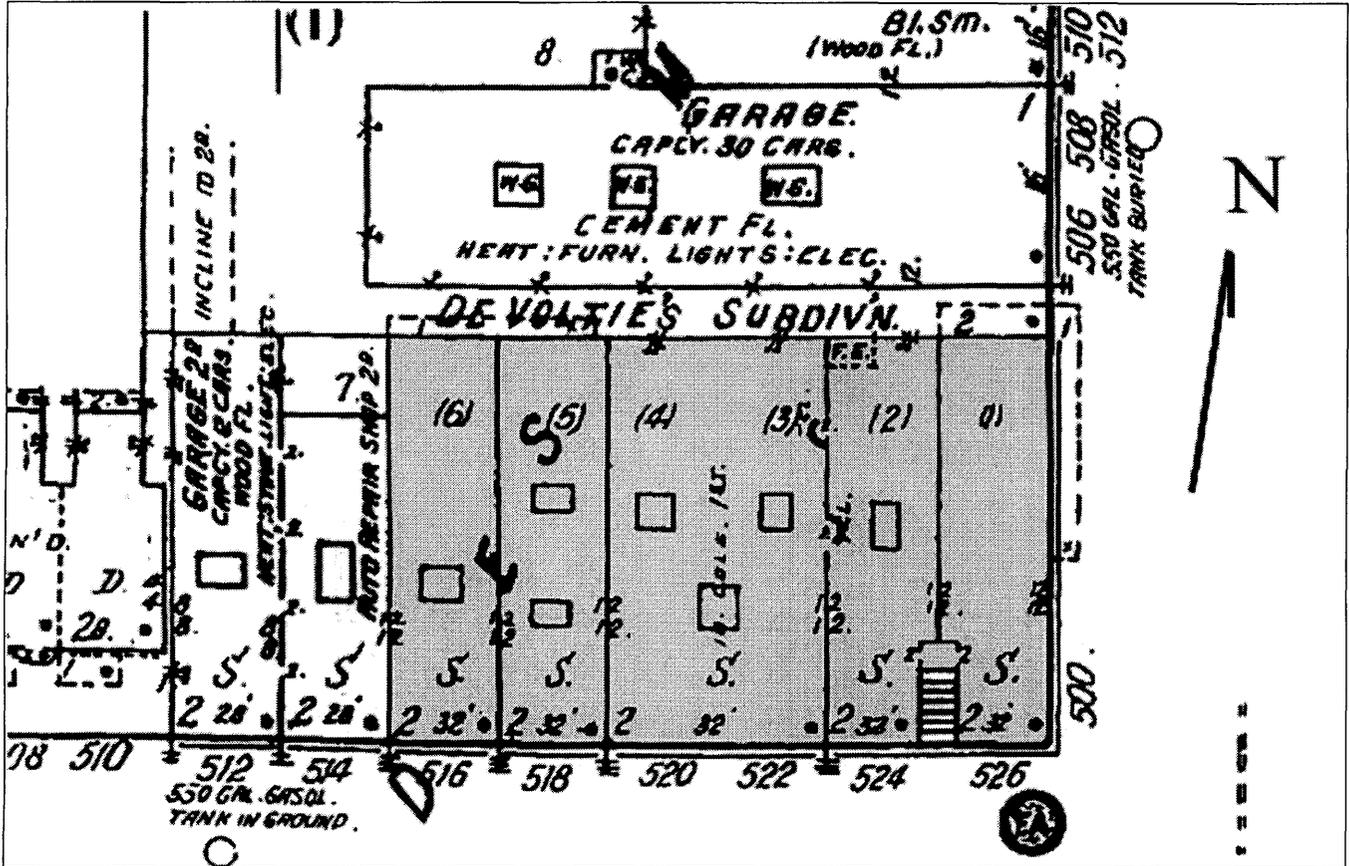
Figure 36: Detail, Sheet 154, Volume II, 1920 Sanborn Fire Insurance Map, Des Moines, Iowa
(nominated buildings are shaded gray)

Pre-1940: The metal cornice that separated the transom and upper level of 516-518 East Grand was removed. It appears that a large I-beam occupies the area that was covered by this cornice (Figure 36).

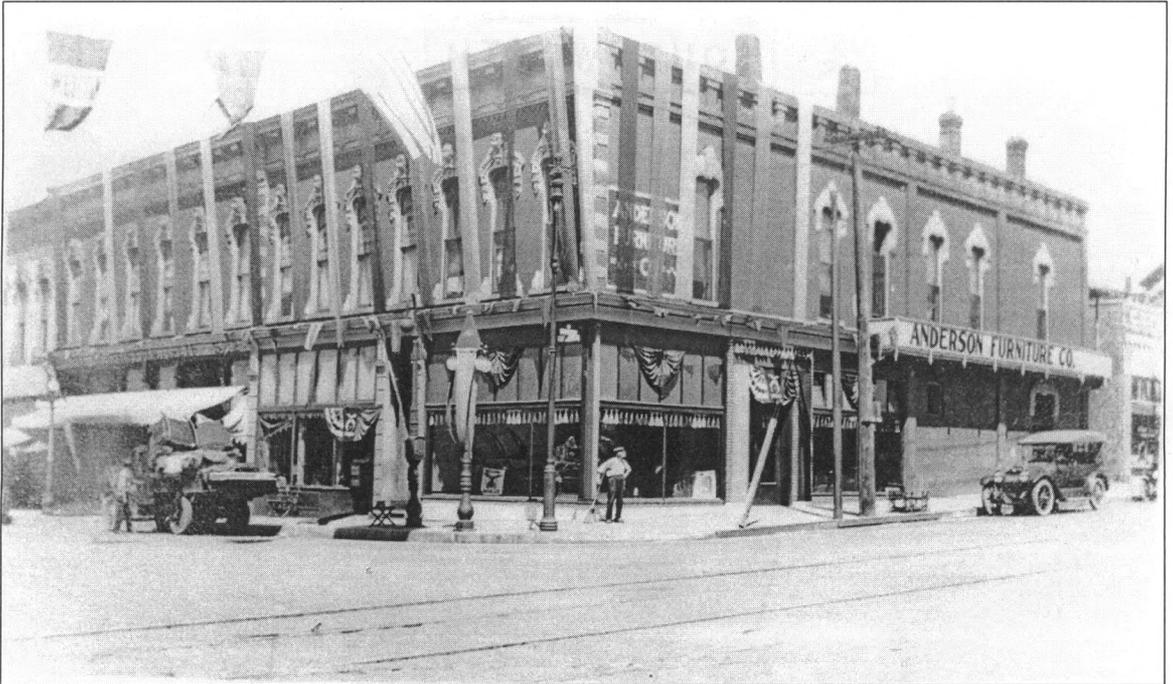
Figure 37: Anderson Furniture Company. Shriners' Convention Decorations, c.1920-21 (Courtesy Jim Boyt)
Note also that the rearmost five stone hoods above the East Sixth Street have all been cut back to the wall plane, in preparation for the scored stucco covering that was to follow

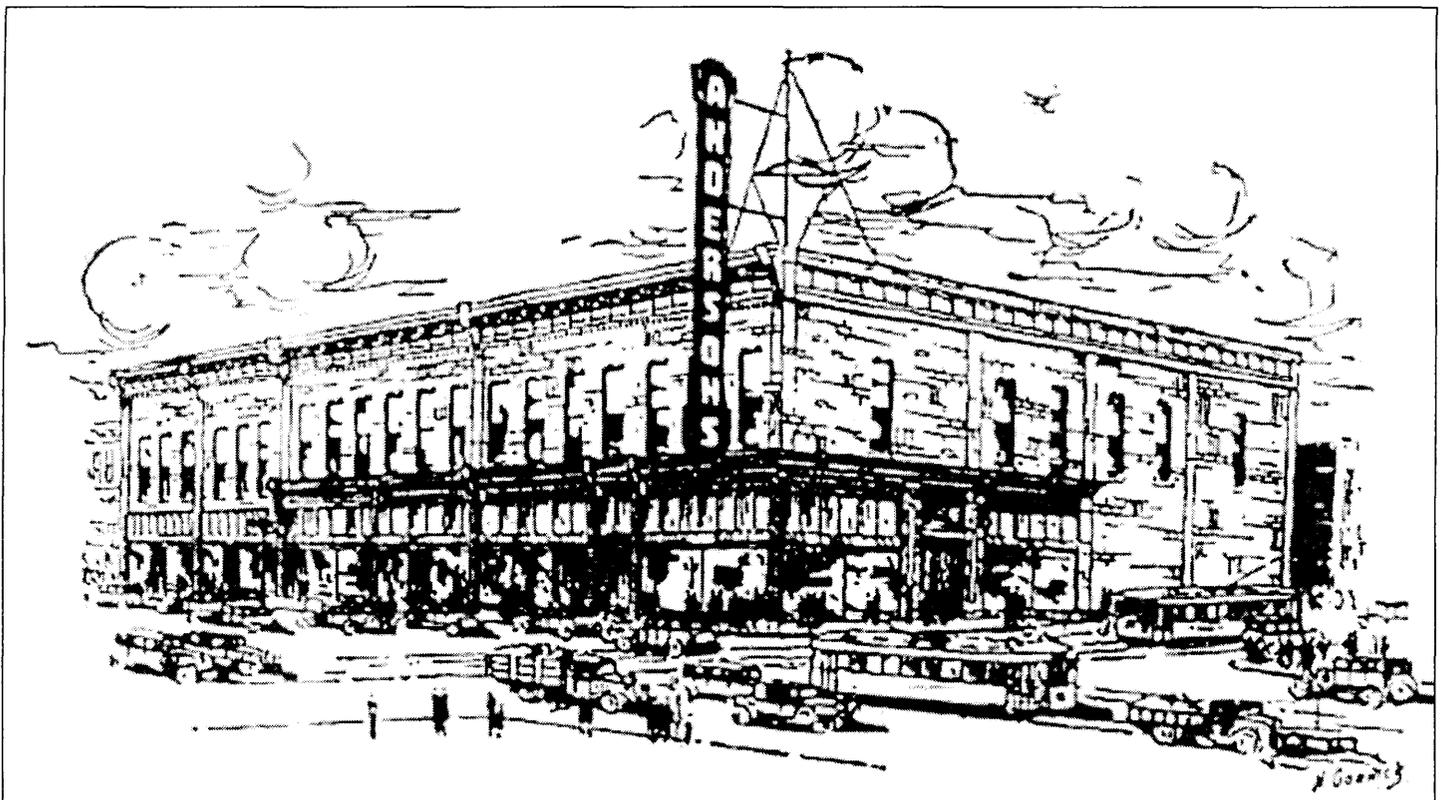
Figure 39: Remodeled building exteriors (*Tribune*, January 29, 1932)

Figure 39 depicts the initial storefront remodeling that the Anderson Furniture Company carried out once it expanded to occupy the four storefronts. Most notable is the brick-framed East Sixth Street side entrance. The image matches the details evident in the 1920 Sanborn Map (see Figure 36).

Building permits issued March 2, 1921 (for 526 East Grand, for \$700) and March 3, 1922 (for 522-26 East Grand, \$2,000) mark internal and external modifications. The buildings' exteriors were stuccoed and generally remodeled (see Figure 39). In 1933 the store expanded westward to add 518 East Grand, occupying all but the westernmost storefront, 516 East Grand. In 1947 this last addition was vacated, and the business occupied four storefronts through 1962 when it was sold to Gene Nicholson. Anderson celebrated his 50th Anniversary in the furniture trade in 1932 (the store then had 23 employees) and as late as mid-September 1945, aged 85 and 63 years in business, continued to report daily for work. He was still reporting for work at the age of 88 years, when, in early October 1948, he suffered a broken hip that eventually resulted in his death a few weeks later. His son Herman Frederick Anderson (1886-1975) long served as the company vice president and took over its management with his father's death (*Plain Talk*, February 23, 1911; *Tribune*, January 1, 29, 1932; September 11, 1945; *Register*, October 23, 1948; Property Abstract).

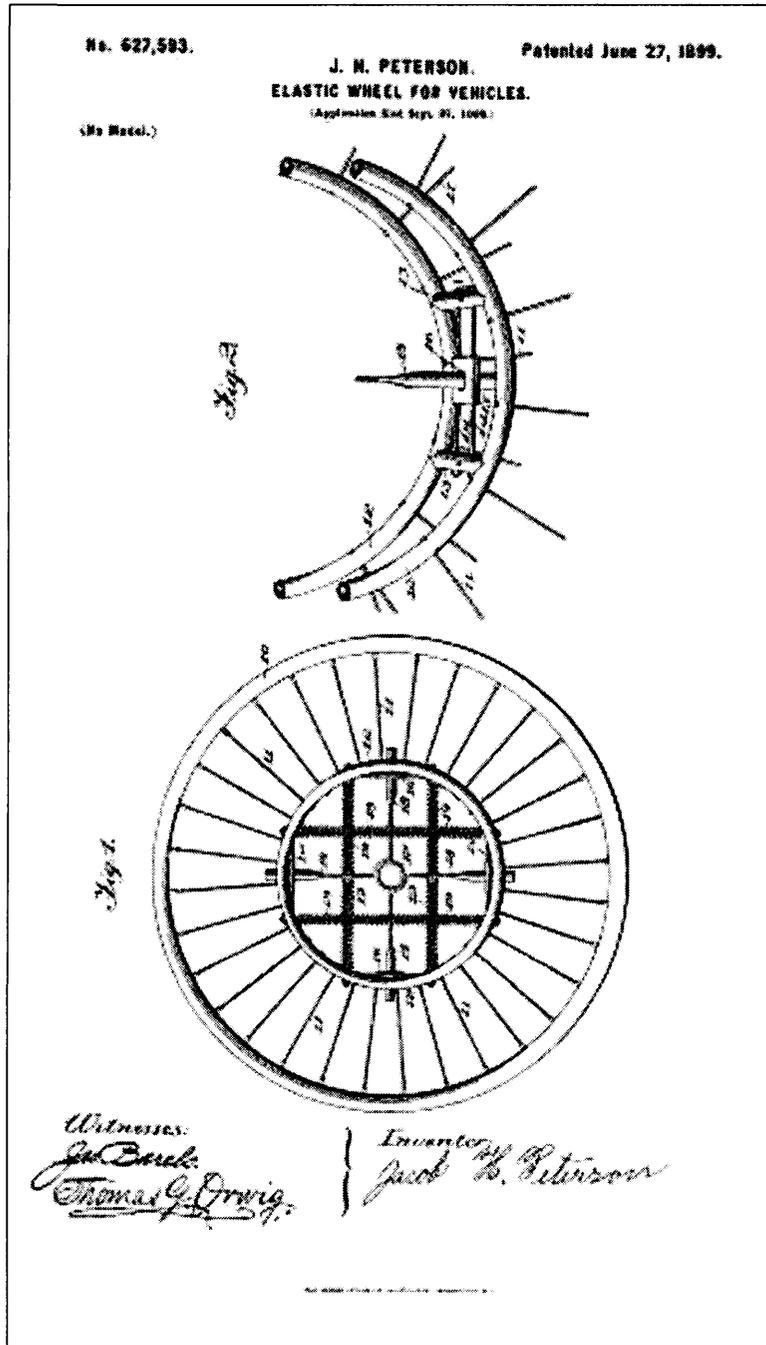
Figure 42: Patent #627,593, awarded to Jacob H. Pederson, Des Moines, Iowa

Figure 42 depicts the spring hub bicycle patent. The traditional bicycle hub was placed within a sprung secondary rim that was linked to the wheel rim using shorter but standard wire spokes. Four springs were crisscrossed within the inner double-tubed and four metal ties linked the hub and inner rim. These ties could slide across their mounts and their reactive movement was cushioned by the springs (United States Patents).

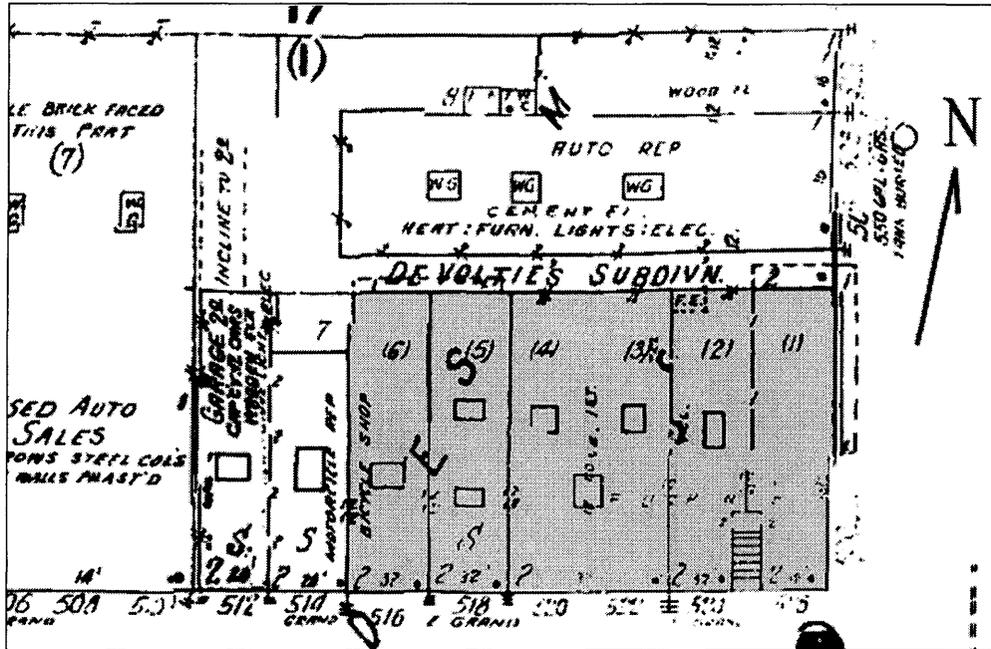
Figure 43: Detail, Sheet 154, Volume II, 1950 Sanborn Fire Insurance Map, Des Moines, Iowa
(nominated buildings are shaded gray)

The only substantial change in the half-block (Figure 43) is the replacement of the tri-plex to the west with an auto salesroom. Figure 432 continues to depict a northeast corner remnant of the exterior balcony, although the 1932 drawing (Figure 38) does not show the balcony.
