NATIONAL REGISTER OF HISTORIC PLACES
INVENTORY - NOMINATION FORM

Morristown District
Morristown
Morris County, Code:027
New Jersey, Code:34

Thematic Nomination of
Operating Passenger
RR Stations in New Jersey

Morristown RR Station,
Morristown Town, Morris County

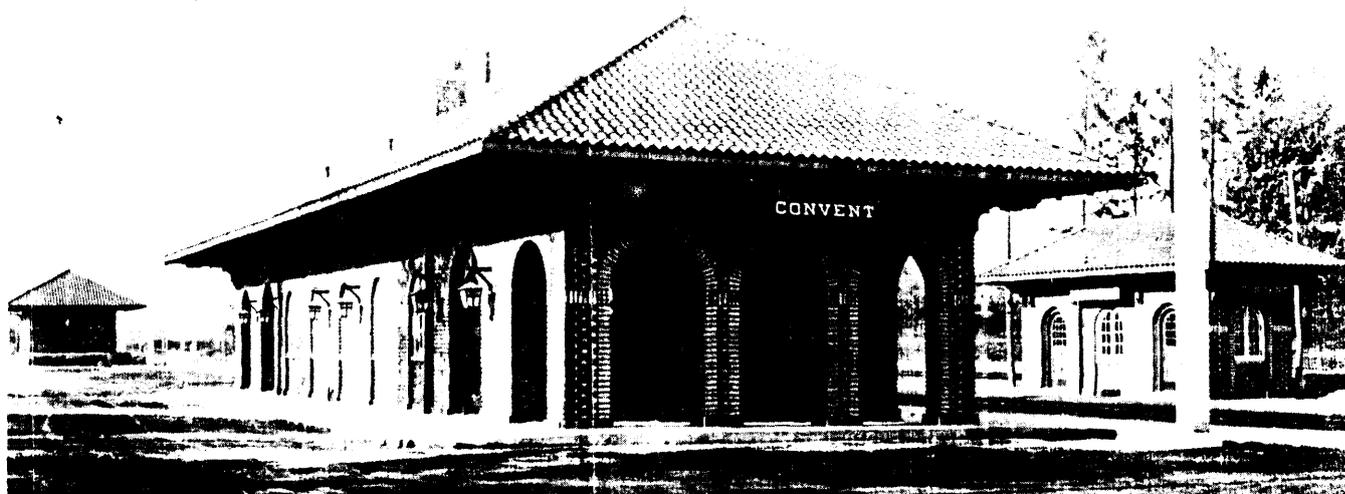
Convent received a new station in 1913-14 similar to several others to serve the College of St. Elizabeth students. On the far side of the westbound waiting room are the trolley tracks of the Morris County Traction Company. In the distance is the small freight house built at the same time. This picture was taken from adjacent to the grade crossing going into the college — the only grade crossing left east of Dover. Until after World War II, few people commuted from Convent, but all that changed rapidly, and the open fields around the station soon became paved parking lots.

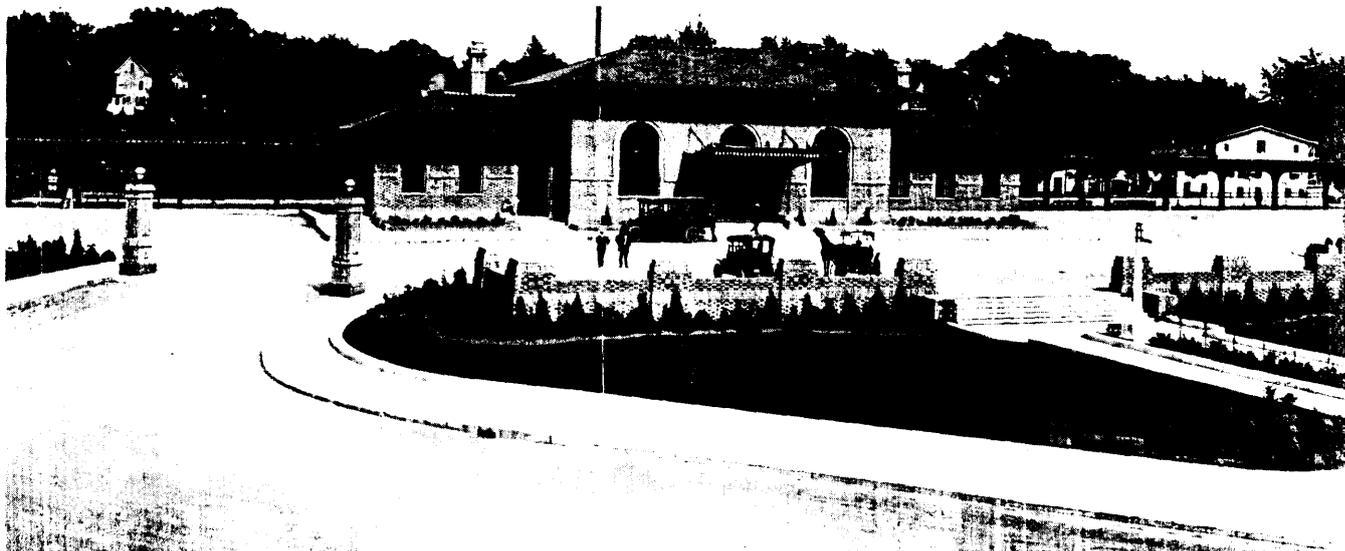
Morristown, as the county seat of Morris County and the largest community west of the Oranges at one time, was the stopping point for the Buffalo trains. By 1910 the Lackawanna had completed plans for the elevation and was ready to start work until President Richard McEwan of the little Morristown and Erie Railroad said nothing doing unless the Lackawanna made a certain road under the tracks public and raised the tracks higher so that a trolley could run under them to his station. Not only would raising the tracks add additional expense, but it put the M. & E. in a potential position to seriously challenge the Lackawanna for New York commuters. The Erie occasionally considered completing the Montclair tunnel which would mean that the Morristown and Erie route would be two or three miles shorter than the Lackawanna. The M. & E. could foreseeably run its trains over the trolley tracks up into the center of Morristown whereas the Lackawanna station was three-eighths of a mile away. The stalemate continued throughout 1911 with thousands of words appearing each month in the local newspapers. Finally, in 1912 President Truesdale announced that they would not elevate through Morristown if President McEwan didn't give in. Truesdale agreed to make the private road public, and McEwan gave in on his height demand — thereby assuring that the Lackawanna would not lose business to McEwan. The new yellow brick station was opened for service November 3, 1913 and formally dedicated on December 10th. In front of the station in this view is the Morristown - Mendham jitney bus.

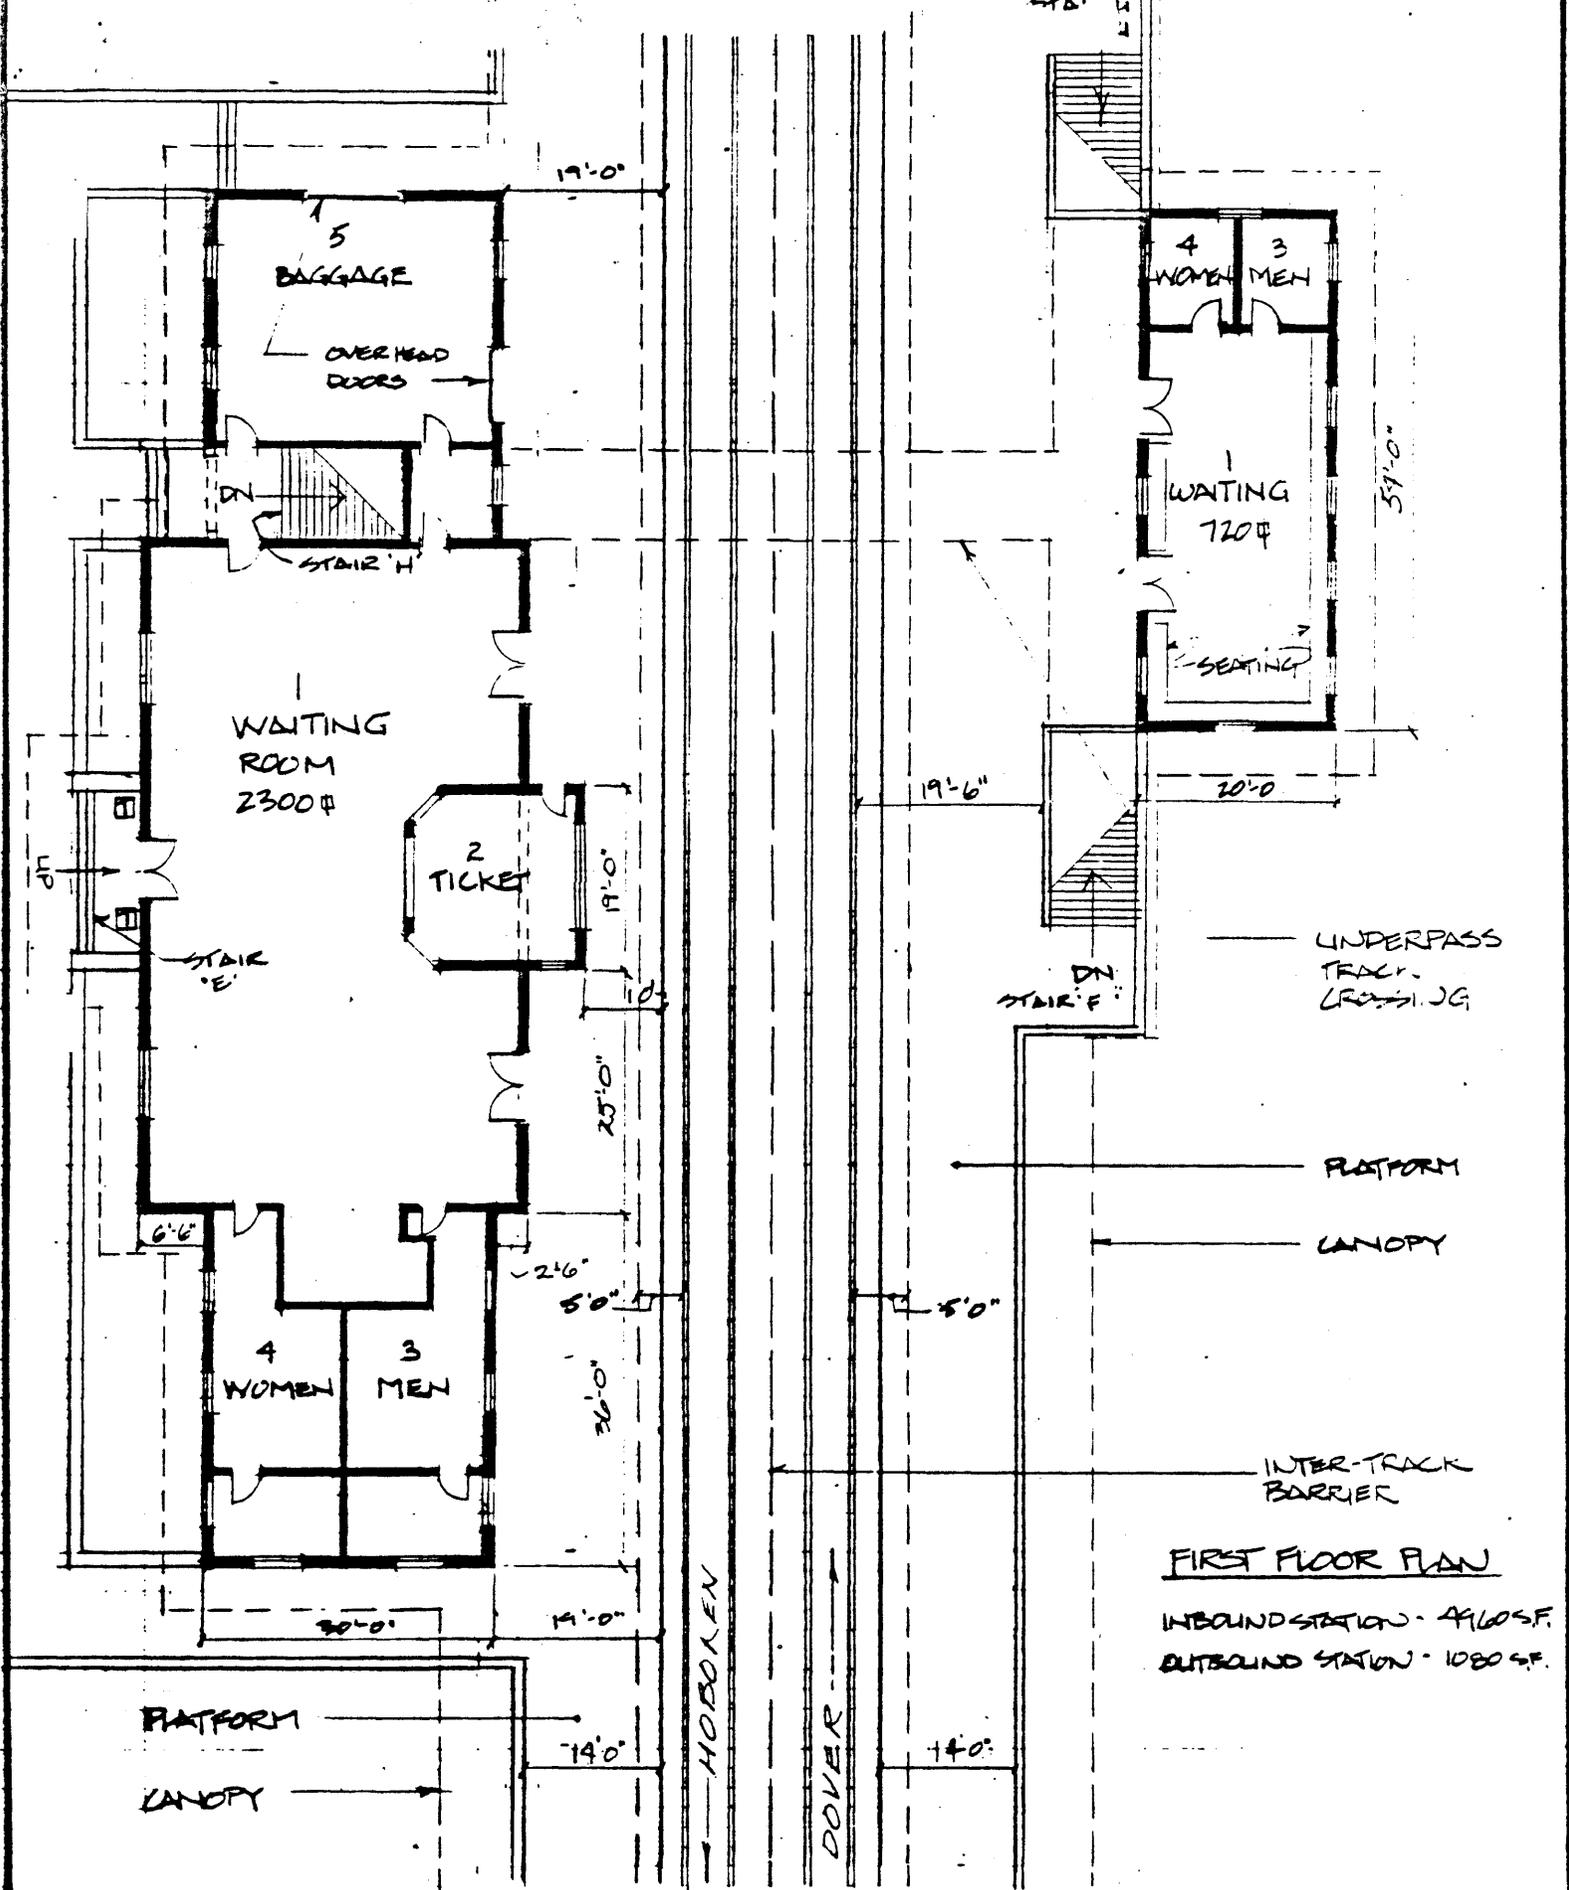
FIRST FLOOR PLAN
 INBOUND STATION - 4160 S.F.
 OUTBOUND STATION - 1080 S.F.

The spaces of the Morristown station are on one level (basement excepted). The main block comprises the Waiting Room (1) and, fitted into the E facade projection, the Ticket Office (2). Adjoining the Waiting Room on the N are the Baggage Room (5) and the W entry to the pedestrian tunnel. To the S of the Waiting Room are the rest rooms (3,4). All spaces have typical D, L, and W finishes (see schedules) and are in original condition. Of particular interest are the classical detailing of the Ticket Office partition, and the terra cotta trim of the Waiting Room walls.
